Damage Identification in Masonry Structures with Vibration Measurements

L.F. Ramos & P.B. Lourenço

For the first phase of the proposed approach it is presented the case study of Mogadouro Clock Tower. The Mogadouro Clock Tower is located inside the castle perimeter of Mogadouro (see Figure 1), a small town in the Northeast of Portugal. It has a rectangular cross section of $4.7 \times 4.5 \text{ m}^2$ with an interior hole of $2.5 \times 2.3 \text{ m}^2$, and a height equal to 20.4 m. It was built in stone masonry with granite and shale, with dry joints at the corners and with mortar joints in the central part of the walls. The walls have, on average, 1 m of thickness and are composed by an irregular bond of stones.

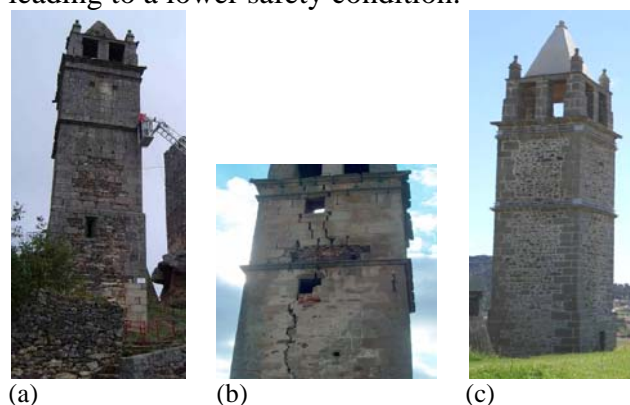
Due to lack of maintenance, severe damage was observed in the tower in 2004. The damage was characterized by cracks, material degradation, out-of-plane displacements, loss of material in some parts, and biological growth, see Figure 1a. The most severe damage was a pair of cracks in the East and West façade, see Figure 1b, that divided the box

cross section of the tower in two separated U bodies, leading to a lower safety condition.

Figure 1 – Mogadouro Clock Tower: (a) and (b) general view of the tower with severe damage; and (c) the tower after the strengthening works

To re-establish the tower safety, consolidation works were carried out in 2005. The remedial treatment included: injections for the walls consolidation, replacement of deteriorated materials and the installation of tie-rods at two levels with very light prestressing stress. Figure 1c presents the final appearance of the tower after strengthening.

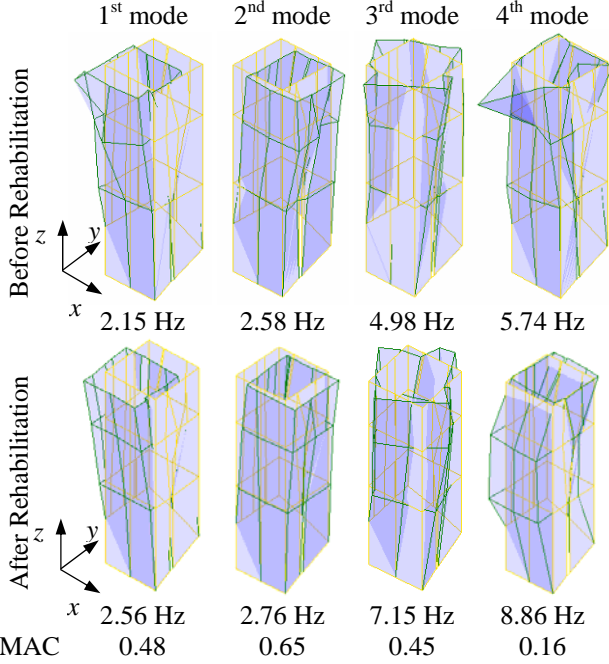
Figure 2 – Estimated mode shapes before and after strengthening, together with the MAC values

Analyzing the modal displacements, local protruberances can be observed in the areas close to the cracks and in the upper part before the rehabilitation. This is due to the presence of severe damage. The structure only behaves monolithically after the rehabilitation.

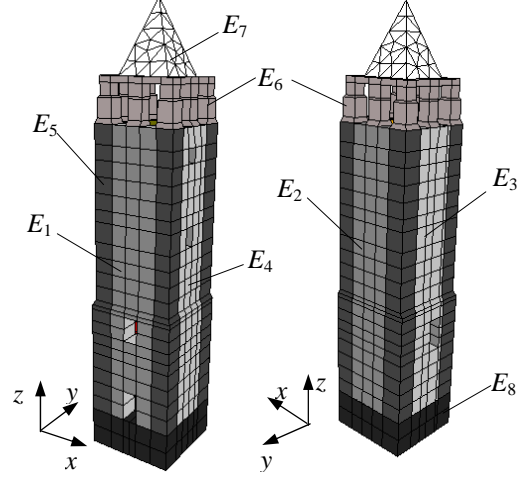
Figure 3 – Selected updating parameters

The results indicate that the damage on the tower was severe on the central parts of the South, East and West façades and at the upper part of the tower. These areas in the structure are the ones which suffer large mortar loss due to deterioration, meaning

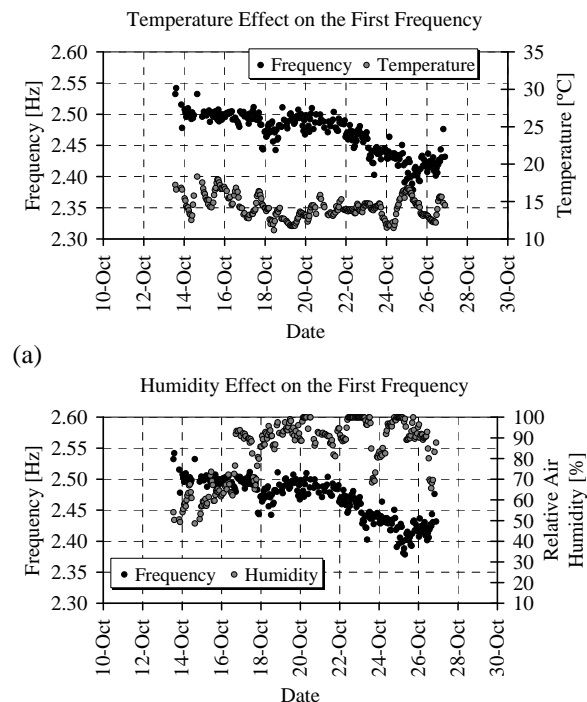
Here it should be stressed that a significant frequency shift related to the walls water absorption happens twice a year. Figure 5 presents the first resonant frequency variation compared with the environmental variables along short period. During this period the temperature did not change significantly, while the relative air humidity after 18th of October is close to 100%, i.e. the first raining season on the site. After 22nd of October the frequency values decrease linearly with humidity almost constant. This indicates that the structure absorbs water and the mass changes, reducing the frequency values because the two quantities are inverse related. It can also occur that water leads to a stiffness reduction, at least in the lime mortars. The inverse drying phenomenon also happens during the hot period.

Figure 5 – Environmental effects of the dynamic response

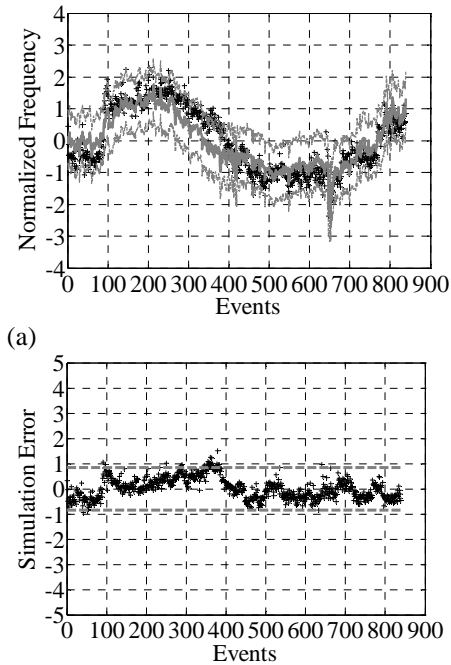
Figure 6 shows for the first natural frequency the fitting model through the normalized frequency and simulated errors with the 95% confidence intervals ci . In general, the model represents the frequency variation, but it doesn't account the water absorption phenomenon, because the relative humidity variation does not totally represent that change. Furthermore, the damage is detected by frequency shifts that significantly go outside the confident intervals ci .

Figure 6 – Numerical simulation: (a) ARX model; and (b) the residuals distribution

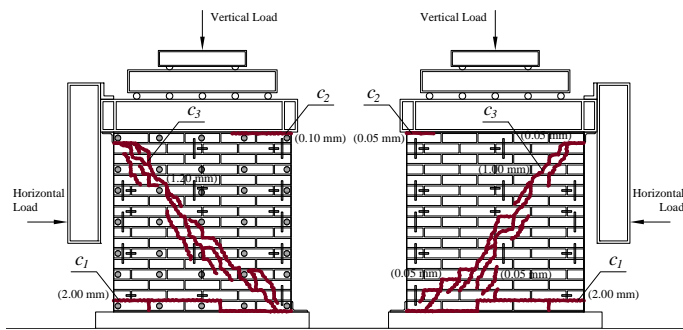
Figure 8 – Wall static tests: (a) test apparatus; (b) static response of the last series of tests; and (c) final crack pattern from the front and back sides of the wall

The final crack pattern includes three cracks. One bending crack is at left bottom part, and another bending crack is at right top part of the wall, namely crack c_1 and c_2 , respectively. The third crack (c_3) is a shear crack in the diagonal direction of the wall.

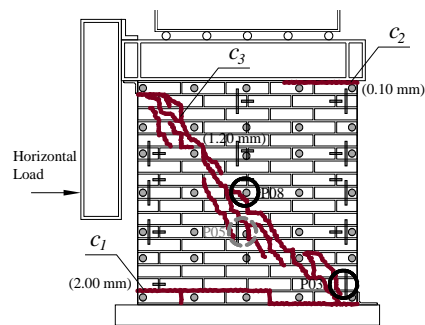
The results combination of the selected methods is extensively presented elsewhere (Ramos, 2007). As an example, Figure 11 shows the locations results for the case of the last DS when is compared with the preceding one (relative comparison). The damage location is given by the circles.

Figure 11 – Combination of non-model based results for the comparison between DS_{III-C} and DS_{IV-C}

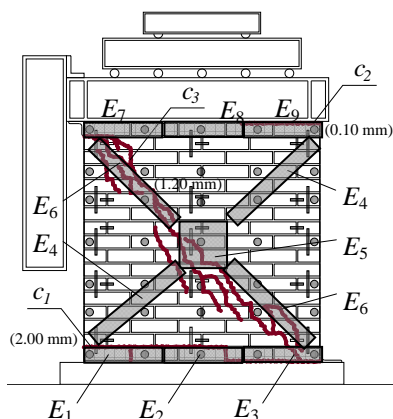
Figure 12 – Updating parameters for the damage analysis

In this series, the damage was expected to be localized at position E_5 and E_6 (crack c_3) and it was also expected to be observed the crack growth at positions E_8 and E_9 (crack c_2). Table 4 presents the relative values for the updating parameters, when compared to the values obtained for the same type of analysis but calculated to the RS_C.

The damage pattern was obtained with the updating analysis DS_{II-C} and DS_{III-C}. In the last updating analysis (DS_{IV-C}) the results were not consistent with the observed cracks, as damage at position E_4 was also pinpointed. This might be related to the large
