ASSESSMENT OF THE BÔCO HISTORICAL RC BRIDGE

José Sena-Cruz¹, José Carlos Araújo², Fernando Castro³, Marco Jorge⁴

Keywords: Concrete bridge, Hennebique system, Survey

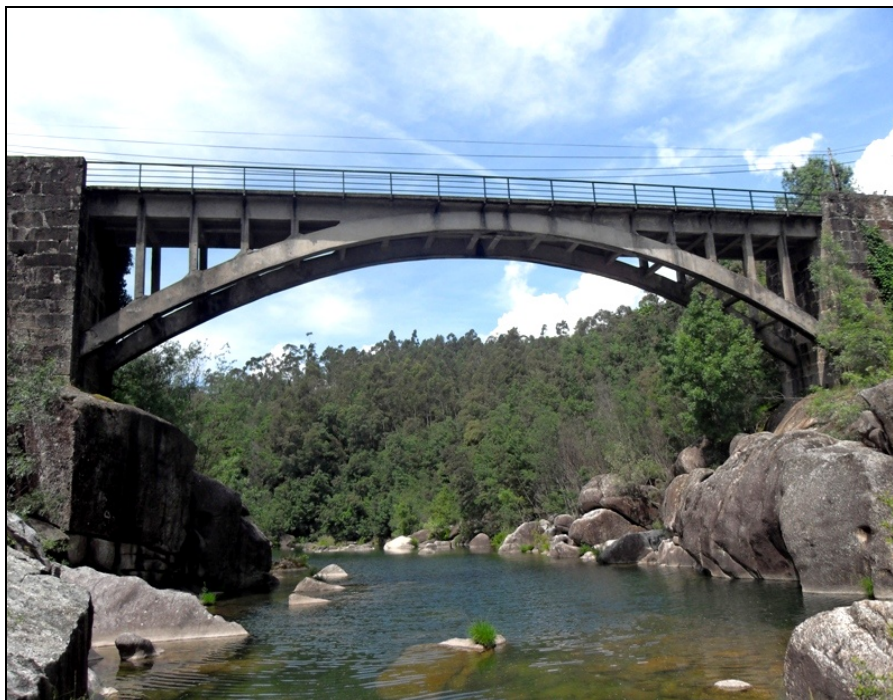
After 50 years rehabilitation has happened, without any additional intervention, the Bridge presents some degradation level. In spite of that, a nice landscape can be seen, as shown in Fig. 2. A comprehensive study of Bôco Bridge was carried out. These studies include the geometrical and

Fig. 2 View of the Bôco Bridge revealing its current state

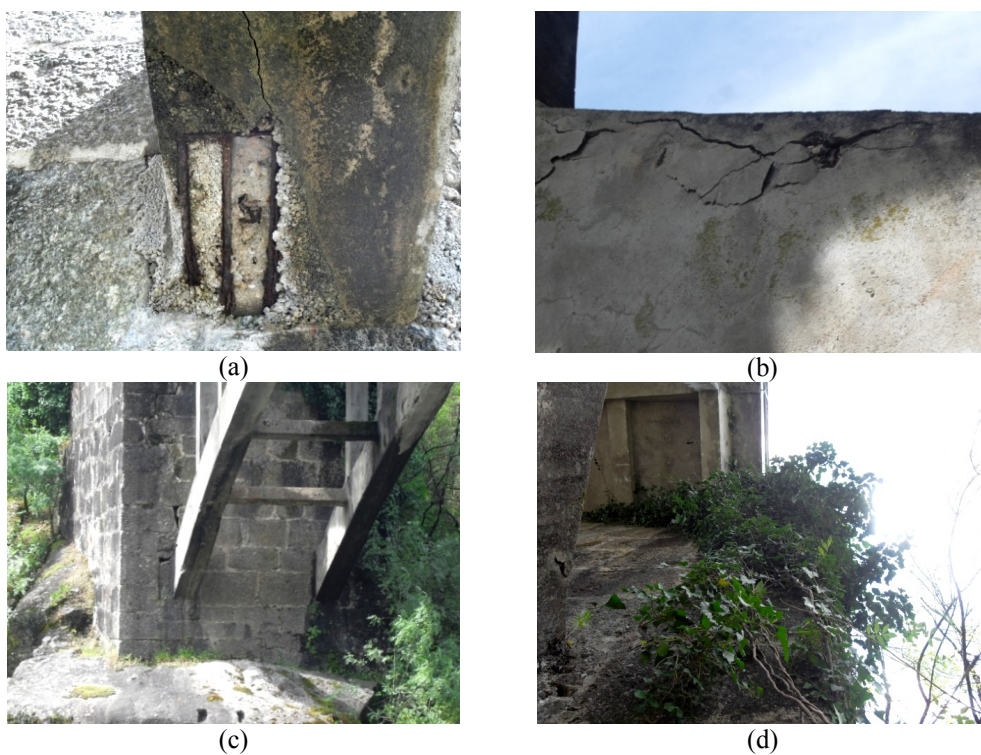
- Corrosion of reinforcement and loss of concrete cover due to spalling (Fig. 6a);
- Concrete spalling probably due to corrosion of reinforcement (Fig. 6b);
- Cracks in the masonry abutment (Fig. 6c);
- Biological growth (Fig. 6d).

The bridge is subject to extensive biological growth due to the ideal conditions to the development of these organisms. In general, the bridge presents good condition. However, arches at the abutments vicinity show some degradation due to corroded reinforcement. Spalling is an indirect effect caused by the reinforcement expansion due to corrosion.

Fig. 6 (a) Corrosion of the steel reinforcement and loss of concrete cover due to spalling (b) Concrete spalling; (c) Cracks in the masonry abutment; (d) Biological growth on the bridge

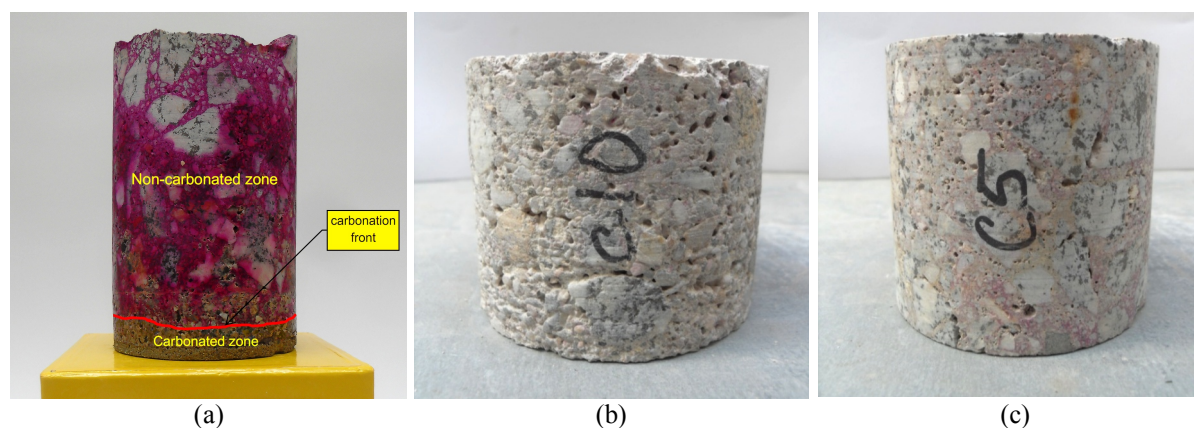
Table 2 includes the obtained results in terms of thickness (t) and corresponding carbonation depth (C) of each layer composing the sample, mainly the mortar (MO), new concrete (NC) and old concrete (OC). Fig. 8a shows core C3 after being tested for the evaluation of the carbonation depth. From these values it is clear that the mortar layer is completely carbonated. For the cases analysed old concrete does not have carbonation. This may be explained by the procedures adopted in rehabilitation performed in sixty decade of the past century. In fact prior doing the concrete enlargement of the cross-sections, a layer of the existing concrete was removing.

Fig. 8 Cylindrical cores: (a) Carbonation depth evaluation; (b) New concrete; (c) Old concrete

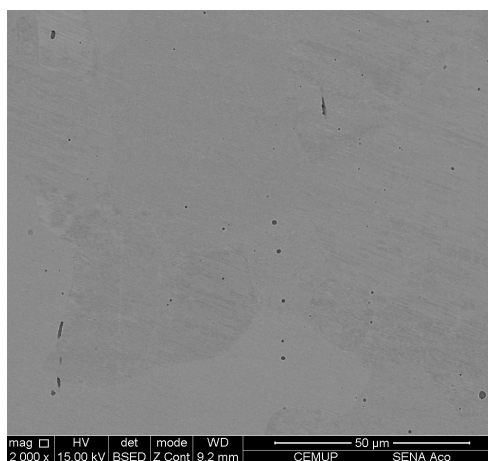
A sample of steel was taken from the bridge and was subject to chemical analysis by X-ray fluorescence spectrometer and a basic carbon element test. The results are presented in Table 4. The analysis revealed a mild steel with low level of carbon. Then the specimen was observed in SEM (see Fig. 9). The micrograph shows the existence of manganese sulphide inclusions, often aligned along the ferrite grain boundaries.

Fig. 9 Micrograph of the steel
