# POST-EARTHQUAKE SEISMIC ANALYSIS OF ST JAMES CHURCH, NEW ZEALAND

Ana F. Araújo, Paulo B. Lourenço, Daniel V. Oliveira & João C. Leite

ISISE, Department of Civil Engineering, University of Minho  
Azurém, 4800-058 Guimarães, Portugal.

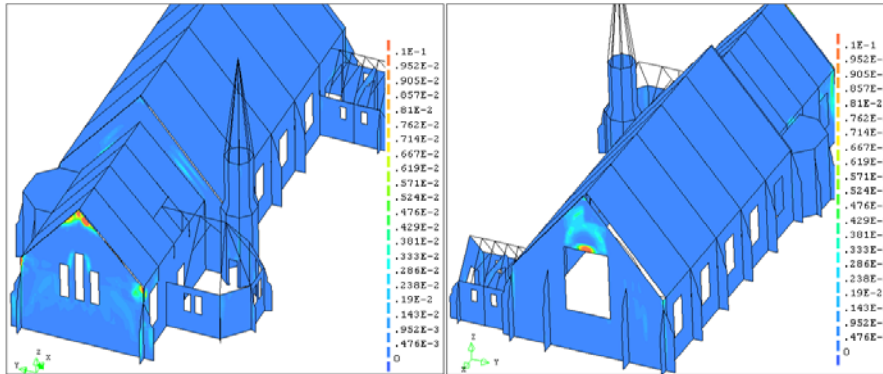
Figure 2 : Principal maximum strains distribution on the damaged model

As expected, the direction perpendicular to the transversal walls is proven to present the weakest resistance values, confirming previous considerations originated from both experimental results and visual inspection. For this reason, this study focuses mainly on the referred direction. Concerning the pushover analysis in the damaged model, the principal tensile strains are plotted as an indicator of damage (see Figure 2). In this analysis damage

is concentrated in the transversal walls as a result of out-of-plane deformations. Moreover, it can be easily noticeable that the maximum concentration of strains occurs on the top of the tympanum of the east wall, limiting the capacity of the Church. A possible interpretation of the collapse mechanism is a local failure in the east wall with the detachment of the top of the tympanum, which can then lead to the out-of-plane collapse of this whole part of the structure due to the pre-existent horizontal crack.

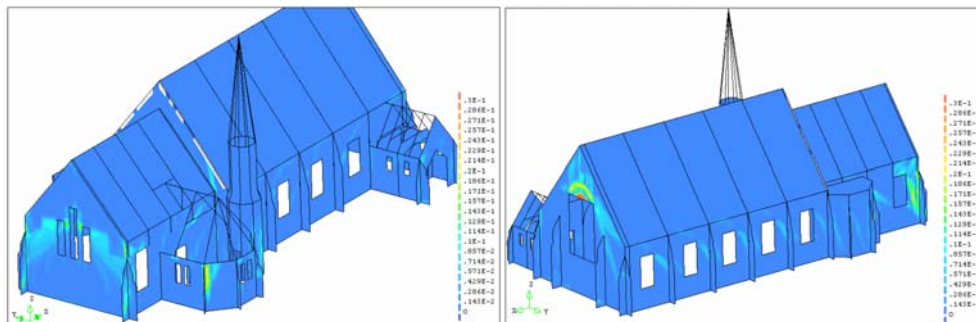
Figure 3 : Principal maximum strains distribution on the undamaged model

The analysis results of the undamaged model were evaluated and compared not only with the crack pattern due to the earthquake, but also with the previous analysis. As presented for the model with existing damage, the principal strains distribution resulting from pushover analysis is exposed in Figure 3. The damage obtained in the pushover analysis is in reasonable agreement with the damages observed in the structure, i.e. the horizontal crack formation in the east wall or the developing of diagonal cracks on the longitudinal walls.

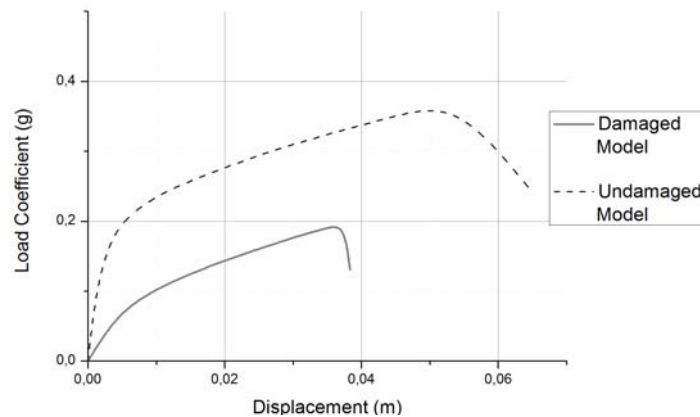
Figure 4 : Comparison between the pushover curves of both numerical models

The analysis of the capacity curves depicted in Figure 4 shows differences between the maximum load coefficient values in both numerical models. For the damaged structure, the capacity is determined by the out-of-plane collapse of the gable wall reaching 0.20g. Nevertheless the maximum load supported for the

undamaged structure was around 0.40g, with the seismic capacity being determined by the transverse direction, which means that the earthquake reduced the capacity to the half. Both pushover curves present similar shape though with different scales, beginning with a linear development, followed by a clearly non-linear path until the maximum load is reached. The curves end with a post peak softening behaviour, consisting of a gradual decrease in the mechanical resistance of masonry under a continuous increase of deformation. Overall, considering the results related to the Church's seismic assessment and pushover analyses, a conclusion should be made: due to its extensive damage, the capacity of the Church is now relatively low (0.20g). A reinforcement solution is proposed aiming to increase the seismic capacity of the Church.

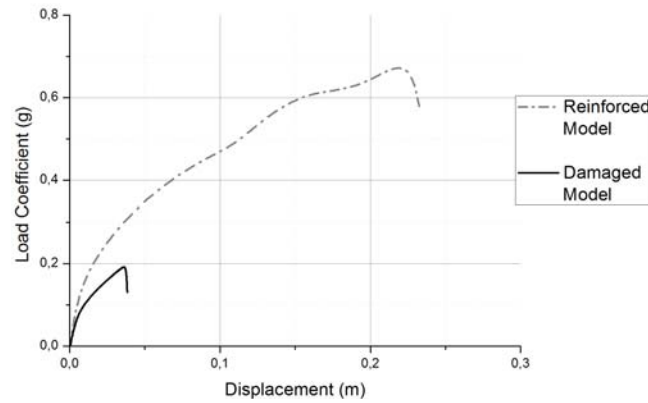
Figure 5 : Comparison between the pushover curves for the reinforced and damaged models

this structure, as expected. It is also important to note that the levels of principal strains that the structure can sustain are considerably higher than the ones achieved for the damaged model. Moreover, the capacity curve achieved for this model reaches a maximum load coefficient of 0.71g and a quite peak displacement of 23 mm, significantly higher than the initial values of 0.20g and 4 mm, respectively (see Figure 5). The initial stiffness of the structure increases slightly. The initial goal was thus achieved in the sense that the building is now able to behave monolithically, transmitting the efforts throughout the structure. The reinforced structure has a global collapse mechanism instead of a local one.

With regards to the damage identification, provided by the experimental results, visual inspection and the pushover analysis results, it should be highlighted the deficient connection between the roof structure and transversal walls, which is compromising the global capacity of the Church. In order to connect the transversal walls with the triumphal arch, steel tie bars are introduced at the roof level to attach the roof structure to the walls on both sides, allowing the structure to be fully mobilized. The longitudinal deformation of these bars is controlled and reduced with the introduction of some non-structural metallic elements attached to the existent trusses. Furthermore, the existing damage in the transversal walls with regards to the cracks should be also taking into consideration. The injection of grout or fluid resins for the repair of cracks was proposed because it guarantees that the original aspect of the wall remains unaltered and it allows to recover its original undamaged resistance [15]. According to the reinforcement strategy presented below, the numerical model of the Church was adjusted in order to simulate these modifications and pushover analysis carried out. The results show a more widespread damage distribution for
