# Journal of Civil Structural Health Monitoring

## Structural and health assessment of historic timber roofs from the Convent of Christ in Tomar --Manuscript Draft--

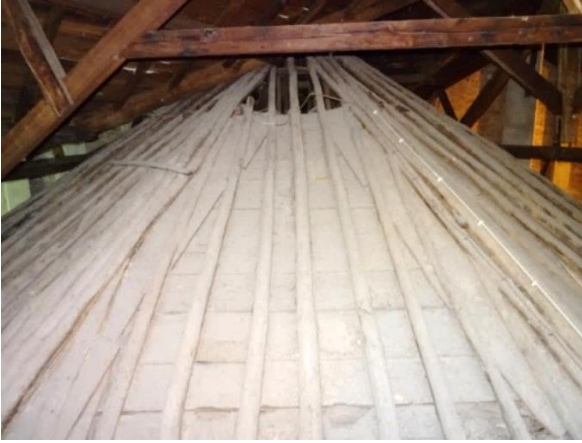
Room 68 (a). Rafters featuring insect wood-deteriorations on their external surfaces, and fungal decay at their ends (birdsmouth joint) with the wall plates (b).

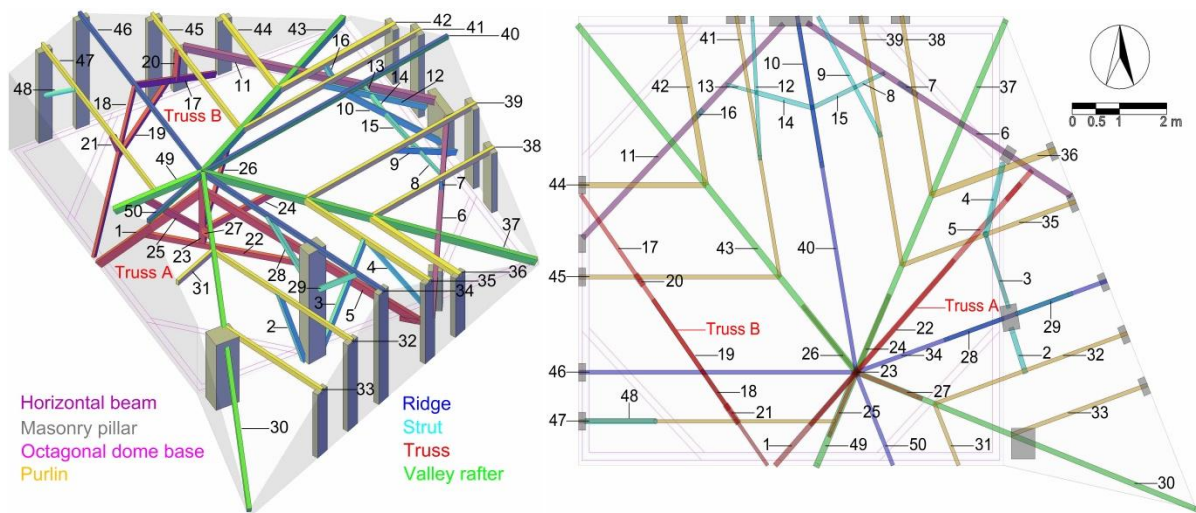
Figure 10 – 3D modelling and horizontal blueprint of the carpentries set above the octagonal dome in the Knights' Hall. King-post truss (Truss A) and A-shaped truss (Truss B).

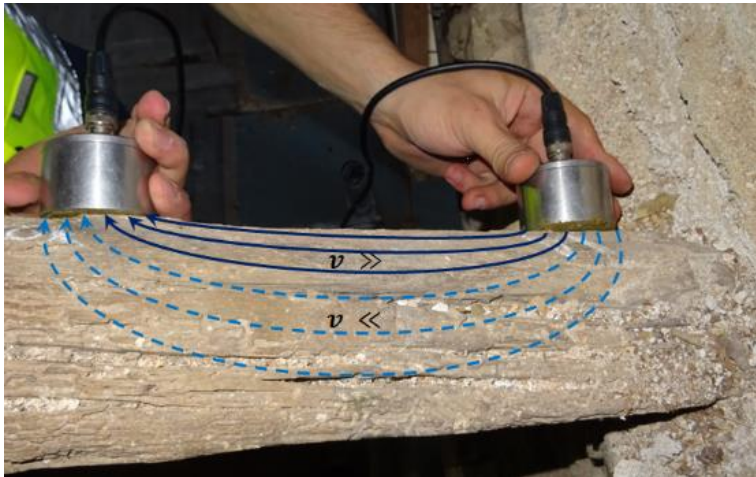
Figure 13 – Tensile crack of the horizontal beam (11) under excessive bending (a). Collapse of the purlin (42) due to the failure of the masonry support (b).

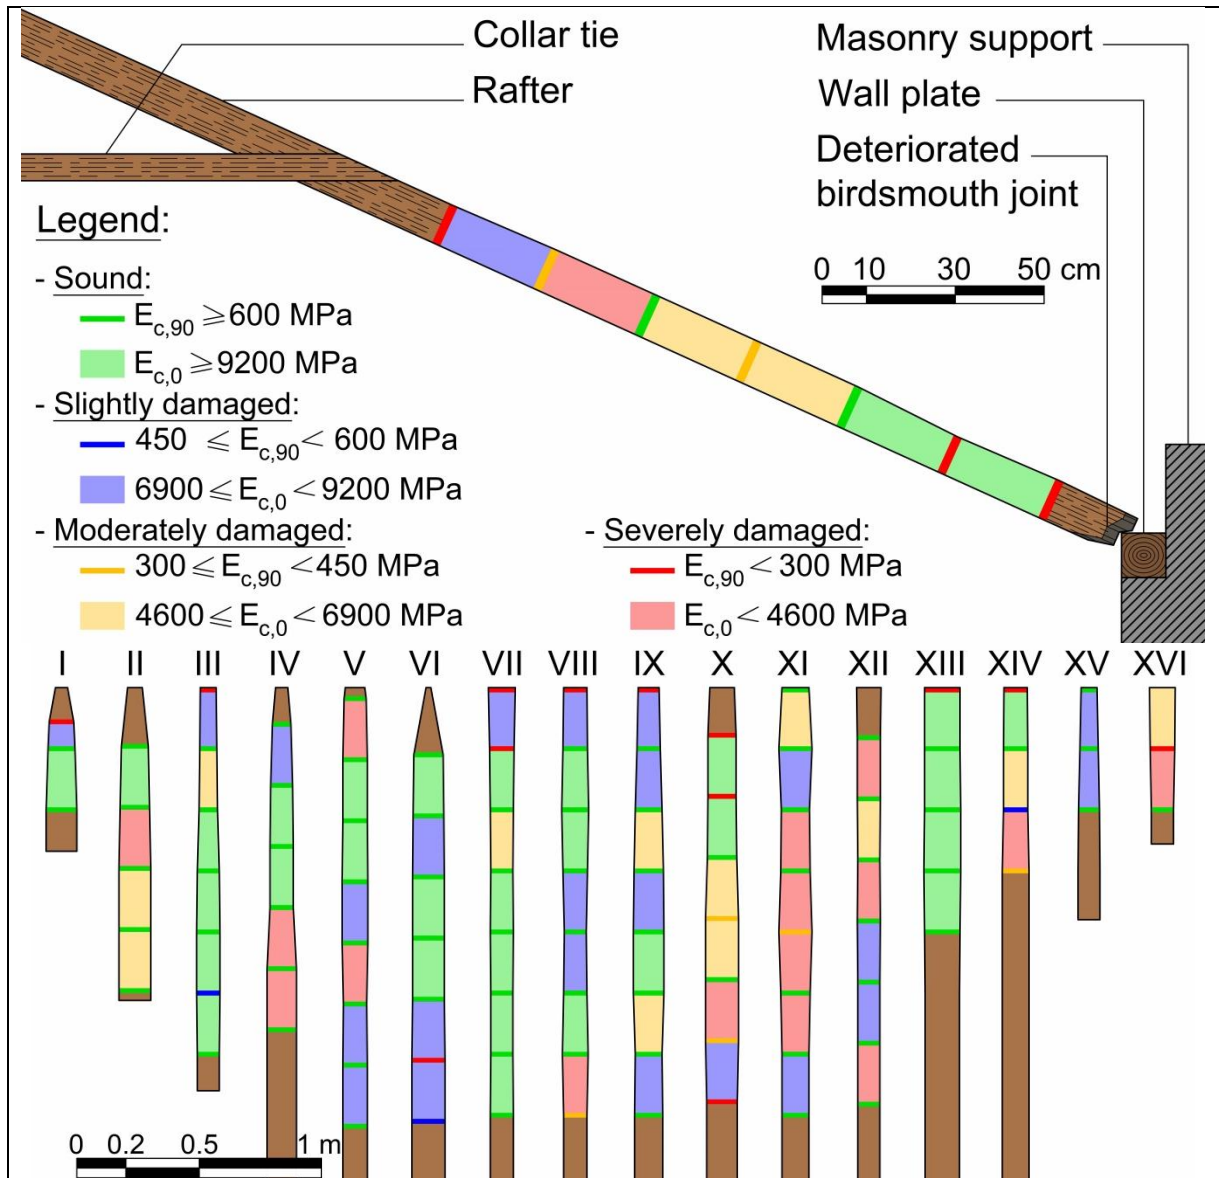
Figure 15 – Classification of external surfaces exposed to biological deteriorations, according to the wood compressive elastic modulus parallel ( $E_{c,0}$ ) and perpendicular ( $E_{c,90}$ ) to the grain, for the rafters in the Room 68.

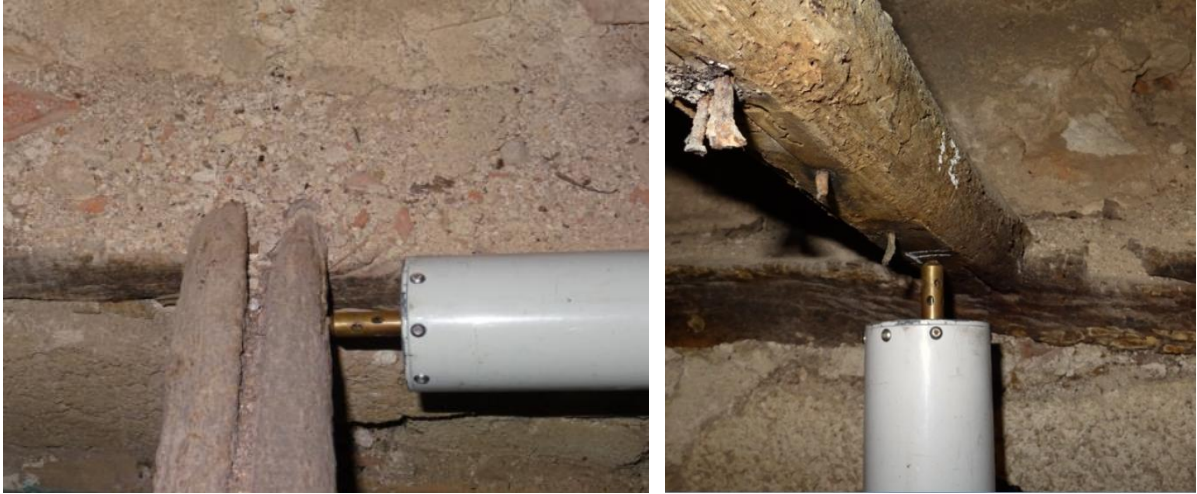
Figure 16 – Resistograph® 3450 RINNTECH used for the Drilling Resistance tests.

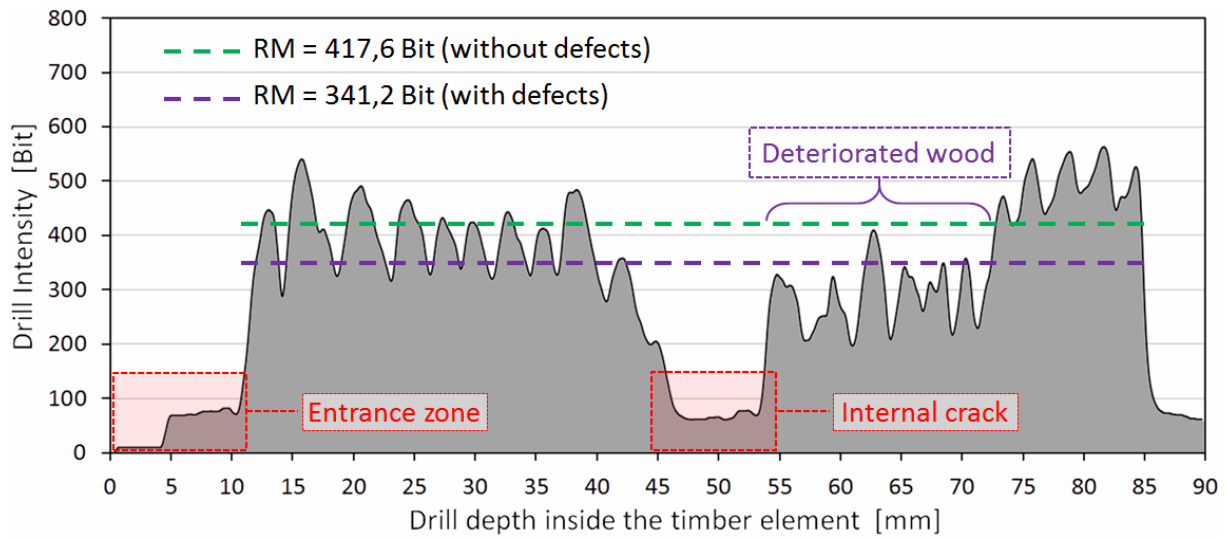
Figure 17 – Drilling resistance graph in respect with the drill penetration depth, including Resistance Measure (RM) values with and without defects.

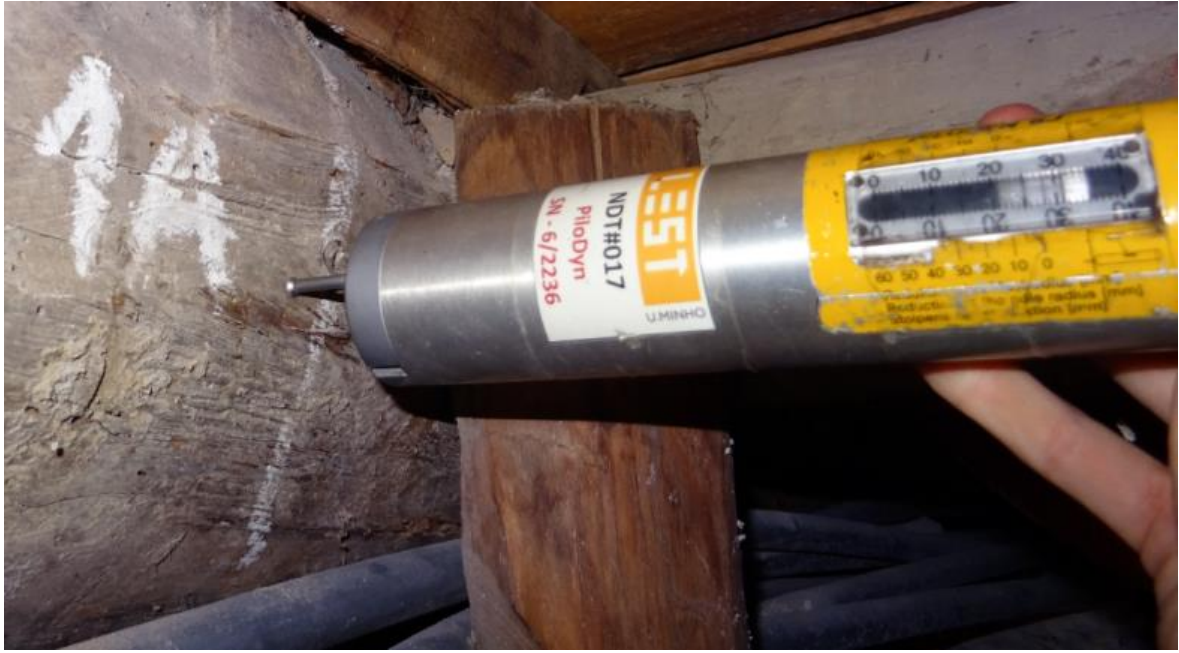
Figure 18 – Dynamic indenter Pilodyn® 6J Forest used for the Impact Penetration tests.

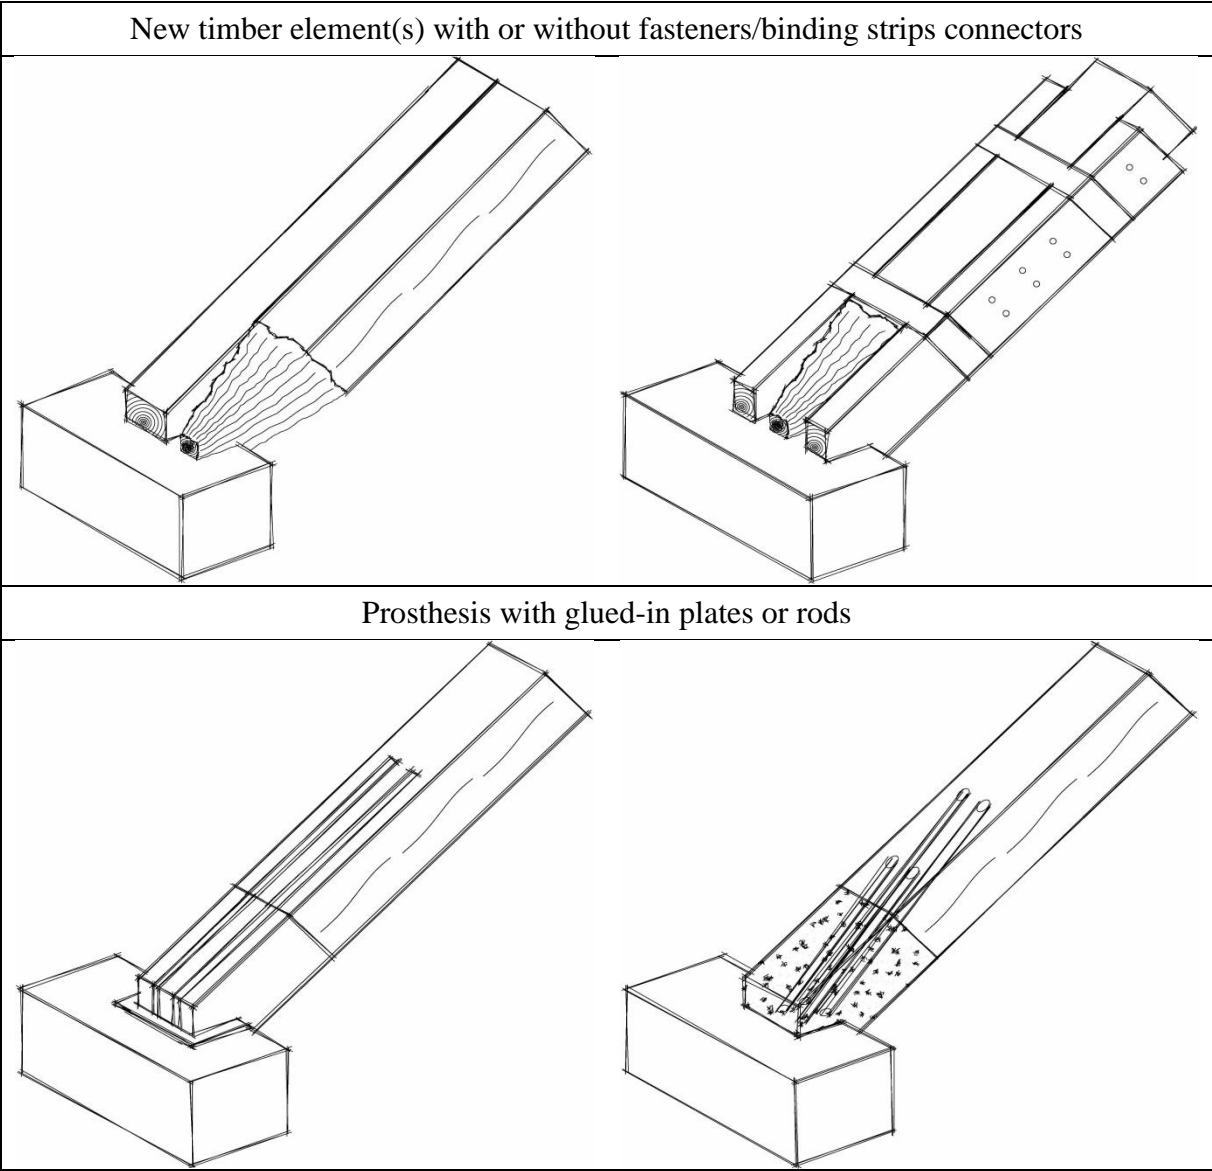
Figure 22 – Techniques to retrofit or repair decayed birdsmouth joints (adapted from interventions on the decayed timber beam-end [36]).

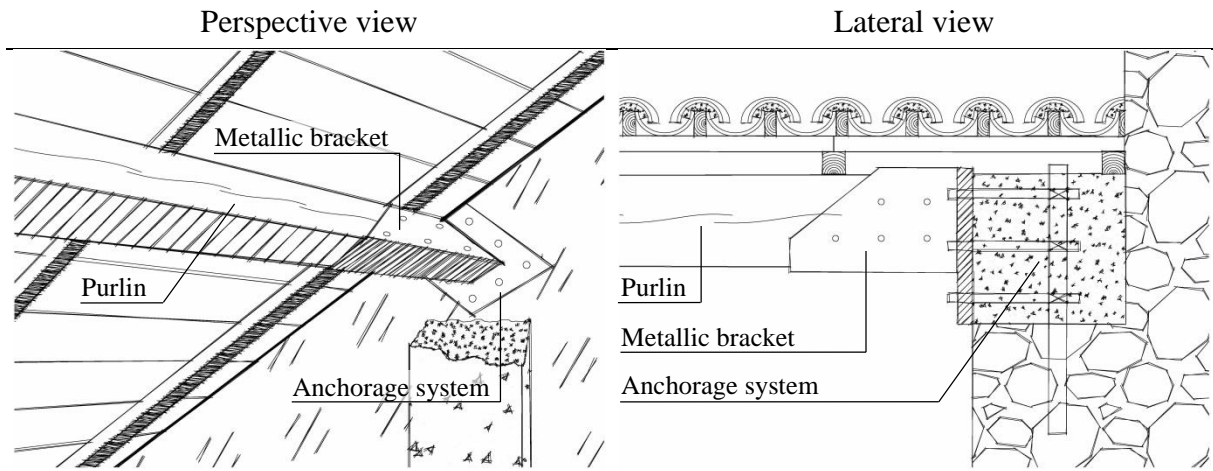
Figure 23 – Strengthening of the purlin support with a bracket anchored in the masonry wall.

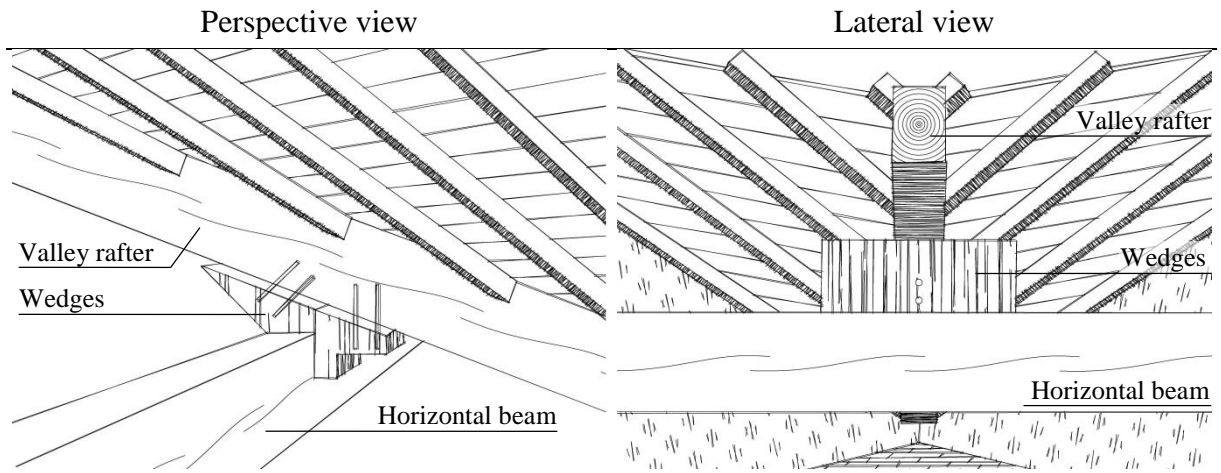
Figure 24 – Substitution of the failed horizontal beam and enhancement of the compressive contact area with the valley rafter.
