Inspection and Analysis of ancient Monastery of “São Romão de Neiva”, Portugal

Abstract. The monastery of São Romão de Neiva is an ancient building located in the north of Portugal, in the district of Viana do Castelo and it is considered to be of national interest by the Portuguese Institute of Monuments (DGPC). Due to its importance, an inspection to identify damages and their causes was performed on this building. The inspection and diagnosis included a historical, geometrical and defects survey, and mechanical and physical characterization of the masonry stone. Non-destructive tests on the structural elements such as GPR and sonic tests were also carried out to assess the internal morphology of the stone masonry walls and estimate the quality and modulus of elasticity, respectively. Qualitative assessment of masonry walls using the MQI (Masonry Quality index) was also carried out. Finally, by means of a visual inspection of the structure, the assessment of the damages and pathologies on the structural elements was performed. This **work focus on** the most important **experimental results** and some recommendations to apply them on a structural analysis.

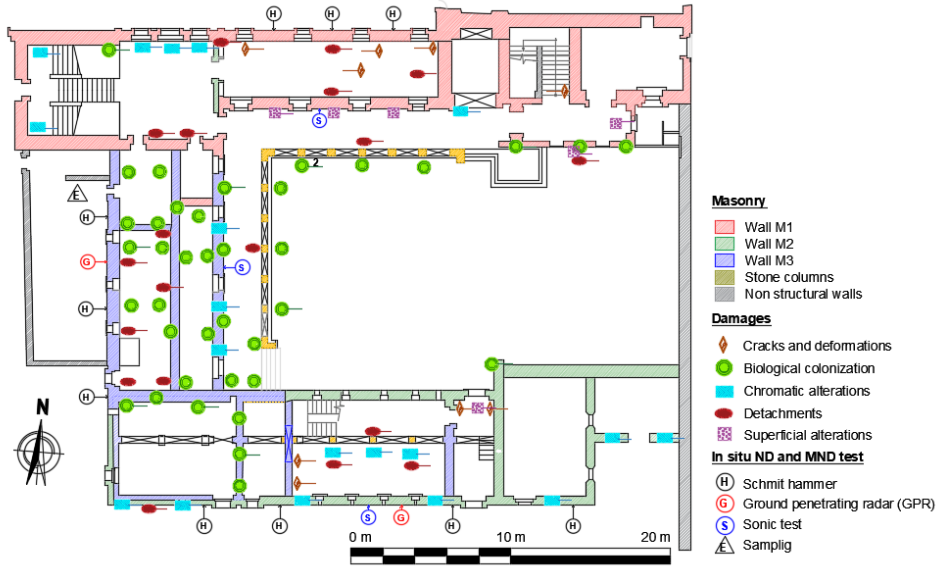
The identification of the damages was carried out by visual inspection to map the main damages, and to identify the different materials and structural forms. The origin of the damages was diverse, it is possible that mechanic and environmental effects, and past interventions would have been the main cause. The defects found in the monastery are shown in detail in Figure 4, in accordance with the ICOMOS recommendations [2].

Figure 4: Typologies of masonry walls, mapping damages and an ND & MDT in situ test

The calculation was carried out taking into consideration the behavior of the walls when subjected to vertical loads (V) for three types of walls as shown in Figure 4. The highest value of MQI corresponds to category A wall indicating a good behavior for regular masonry. The medium quality masonry corresponds to category B,

an appropriate behavior, with semi-regular masonry. The worse quality is associated to category C (irregular masonry), characterizing a masonry with poor mechanical behavior for vertical loads. Table 1 shows the MQI values and the corresponding categorization for the three types of walls.

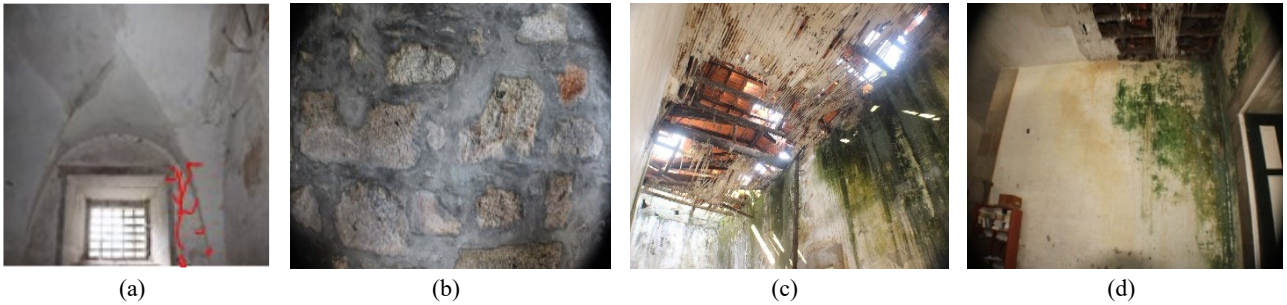
Cracks along the vaults and vertical cracks on one of the walls were identified as shown in Figure 5a, probably these cracks were due to deformation and displacements caused by compression and bending. Other cracks were related to non-structural causes, like material incompatibility between old and new materials such as the addition of cement mortar over the masonry walls (Figure 5b). The damage of higher impact identified was the collapse of timber structural elements (Figure 5c): the wooden beam floors, especially in the west wing of the building and the wooden trusses. The collapse might be related to overloading in some of floors and to the lack of roof in the west side sector, allowing rainwater infiltrations which led biological colonization on these elements (Figure 5d).

Figure 5: Damages. a) Cracks along the vault. b) Superficial alterations. c). Collapse of structural elements. d) Biologic colonization

It would be recommendable to build a drainage system around the building, in order to collect rainwater and avoid the upward humidity that affects the structure in some localized areas. It is also important to carry out the removal of the biological material present throughout the structure.

Based on inspection and diagnosis of the monastery, it was observed that the deterioration of the building might be mainly associated with environmental factors, hence it is recommendable to take measures to protect the monastery. In this sense, the construction of a roof structure to protect the building from water infiltration is of highest importance.

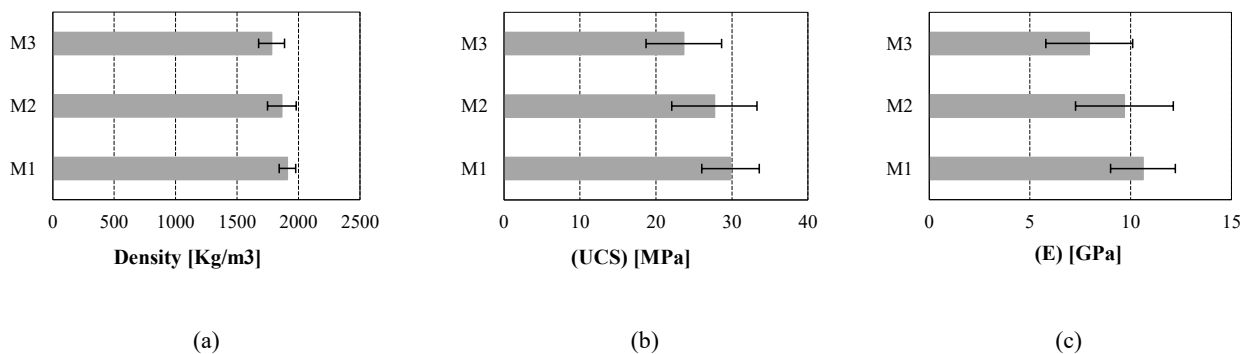
The Schmidt hammer method helped to identify the superficial hardness of the granite stones. The test was carried out on the exterior and interior walls of the monastery, making 10 measurements with 3 repetitions. A Schmidt hammer (NR) to concrete was used in this study, and to calculate the number of rebound correspondent to a hammer (RL) for stone, a correlation was made according to the relationship proposed by H. Viles & A. Goudie [4], Poole & Farmer [4] and A. Aydin [5]. Finally, to estimate the mechanical properties of the stone as a function of the blows of the hammer, such as the density (ρ), the compression strength (UCS) and the young's modulus (E), the correlations proposed by O. Katz & Z. Reches [6] were used. The results of this test are showed in Figure 6, where is presented the average values and the coefficient of variation by each estimated parameter.

Figure 6: Parameters obtained with the Schmidt hammer test (a) density, (b) compression strength and (c) young's modulus

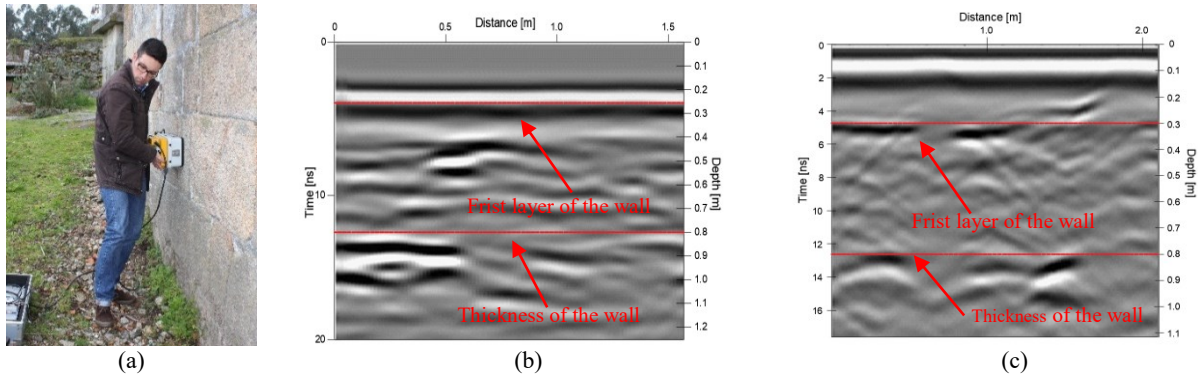
The GPR test was performed to estimate the thickness and the internal morphology of the masonry walls, using an antenna of 800 MHz with an EM wave velocity of 12.5 cm/ns. Two tests were carried in the south (M2) and west (M3) side of the monastery (see Figure 4). Figure 7a shows the scanning on the wall M3, and Figure 7b shows the radargrams of the scan of the wall M2, allowing identify the exterior and interior layer with 25 cm and 55 cm of thickness respectively. On the other hand, for the wall M3 the exterior and interior layer were a

thickness of 30 cm and 50 cm respectively (see Figure 7c). Measurements on the wall M1 did not result in any legible information since the high humidity level did not allow for any reflection.

Figure 7: GPS test. a) Horizontal Scanning. b) Longitudinal radiogram wall M2. c) Longitudinal radiogram wall M3.

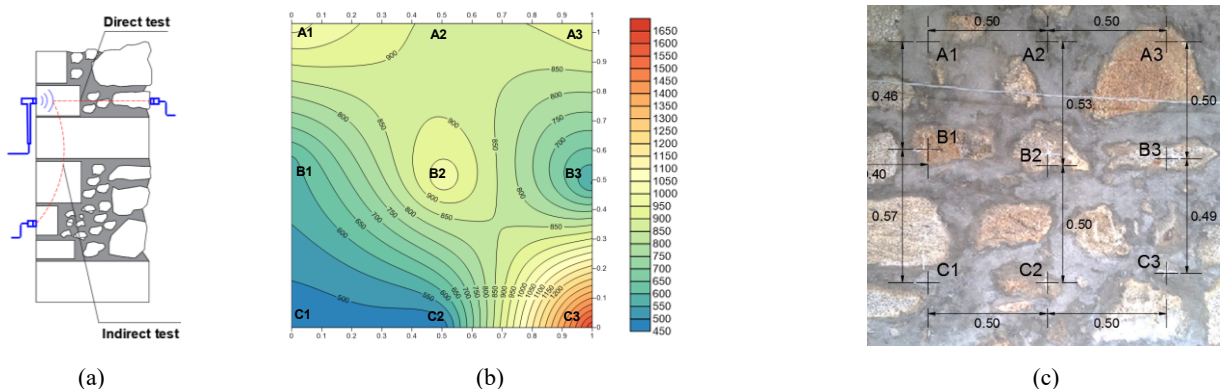
Sonic test was performed in the three different types of masonry walls as shown in Figure 4. Direct and indirect test (see Figure 8a) were undertaken in order to determine the internal configuration of the walls and stones and to estimate the mechanical properties of the masonry. The results of the direct test average of the VP (primary wave) in all the walls was 1009.4 m/s (CV=16%). The test were carried out over a surface in a grid of points, separated from each other by random separation between 0.40 m to 0.60 cm as show in Figure 8c. Some velocities registered the walls were lower than 700 m/s, probably due to presence of holes inside the masonry configuration (see Figure 8b). In the indirect tests, the VP and VR (Rayleigh wave) were also calculated to estimate the estimate the Elasticity Modulus (E) and the Poisson coefficient (ν) for each wall, the volumetric mass (ρ) was adopted of [7]. Table 2 shows the estimated mechanical properties of the walls types tested, the wall M3 is one that presents the highest value of Young's modulus

Figure 8: Sonic test. a) Direct and indirect sonic test, (b) Curves of wave velocities, wall M1. c) Location of the test points wall M1

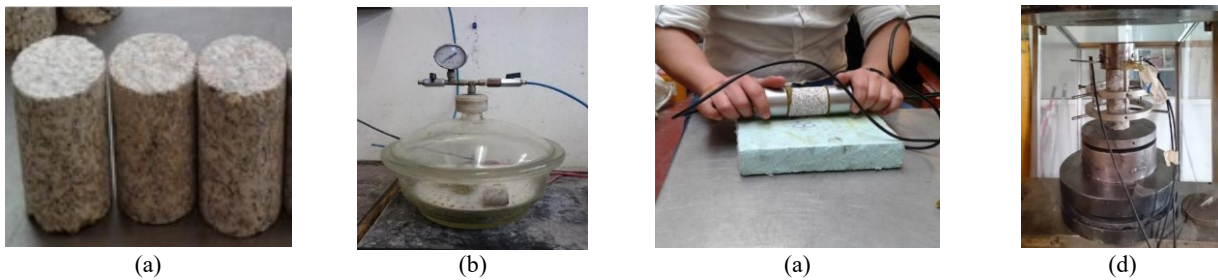
Stone samples were taken from the east side of the monastery (see Figure 4) to perform physical and mechanical test in laboratory tests to characterize granite stone. In Figure 9a the three obtained specimens are shown. The following laboratory tests were carried out: porosity and natural density, absorption by atmospheric pressure, (see Figure 9b). Capillarity, ultrasound test, (see Figure 8c), compression strength and young's modulus (see Figure 8d).

Figure 9: Laboratory test. a) Specimens. b) Absorption. c) Ultrasonic test. (h) Compression strength and young modulus.

Table 3 shows the results of laboratory tests for the stone's specimens with average values and the standard deviation (σ), and coefficient of variation (CV). According to [8] and [9] the value of density are into the range of the corresponding for the granite stone, but the porosity is higher than the typical values corresponds to this material (0.5-1.5%). As it is possible to note, the young's modulus obtained with the compression test (6.07 GPa) is lower than these estimated with the Schmidt hammer (7.9–10.6 GPa), but the compression strength (75 MPa) is higher than theses estimated with the Schmidt hammer (23.7–29.8 MPa)
