INSPECTION, DIAGNOSIS AND MODELLING OF AZURARA CHURCH IN THE NORTH OF PORTUGAL

Abstract. *Santa Maria de Azurara church is a XVI century church in Portugal, classified as a national monument since 1910. The building shows not only the influence of the Manueline architectural style (Portuguese late Gothic style), but also Baroque and Mannerism styles. Presently, the church presents some structural and non-structural problems, so an inspection and diagnosis of the main building pathologies was carried out. This process was assisted by non-destructive testing (NDT) techniques which included sonic tests, ground penetrating radar (GPR) and Schmidt hammer for masonry elements and Pilodyn and ultrasonic pulse velocity for the timber elements. In addition, scanning electron microscope and x-ray diffraction analysis were used for mortar and stone characterization. Furthermore, dynamic identification tests were performed. Numerical analysis was performed to assess the nonlinear behaviour of the structure under different load conditions. In order to create an accurate model, material properties were estimated from the non-destructive tests and the dynamic properties were used to calibrate th

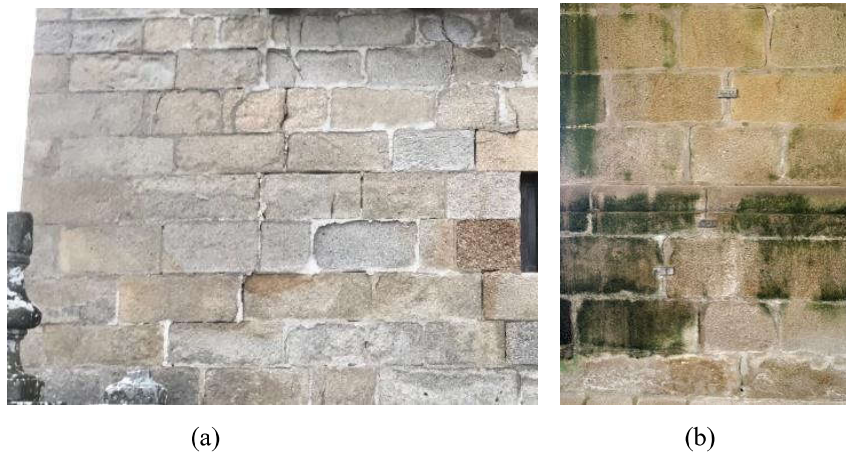
The most prevalent appearance of cracks is on the bell tower. Major cracks can be seen on the exterior part of its western facade, under the balcony projection. Also, a major crack is noted on the internal facade which was measured and marked previously in the year 1985 (Figure 2). The crack meter placed there has detected movement since that date.

Figure 2: Cracks under the balcony of the tower in (a) external west facade and (b) internal east facade.

The overall state of conservation of the church is good. No major structural deficiencies were observed. Recommendations include repointing in areas of lost mortar, cleaning of efflorescence and staining, replacing rotted wood, applying a chemical anti-termite barrier in walls and altars, improving ventilation, installing a stormwater drainage system, and performing continued monitoring and maintenance.

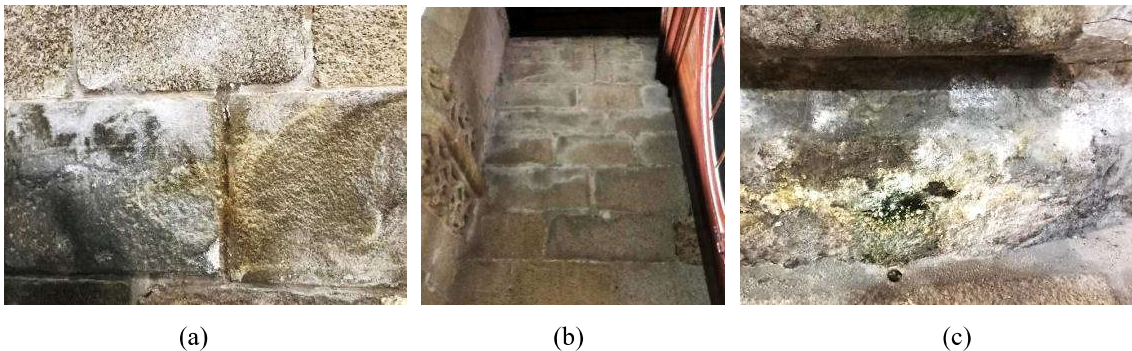
Staining and soiling were present on the exterior walls. Moist areas could be seen in the interior. Efflorescence was densely observed on the lower areas of the internal surface of the walls (Figure 3(a)). It was also observed in areas close to the roof and all the column bases (Figure 3(b),(c)). Clearly, the existing drainage system is not sufficient. The problems in the rainwater system in the roof are the cause of this pathology in the upper part of the walls.

Figure 3: Efflorescence damage observed in (a) internal wall, (b) areas close to the roof and (c) column bases

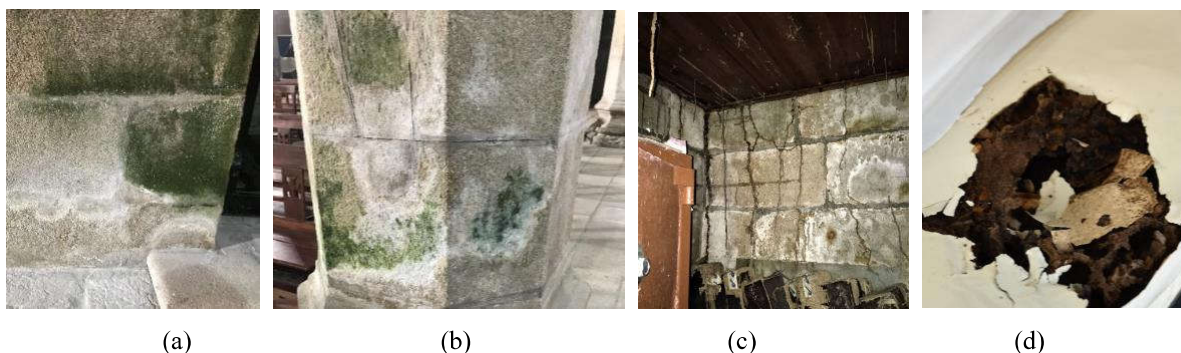
Plants and lichen were observed on the external facades due to inaccessibility, lack of cleanliness and maintenance. Widespread growth of algae can be seen in the interior walls and columns (Figure 4(a),(b)). Algae generally constitute superficial films. However, in the church interior they seem to be growing within the stone rather than on the surface.

The timber altars and roof are heavily infested with termites, wood boring beetles and rot (Figure 4(c),(d)). Termites have infiltrated all of the altars; the small room behind the main altar is the most infested. Trails can be found throughout the building, including in masonry. Holes created by wood boring beetles can mostly be seen on decorative parts of the altars.

Figure 4: Algae observed on (a) interior walls and (b) column base; (c) termite infestation behind altar; (d) rot in altar

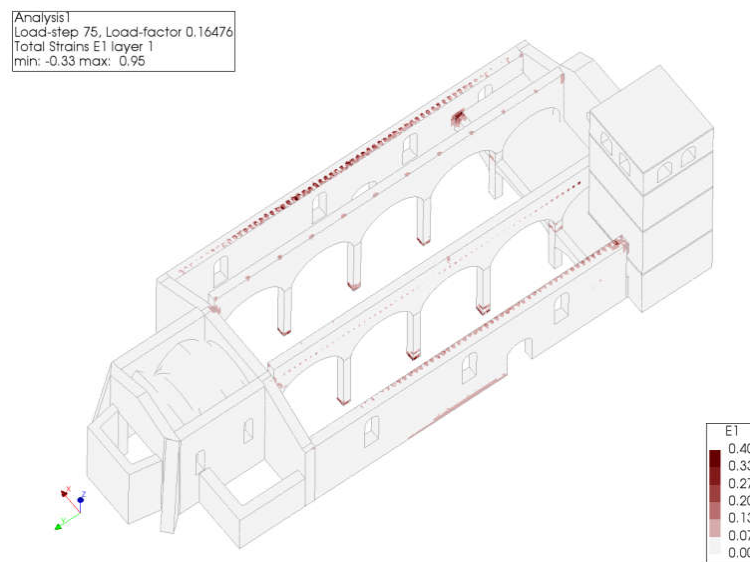
The strain graphs for the pushover in X shows concentrations in the base of the columns and in the connection of the arch of the choir with the lateral wall, see Figure 9. To a lesser extent, strain also appears in the base of the longitudinal walls.

Figure 9: Maximum principal strains E1, x-direction

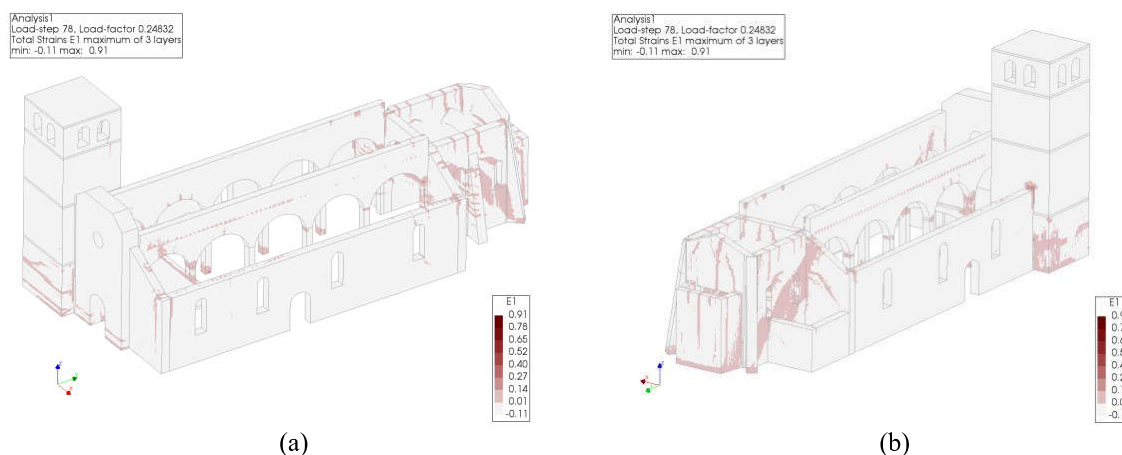
A different pattern is obtained from the pushover analysis in the y-direction. In this case the strain concentration is located at the base of the tower and the main façade in the shape of horizontal lines (Figure 10(a)), as well as in the connection of the tower with the church walls and in the body of the altar, where the strain pattern is diagonal in the lateral walls and vertical in the wall perpendicular to the force (Figure 10(b)). This diagonal concentration indicates shear failure may happen in the chancel under high loading in the y-direction. Maximum strain values are located in the connection of the arches of the choir with the longitudinal walls.

Figure 10: Maximum principal strains E1, y-direction (a) front view; (b) rear view
