## Assessment Methodology for Conservation Planning of Concrete Buildings: Ocean Swimming Pool (1960–2021) by Álvaro Siza in Portugal

Teresa Cunha Ferreira, Nuno Mendes, Rui Fernandes Póvoas & Paulo B. Lourenço

The paper intends to provide a building assessment methodology for the conservation planning of concrete buildings, presenting the demonstrative case-study of the Ocean Swimming Pool (design 1960–1966; conservation 2018–2021) conceived by the Pritzker Prize Álvaro Siza, in Portugal. The building is a landmark of 20<sup>th</sup> century architecture in the national and international context, being listed as National Monument and included in the World Heritage Tentative List. The article will focus particularly on the building assessment methodology, supported by the cross-analysis of the ‘documentary evidence’ and ‘physical evidence’, allowing for an integrated approach for conservation planning. The paper includes documentation on the building chronology and construction, as well as on the inspection and diagnosis using both non-destructive and minor destructive testing. Moreover, the article presents a pilot demonstration of concrete repair supported on the building knowl

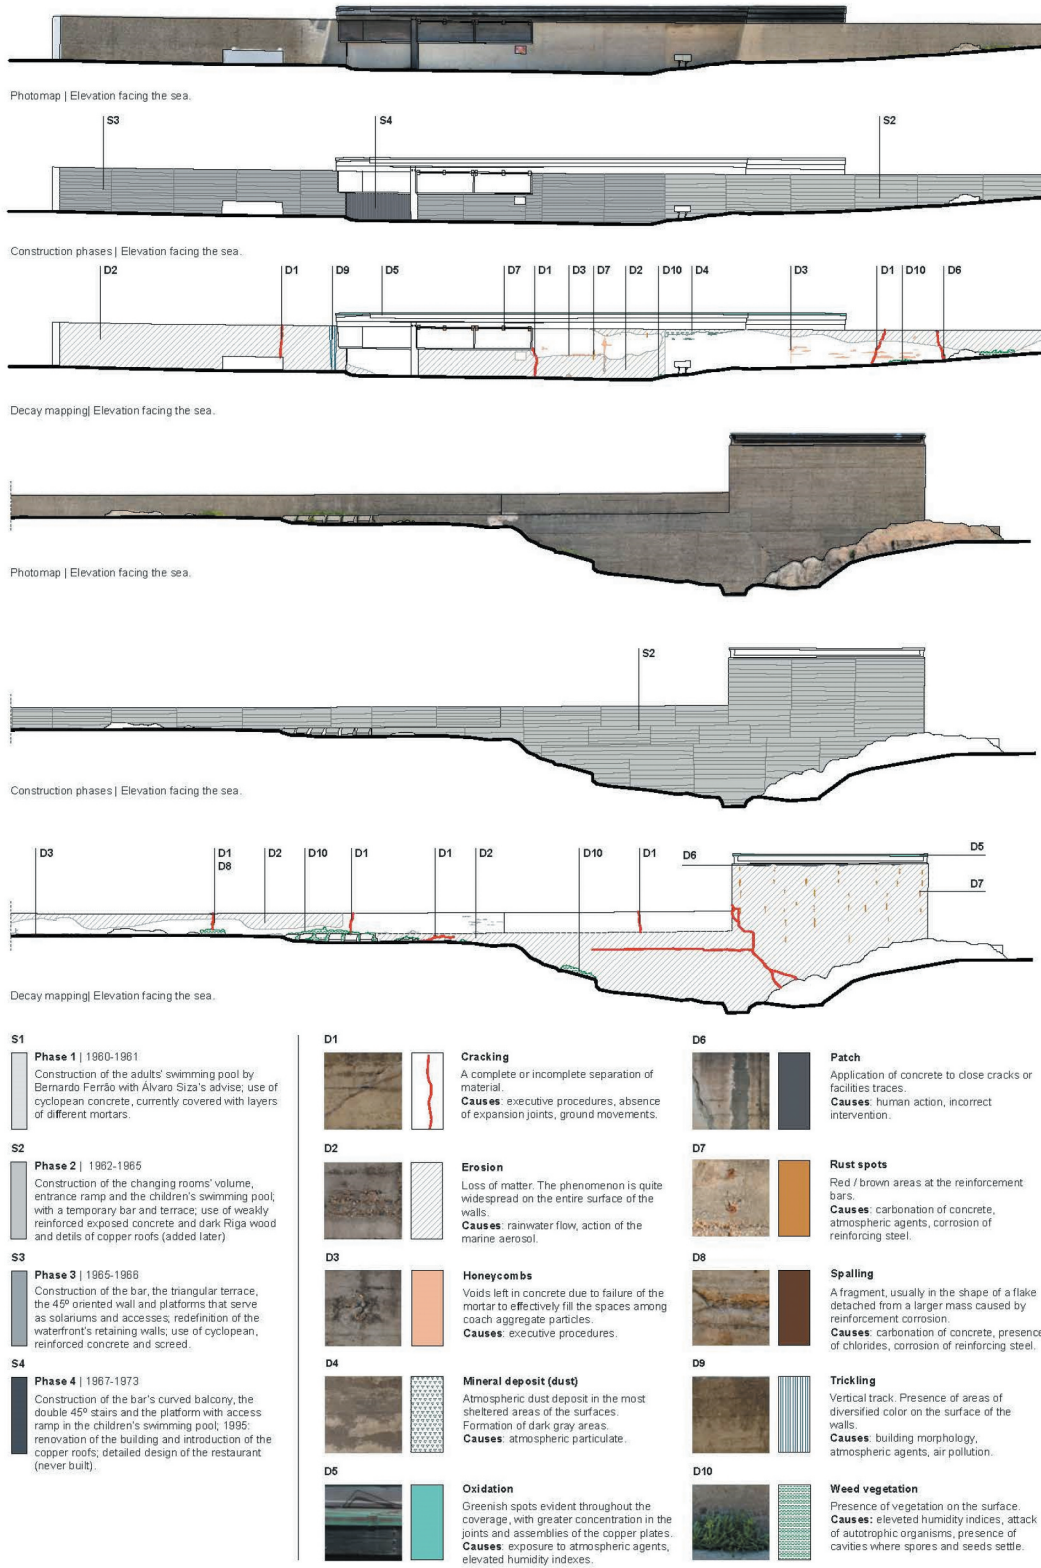
Figure 12. Condition survey mapping.

The visual inspection allowed to verify that the building is in a reasonable state of conservation, without interventions that have substantially altered its original form (Figure 12). However, the building has been at risk because of its maritime location and the nearby oil refinery, which together have aggravated the decay of the concrete, by triggering cracking, corrosion and spalling of its steel reinforcement. While the carbon dioxide from the refinery accelerates the carbonation process, the chlorides of the salt water and salt fog penetrate the concrete and cause reinforcement corrosion, which consequently causes the cracking and spalling of the concrete. Furthermore, repair campaigns conducted by the Matosinhos Municipal Council since the 1980s have led to problems such as delamination, pattern cracking and staining.

The most evident signs of deterioration in the concrete walls are in the form of cracks, creating visible discontinuities in the surface of the material. Most of these cracks are not apparently related to steel corrosion. The vertical cracks in the longitudinal walls seem to be caused by the absence of movement joints in the original design, which corresponds to a damage over time possibly due to shrinkage and/or thermal movements. These were worsened by interventions performed by the Municipal Council, namely the filling of the cracks with incompatible mortar (Portland cement mortar with limited compatibility, reversibility or aesthetic integration concerns) (Figure 13a). Moreover, some concrete surfaces have small red/brown stains created by the oxidation of rusted metal inside the concrete, which has deposited on the surface. In some beams, there are signs of a loss of material (spalling), caused by the corrosion of reinforced steel rebars (Figure 13b). The bottom surface of the slab of the South's storage room was severely affected by the corrosion of the rebars (Figure 13c). There is also damage associated with distributed cracking (taking the form of a polygonal net, similar to a spider's web) caused by the addition, in the 1980s, of a 4 cm concrete layer (with light mesh) over

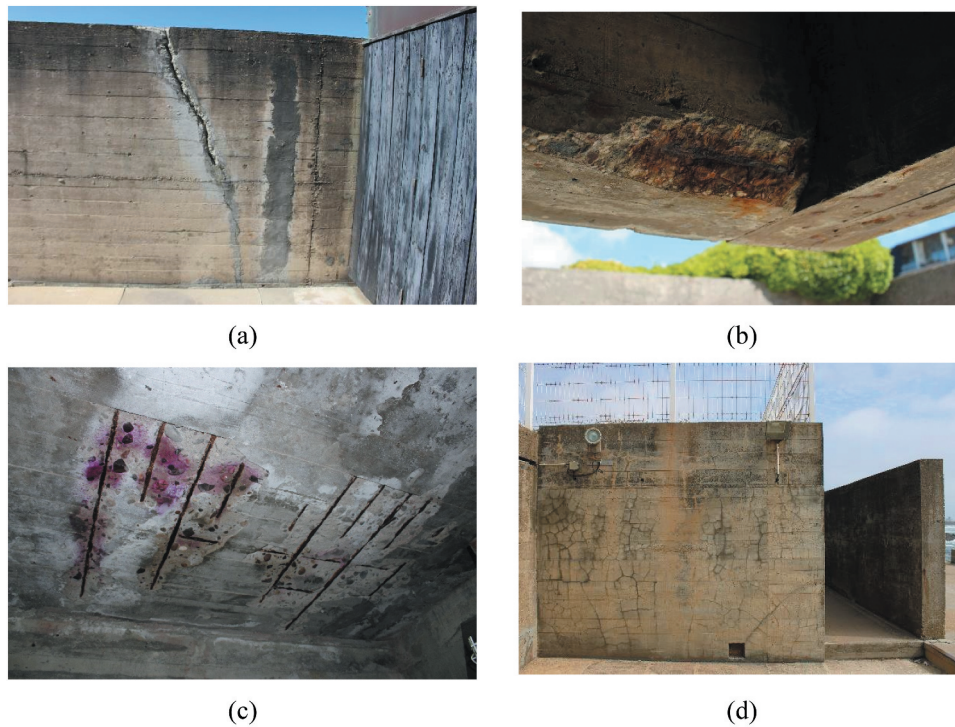
**Figure 13.** Examples of damage: (a) cracks and repair with the application of mortar; (b) spalling caused by reinforced steel corrosion in a beam; (c) distributed crack pattern; (d) concrete slab severely affected by the corrosion of the reinforced steel.

some walls, because of incompatibility with the pre-existing concrete walls or shrinkage (Figure 13d).

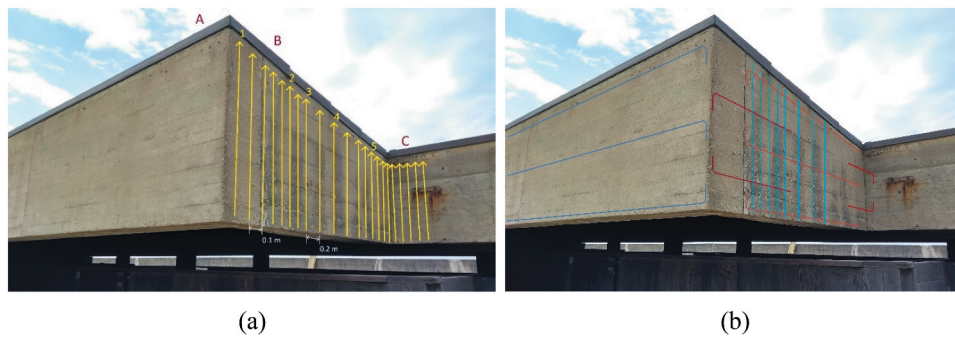
**Figure 18.** GPR tests on the beam over the changing rooms: (a) location of the GPR profiles; (b) likely reinforcement details of the connection between the beam supported by the two cantilever beams.

reinforcement bars (in orange) of beam B, again in each face. The probable location of the three longitudinal reinforcement bars in beams A and C (in dark blue), and in each face, is also shown. The arrangement is assumed to be symmetric from the vertical axis of the beams. Finally, GPR tests were also carried out at other reinforced concrete walls, aiming to verify the spacing of the vertical and horizontal reinforcement. In the walls of the changing room, the spacing between vertical rebars ranges from 20 to 30 cm, and the rebars are located at a depth of approximately 4 cm. In the exterior wall of the South's corridor, a spacing of 30 cm and 10 cm between vertical and horizontal rebars were estimated respectively. The horizontal bars are placed at a depth of approximately 2–3 cm. The vertical reinforcement bars seem to be more deeply located, approximately 4 cm within the concrete.

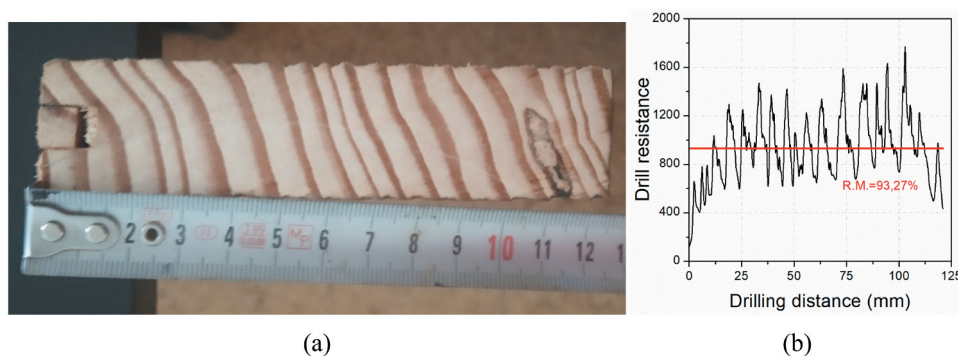
A timber specimen ( $2 \times 12 \times 3\text{ cm}^3$ ) was collected from the structure in order to be inspected and tested in laboratory conditions. From an initial visual inspection (Figure 19a), the plank did not present any superficial defects, for example, knots or splits and cracks. There was no slope of grain and the growth rings are regular.

The density of the specimen, species is Riga (*pinus sylvestris*), was obtained according to standard ISO 13061-2 (2014), in which 10 specimens were cut with dimensions of  $20 \times 20 \times 25\text{ mm}^3$ . The specimens were measured and weighed, and wood density of  $635.41\text{ kg/m}^3$  was obtained. Finally, Resistograph tests were performed on the timber specimen to determine the quality of the timber, the presence of possible cavities or decayed parts in the timber specimen not detected by a simple visual inspection. A resistographic measurement of 93.27% was obtained. From the graph (Figure 19b), it is clear that throughout the section, the timber has a good quality, maintaining a uniform resistance.

**Figure 19.** Survey and testing of the timber specimen: (a) cross-section; (b) resistograph result.

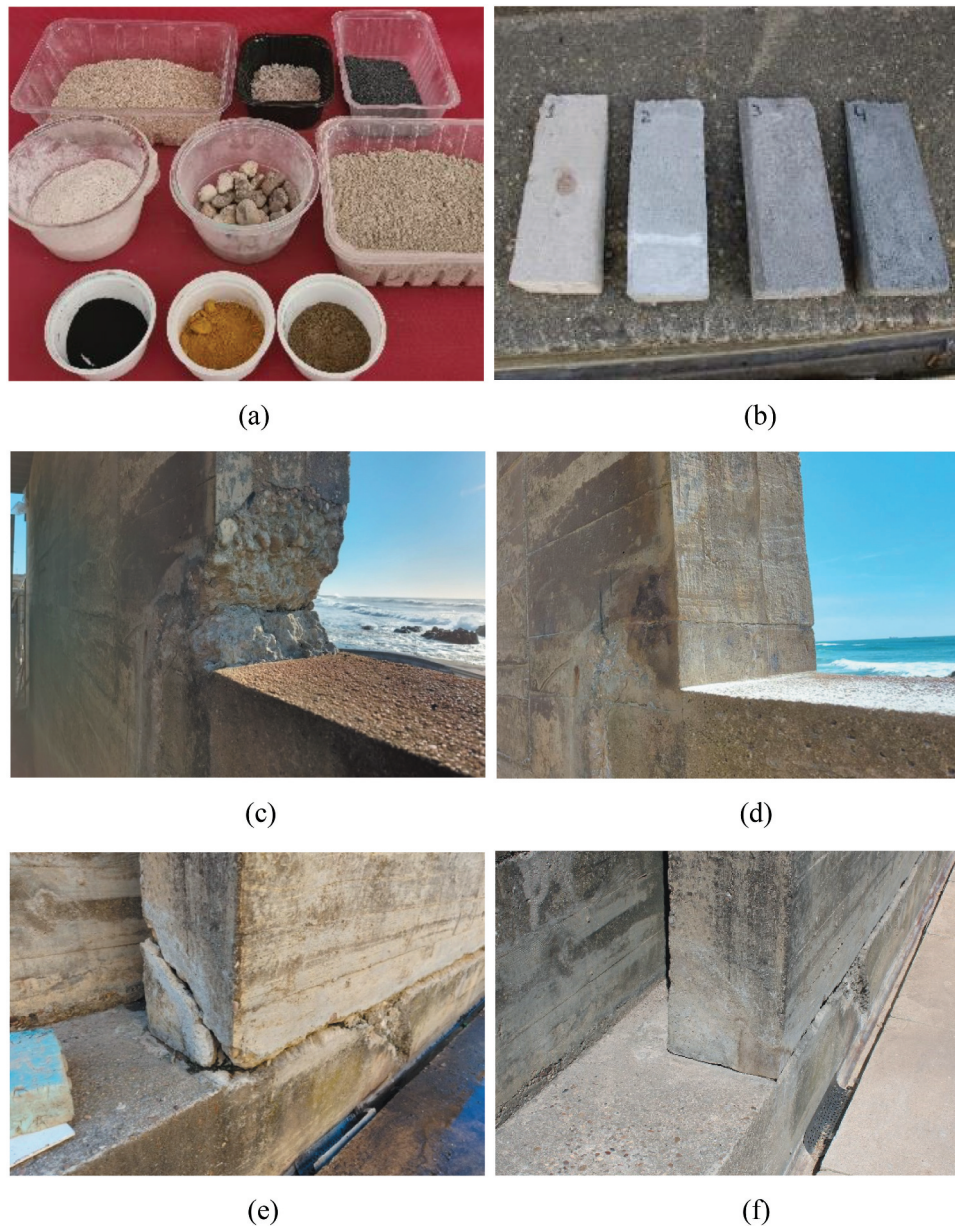
In this context, Siza selected two spots for pilot demonstration of concrete repair in the main façade (west) that presented fragmentation and material discontinuity. The first pilot demonstration is a concrete detachment of about  $0.5 \text{ m}^2$  in the joint ( $90^\circ$  angle) between a higher and a lower wall (R1), caused either by the lack of movement joints or by foundation movement (Figure 20c). The second pilot demonstration is located in the same façade at the lower corner of the wall over the concrete bench, where the material discontinuity led to the separation of a wall fragment, possibly due to the dilatation of a corroded vertical rebar (Figure 20e) (see pilot demonstrations location on Figure 10).

**Figure 20.** Pilot demonstration of concrete repair: a) Aggregates and pigments for repair mortar; b) Samples for concrete repair (4 of 10); c) R1 before and d) after concrete repair; e) R2 before and f) after concrete repair.

The repair of the first crack (R1) required the reconstruction of the detachment's gap volume. With this purpose, 316 stainless steel threaded rods were inserted in the preexisting concrete and coated with epoxy resin before the application of the restoration mortar. A siliconized sheet was then applied on top of it with the objective of keeping the joint open and allowing structural movements. Wooden planks were used as formwork to achieve the intended texture similar to the original. The repair mortar was gently introduced inside the formwork and after 10 to 15 min of curing, a water-soaked sponge was used to mimic the wear in the existing surfaces, followed by a supplementary

localized chromatic reintegration to mimic the existing concrete wall's pigmentation (final result in [Figure 20d](#)).

The repair process of the second area (R2) started with the detachment of the loose fragments and their numbering for later repositioning. The 2 cm corroded vertical rebar was subjected to mechanical and chemical cleaning, followed by the application of a rust converter and an epoxy resin coating to prevent future corrosion. The fragments' inner surfaces were punctured to allow their realignment with the wall and then glued with an epoxy resin. Lastly, the remaining gap created by the fragmentation was filled with the same mortar and methodology used in

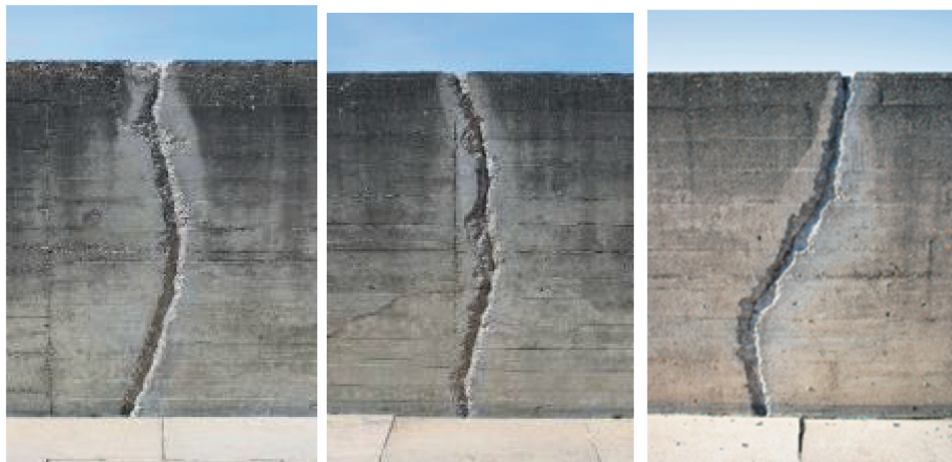
Differently, the other damages present in the building, namely the several vertical cracks on the walls related to the absence of expansion joints in the original design (and are not related to rebar's steel corrosion), were very difficult to repair with the same approach,

**Figure 21.** Vertical cracks due to the absence of movement joints after recent conservation by Alvaro Siza (2021).

because of its bigger dimensions and very irregular geometry. Hence, acknowledging the difficulty of repairing all the anomalies on exposed concrete and assuming the impossibility of disguising ‘patches’ in the concrete — as many of the localized repairs (preferable to a full replacement in his opinion) would necessarily be visible — Siza chose to preserve several cracks open in the exposed concrete as ‘scars of time’ that testify to the material history of the building, see [Figure 21](#). This is also, in his words, the “most brutalist” attitude and therefore coherent with the option of truth advocated by the use of raw materials in the original project (Ferreira 2022, 25).
