# Historic Mortars and RILEM TC 203-RHM Final Workshop HMC2010

## Causes of Decay of the Aveleiras House Decorative Plasters (in Torre de Moncorvo)

## 2 Study Case – plastered ceilings of Aveleiras House

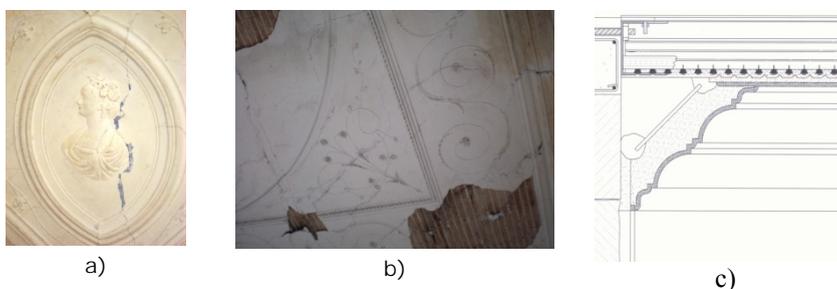
**Fig. 2** a) Decorative plasters, in the “Adam Style”, of English influence; b) cracking and unfastening of parts of the plaster; c) repair suggestion of plastered ceiling (CAVALHEIRO Photos; 2007)

The anomalies presented in this chapter were identified in a case study of the early 19<sup>th</sup> century decorative ceilings of the main floor of Guerra’s House (of Aveleiras), in Torre de Moncorvo [5] (Fig. 2).

The building is in a poor state of conservation, with collapsed roof sections creating subsequent degradation to the interior subjacent zones. The ceilings and lath work present damages including: cracking, standing up and putrefaction of plaster; dirt stains, biological colonization and mould; fissures and disintegration of the mortars; and the absence of support laths for the plaster. The ceilings of plaster, which consist of wooden laths nailed to the structure of the roof, were affected by deformation of the supports owing to the progressive camber of beams caused by water retention.

This structural phenomenon created deformation of the ceilings which in turn produced cracking, loss of adherence of plaster and loosening of the plaster. The occurrence of water infiltration from the roof or floor, produced the putrefaction of the laths, the oxidation of the nails of fixings and volumetric expansion which led to the further decline of the plaster ceilings. The difference in behaviour between the masonry walls and ceilings, resulted in the appearance of cracks in the connexions between those constructive elements, namely in the coves. The poor execution of the different plaster layers, due to inadequate soaking during

application, led to the presence of quick lime; this combined with a deficient mix design has resulted in weakened areas and the loss of adherence between the different layers of plaster and the appearance of fissures.

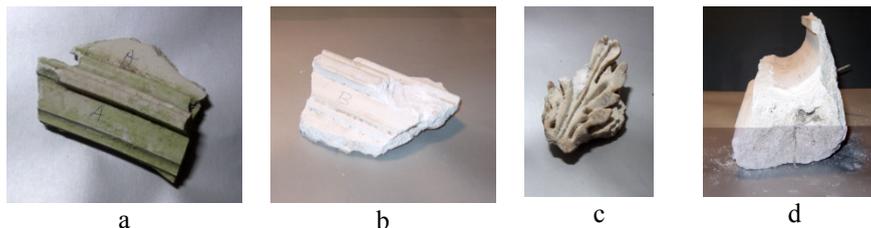
**Fig. 3** Samples of plastered ceilings from Aveleiras's House: a) Sample colonized with algae of green colouration; b) Sample from a ceiling; c) Decorative motive; d) Sample of a cornice cove.

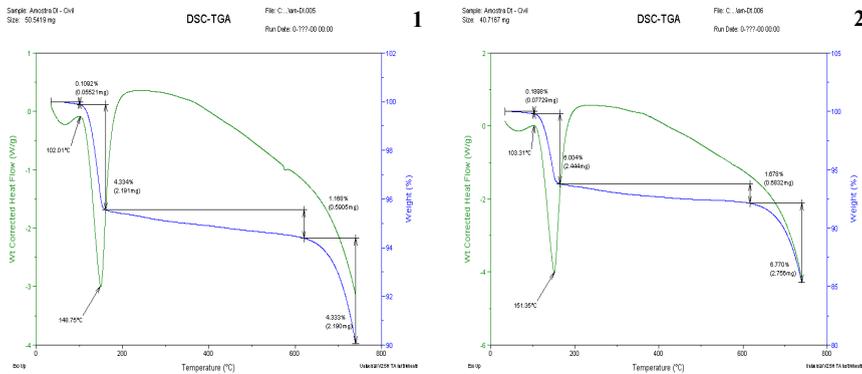
Samples	A	B	C	DI	DT
Quicklime (CaO)	14.06	8.50	18.65	5.52	7.64
Gypsum (CaSO <sub>4</sub> ,1/2 H <sub>2</sub> O)	49.72	78.35	49.38	23.25	36.36

**Fig. 4** Thermo-gravimetric Graphs of sample D: 1) DT, surface of plaster; 2) DI – internal layer of plaster from near the support.

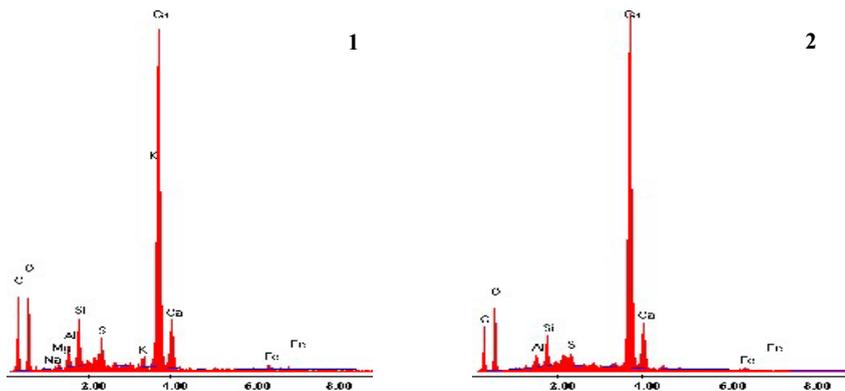
**Fig. 5** Spectra of chemical analysis of the plasters of Aveleiras’s House; 1) Sample A, external surface of the plaster (with algae); 2) Sample B, external surface of the plaster (without algae).

The plastered ceiling, represented by sample A, contains 2.80% of Magnesia which has a destructive effect in the plasterwork; sample A could be broken into

pieces by hand easier than the other samples analysed. The higher proportions of K and Si in this plaster indicate the probable employment of silicate of potash to increase the hardness of the mortar, a common practice in the 19<sup>th</sup> century [6].

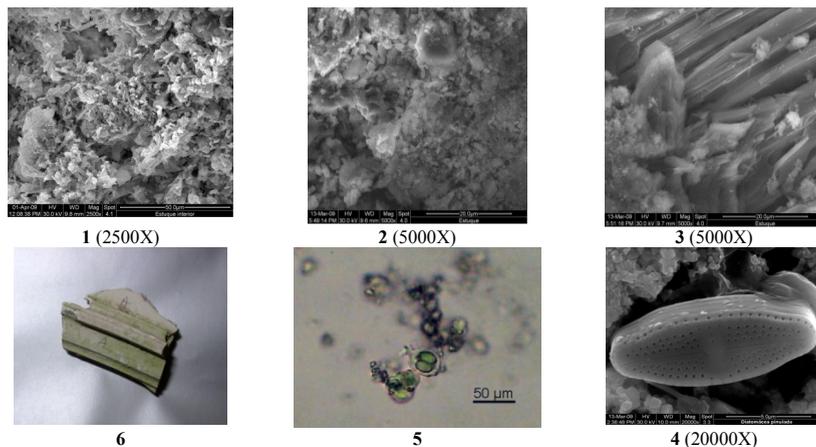
The micro-analysis obtained by SEM on a cross section of a sample of plaster without biological colonization (Fig. 6 -Micro-analysis 1) indicates that the initial layer of plaster closer to the support had coarser aggregates and less binding material than the finishing layer of plaster. The micro structural analysis of the exposed surface of the plaster sample, (see Fig. 6 - micro-analysis 2 and 3) revealed prismatic and acicular crystals of calcium sulphate, and scaly and rugous

particles of small calcium carbonate crystals, which present exfoliation planes of trituated calcareous stone but do not present any specific morphology of micronized calcium carbonate.

The microscopic image of samples of plaster with algal colonisation showed biological colonisation was more prevalent in the more humid areas of the ceilings. The microscopic image in Fig. 6 corresponds to the visualisation of a

sample of plaster which contains green algae. The images obtained by *SEM* on samples of plaster with algal colonization, (Fig. 4), indicate the presence of algal Diatoms of two orders, centric (or *Centrales*) and pinnate (or *Pennales*). They are, therefore, unicellular organisms which have one carapace or siliceous wall denominated frustule, localized externally to the plasmatic membrane. These structures, left by the algae, are seen on the surface of sample A.

**Fig. 6 Micro-analysis:** 1) Sample B, cross section of surface of plaster. 2) & 3) Sample A, surface of plaster, deposited algae having been removed. 4) Plaster colonized by algal diatoms. *Microscopic image:* 5) Visualization of sample showing the region which contained green algae (Chloroficeas). 6) Sample A with algae.

The lack of bonding between some areas of the plasters to the supporting lathwork indicates that the innermost plaster in contact with the wood laths is separated and totally disintegrated. Due to the decayed roof, the wood and the plastered ceiling have absorbed infiltrated rain water, which can only escape through evaporation and osmosis through the plaster of high permeability. The consequence of the presence of this stagnant water is the solubilisation of the plasters and their disintegration. This decay process is intensified by the development of microorganisms in the deteriorated areas. They inhabit fissures and holes in different layers of the plasterwork, leading to the decrease of its cohesion and consistence and a consequent loss of bonding. Algae have also contributed to the disintegration of the decorative plasters, as is represented by sample A. Many of the porous and damp surfaces of plasters are dominated by communities of algal *Diatoms* which produce  $H_2CO_3$  and organic acids, which promote carbonate dissolution in the algae/plaster interface.
