An Inspection of Three of Famagusta's Churches

Paulo B. Lourenço and Luís F. Ramos

In Famagusta three churches were selected for advanced, non-destructive inspection, namely dynamic and sonic testing, and preliminary diagnosis. These were: St. George of the Latins, St. George of the Greeks and The Carmelite Church.

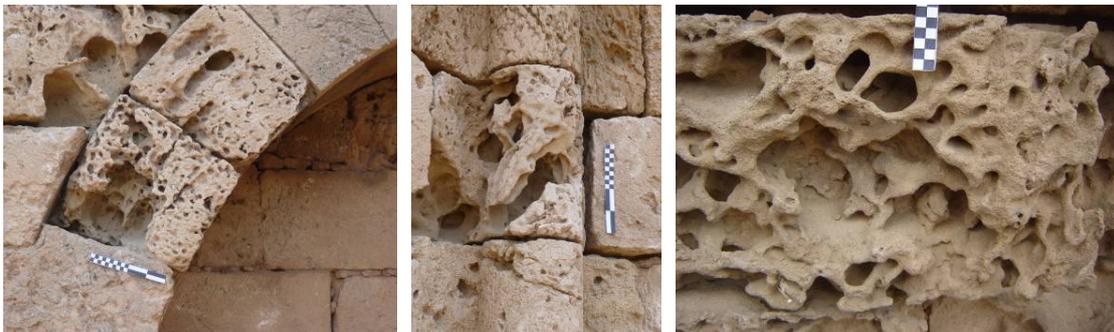
(a) severe stone deterioration;

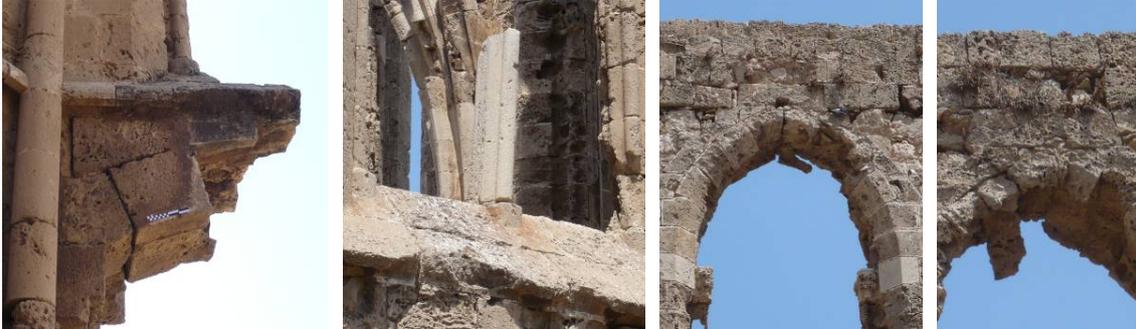
(b) loose stone elements;

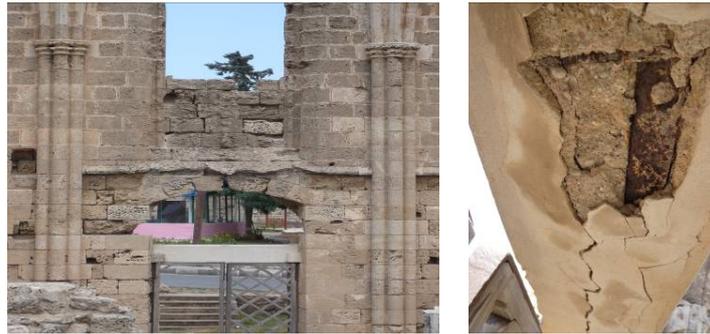
(c) highly corroded reinforced concrete lintel in main door.

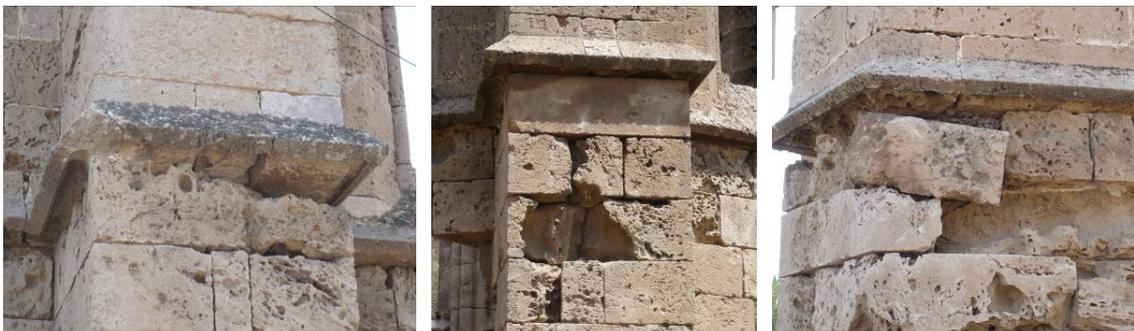
(a) mostly inefficient buttresses due to stone deterioration;

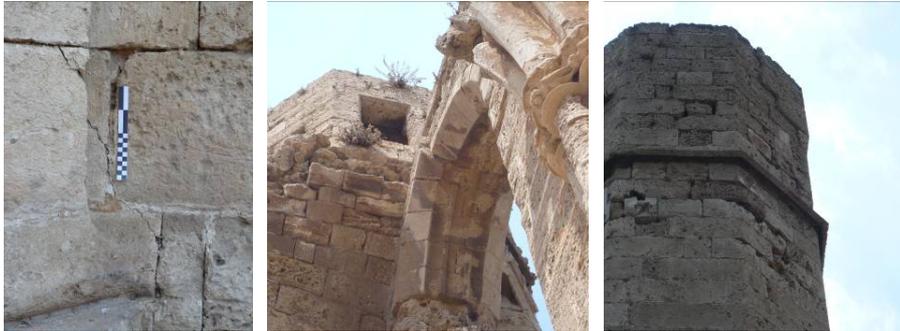
(b) a crack / rotation of the tower, possibly due to a previous earthquake / foundation problems.

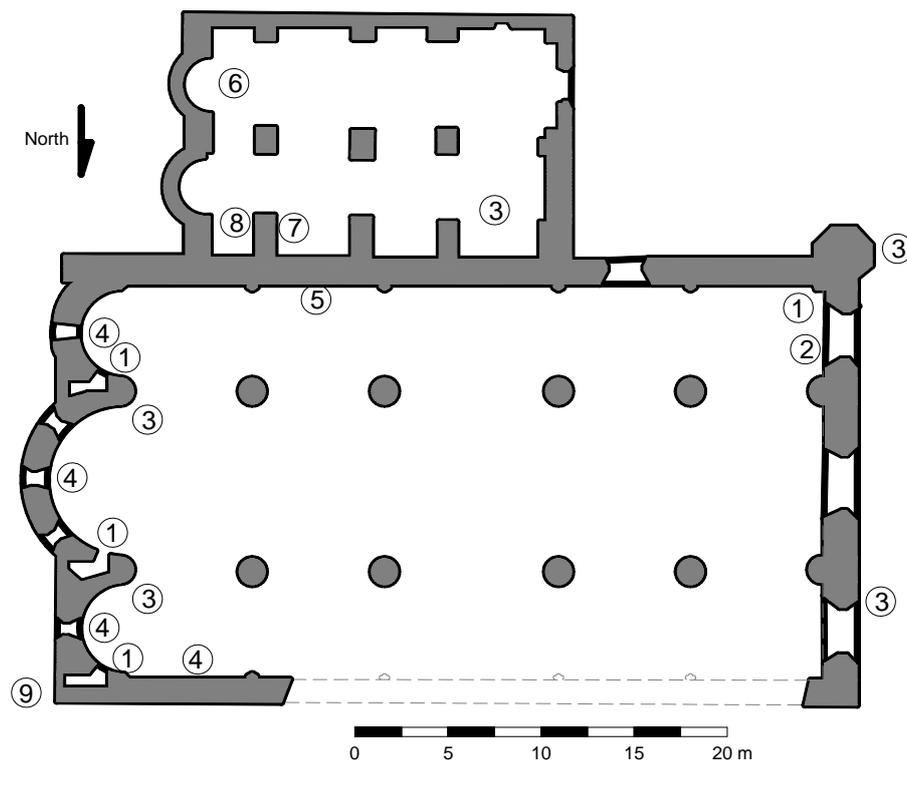
Figure 3: Saint George of the Greeks and Saint Symeon

Recorded damage / possible remedial actions: (1) doors required to prevent free access; (2) moderate cracking present, (3) need to verify if removal / consolidation of masonry / stones are needed, (4) needs protection of frescoes and engravings, (5) needs consolidation of window tracery, (6) needs consolidation of vault (roof possibly needs works to protect from rainwater), (7) needs consolidation of arch, (8) severe biological contamination; (9) needs consolidation of flying arch.

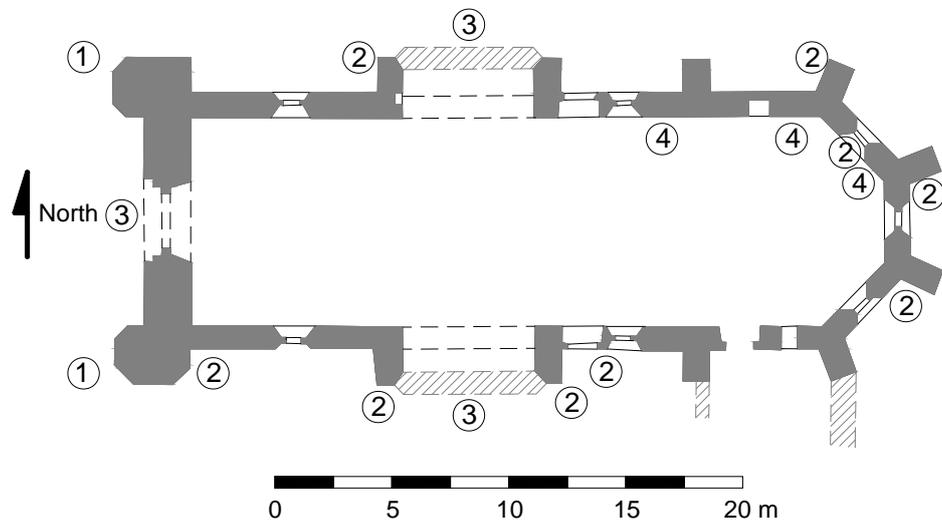
Figure 5: St. Mary of Carmel Church

Recorded damage / possible remedial actions: (1) base of the towers exhibiting severe stone deterioration, (2) voids in the masonry, (3) possible elements to remove, (4) protection needed for frescoes and engravings.

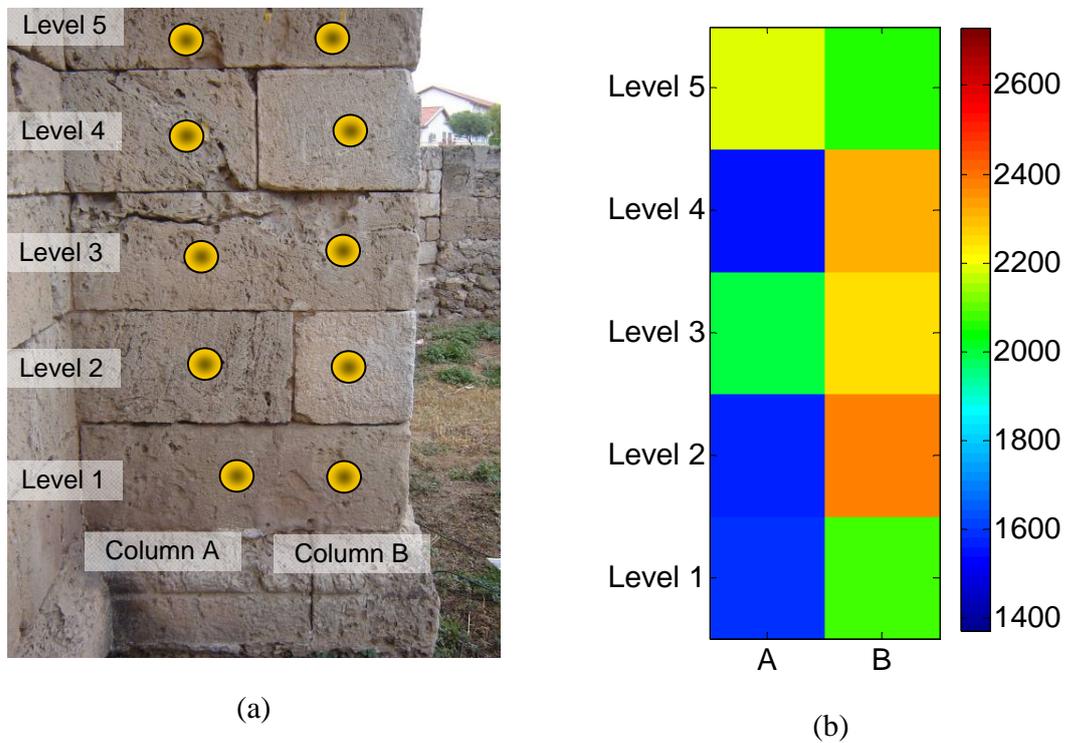
Figure 8: Sonic Testing at St. George of the Latins

Sonic tests were only carried out at George of the Latins church on two buttresses, one on the North façade and one on the South façade. The aim was to evaluate the internal condition, mainly if there are internal voids, different density materials, or if repair works had occurred in the recent past. The tests were carried out with two accelerometers and one small hammer. The hammer was used to hit next to one accelerometer (the transmission sensor), while the other (the receiver) was placed in an opposite side of the stone or buttress. Two vertical alignments (A and B) and five horizontal alignments were tested (10 points per alignment). For the North buttress, Figure 8a presents the tested points. The results are illustrated in Figure 8b, and the sonic velocity ranges from 1400 to 2400 m/s. The average value for alignment A and B is 1597 and 2249 m/s, respectively. It is possible to see that the outer points of the buttress (alignment B) have a higher velocity than the inner points (alignment A). The results indicate that the stones in

the outer alignment were probably replaced by new ones in the recent past, while the internal part of the buttresses are in worse condition. In the South buttress small differences were found between the velocity values. Ranging from 1400 to 2600 m/s, the average values for alignments A and B were 1923 and 1996 m/s, respectively. The values indicate that the internal condition of the buttress in the two alignments is similar, with similar distribution of voids.
