# SAFETY ASSESSMENT OF THE SOUTH OCULUS, CANTERBURY CATHEDRAL (UK)

## ABSTRACT

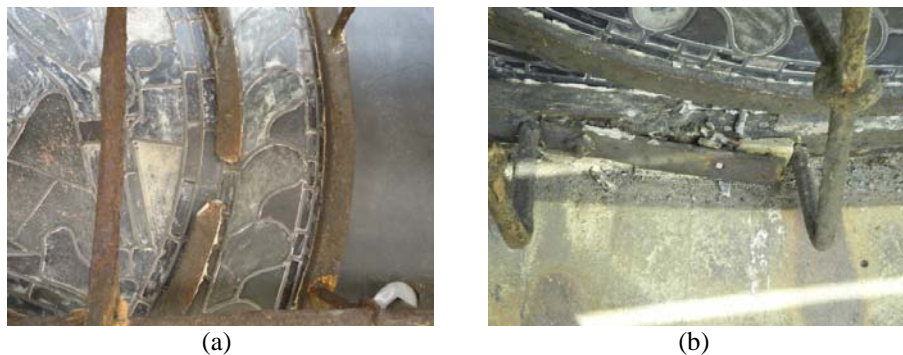
In general, the Ferramenta members were in very good condition despite their 850 years age, as no remarkable change in their initial shape was noticed and damage was limited. Except for one broken section, Fig. 5a, no damage was noticed in the Ferramenta members. There are a number of old repairs but they do not seem to affect the stability of the structure, see Fig. 5b. There is a coating of stabilized corrosion products on the iron's surface and the connections are in very good condition. The sections of the Ferramenta members are of rectangular shape in the range of 3 to 8 cm and were measured using a digital calliper, see [4] for details.

**Fig. 5** Visual inspection of the Ferramenta: (a) Broken section; (b) Old repair

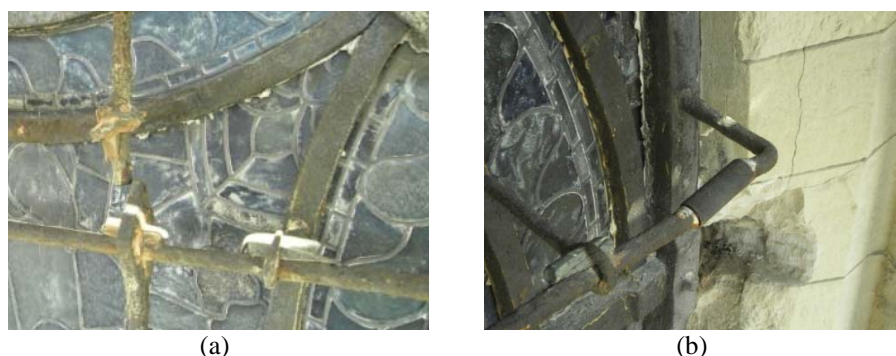
The Grille is more damaged and deformed, without a regular spacing of bars. The third vertical grille bar from the left is broken, see Fig. 6a, whereas some bars were repaired by using tubular sections, see Fig. 6b. These repairs should be removed as they are promoting galvanic corrosion to the iron grille [5]. The shape of the bars is not perfectly circular and the sections of the grille bars were again measured in two orthogonal axes. The average diameter is 24 mm [4].

**Fig. 6** Visual inspection of the Grille: (a) Broken section; (b) Old repair

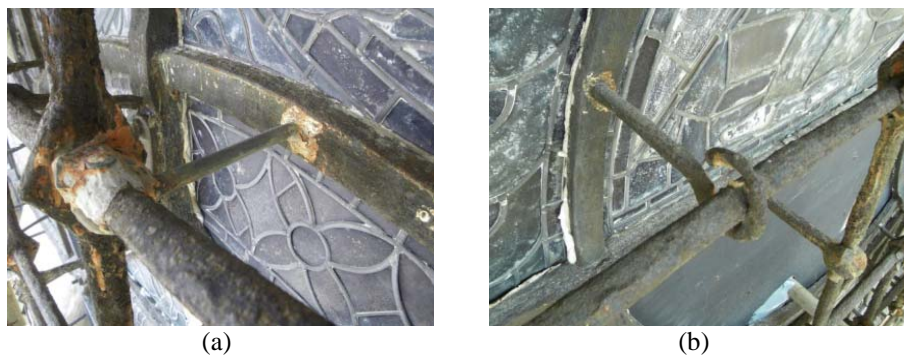
The majority of the pins connecting the Ferramenta and Grille have a similar shape, with the exception of existing hardly deteriorated pins and pins that were replaced in the past, Fig. 7. The pins are the most deteriorated part of the structure, with a serious reduction of their cross section near the connection with the Ferramenta in most pins. Scars on the Ferramenta reveal that many of the original pins are missing from the structure. Furthermore, the “eye” of many pins is destroyed, making them inactive. This is possibly due to the electrochemical reactions between the wrought iron pins and the wrought iron Grille and Ferramenta. The connections of the pins to the Ferramenta (cold rivets) are in

**Fig. 7** Details of the pins: (a) Recent pint; (b) Original deteriorated pin

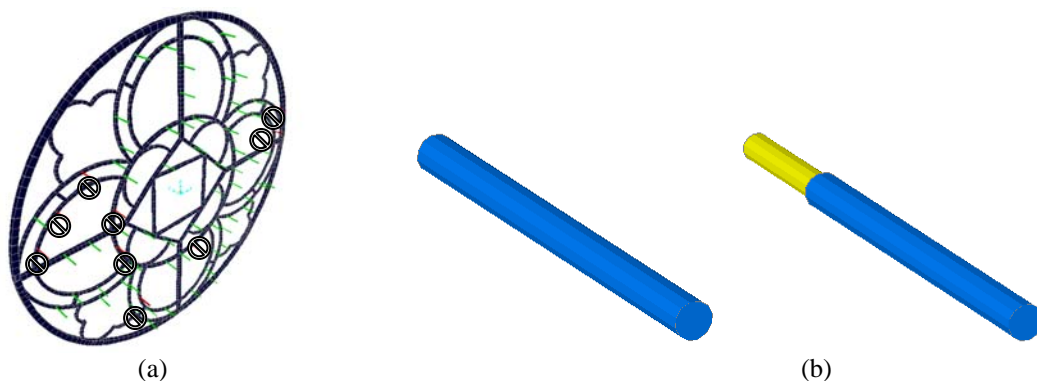
good condition. All Grille - pin joints were inspected and two types of failure were identified, namely a damaged pin “eye” because of the deterioration and the loss of wedges and putty. Nine pins were considered inactive because of this damage, see Fig. 8a. The sections of the pins are not constant and the diameter of each pin was measured at three points along its axis (two ends and central section). Two measurements were taken at each point, one horizontal and one vertical, proving diameters between 9 and 21 mm [4]. Forty-five pin sections (out of total of seventy-one) were measured due to the time available to carry out the survey. According to the results obtained the pins were classified into two groups, Fig. 8b: (a) pins with a diameter greater than 15 mm at the Ferramenta connection, assumed with a constant section given by the average of the readings in the three pin sections; (b) for the other pins, the section is divided in one deteriorated part and a non-deteriorated part [4].

**Fig. 8** Details of the pins: (a) Inactive pins (forbidden sign); (b) Types of pin considered

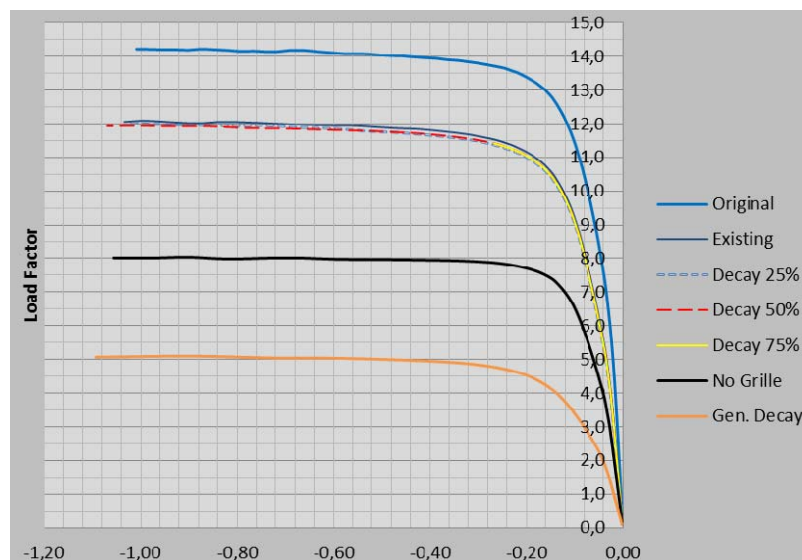
**Fig. 11** Load-displacement diagrams for different simulations

Subsequently, a parametric analysis was carried out with different assumptions. Firstly, the “original” structure is considered as the structure just after its construction with no damage or deterioration. Fig. 11 shows that the load factor is now 14.2 (+17%), which indicates a moderate effect of deterioration. Secondly, the Grille and the pins were removed from the finite element model, in order to assess the behaviour of the existing Ferramenta only. The load factor is now 8.04 (–34%), which demonstrates the importance of the Grille for the safety of the structure. Thirdly, the influence

of further decay of the condition of the structure is investigated, with a 50% reduction of the already deteriorated sections and 25% of the sections in good condition. The load factor is now 5.01 (–59%). The safety factor is moderate (4.2) but still above the value required by the codes. Finally, the assumption that decay will progress only to the parts of the structure that are already deteriorated was tested. Three cases were studied with 25, 50 and 75% reduction of the pins cross section respectively. It is observed that the deteriorated pins have minor influence on the safety of the structure.

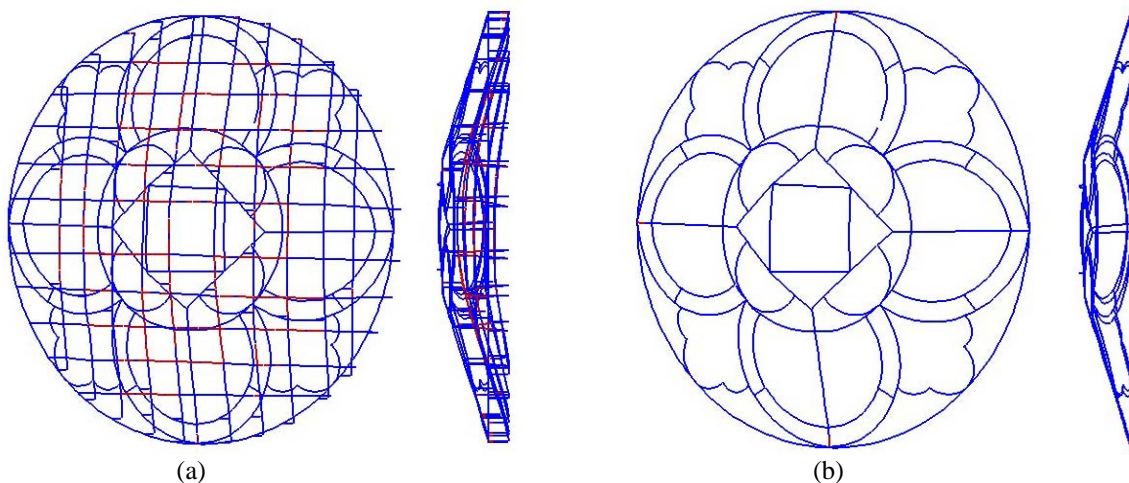
perfectly plastic stress-strain relation was adopted with a yield value of 180 MPa, a lower end value from [8]. Fig. 11 presents the variation of the horizontal displacement of the central point of the Ferramenta, as function of the load factor. The structure enters into plasticity for load factor of 12.1, i.e. for a wind load equal to 12.1 kN/m<sup>2</sup>. This value, compared with the characteristic value that EC1 proposes for the wind load, gives a safety factor of 10.2, which is rather large. Note that very large displacements are found at ultimate stage. Figure 12a presents the deformed mesh of the structure at failure. The red colour here corresponds to the sections where the yield strength is reached. Yielding appears in the Grille bars (vertical and horizontal) and also in the deteriorated part of some pins.

**Fig. 12** Failure modes: (a) Structure in present condition (red colour indicates yielding); (b) Ferramenta only
