# SHM of a Masonry Chimney after a Lightning Accident

L. F. RAMOS, M. G. MASCIOTTA, P. B. LOURENÇO and M. VASTA

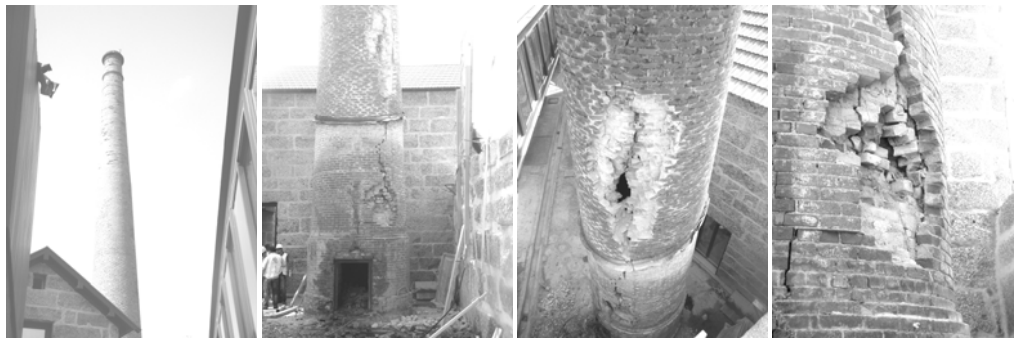
Figure 1. The Chimney and the severe openings caused by the lightning.

The accident occurred in July 26<sup>th</sup> 2012, made the structural condition of the chimney even worse causing two further severe openings (see Figure 1) and the increasing of crack openings, so that, firstly, urgent temporary remedial works were carried out to maintain the chimney in safe condition and, secondly, an in-depth intervention was planned and executed to re-establish its healthy structural condition [2]. During this lapse of time, a detailed survey of the chimney was carried out to inspect all the anomalies, as well the dynamic response of the structure was monitored to catch changes in the modal parameters. The permanent dynamic identification system for the monitoring was also used as reference system for the Ambient Vibration Tests performed to investigate the two structural conditions.

The intervention was carried out between December 2012 and February 2013. The works included: (a) chimney consolidation through reconstruction of damaged parts, cracks closing and mortar injections, (b) chimney washing and waterproof protection.

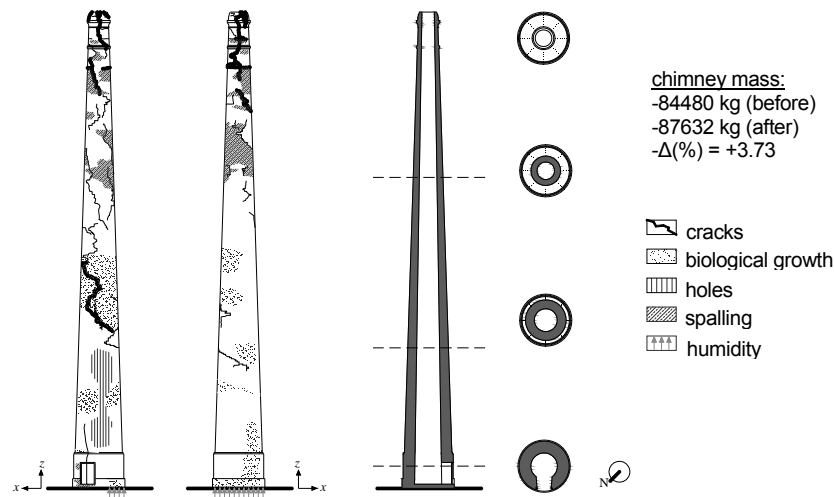
Figure 2. Geometrical survey and damage pattern in the chimney: West front, East front, sections.

The previous monitoring had already highlighted the structural condition of the Chimney: slight rigid rotation of the upper part in the North-East direction, several structural cracks, permanent plastic deformation affecting the upper two thirds of the structure and severe disconnection of the top of the chimney with respect to the rest of the body due to horizontal and vertical cracks.

In addition to this, the chimney was hit by a lightning in the morning of July 26<sup>th</sup> 2012 since the lightning rod located on the South-East side of the structure was in poor condition or cut at 6 m high from the ground floor. The electrical discharge blew the chimney wall in the side right opposite to the lightning rod creating two significant holes: one at 3 m height from the ground floor (close to the chimney opening) and the other one at 6 m height (see Figures 1-2). The masonry bricks were totally exploded and fell down on surrounding roofs circa 15 m far from the chimney. The accident did not worsen the permanent deformation of the chimney, but it caused an increasing of the existent vertical cracks width of 3 mm. Furthermore, due to the lack of maintenance, the damage survey that took place in November 2012 also recorded spotted spalling, widespread biological growth and presence of humidity in the bottom part of the chimney (see Figure 2).

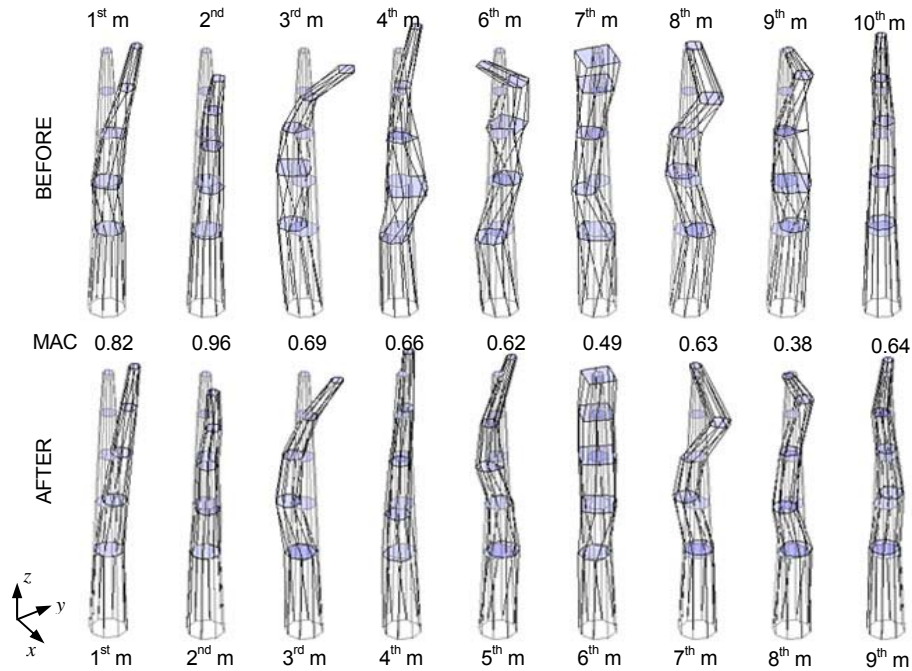
Regarding the mode shapes comparison between the two structural conditions, it is possible to remark a good fit in terms of mode configuration as well as a quite fine correlation in terms of MAC values (see Figure 4).

Figure 4. Experimental mode shapes and MAC values before and after rehabilitation works.

Analyzing the modal displacements in detail, local effects essentially due to the existence of both holes and severe cracks affecting the upper part of the chimney can be observed before the rehabilitation works, while a monolithic behavior characterizes the structure after the intervention. In fact, the higher changes in terms of frequency content are recorded for modes 7, 8 and 9, exactly reflecting the local effects attenuation that is also evident for the first modes even though, in this case, the frequency content does not change significantly.

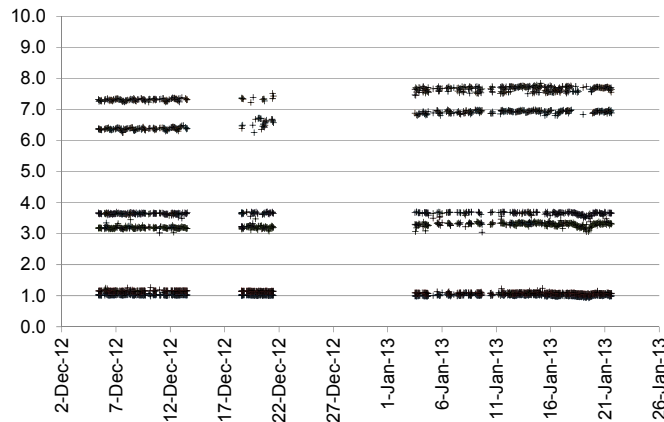
Figure 5. Monitoring of the first six natural frequencies [Hz].

The results of the first six natural frequencies are presented in Figure 5. As can be seen, only the upper natural frequencies suffer significant changes due to the structural consolidation works, while the first two frequencies close to 1 Hz didn't change its values.
