## Dynamic identification and modelling of Clérigos Tower: initial studies

Álvaro Cunha<sup>1</sup>, Luís F. Ramos<sup>2</sup>, Filipe Magalhães<sup>1</sup>, Paulo B. Lourenço<sup>2</sup>

**ABSTRACT:** This paper describes the work carried out to assess the dynamic properties of the historical construction of the Clérigos Tower in Porto, Portugal. A brief description of the Church, Infirmary and Tower is presented followed by a quick survey of the construction in terms of geometry and damages. Later it is discussed the dynamic test plan, and the first results from the modal identification tests are presented and discussed. Finally, a preliminary numerical analysis to tune the mechanical properties is presented as a first attempt to evaluate the structural behaviour and safety of this historical construction.

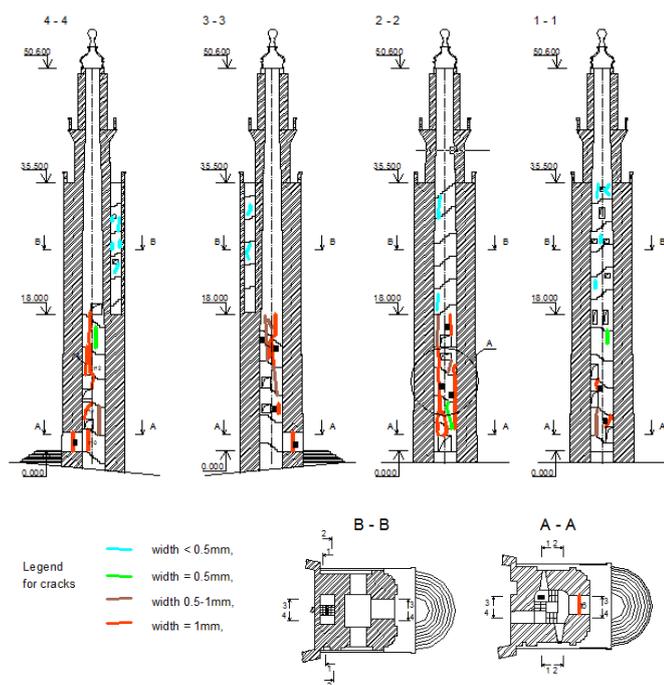
This first check was followed by a damage survey, including the material deterioration and other structural damages, such as cracks. Damage maps were drawn as can be seen in Figure 4. Damage map from the Bell Tower [5].

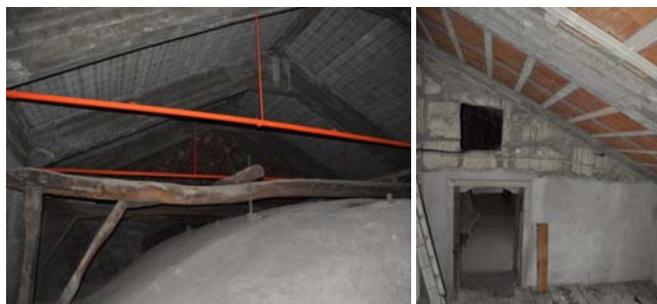
Figure 5. Configuration of the roof structure.

The roof of the church and, partially, of the *Casa dos Clérigos*, was substituted (probably in 1984) by a (heavy) reinforced concrete roof. Some original elements (tie beams of timber trusses) were left, adding some steel ties, as can be seen in Figure 5.
