Safety Analysis of Modern Heritage Masonry Buildings: Box-buildings in Recife, Brazil.

Short Title: Safety Analysis of Box-buildings in Recife

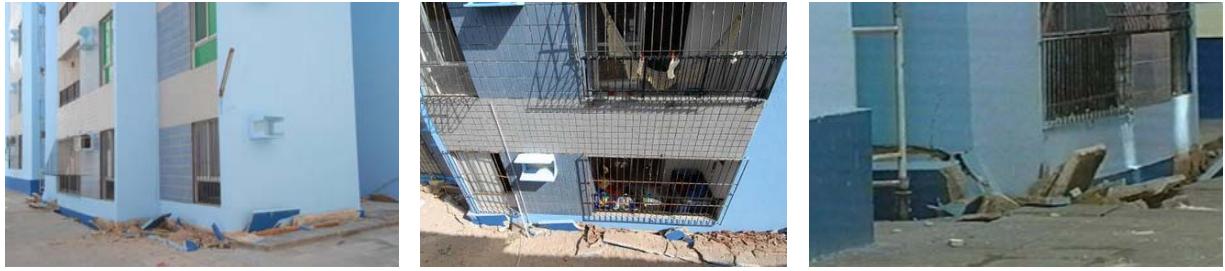
On December 2007, the building under analysis collapsed and sank more than one meter because of the failure of the saturated masonry walls at the foundations. The building did not entirely collapse due to the existence of tie-beams at every floor level. In fact, the floors above ground remained in fairly good condition, showing little damage except in some localized parts. These localized parts of the building may have collapsed due to the dynamic effects resulting from the impact of the building to the ground. The results of the analysis considering only vertical loading show good agreement between the crack patterns observed in reality and the damage achieved numerically at the current condition ($LF=1$). The failure mode seems to be well matched, even though the safety factor obtained does not justify the collapse observed in reality. The foundation walls must collapse at a much earlier stage than the one predicted by the model.

FIGURE 1 Views of the building after the collapse.

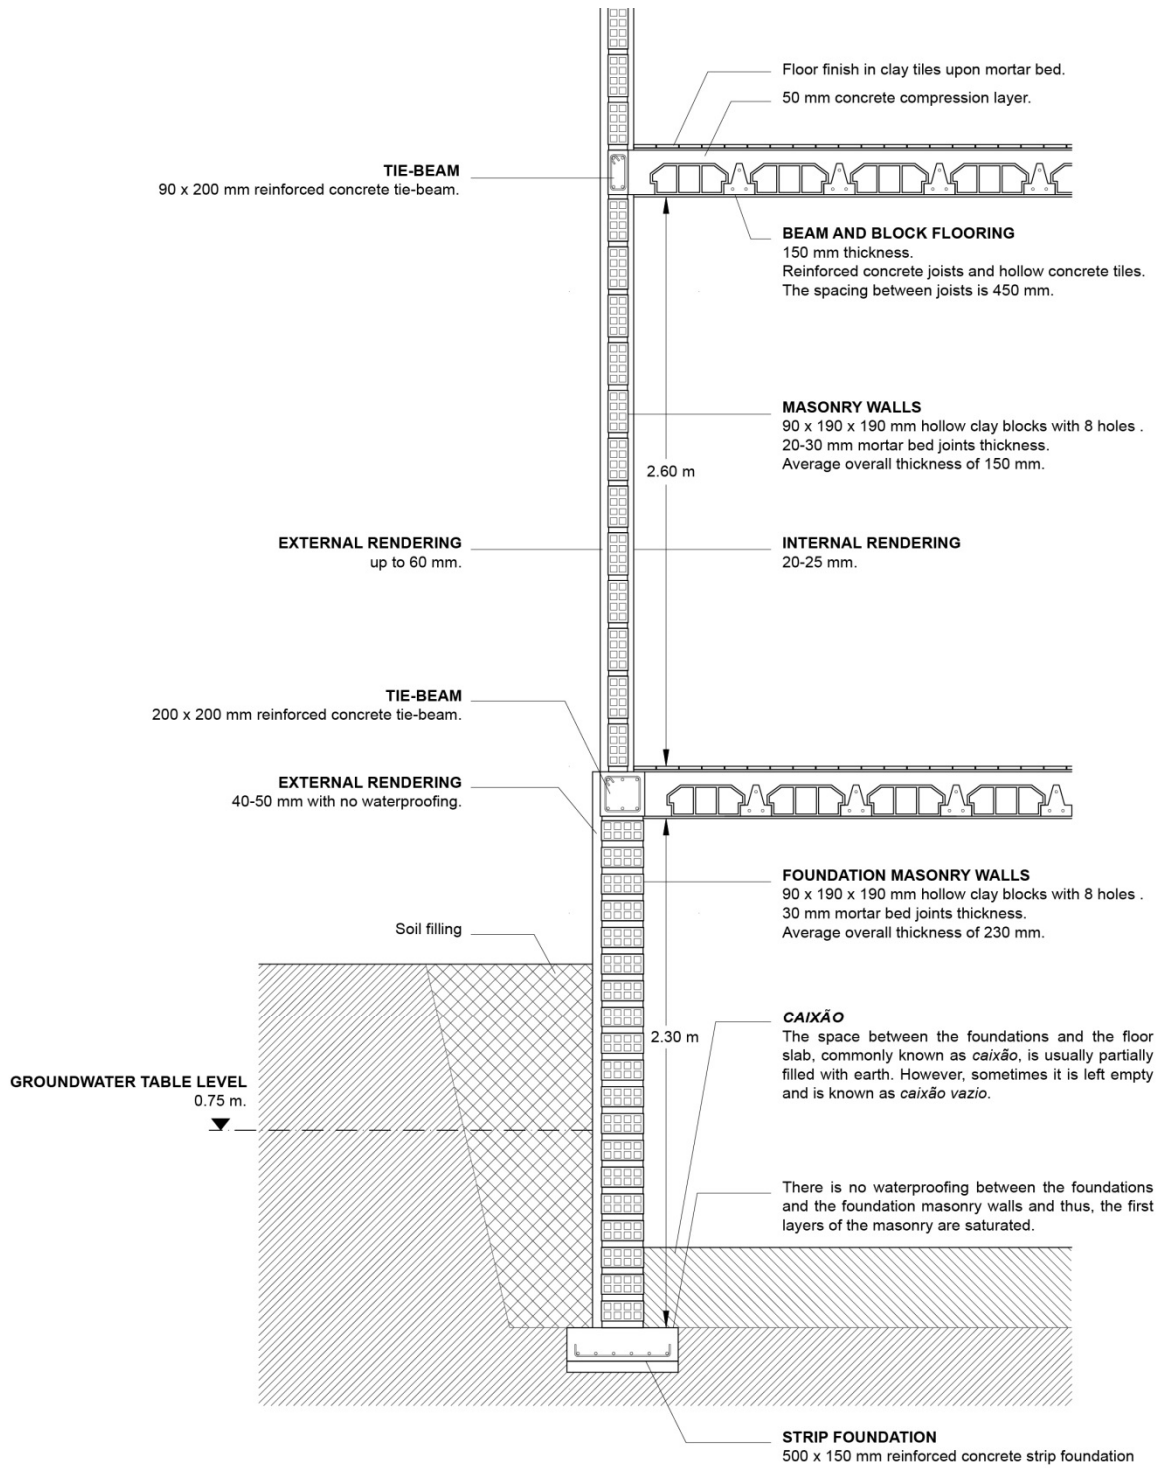
Figure 3 shows a construction detail from the foundations to the ground floor. The foundations are made using continuous reinforced concrete footings, with a width of 500 mm and a height of 150 mm, and unreinforced masonry walls. The masonry walls are built with hollow clay blocks with dimensions about 90 × 190 × 190 mm³ with 8 holes positioned horizontally. They lay on their largest dimension, 190 mm, and the average thickness of the mortar bed joints is 30 mm, but it is very variable. The external mortar rendering has a variable thickness between 40 and 50 mm. No internal rendering is present and altogether, the masonry walls are around 230 mm thick. The depth of the ground water table is 0,75 m and, therefore, a significant part of the foundations is in direct contact with water. As there is no waterproofing, the first layers of the masonry are permanently saturated. Moreover, there is no sewage collector in the building and the water is contaminated, which may result in accelerated degradation of the mechanical properties of the blocks [de Oliveira, 2009].

FIGURE 3 Construction details of the building.

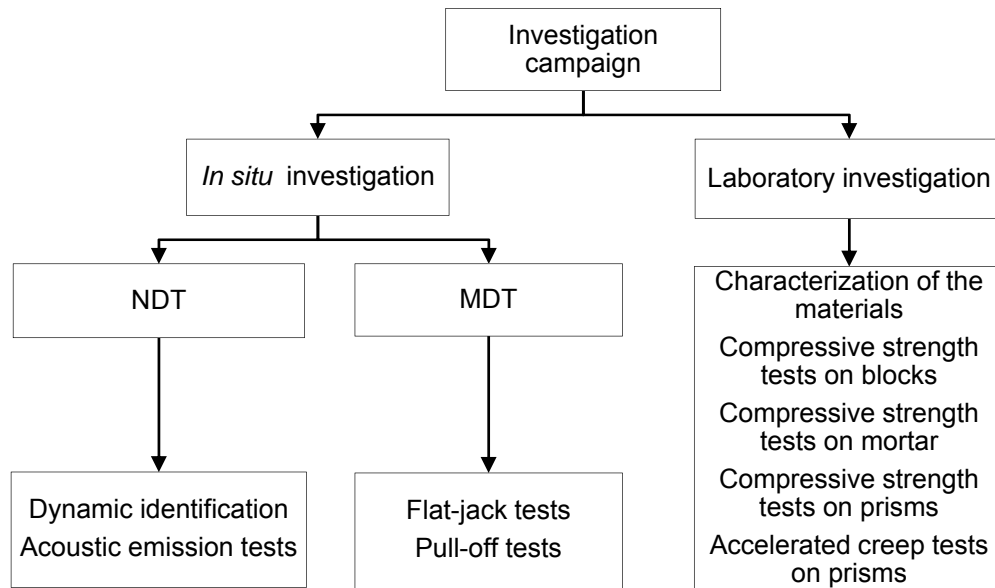
The investigation campaign performed on the building to assess the existing damage and to better understand its structural behavior is summarized in Figure 4. Non-destructive and minor destructive *in situ* tests were performed and 22 prisms samples were extracted from the building for further testing on the laboratory. Ten prisms were tested in the laboratory of the University of Minho, in Portugal, and twelve prisms were tested in the laboratory of SENAI-PE, in Brazil. Most of the parameters later used in the FEM model were determined from this extensive experimental research. A brief description of the tests most relevant for the present work is provided next. Further discussion on the results of the other tests can be found in de Carvalho [2010] and Ortega [2013].

FIGURE 4 Investigation campaign carried out in the building [de Carvalho, 2010].

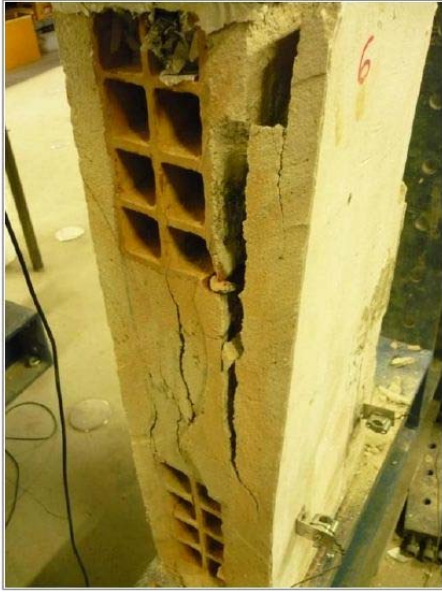
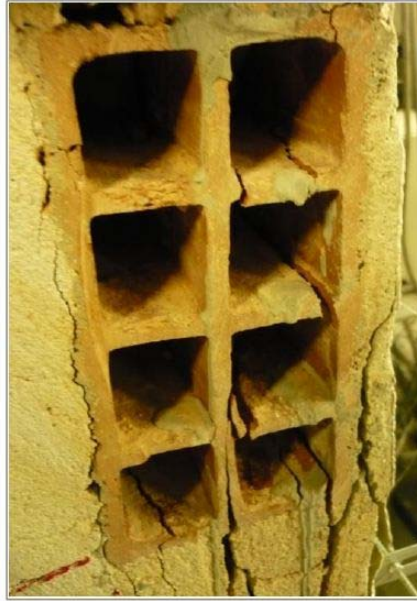
the laboratory of the University of Minho. Since some of the blocks are expected to be saturated in the building, an important distinction was made between saturated and non-saturated condition. Therefore, three of the prisms were immersed in water for 28 days prior to testing. The thickness of the prisms was remarkably variable and the average thickness of the mortar bed joint was assumed as 27 mm. Monotonic compressive tests were then performed on the prisms and from these tests, the compressive strength and the elasticity modulus were obtained. Table 1 presents the geometrical characteristics of the prisms and the results of the compressive strength tests, which were later used in the FEM model. The collapse of the prisms occurred right after the first detachment of the rendering, leading to a sudden failure. A very brittle behavior of the masonry was then verified, as cracking of the block occurred very close to the ultimate load. Figure 5 shows the failure modes of the prisms and the detachment of the rendering.

FIGURE 5 Failure mode of the masonry prisms tested.

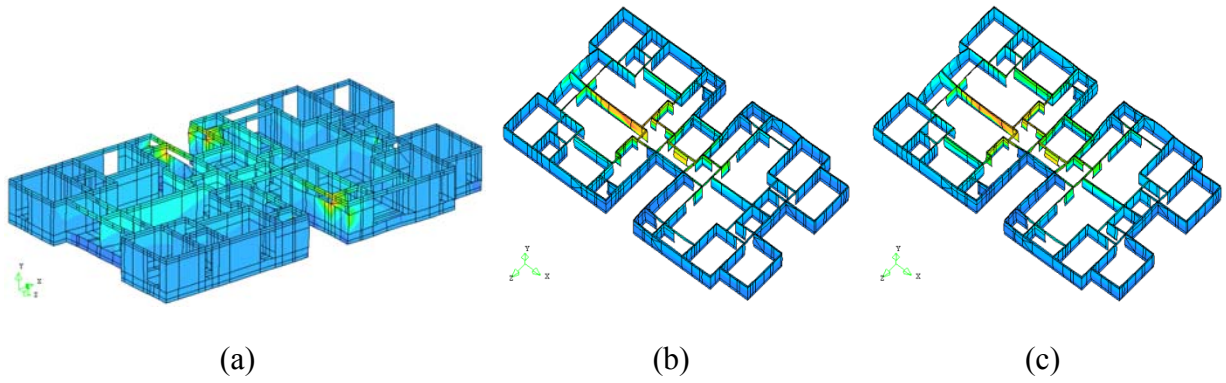
The results indicated that the initial value adopted for the compressive fracture energy needed correction, as the failure mode obtained from the numerical analysis was not in agreement with the observations. It is noted that the available data for the compressive failure of hollow clay block masonry is not available. Failure is much localized, taking place in the ground floor, at the connection between an internal wall and an opening, and occurs very explosively, i.e., it was not possible to have a follow-up of the collapse. As the real collapse of the building occurred after partial collapse of the foundation masonry walls, this result was not considered as representative of the global structural behavior of the building and the compressive fracture energy was subsequently increased aiming at obtaining a failure mode closer to reality. Figure 8 illustrates these results, it can be observed that the failure mode changed when the compressive fracture energy was modified, and collapse was due to crushing of the foundation saturated walls, matching better the observed failure mode. The

FIGURE 8 Incremental displacements at the ultimate stage depicted on deformed mesh: (a) unacceptable failure mode resulting from the first analysis ($d=1.6$ mm), consisting of failure of the masonry walls at the ground floor; (b) failure mode resulting from the second analysis ($d=3.2$ mm), consisting of crushing of the foundation walls; and (c) failure mode resulting from the third analysis ($d=6.4$ mm), consisting of crushing of the foundation walls.

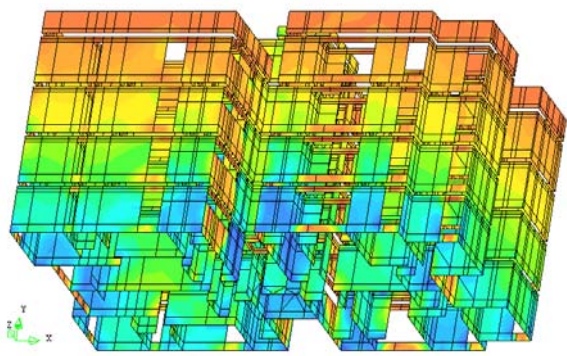
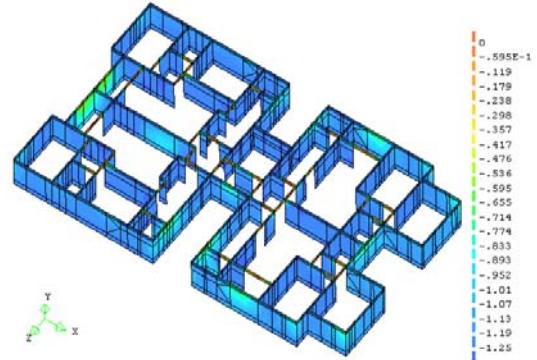
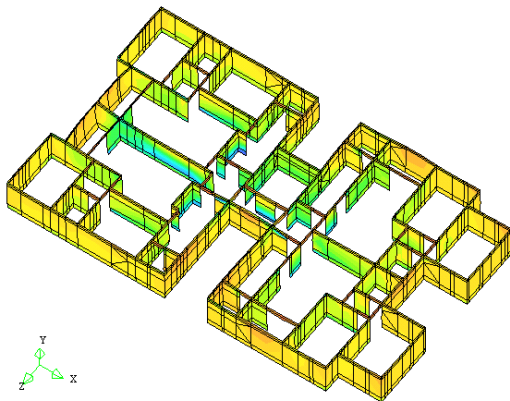
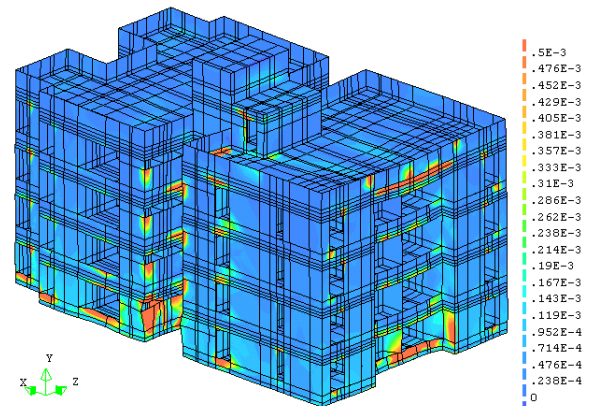
Additional results are shown in Figure 10, in terms of minimum principal strains, minimum principal stresses and maximum principal strains. As previously mentioned, the action that leads the collapse of the building is the crushing of the foundation masonry walls, specifically the walls located in the central part. Crushing results from reaching of the ultimate compressive strength. Figures 10a and 10b display the minimum principal stress distribution at the peak stage above ground and at the foundations. The areas above ground showing more stress concentration are localized close to the openings and balconies at the ground floor. In contrast, it can be observed that the stress distribution at the foundations is much homogeneous and the ultimate compressive strength has been reached by almost every wall. Figure 10c presents the minimum principal strains at the peak stage, which reach very high peak values.

Tensile damage starts arising in the structure at very early steps. After applying the full load ($1.35DL + 1.5LL$), some cracking is visible. The most sensitive regions to cracking are located at the openings, balconies and lintels, particularly at the ground floor. This evidence is in good agreement with what was observed during visual inspection, where cracks were already identified in those areas. The maximum principal strains at the peak stage are widely and intensely spread, see Figure 10d. The fact that, in reality, the building at collapse showed very little damage above ground confirms that the failure load is high and collapse

must occur at a much earlier step at the foundations. There is also cracking taking place at the foundations given the high compressive stresses to which these walls are subjected.

FIGURE 10 Results of safety analysis at the peak stage: (a) minimum principal stress above ground; (b) minimum principal stress at the foundations; (c) minimum principal strains (a crushing measure) at the foundations depicted on deformed mesh; and (d) maximum principal strains (a cracking measure) above ground depicted on deformed mesh.

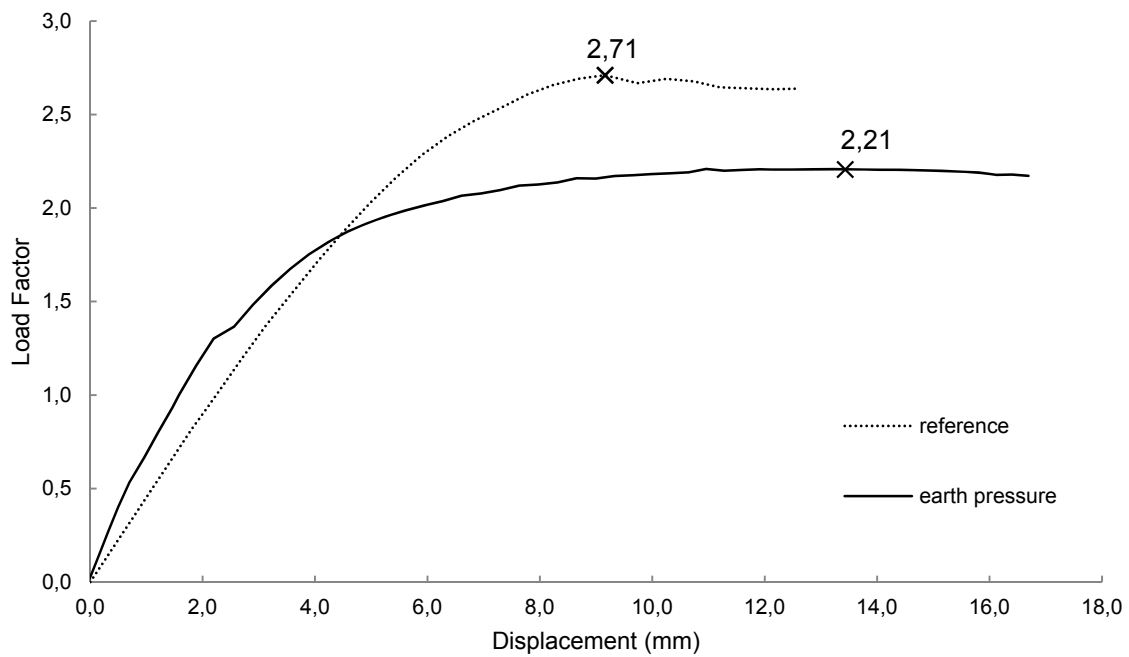
The load-displacement diagram for a point at the foundation masonry walls that presents the maximum buckling is presented in Figure 22. It is noted that the load factor is reduced to 2.21, which means a reduction of 18%. This demonstrates that this pressure might have helped to lead to the building collapse. However, it again does not justify the failure of the building. Given the compressive dominated failure of the masonry walls, the arching effect in the vertical direction that could have been assumed to mitigate this effect, has only minor influence.

FIGURE 22 Load-horizontal displacement diagram for a point at the foundations where the buckling is maximum taking into account the lateral earth thrust. Note that the load-vertical displacement diagram for a point top of the building is also given as a reference, even if the diagrams cannot be compared.

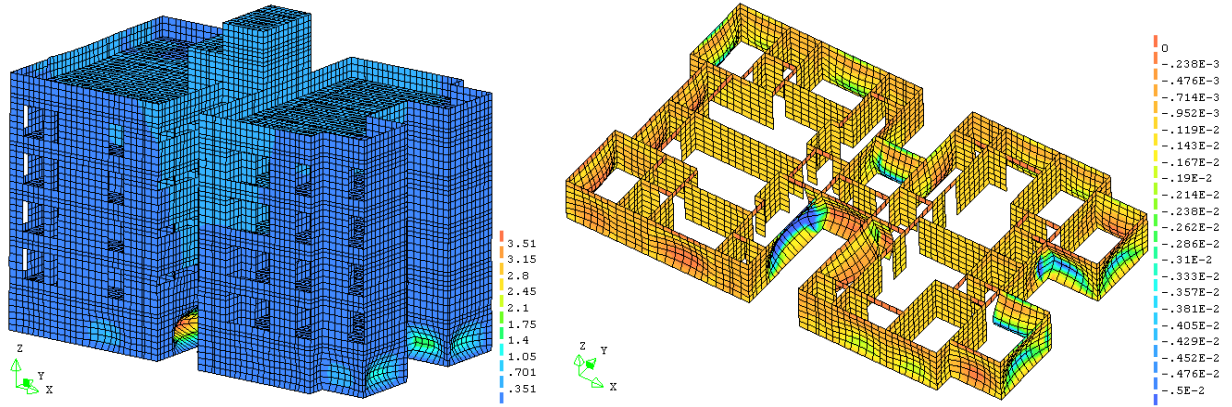
The failure mode for this new analysis still occurs at the foundation masonry walls but now takes place at the larger perimeter walls where the earth pressure, as shown in Figure 23.

FIGURE 23 Results of analysis taking into account the earth pressure at the peak stage: (left) incremental displacements depicted on deformed mesh; (right) minimum principal strains at the foundation walls.
