Rui Tiago Pinto dos Santos Beleza de Seabra Assessment of a Gothic steel church: San Sebastian Church

Portugal | 2016

Master's Thesis

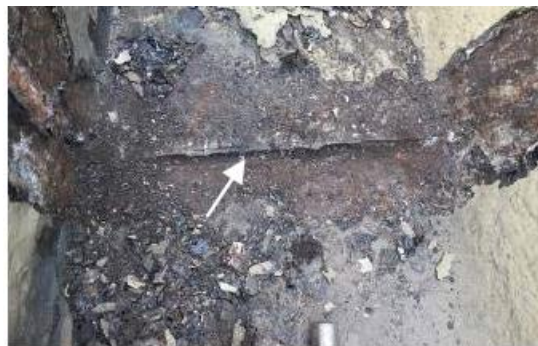
Figure 30 – Gutter being mechanically cleaned.

In addition, the nave gutter was one of the elements that needed to be repaired more urgently. These elements were mechanically cleaned with the help of a brushing cup (Figure 30). After being properly cleaned, the elements were cold-galvanized with zinc-rich-paint. The same intervention was performed in the corner gutters, but in these, the used material was fiberglass-reinforced plastic.

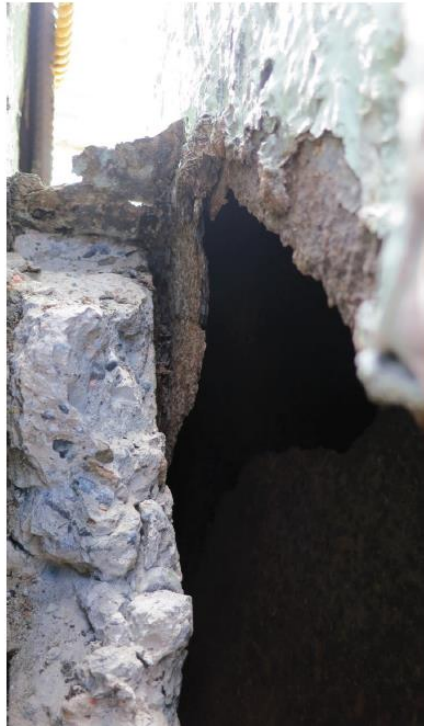
Figure 31 – Concrete applied on the pinnacle valleys.

One intervention to be noted was done in the pinnacles, where concrete was poured to avoid the water dropping to the inside of the columns. Such intervention, according to information provided by the parish, was performed in the 1980's (Figure 31). The pinnacles also had to be intervened, where some plates had to be fixed, since they were detaching rapidly.

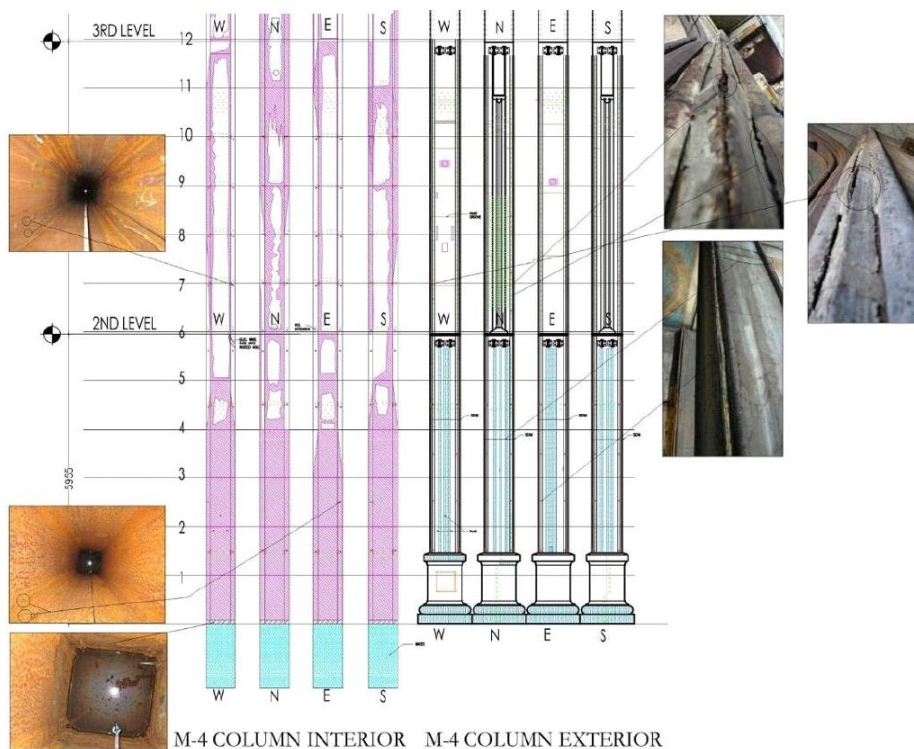
Examples of the column condition assessment of the thickness are presented in Figure 33 and Figure 34. These studies were carried out in 2014 and, current damage can be larger (Figure 33 and Figure 34). The pink colour in Figure 33 indicates the bulging damage. The identified damage in this column was bulging of the column/plate corner where the rivets attach the pipe moulding to the column.

Figure 33 – Damage pattern in the lower part of column M-4.

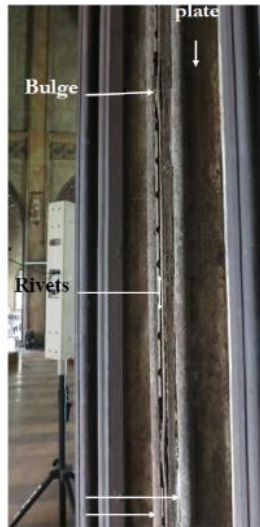
Figure 34 – Bulging at the column.

Some splaying of the corner is believed to have been caused by rust jacking. There is rust at 12m height on all sides of the column, and some water has accumulated at the base. Heavy rust is present at the angle bar and in the column plate.

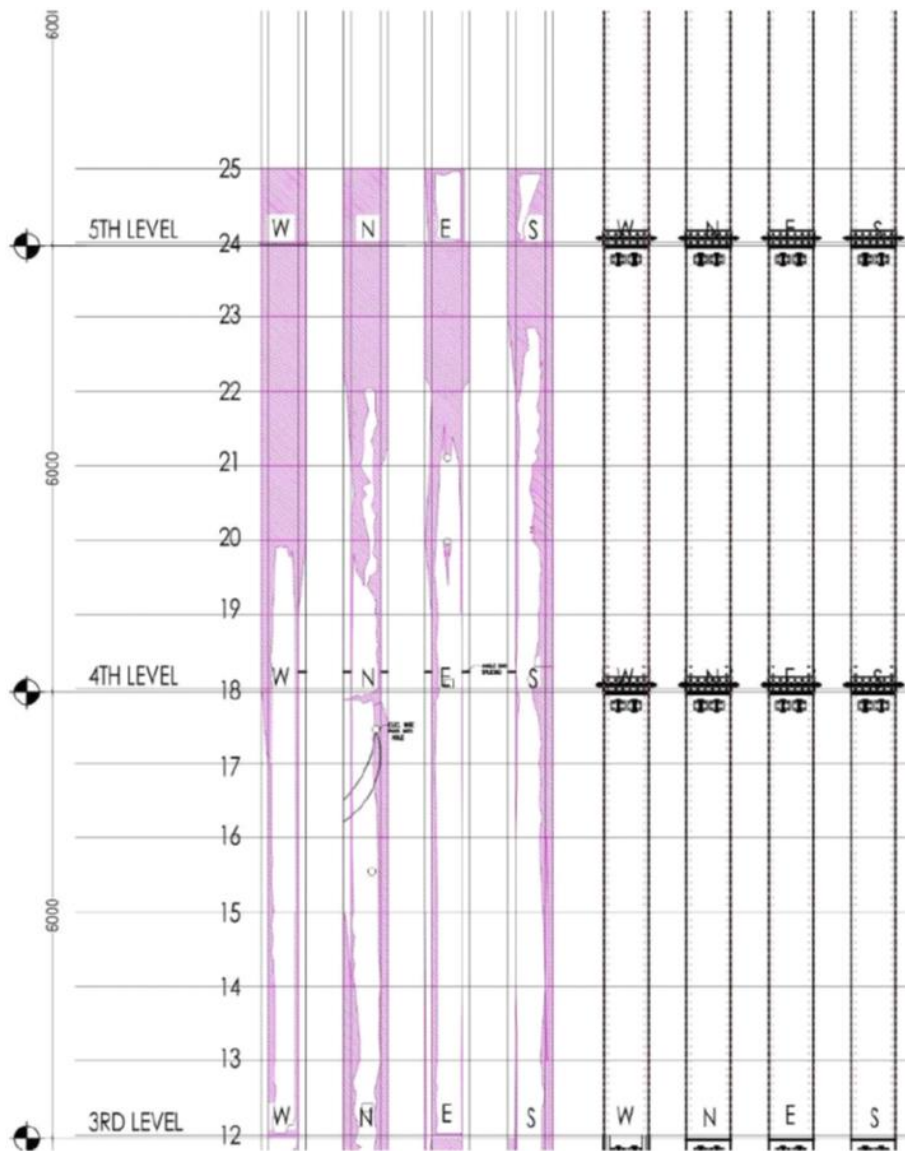
In column M-4, but at a higher level, bulging at column plate is found, but in small quantities. From 24m higher, this condition gets worst, mainly because rivets are not being protected by pipe mouldings and are exposed. Open corners were heavily repaired with putty. Corrosion is mainly located between the angle bar and the column plate.

Figure 35 - Damage pattern in the upper part of column M-4.

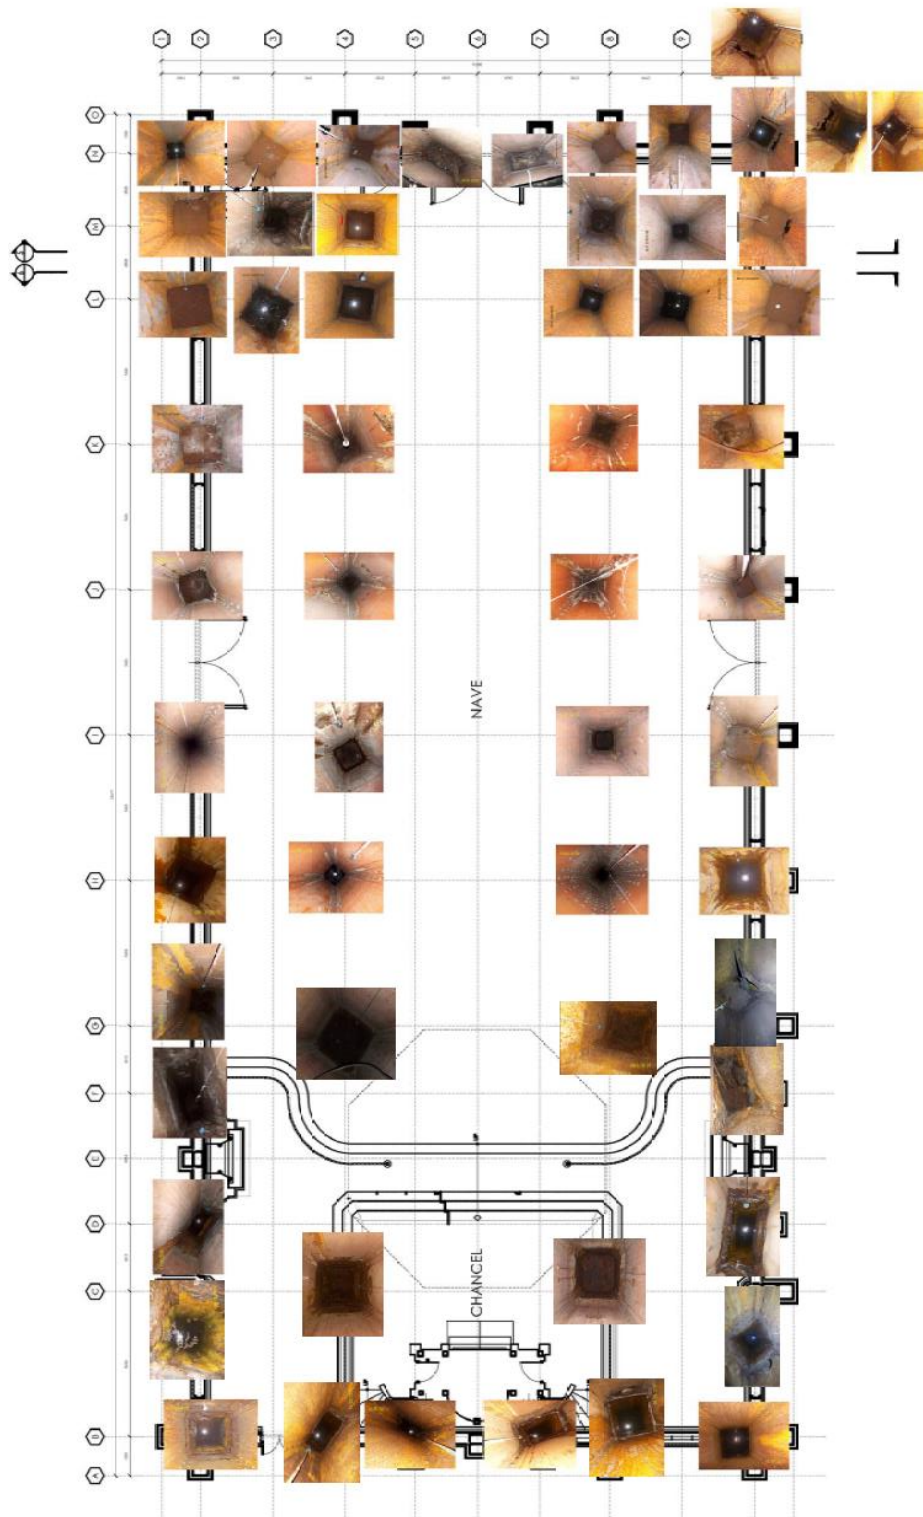
Figure 36 presents a plan with a photo of the inside of the columns of the structure. It is possible to observe that the higher damage in columns occurs in the outer ones. The inside columns are almost undamaged.

Figure 36 – Plan of the structure with photos of the column's interior.

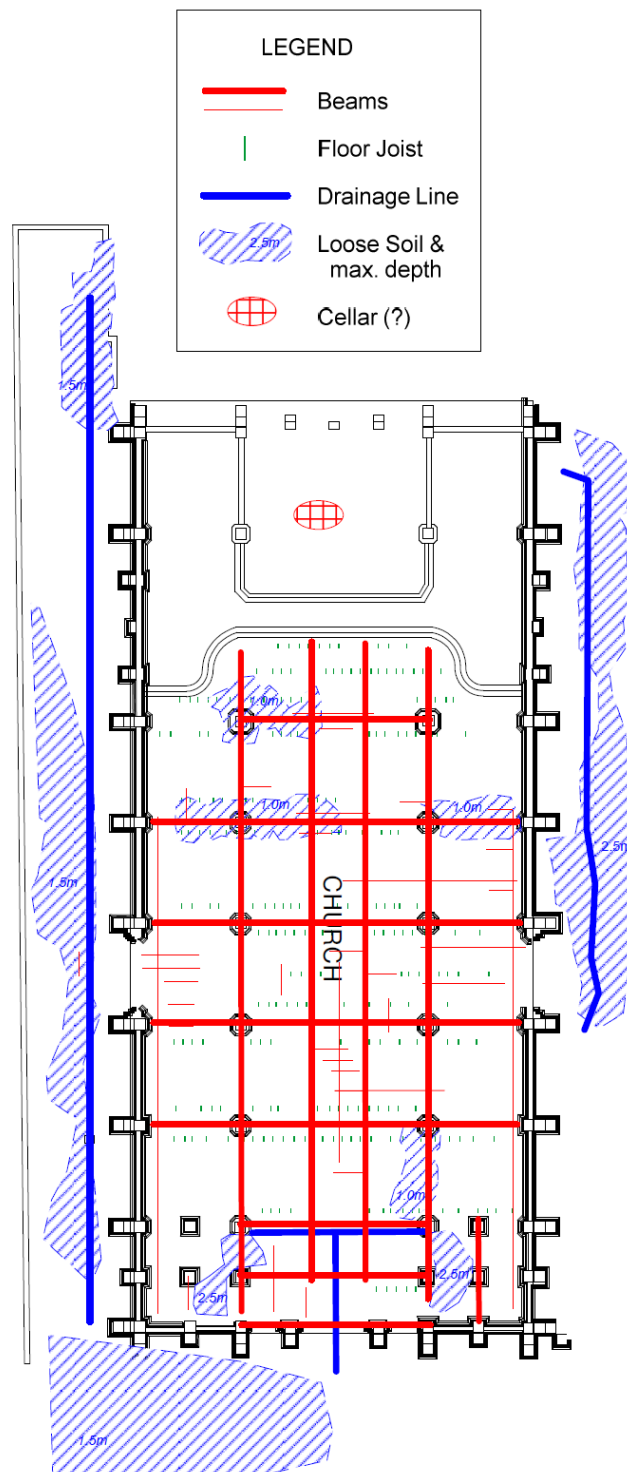
Figure 41 presents a map of the structure containing a summary of what was found in all the GPR tests.

Figure 41 – Summary of the GPR results and findings.

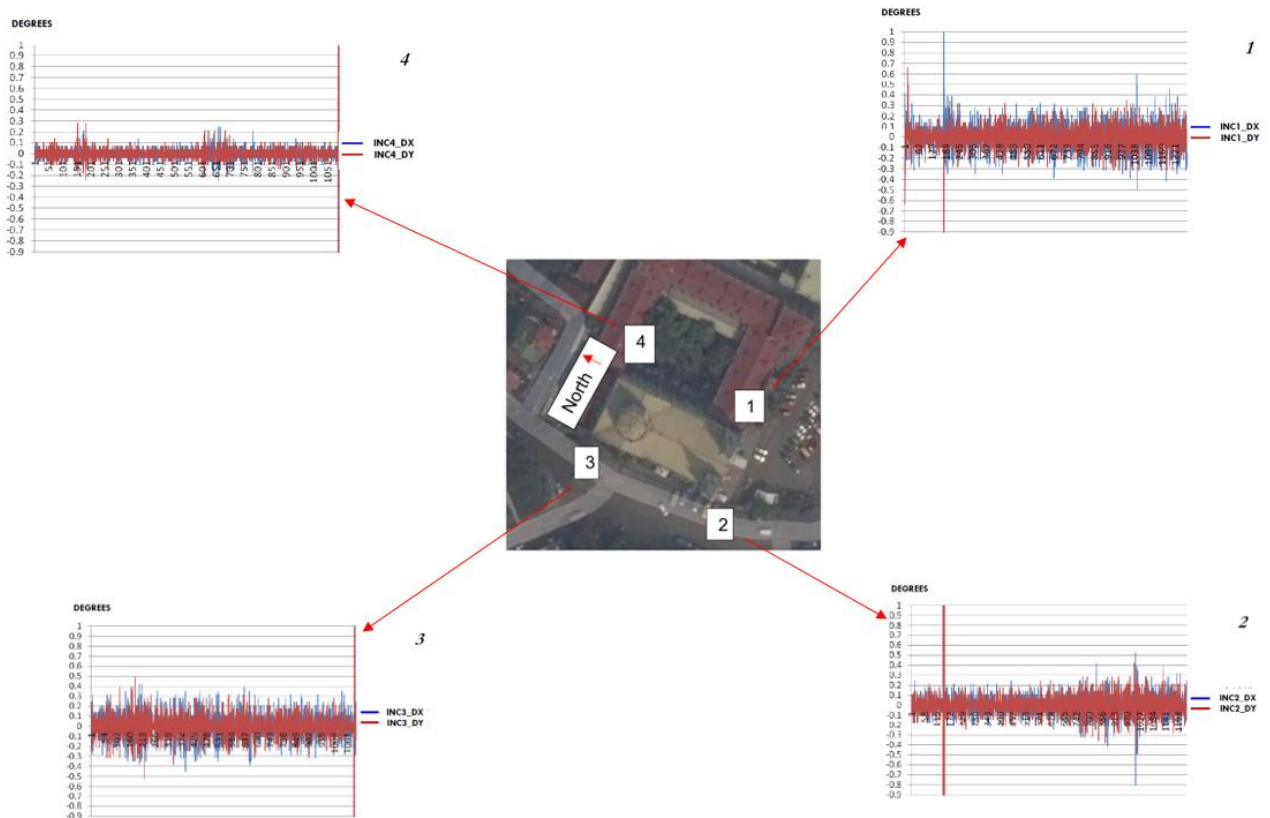
Testing with inclinometers was performed because surveying indicated patterns of open building joints. These patterns were possibly indicating an active movement of the building. For this purpose, four 2-axis inclinometers were installed, where the rotation in the two directions was measured. The inclinometers were installed in the four corner columns. Inclinometers 1, 2 and 3 registered similar maximum rotation values, maybe due to the fact that these columns are subjected to more or less the same wind loads. Inclinometer 4 was the one that registered the smaller values possibly because it is closer to the adjacent buildings on the northeast side. The rotations were measured during the months between November 2013 and February 2014, and the maximum rotation was 0.01° , obtained when the bells were ringing, see Figure 42.

Figure 42 – Location of the inclinometers and the collected data.
