## Selected research and case studies in ancient Portuguese structures

### Summary

The present paper presents some of the recent activity of University of Minho, regarding case studies for Portuguese timber structures in four ancient buildings, including the Cathedral of Porto, a Church in Coimbra and a Church in Braga. NDT is combined with analysis methods aiming at non-invasive strengthening solutions or replacement of the timber structure (only as a last resort). Research studies carried out in UM and currently running on LNEC and UM are also presented, being showed the relevance of this research studies for the assessment and analysis of historical timber structures.

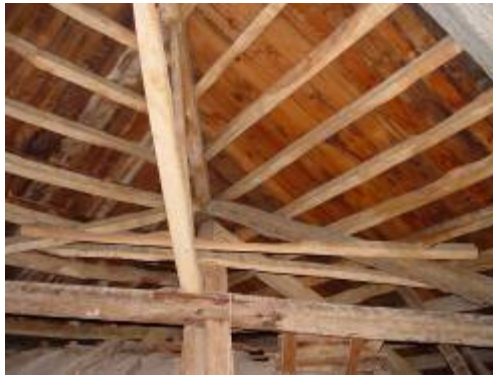
The roof timber structure is extremely complex as a result of additions and successive attempts to correct the observed damage, see Fig. 2a. Damage includes humidity stains and rotten roof sheathing (the estimate is that 30% of the sheathing needs replacing), see Fig. 2b. Several truss elements exhibit excessive deformation, which is leading to cracking and damage of the lathwork vault, see Fig. 2c. As a result of the deformation of the truss elements, struts and wedges supported in the timber vault have been added to the structural system.

*Fig. 2: Aspects of the roof: (a) complexity of the structural system; (b) moisture; (c) excessive deformation and rotten wood; (d) defects*

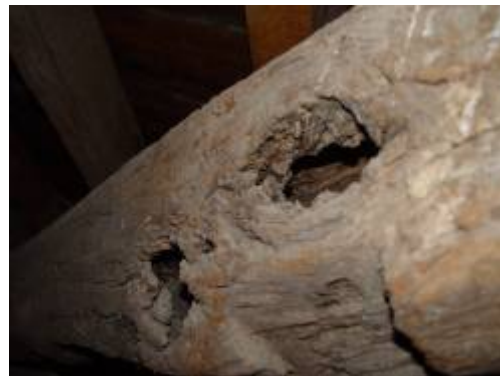
(d)

The wood elements are generally attacked by xylophagous insects, usually limited to the sapwood. Larger defects are also present, see Fig. 2b, d, together with inefficient connections and corroded ties. The vault ribs are widely attacked by the common beetle, see Fig. 3.

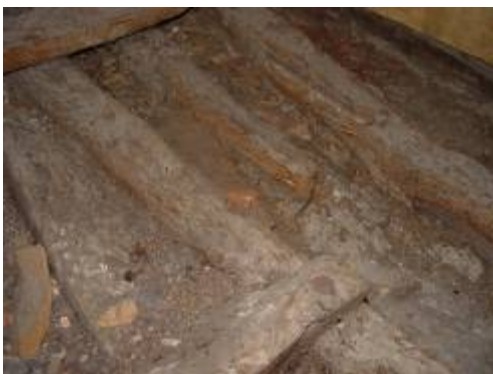
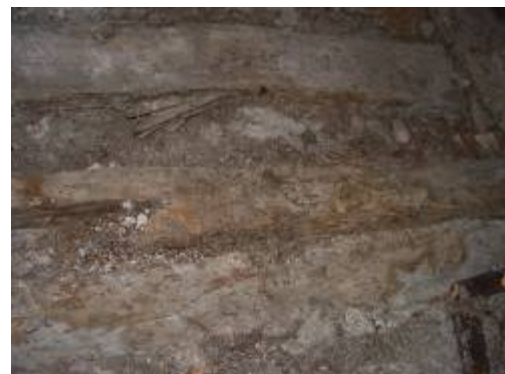
*Fig. 3: Details of the generalized infestation and the irregularity of the cross section of the ribs due the attack*

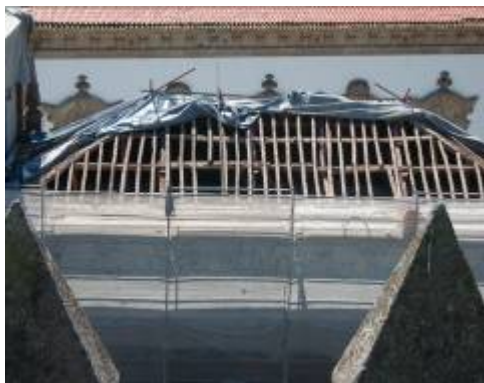
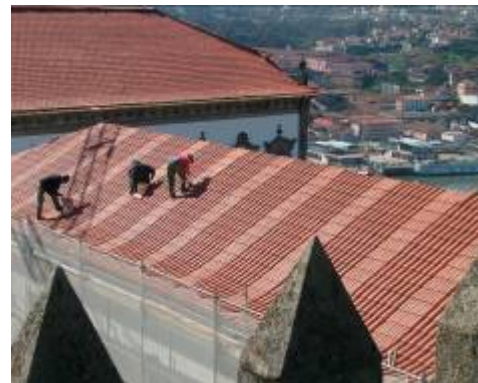
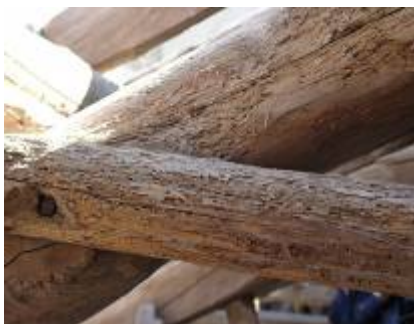
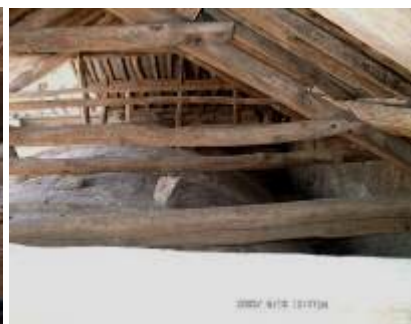
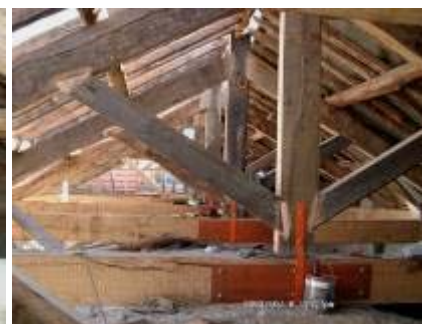
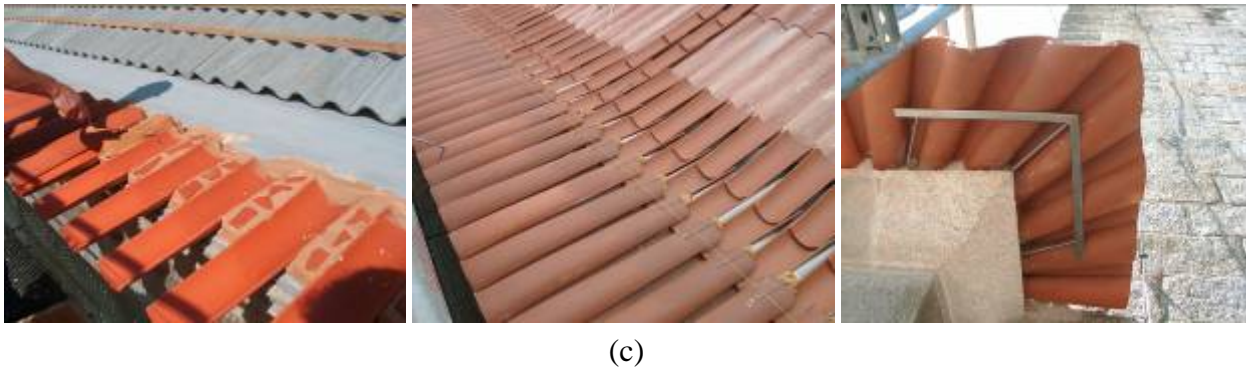
The origin of this building dates back to the middle of the 12<sup>th</sup> century and large conservation works have been carried out recently. With respect to waterproofing and roof structures, the works aimed at using traditional techniques and keeping remedial measures to the minimum. Remedial measures included cleaning, application of biocide, application of preservation products, consolidation, strengthening and local replacement, see Fig. 6. The decision was based in continuous *in situ* diagnosis and structural assessment.

Fig. 6: Typical roof details: (a) roof during and after works; (b) structural details and local replacements; (c) clay tiles details

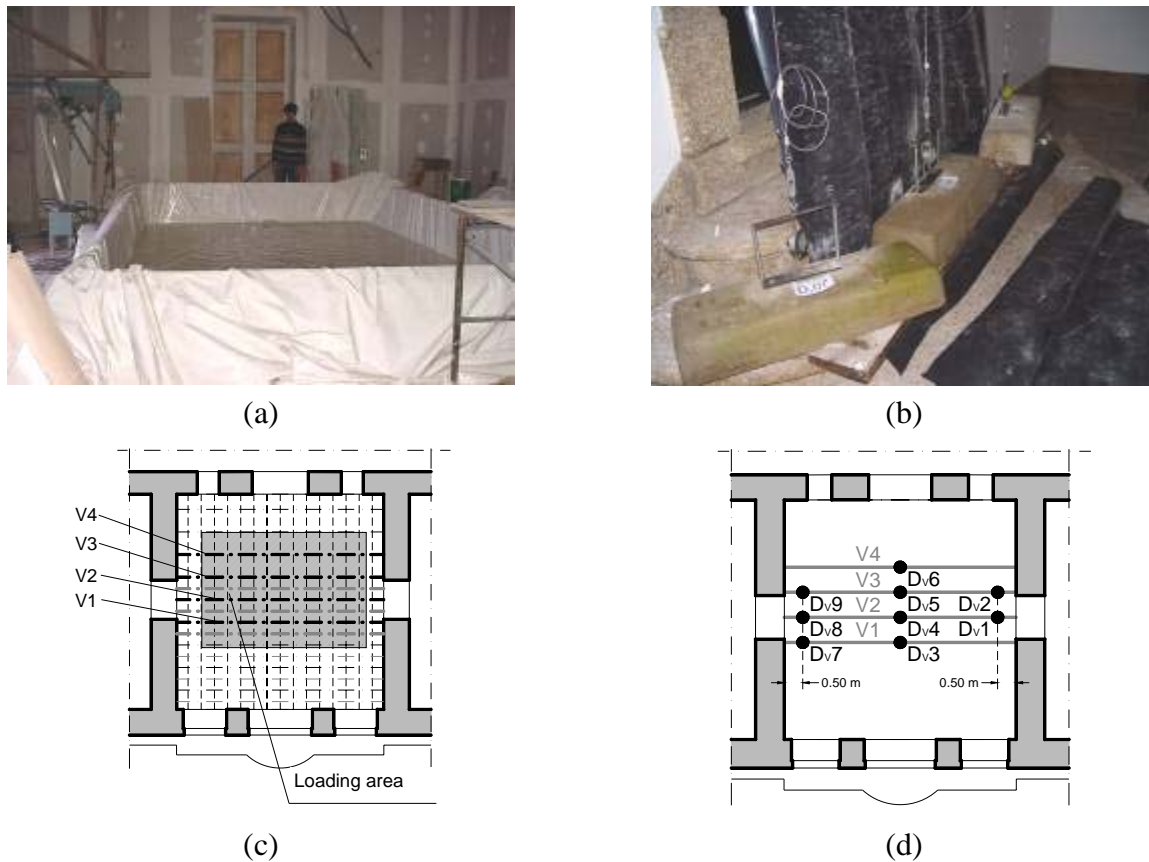
The load test was carried out according to [5], given the lack of national or international normative. The load was applied using a flexible water reservoir without bottom, so that no favourable action from the deposit would affect the structure, see Fig. 8. Nine displacement transducers were used to control the test.

Fig. 8: Load test: (a) water reservoir for load application; (b) detail of fixings for vertical displacement transducers; (c) location of reservoir; and (d) location of displacement transducers

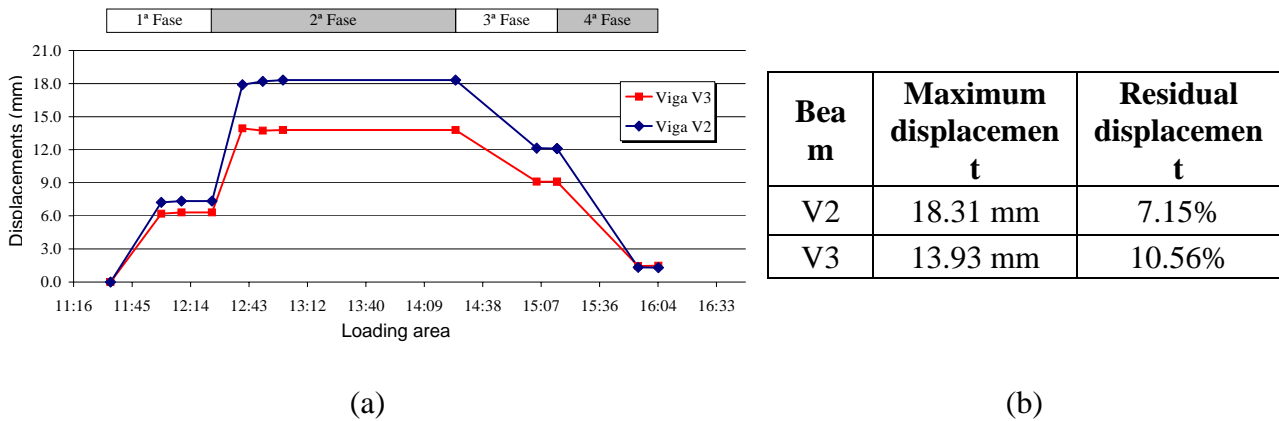
The load test was carried out in four loading steps: (a) 50% of the total load; (b) 100% of the total load; (c) unloading up to 50% of the total load; (d) total unloading. Each load step lasted between 25 and 40 minutes, making a total test duration of 5 hours, including the time intervals for loading / unloading decision. Upon completion of the test, residual displacements were observed in all displacement transducers, which is normal for any *in situ* load test. Fig. 9 illustrates the flexural response of beams V2 and V3. The maximum displacement measured in beam V2 is 18.3 mm, value that should be lower than 1/300 of the span for short term loading (21 mm). The average residual displacement is 9%, which is more than reasonable for this type of structure. Therefore, the floor structure can be used for a load of 3 kN/m<sup>2</sup>, without strengthening.

Fig. 9: Load test results for beams V2 and V3: (a) diagram of vertical displacements vs. time; (b) maximum displacements at mid-span and residual deformation

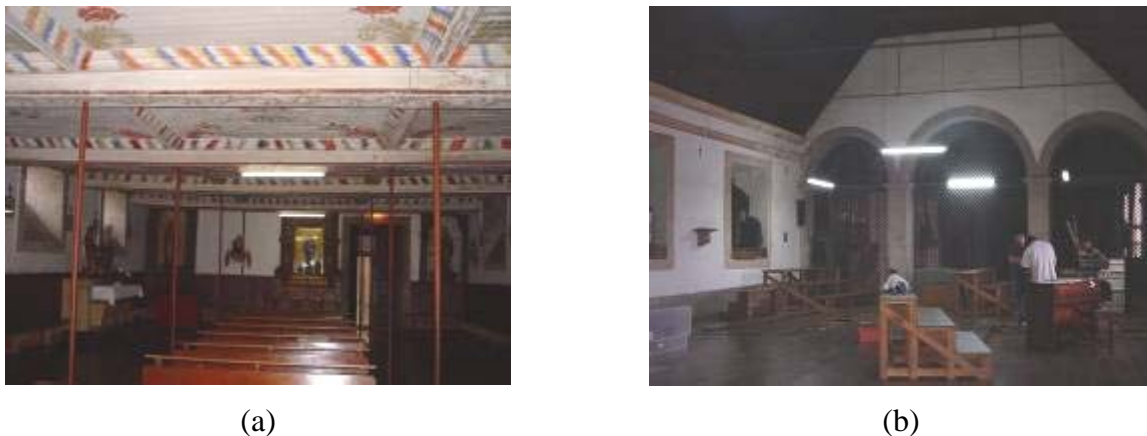
The present study aims at assessing the safety conditions of a floor structure in a church subjected to a change of use (from a choir not opened to the public in general, to a museum), see [6] for details. The floor is located in the Church of Our Lady of Conception dates from 1625, see Fig. 10, and exhibits considerable permanent deformation (sagging).

Fig. 10: Choir floor's views: (a) from below; (b) from above

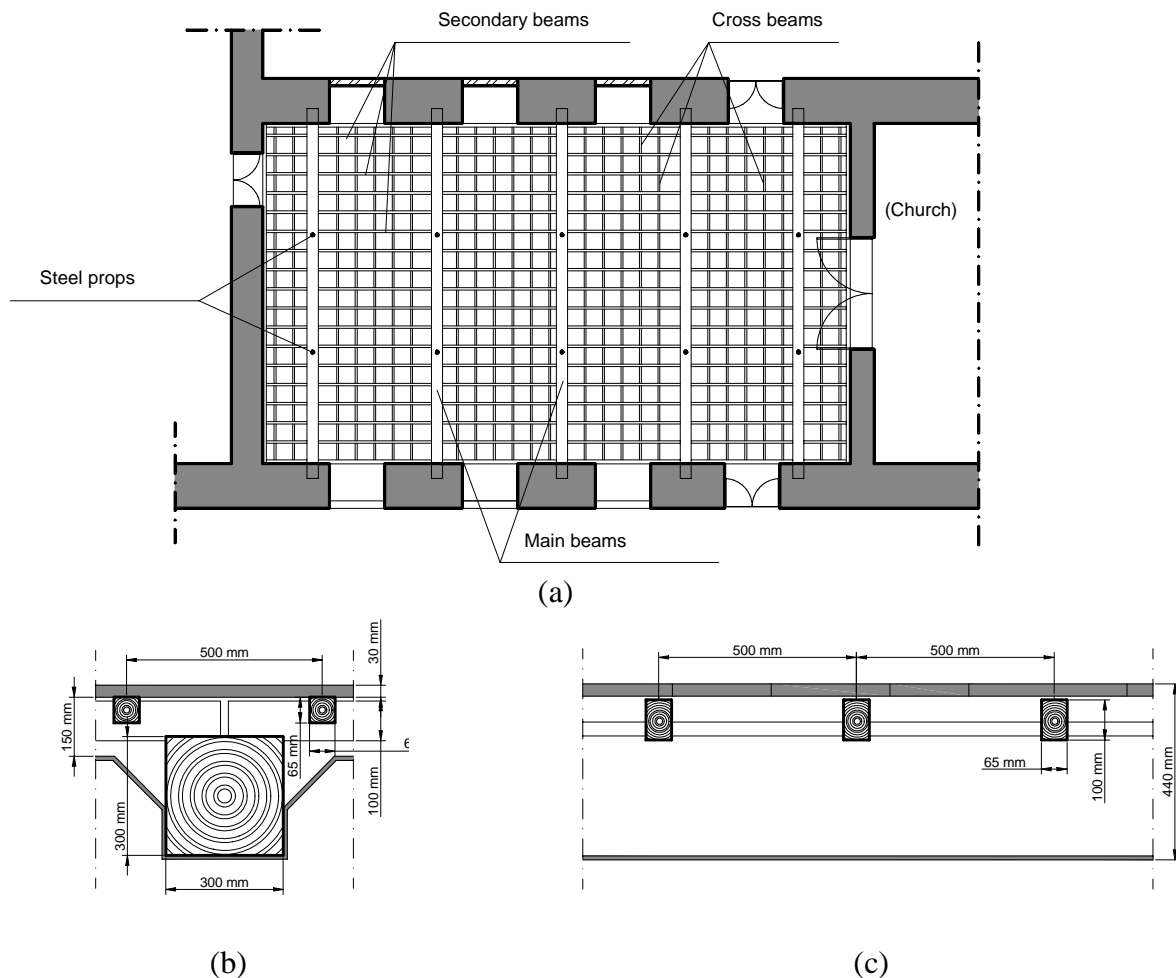
structural elements are in good condition, with the exception of one beam, see Fig. 11a. The floorboard close to the walls has a considerable reduction in the effective cross-section due to active biological attack. The biological attack in the structural elements is mostly superficial.

Fig. 11: Timber structure: (a) plan; (b) cross-section of the main beams; (c) cross-section of the secondary beams

The floor structure was then analyzed according to EC5. The structural analysis indicated that the secondary beams, the main beams and the steel props are not enough to support the code live load of  $3 \text{ kN/m}^2$ . Therefore, strengthening is necessary. The aspects taken into account for strengthening design were: (a) keep the present floor configuration and preserve the existing materials; (b) economy; and (c) do not remove the polychromatic sheating under the floor, due to its artistic value.

The following strengthening solutions were suggested to the owner: (a) strengthening of the secondary beams, using a new set of timber beams in between the old beams, and addition of a steel profile for strengthening the main beam as a steel-timber composite beam (the steel props would be removed and the main beams would be forced back to the original position); (b) strengthening of the system by new steel columns (replacing the existing props) and, again, adding a new set of secondary beams.

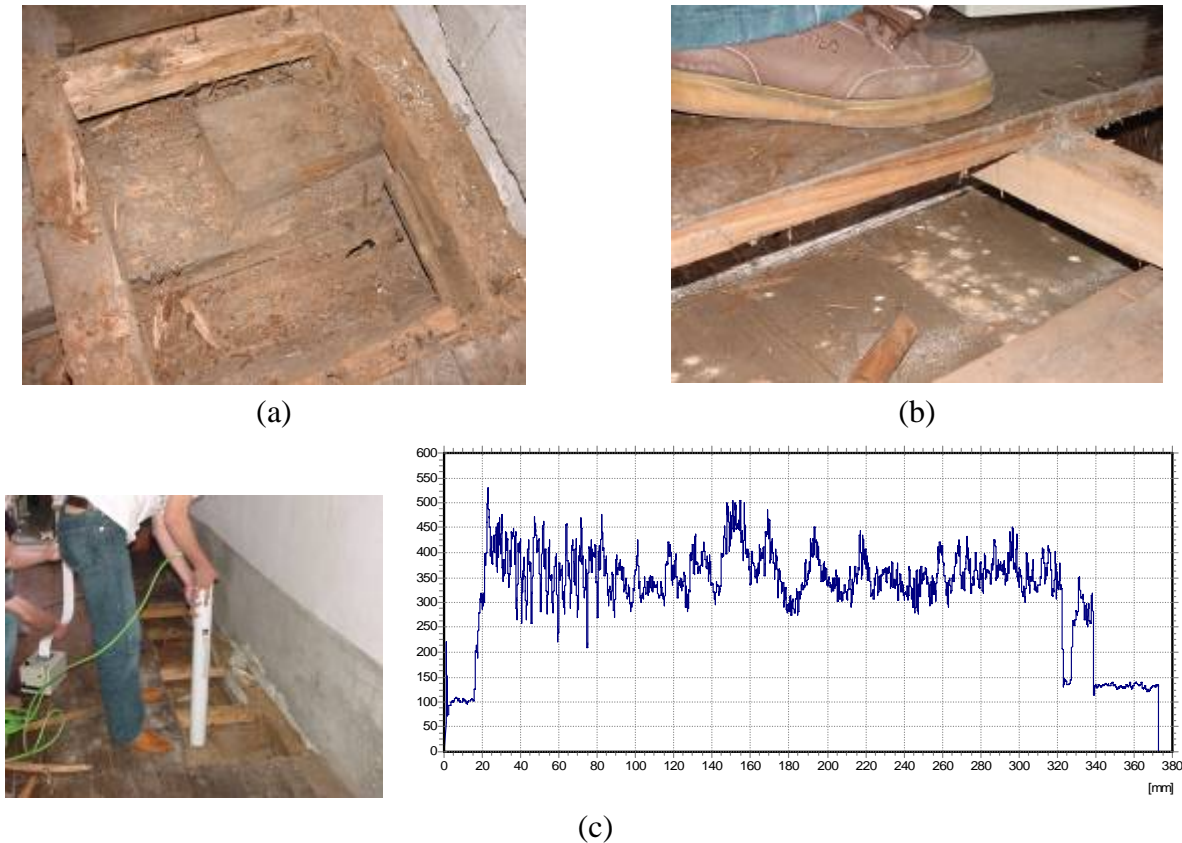
Fig. 12: Details about timber condition: (a) near support of a damaged beam; (b) biological attack at the floorboard; (c) Resistograph results
