DEFECTS AND MOISTURE PROBLEMS IN BUILDINGS FROM HISTORICAL CITY CENTRES: A CASE STUDY IN PORTUGAL

Abstract

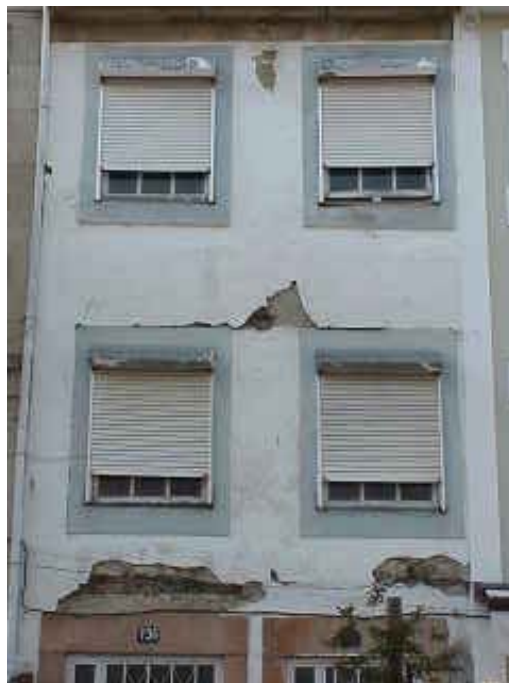
walls; as this is not expected, it seems clear that incompatible materials are being adopted for the rendering and painting.

Figure 7 – Example of damage: (a) collapsed structures; (b) bulging walls; (c) stains in walls at soil level; (d) detachment of rendering and painting; (e) cracks; (f) mould, fungus and vegetation; (g) roof deterioration; (h) timber deterioration in openings frames or balconies

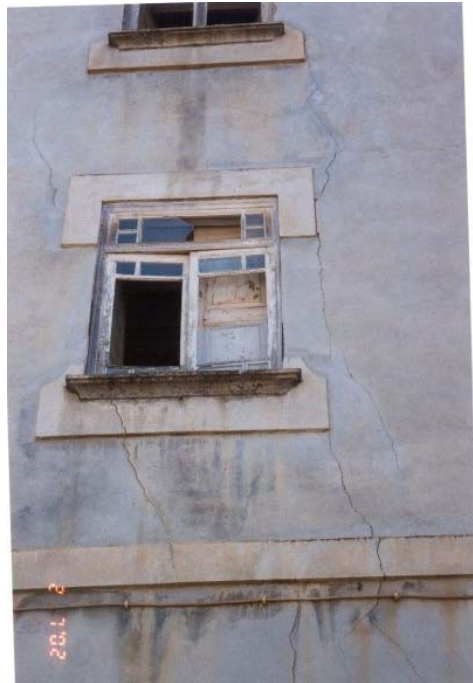
Figure 7 – Example of damage: (a) collapsed structures; (b) bulging walls; (c) stains in walls at soil level; (d) detachment of rendering and painting; (e) cracks; (f) mould, fungus and vegetation; (g) roof deterioration; (h) timber deterioration in openings frames or balconies

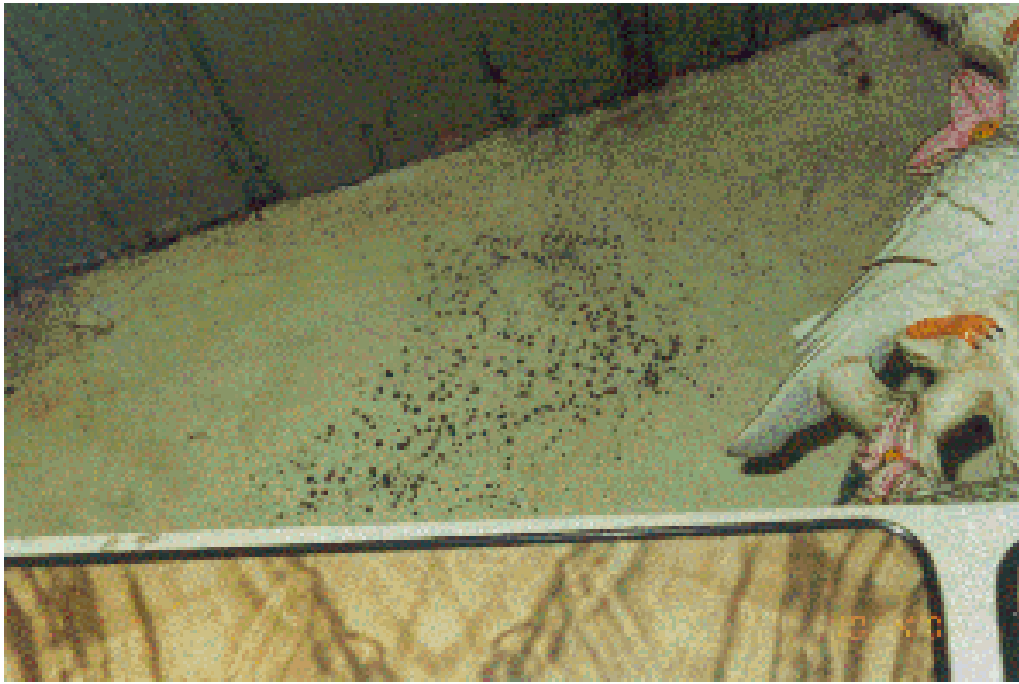
a contiguous building. These moisture manifestations include stains, sometimes accompanied by mould. This type of biological colonization appears also nearby windows and doors frames, corners or roofs, accompanied often by a strong odour.

Figure 13 – Examples of the damages observed inside the houses: (a) biologic activity; (b) stains due to humidity; (c) timber and roof deterioration; (d) detachment of rendering and painting, and efflorescence with high presence of salts.
