ANALYSIS OF A DAMAGED BUILDING IN THE NORTH REGION OF PORTUGAL

Joaquim António Oliveira de BARROS¹ and Francisco Ferreira MARTINS²

Departamento de Engenharia Civil da Universidade do Minho,

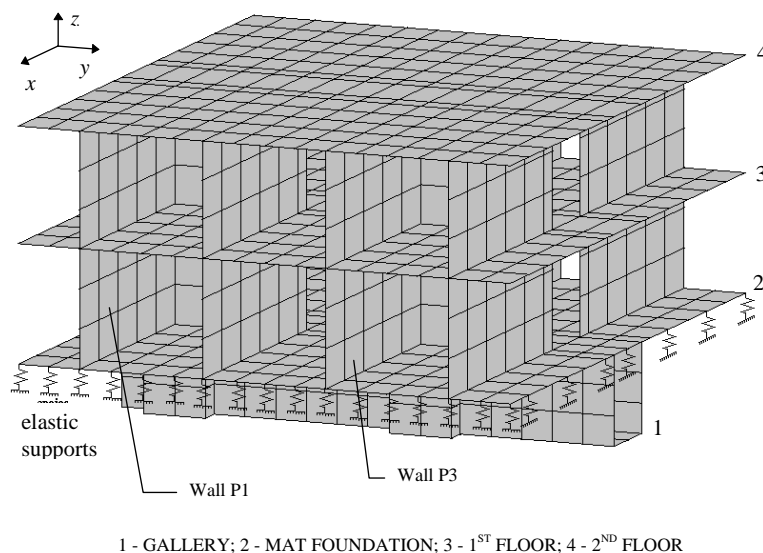
Figure 1 - Finite element mesh.

A representative module of the building structural behaviour is discretized by eight noded Ahmad shell finite elements (Zienkiewicz and Taylor, 1989). The finite element mesh is illustrated in Figure 1.

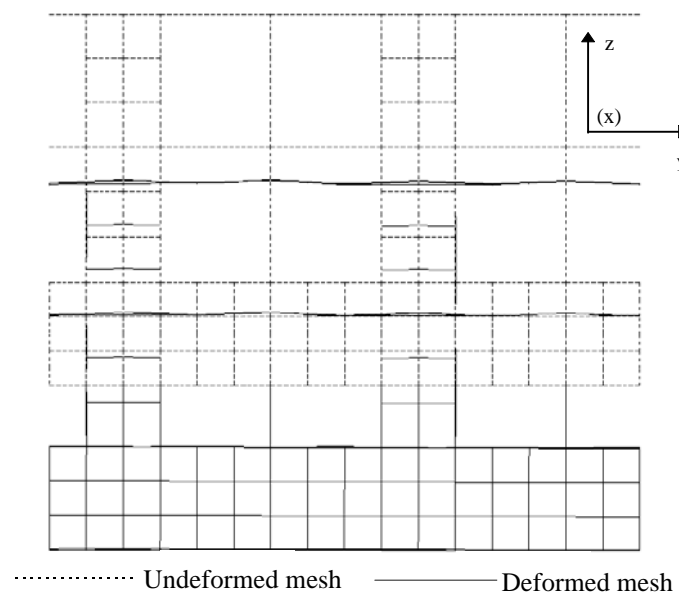
Figure 2 - Deformed and undeformed mesh for analysis A.

The deformed mesh with scaled displacements ($\times 300$) is represented in Figure 2. In this case the building settles almost uniformly. The settlements normal to the floors (in direction of z axe) are equal to 0.011 m. This value is very close to that measured four months after the construction (0.013 m). The pressure on the soil under the mat foundation and under the gallery is approximately 110 kPa.

modulus of subgrade vertical reaction, the differential settlements between the reinforced concrete walls were so reduced that can not justify the macrocracks developed in the air brick masonry.

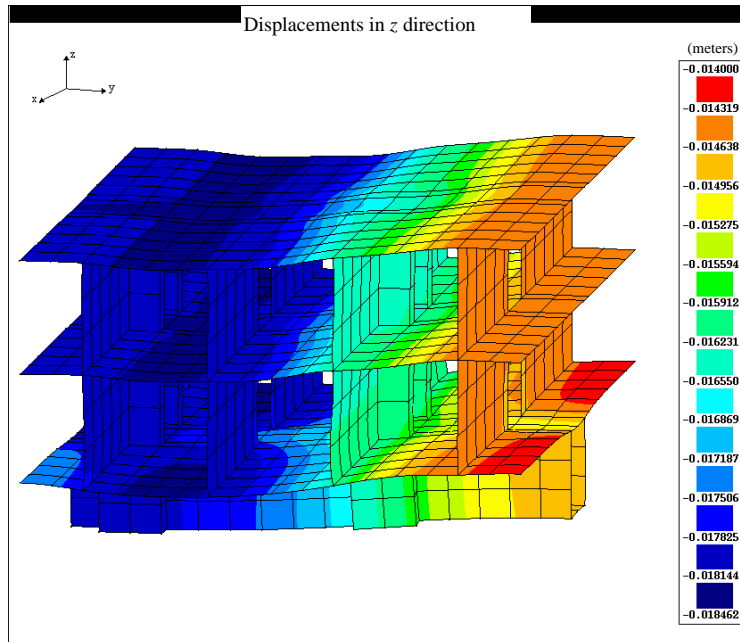
Figure 3 - Displacements in z direction for the analysis B.

In this analysis the soil is considered heterogeneous and two different modulus of subgrade vertical reaction are used. The soil between the walls P1 and P3 (see Figure 1) is simulated by $k_s=2000 \text{ kN/m}^3$, while the remaining soil is characterised by $k_s=10000 \text{ kN/m}^3$. In order to simulate the lost of rigidity due to cracking, a reduced concrete Young modulus of 20 GPa is used. The displacements in z axis (orthogonal to the floors) are represented in Figure 3. A maximum differential settlement of 0.005 m is obtained, which cause the development of compression and tension zones in the air brick masonry (see Figure 4).

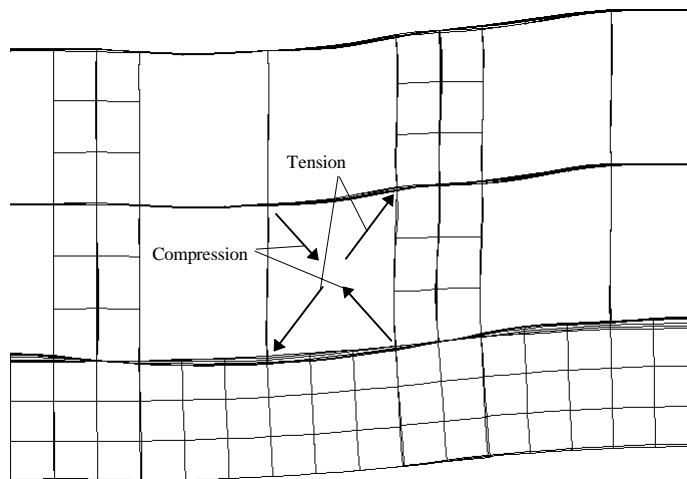
Figure 4 - Deformed mesh for the analysis B.

A panel of air brick masonry between concrete walls and floors is analysed. This panel corresponds to that submitted to greater shear forces introduced by the structural border elements (see Figure 4). It is considered a panel of 0.25 m of thickness with an homogeneous behaviour. The analysis is linear elastic and it is taken a Young modulus of 1 GPa. The panel is discretized by eight noded Ahmad shell finite elements. The actions considered are the generalised displacements introduced by the structural border elements in the contour of the panel.

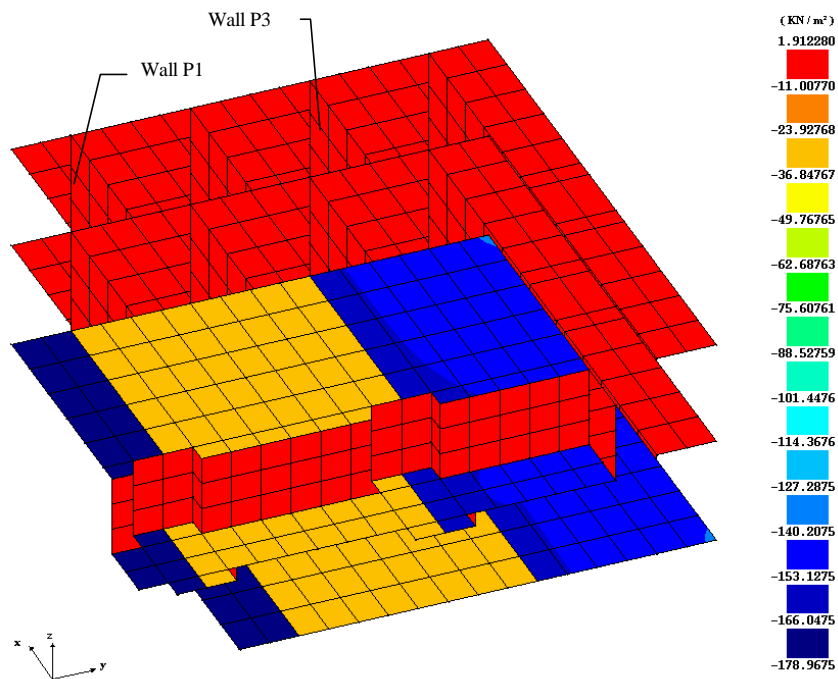
Figure 5 - Soil pressure for the analysis B.

The soil pressure varies from 30-40 kN/m² in the low k_s value zone to 180 kN/m² in the remaining soil (see Figure 5).

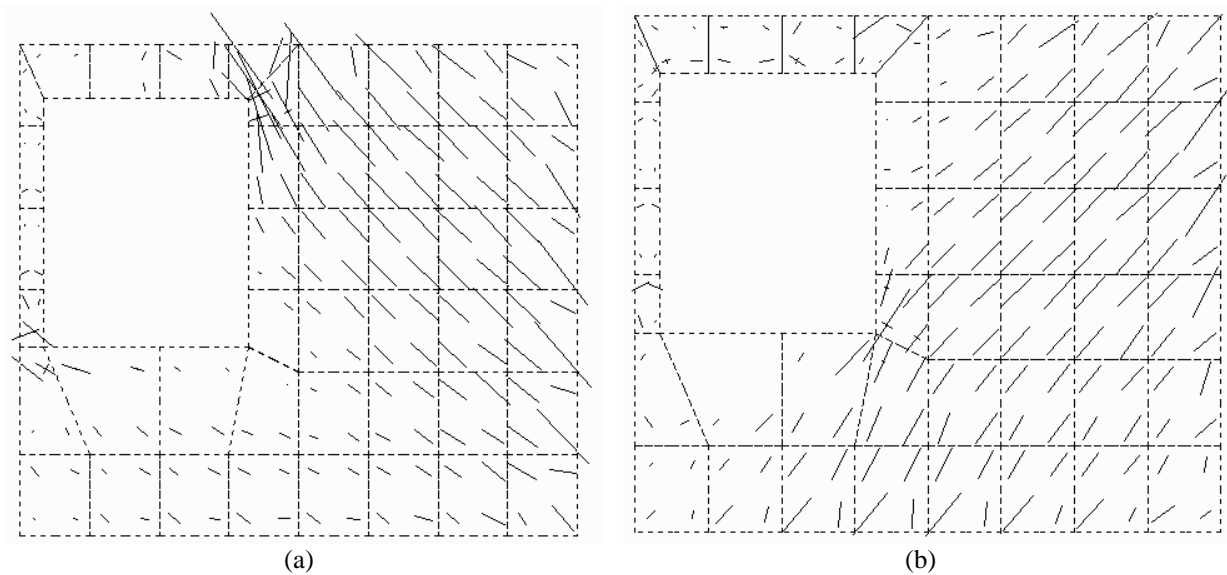
The in-plane principal stresses developed are represented in Figure 6. It is possible to detect the existence of tension and compression zones. The maximum tension and the maximum compression are about 0.5 MPa and 0.9 MPa, respectively. These values are higher than the corresponding material strength (Carvalho, 1990).

Figure 6 - Compression (a) and tension (b) in-plane principal stresses in the panel of air brick masonry.

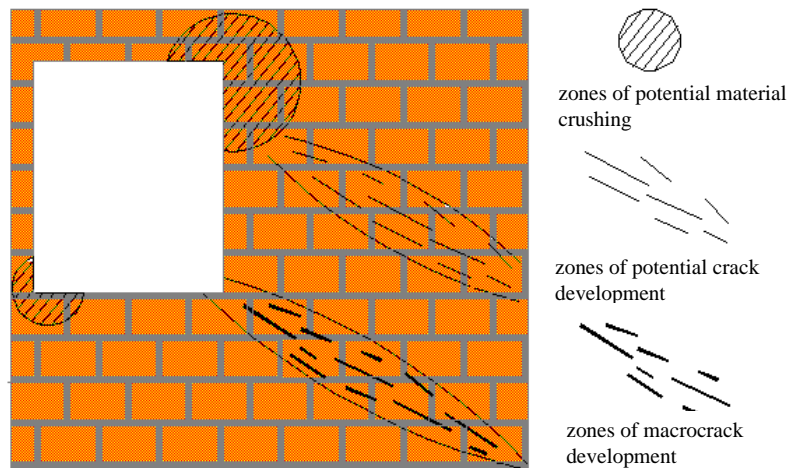
A schematic representation of the damage zones is shown in Figure 7. The concentration of the maximum tension and maximum compression occurs in the corners of the window. This is in accordance with the damages observed in the building.

Figure 7 - Damage zones in the air brick masonry.

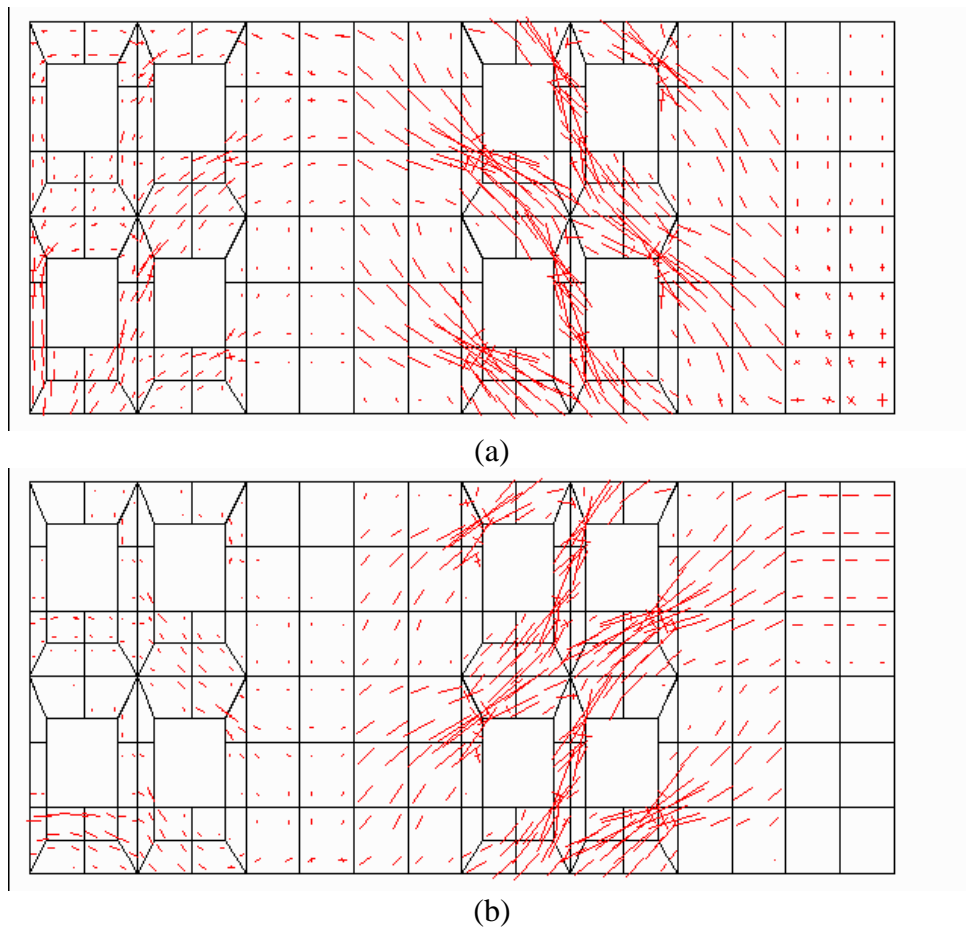
Figure 9 - Compression (a) and tension (b) membrane principal forces in the reinforcing walls.

The compression and tension membrane principal forces in the new reinforcing walls are illustrated in Figure 9. The maximum compression and the maximum tension stress are about 3.6 MPa and 3.2 MPa, respectively.

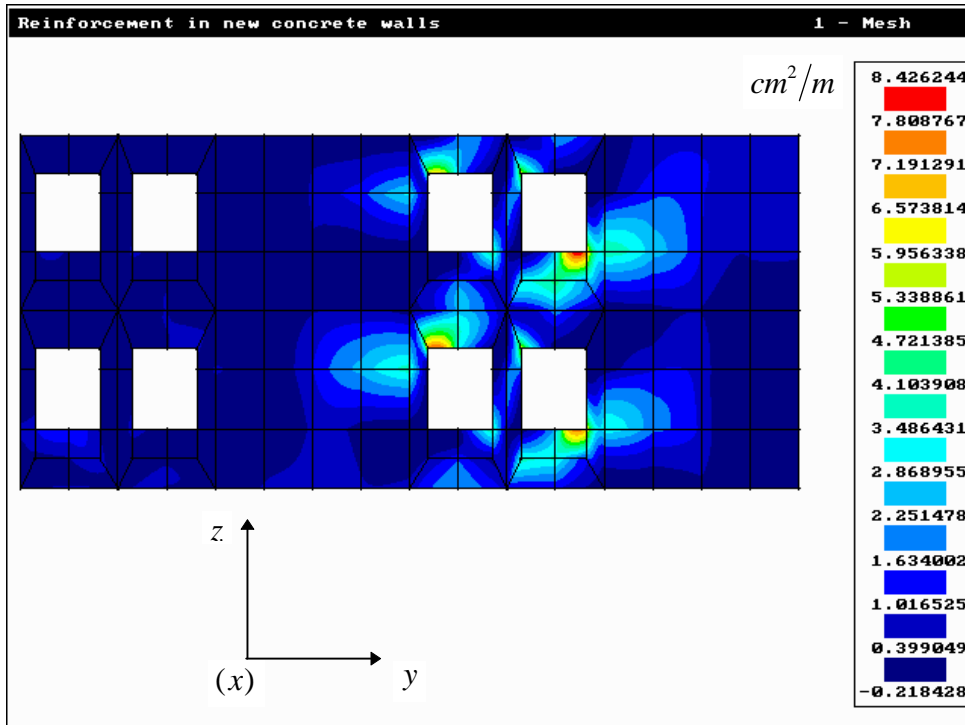
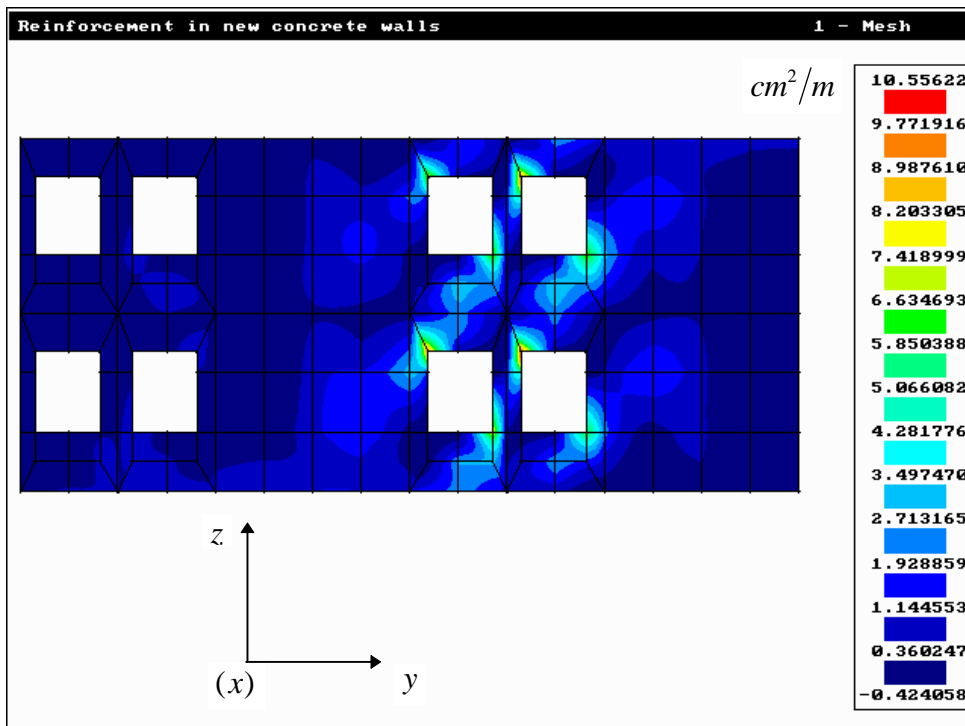
Figure 10 - Reinforcement area at interior surface in the y (a) and z (b) directions (almost equal to the area at exterior surface).

A wire mesh with a steel yield stress of 348 MPa is applied at interior and exterior surfaces of these walls (with a 0.015 m of concrete recover). The area (per unit length) of this reinforcement is represented in Figure 10. The reinforcement at interior and

exterior wall surfaces is practically equal. Near the corners of the windows, each wire mesh must have 8.4 and 10.6 cm²/m in y and z axis direction.
