# PERFORMANCE OF MASONRY BUILDINGS AND CHURCHES IN THE 22 FEBRUARY 2011 CHRISTCHURCH EARTHQUAKE

## SUMMARY

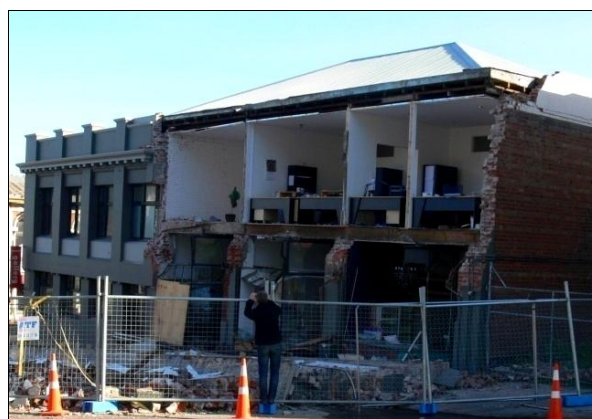
Out-of-plane wall collapse was the most commonly observed failure to clay brick URM buildings following the 22<sup>nd</sup> February 2011 earthquake, with many two-storey buildings losing their entire front façades or upper storey walls (see Figure 3).

Cantilever type out-of-plane failure with the entire top section of a wall or building façade collapsing (see example in Figure 3) was commonly observed. However, when the top section of the wall was well connected to diaphragms, failures in both vertical and two-way bending were observed.

Figure 3: Out-of-plane collapse of parapet and façade, Lyttelton.

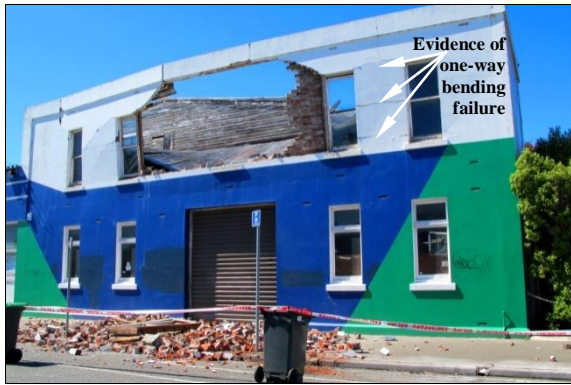
*Figure 4: One-way bending out-of-plane wall failure below a concrete ring beam.*

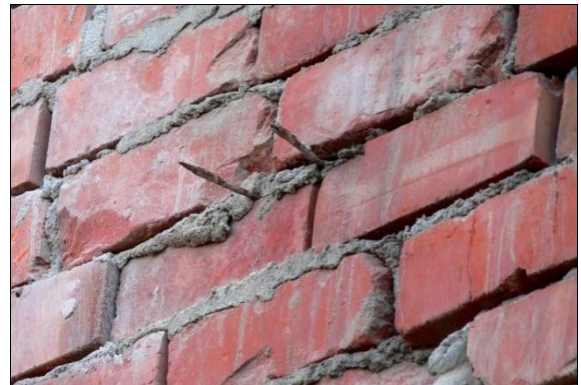
*Figure 8: Deteriorated "horseshoe" shaped wire cavity tie.*

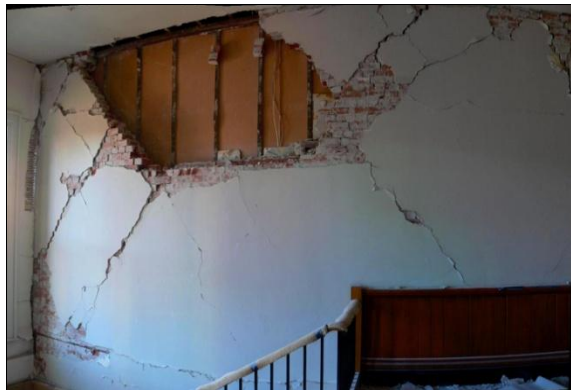
*Figure 5: Two-way bending out-of-plane wall failure.*

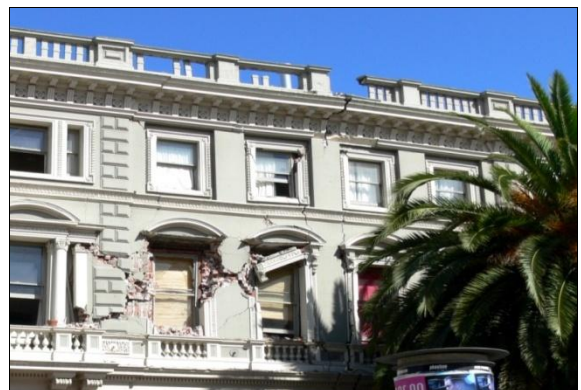
Diagonal shear cracking was observed in piers, spandrels and walls. Figure 9 shows shear cracking in piers and diagonal and vertical cracking through spandrels, and a representative example of diagonal shear cracking through a URM pier is illustrated in Figure 10. Examples were observed of unperforated URM walls that sustained major shear cracking, as illustrated in Figure 11. Although not as common as diagonal shear failures, examples of bed joint shear sliding of URM walls were also observed. Rocking was observed for cases where URM piers had a higher aspect ratio and lower levels of overburden. Only a few cases of the toe crushing failure mechanism, as illustrated in Figure 12, were observed.

*Figure 9: Diagonal shear cracking through piers and spandrels.*

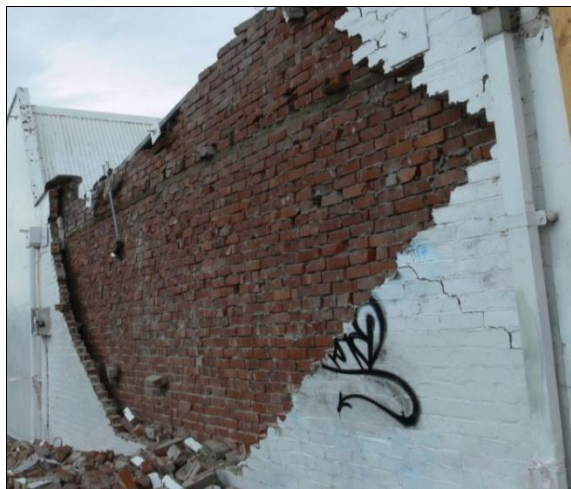
*Figure 6: Out-of-plane failure of a single leaf veneer.*

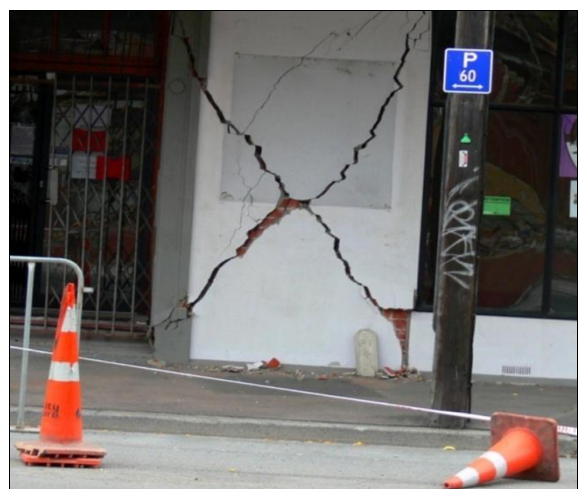
*Figure 10: Diagonal shear cracking through piers.*

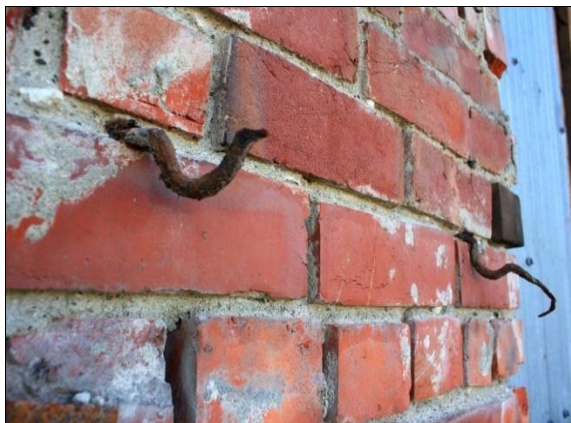
*Figure 7: Metal cavity ties in poor rusted condition.*

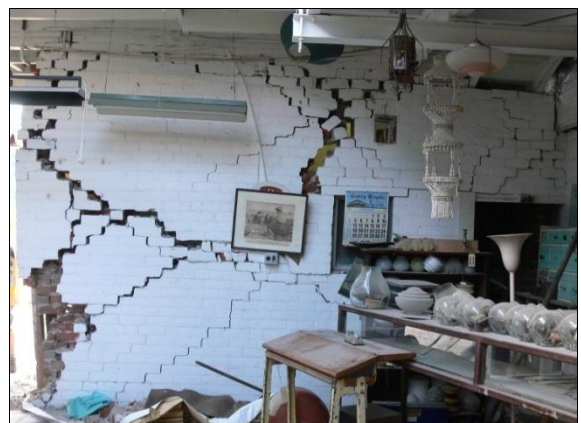
*Figure 11: Diagonal shear cracking of unperforated wall.*

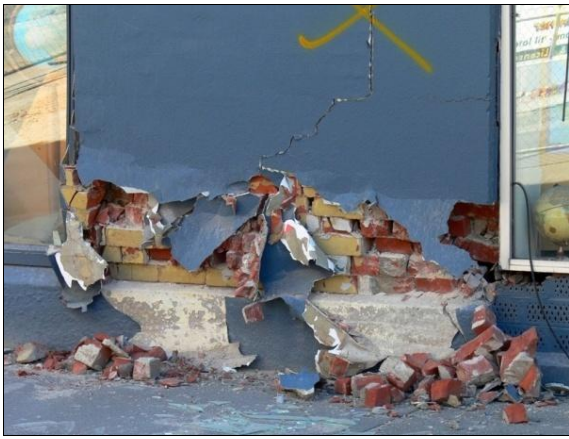
Figure 12: Close-up of toe crushing failure mechanism.

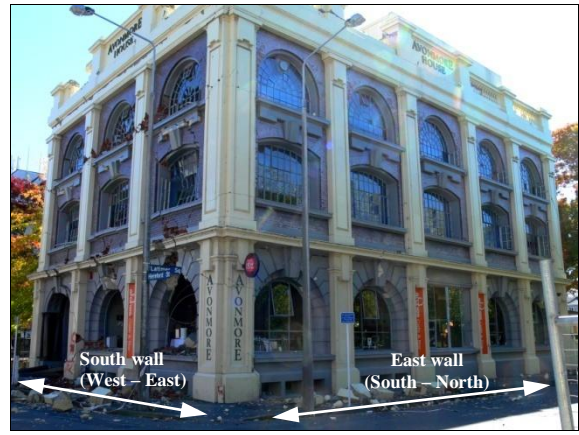
In a large number of cases in the Christchurch Central Business District (CBD) in-plane wall damage was observed on the north and south facing walls, while out-of-plane damage to the eastern and western walls was observed. This damage pattern, as shown in Figure 13, indicates that in the

Figure 13: South east corner – shear cracking only visible on south face.

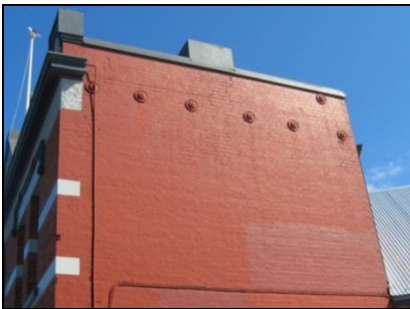
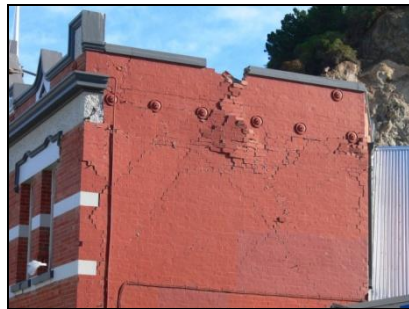
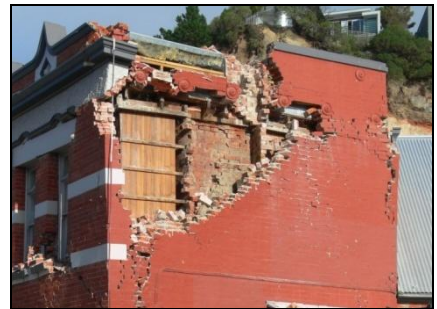
Figure 14: Progressive building damage.

Another interesting observation following the 22<sup>nd</sup> February 2011 earthquake was that many walls were on the verge of collapse. Most noticeable were walls where individual bricks were seen to be on the verge of dislodgement. Had the severe shaking lasted longer, these bricks may have become dislodged, resulting in further wall failures. The damage progression of a URM wall in the September 2010, February 2011 and June 2011 earthquakes is illustrated in Figure 14.

(a) Post-September 2010 – minor visible damage

(b) Post-February 2011 – section of masonry on verge of collapse

(c) Post-June 2011 – collapse of the wall

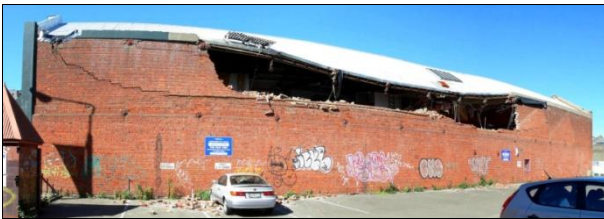
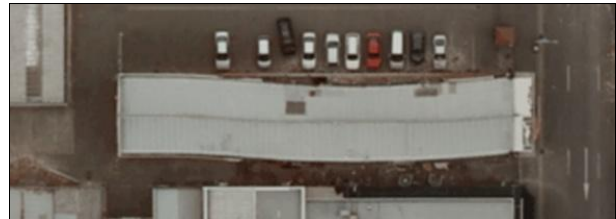
Evidence of diaphragm movement was seen in many buildings, and the effect of diaphragm deformations on wall response varied from cracked plaster to complete wall collapse. As shown in Figure 15, excessive lateral movement of the timber roof diaphragm has displaced the external perimeter walls of this building beyond their out-of-plane deflection capacity and resulted in wall collapse.

Figure 15: Out-of-plane wall failure due to excessive roof diaphragm movement.

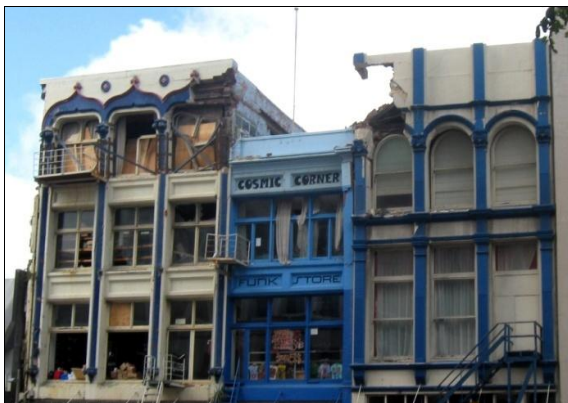
Pounding damage was commonly seen in tightly spaced buildings in the CBD and in many cases pounding appears to have been the loading condition principally responsible for in-plane wall failures. Figure 16 shows an example of pounding damage to adjacent URM buildings.

Figure 16: Pounding between three buildings, causing in-plane failure in URM buildings.

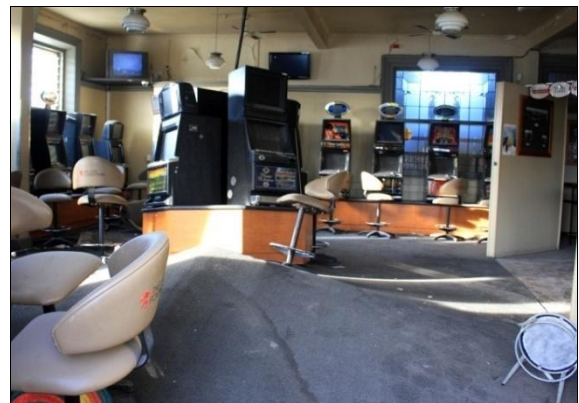
Figure 17: Extreme floor movement due to severe differential ground deformation.

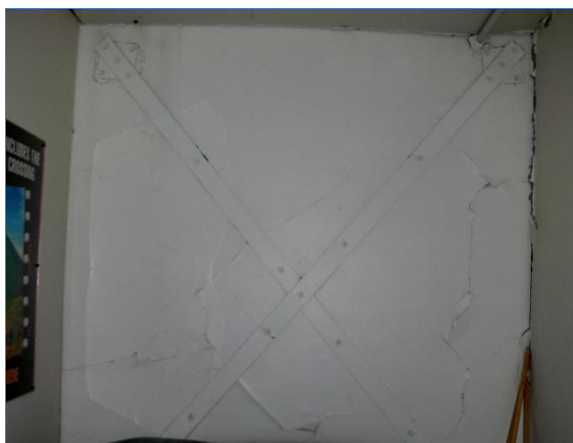
Less common retrofit types were also observed, with an example being the in-plane strengthening of wall sections using diagonally oriented steel straps anchored into the wall. As shown in Figure 22, the masonry restrained by this retrofit sustained considerable damage when compared to the observed condition following the 4<sup>th</sup> September earthquake, as reported by Dizhur et al. [5].

**Figure 22:** 'X' steel bracing retrofit with extensively cracked masonry.

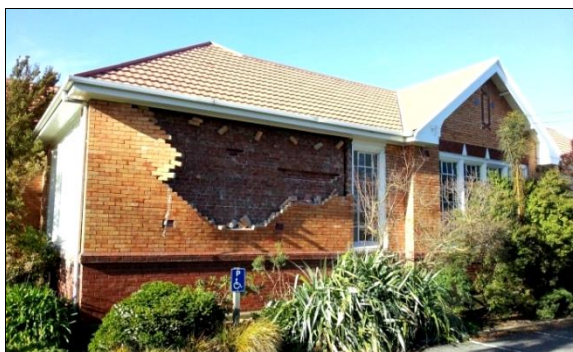
The veneer of the building shown in Figure 23 was retrofitted using inserted high strength twisted stainless steel (SI) rods to tie the veneer to the main structural walls. Following the earthquake on the 22<sup>nd</sup> February 2011, these SI rods showed signs of movement, with the SI rod cover pushed out or becoming completely dislodged. These observations suggest that differential movement occurred between the leaves on either side of the cavity. The outer veneer leaf of the wall collapsed during the 13<sup>th</sup> June 2011 aftershock.

**Figure 23:** Post June 2011 condition of a veneer layer tied using inserted high strength twisted stainless steel rods.

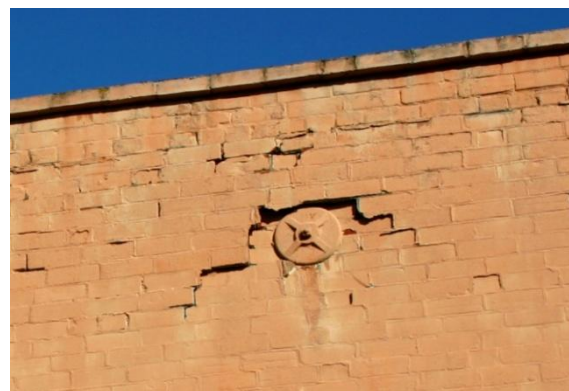
exterior façade of the masonry walls). Punching shear failure was the most common failure type observed, and was mainly attributable to mortar failure as shown in Figure 24. In Figure 25 it is shown that the successful performance of anchors does not necessarily prevent out-of-plane wall failure, as the potential for one or two way out-of-plane wall bending failure is not necessarily precluded.

**Figure 24:** Anchor on the verge of punching shear failure.

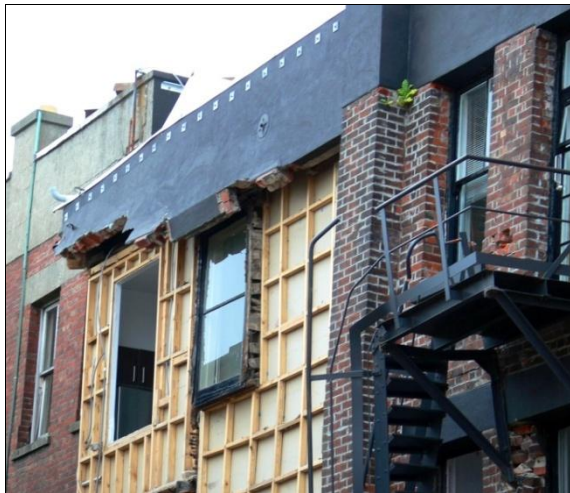
Figure 25: Row of successful wall-diaphragm anchors, with wall failure beneath.

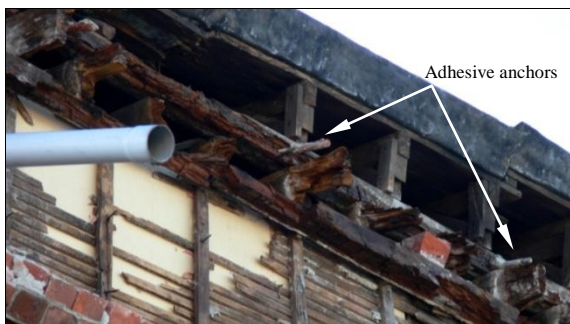
Due to long term deterioration from environmental exposure, numerous cases of reduction of anchorage cross-sectional area were observed. An example of adhesive anchors installed between a URM wall and a degraded roof diaphragm which had badly deteriorated due to severe water ingress is shown in Figure 26. The construction quality of adhesive type anchorages was commonly observed to be poor, due to insufficient anchorage depths and poor workmanship, as shown in Figure 29.

Figure 26: Adhesive anchors installed in a badly deteriorated roof diaphragm.

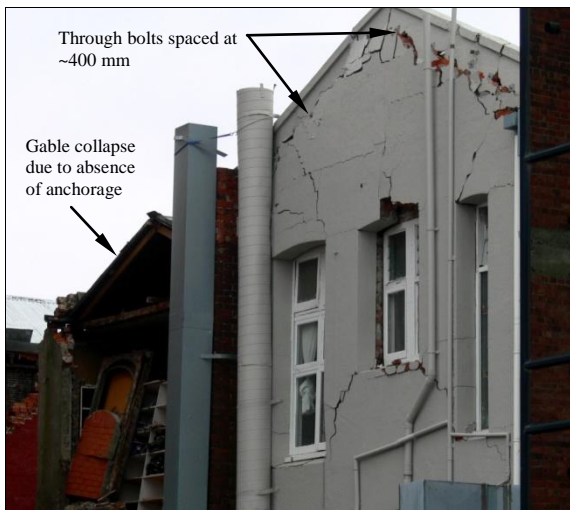
Figure 27: Failure of the gable due to low shear strength of masonry, despite sufficient anchorage.

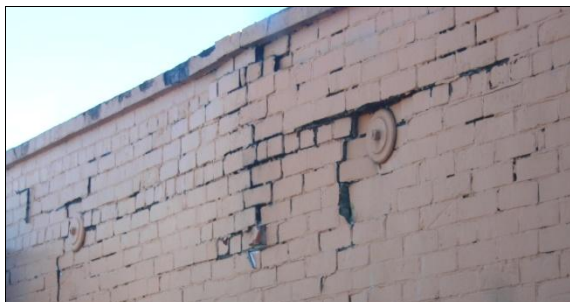
Figure 28: Wide spacing of anchors resulting in horizontal bending failure of masonry.

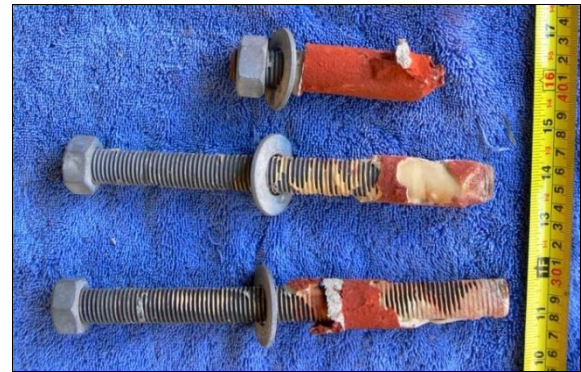
Figure 29: Recovered adhesive anchors that performed inadequately.

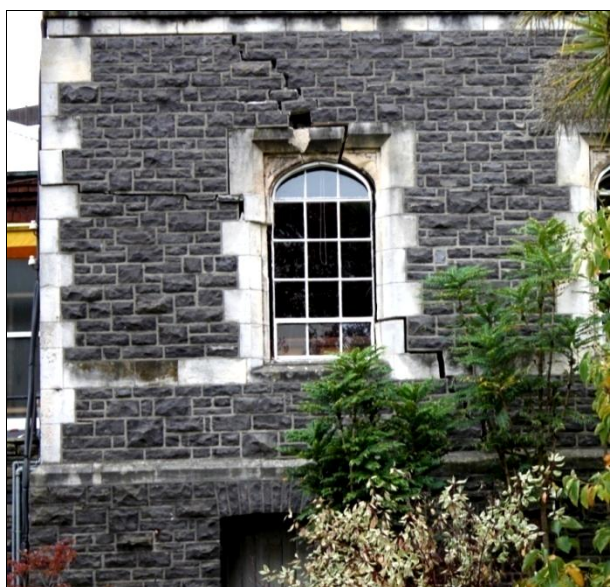
*Figure 37: Canterbury Provincial Chambers - diagonal crack through entire south façade of the east annex.*

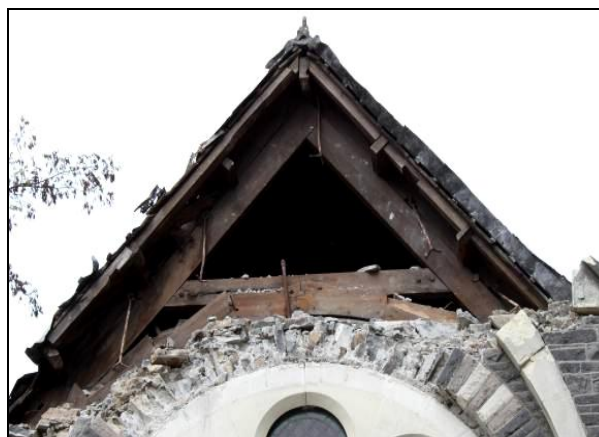
Two cases are presented to show the different behaviour induced by the presence and effectiveness of anchorage. Figure 38 shows the damage resulting from overturning of the gable of the main façade of the former Trinity Church in the Christchurch CBD, where anchors were insufficient in size and spacing to secure the wall in place. Figure 39 shows an example of successful wall-to-roof anchorage in an Arts Centre building.

*Figure 38: Former Trinity Church, showing details of gable end out-of-plane wall failure.*

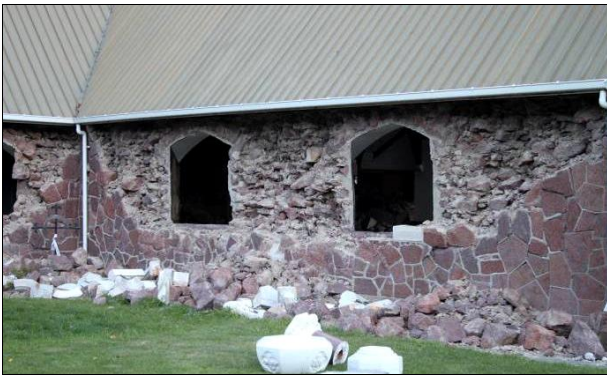
The quality of construction materials played a key role in the response of stone URM buildings. As previously described, one of the typical features of unreinforced stone masonry buildings in Christchurch is the different types of stone and mortar quality present in structures built with three-leaf walls. The use of soft limestone, such as Oamaru stone or the red tuff extracted in the Banks Peninsula, in conjunction with the use of low strength lime mortar, often led to poor earthquake response. Examples of such behaviour include the Holy Trinity Church in Lyttelton, as illustrated in Figure 40.

**Figure 40:** Lyttelton Holy Trinity Church, showing damage induced by movement of the roof.

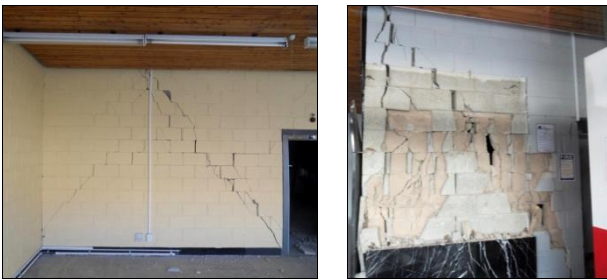
Severe diagonal cracking of RCM shear walls in a multi-storey commercial building in the central CBD was observed, as shown in Figure 43. This building had a glass store front with RCM shear walls in the N-S and E-W directions, as well as an RCM elevator shaft. The reinforcement had insufficient cover in places, causing face shell spalling of some concrete masonry units.

(a) Severe diagonal shear cracking of RCM shear walls (b) Close-up of diagonal shear cracking

Figure 43: Examples of diagonal shear cracking.

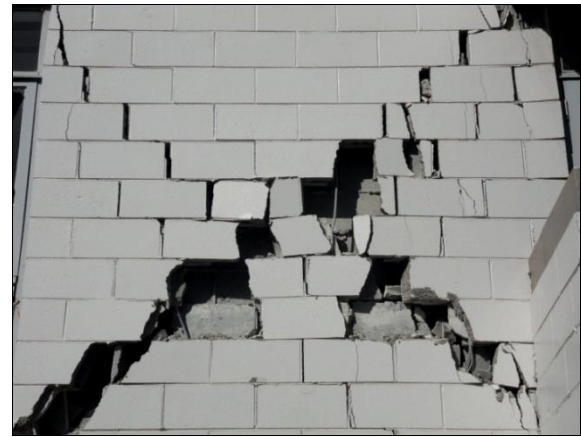
Figure 44: Severe diagonal cracking of RCM cavity shear wall.

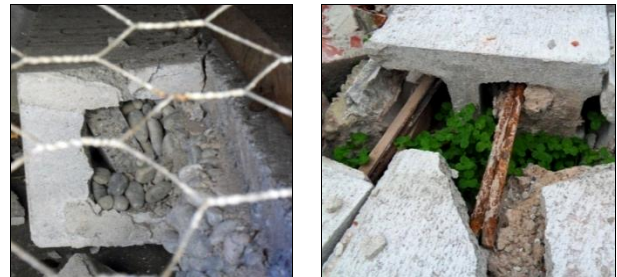
More details of common construction deficiencies are shown in Figure 45. Figure 45(a) shows a bond beam block in a collapsed garage wall that was neither filled nor reinforced. Figure 45(b) shows a collapsed RCM wall addition to a URM building, in which the grout was not continuous even at the top of the wall, leaving the reinforcement exposed. These observations indicate that inadequate inspection procedures existed at the time of construction. Observed damage to RCM buildings suggests that design and detailing of piers around openings also requires further attention. In buildings that appeared to have adequate grouting and detailing, severe failures mainly occurred in these elements.

(a) Poor cell grouting (b) UngROUTED masonry cells

Figure 45: Examples of RCM construction deficiencies.

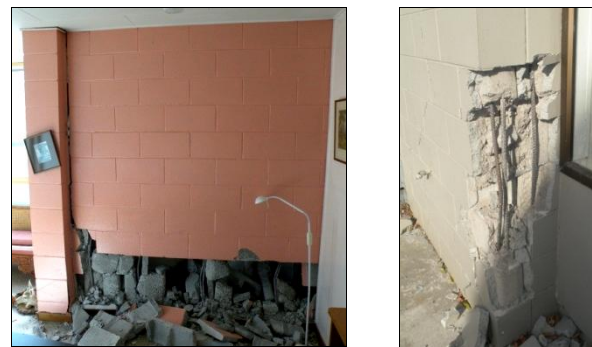
Several instances of structural damage in other inspected RCM buildings suggest inadequate reinforcement detailing. Various cases of lap-splices at plastic hinge locations showed buckling of reinforcement bars. A large number of damaged RCM walls showed vertical reinforcement near the ends of the wall to be unconfined by horizontal reinforcement (see Figure 46(b)) as the horizontal reinforcement terminated prior to the final vertical bar.

(a) Flexural failure of RCM wall due to spalling and crushing of grout (b) Buckling of unsupported lap-spliced vertical reinforcement

Figure 46: Damage to RCM shear walls following the February 2011 earthquake.

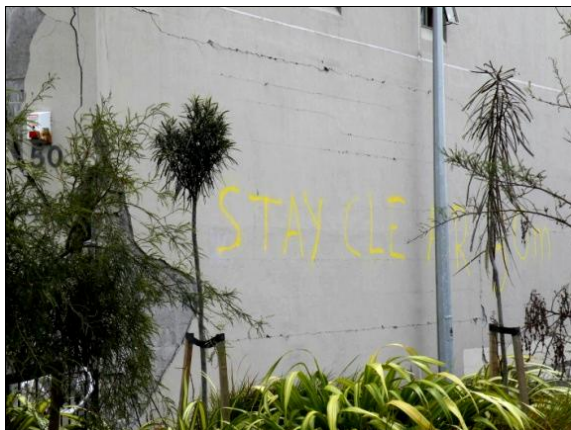
**Figure 47:** Bed joint cracks indicating yielding of reinforcement across the height of the first floor.

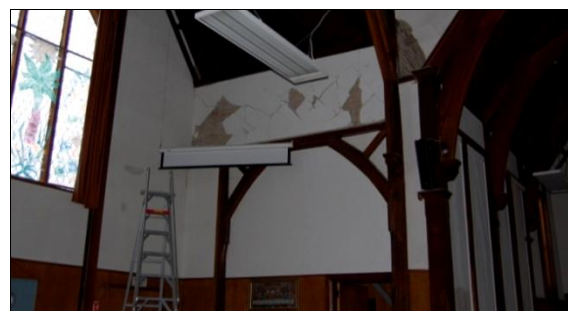
Figure 52: Damage to the internal plaster of St. Paul's Anglican Church, Harewood Road.

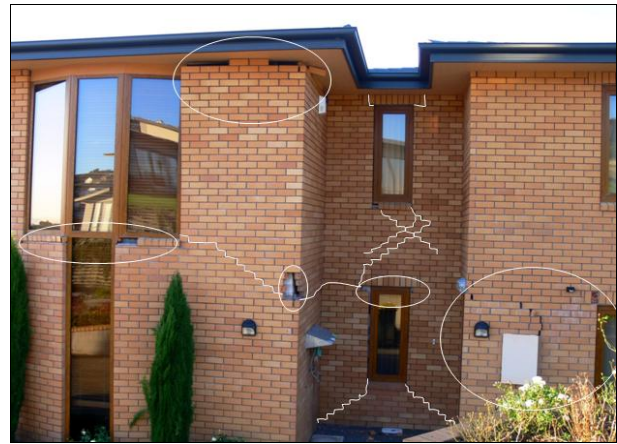
**Figure 55: Example of severe veneer damage level.**

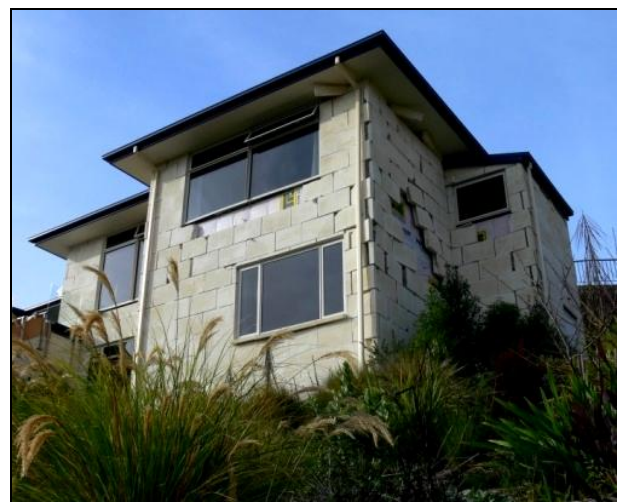
From the survey, it is evident that the use of Oamaru stone veneer (and solid veneer units in general) performed the worst, and a typical example of such performance is illustrated in Figure 56.

**Figure 56: Poor performance of Oamaru stone veneer.**
