Seismic analysis of the Roman Temple of Évora, Portugal

15 WCEE
LISBOA 2012

SUMMARY

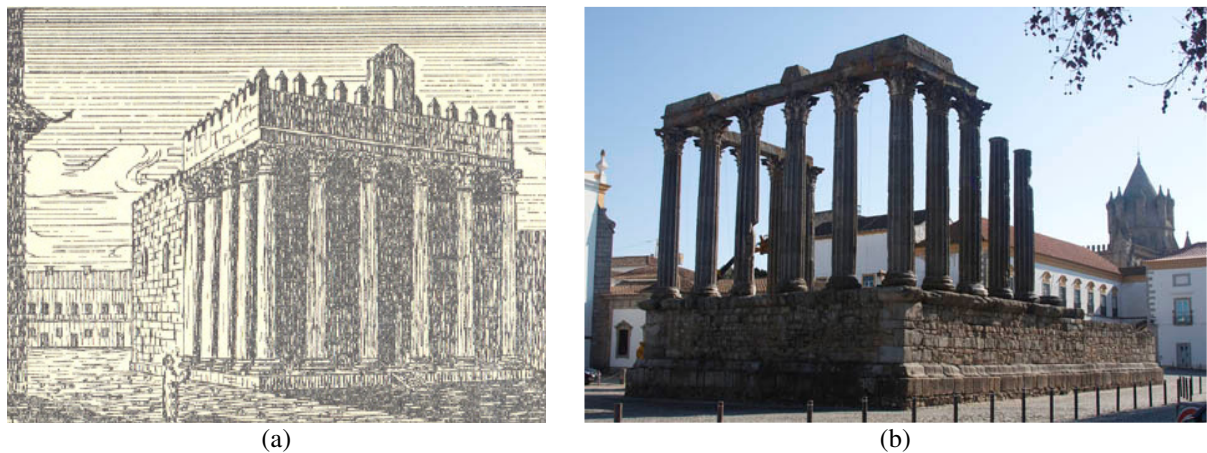
Figure 1. The Roman temple of Évora: (a) in 1795 before Cinatti's restoration (Pereira 1934); (b) in its current state.

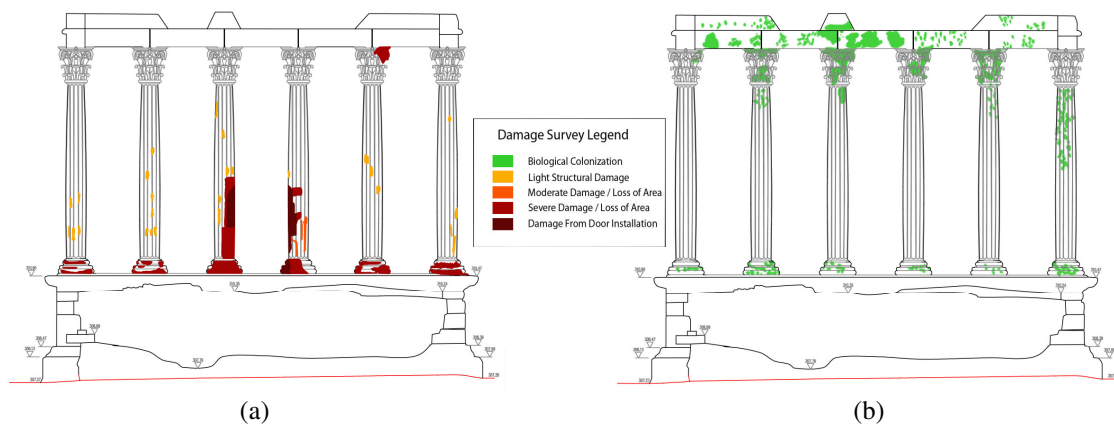
A visual inspection was carried out in order to check the damage level of the temple and to confirm its geometry. It was found that the most damaged columns are the two front central columns where a door was previously fixed when the temple was used as the tower of Évora Castle. Generally, the other remaining columns are in good condition, however some of the marble bases have separated into two pieces. Some of the capitals have missing parts of their decorations, but it is not thought to compromise their stability. Also the degree of biological colonization was checked. Mainly, this is a result of the growth of lichen, algae, and moss, which is easily visible throughout the temple. The most severely affected areas are the bases of the columns, which exhibit a range of moss and fungus growth. However, due to the lighter colour of marble compared to the granite, biological growth on the capitals and bases is more obvious. Examples of damage and biological colonization maps can be seen in Figure 2.

Figure 2. Damage survey: (a) structural damage and loss of area (b) biological colonization.

With regards to biological colonization, only a general survey was conducted. Removal of the biological colonization was not discussed due to the conclusion that the current state of growth is of relatively low concern strictly regarding the structural system. More detailed investigations into treatment or removal of the biological colonization is advised for future interventions.

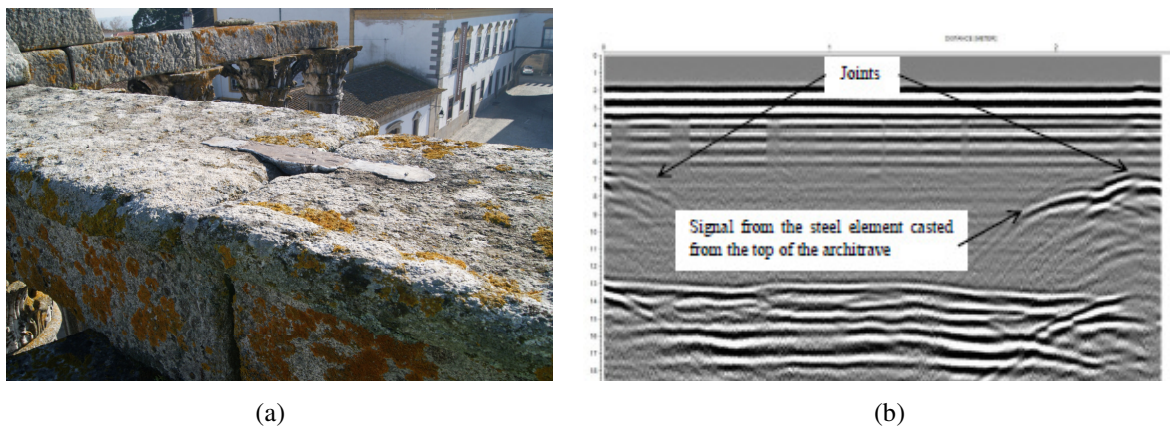
Ground penetrating radar (GPR) tests have also been performed and as a result it's thought that there are no connections between column drums, but steel connectors were detected between several architraves, see also Figure 3. It was not possible to survey all architrave joints, but it seemed that most of the architraves have been connected using steel elements. Holes in the sides of the stones used on the top outer edge of the podium were also noticed, and a small focused investigation lead to the conclusion that these stone pieces around the temple were most likely interlocked through some connected elements.

Figure 3. Architraves: (a) metallic element identified during visual survey (b) GPR profile of top of respective architrave.

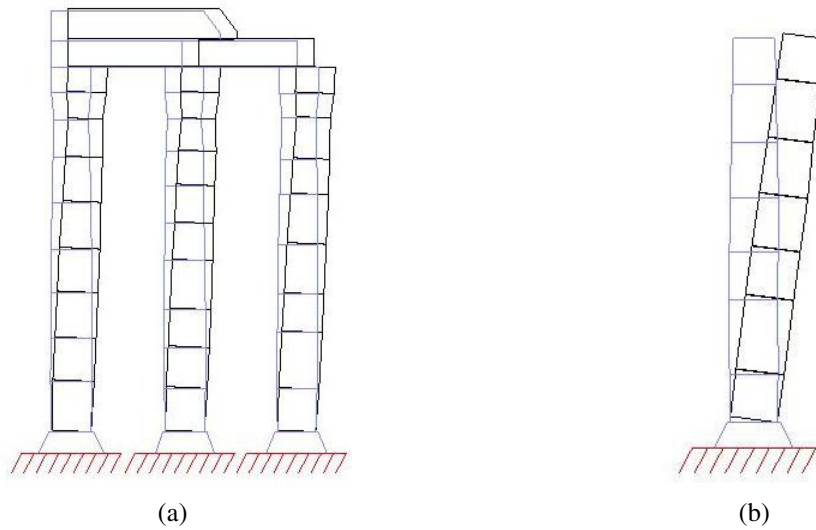
Figure 6 shows the failure mechanisms obtained from the limit analysis using the block software with the horizontal load applied in the +x direction. The friction between the blocks ensures that the columns behave almost monolithically and dissipate energy during a seismic event.

Figure 6. Limit analysis failure mechanisms: (a) west façade; (b) freestanding column E6.

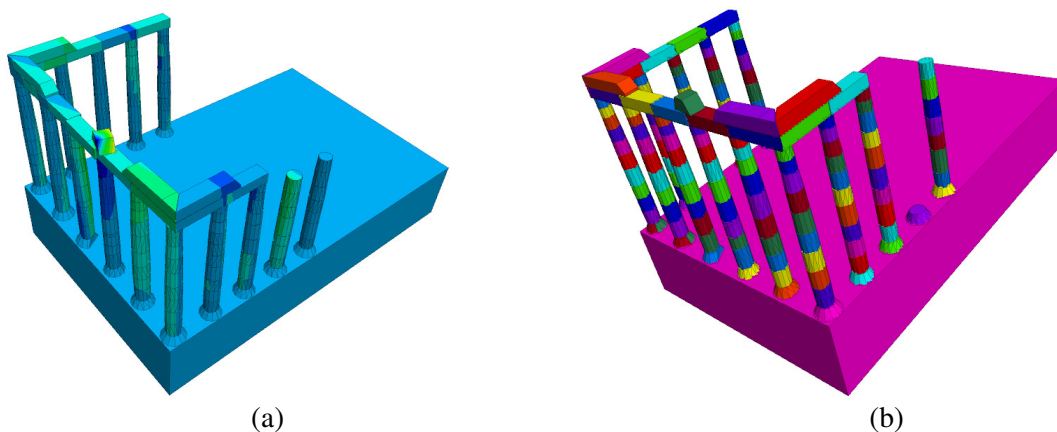
Figure 10 shows final states of the temple excited by earthquakes with PGA multiplier factors of 7 and 10, respectively. Up to a PGA multiplying factor of 7, the blocks of the model presented some residual displacements, after swaying without collapse. The results from a PGA multiplying factor of 10, however, showed that the ground motion induced failure for column D6. The results indicated that the columns connected by architraves show higher resistance than the freestanding columns. It is assumed that this was due to the fact that the additional loads provided by the architraves on the columns and the in-plane behaviour of the façade provides additional resistance against horizontal loads. The maximum displacement for a PGA multiplier factor of 7 was found at the monitoring position 20, located atop column D6, with a value of 42.7 cm in the x-direction, see Figure 10(a). The maximum displacement for a multiplier factor of 10, however, was measured at a point atop the architrave above column C6 (x-direction), with a value of 65.9 cm in the x-direction, as seen in Figure 10(b). This result does not include the failed column D6. In general, the severe loss of cross-sectional area of the lower part of columns A3 and A4 did not significantly affect the global behaviour.

Figure 10. Global response in x-direction: (a) PGA multiplier factor of 7; (b) PGA multiplier factor of 10.
