## Conservation of cultural heritage buildings: Methodology, practice and challenges

P.B. Lourenço

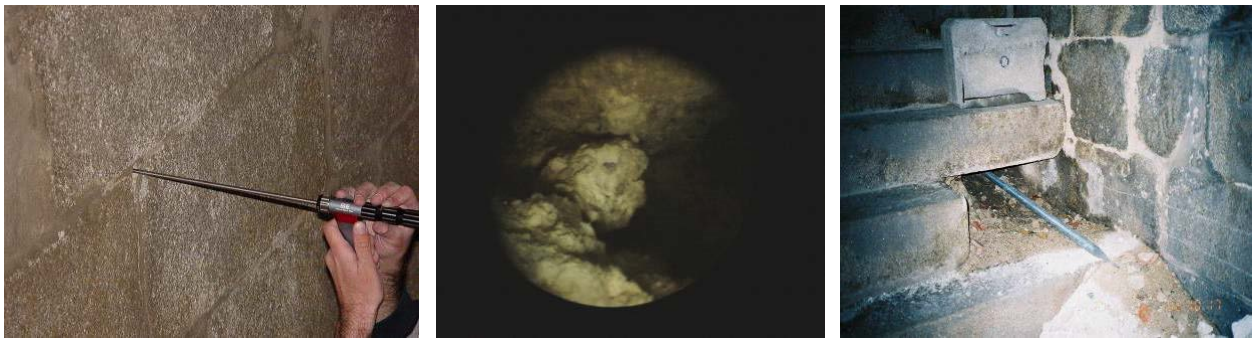
connection between both towers from the top of the main vault. But the two towers have a rather different structure. The North tower (presently with the bells and clock) features a horizontal mid-level with stone slabs and architraves apparently supported in columns and stone struts. The South tower possesses an internal core with a staircase shaped helicoidally. The constitution of the masonry walls from the towers was characterized using visual inspection, removing stones of the outer leaf in the interior of the tower and by using a boroscopic camera inserted in cracks or in holes drilled in joints, see Figure 4. From the inspection, it was possible to conclude that the three-leaf walls have external leaves of granite ashlar with a thickness ranging from 0.30 to 0.70 m, while the middle leaf is made from loose smaller stones and silty soil. The combination of heavy rain in Porto, strong winds in the top of the hill where the Cathedral is located, and the open joints in the external masonry face, results in a wet infill even in the summer and the continuous washing out of the infill.

Figure 4: Visual inspection with boroscopic camera and inspection openings.

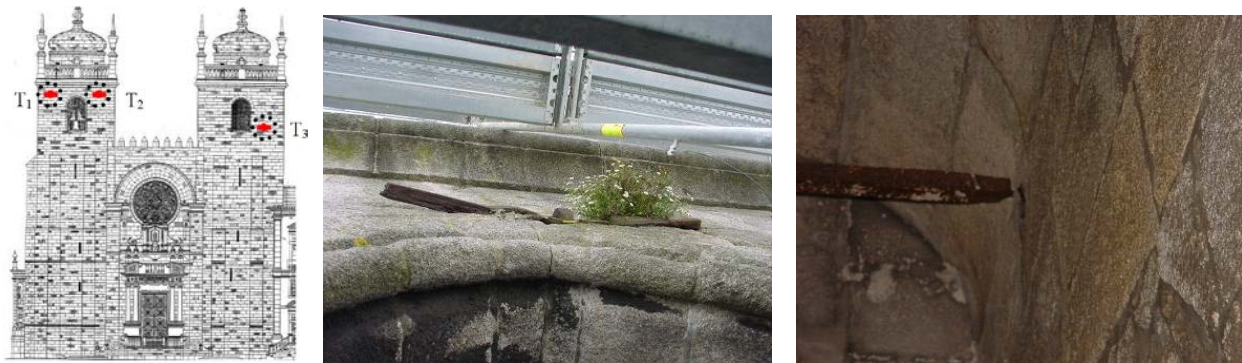
The towers exhibit distributed cracking and significant out-of-plane movements. The existing damage resulted in the past addition of three iron ties (date unknown), see Figure 5. Tie  $T_1$  presents a severely deformed anchorage and tie  $T_3$  is corroded and broken. The separation between the East and West façades of the South tower continued after tie  $T_3$  was broken. The masonry walls in the vicinity of the anchorages are also deformed, as expected due to the application of a large point load. The South tower is more damaged than the North tower, with severe cracks and out-of-plumb walls. Separation between the internal and external leaves of the walls is confirmed by the longitudinal cracking observed in most of the openings, with a maximum width of some centimeters.

Figure 5: Ancient tower ties, with deformed anchorage ( $T_1$ ) and broken tie ( $T_3$ ).

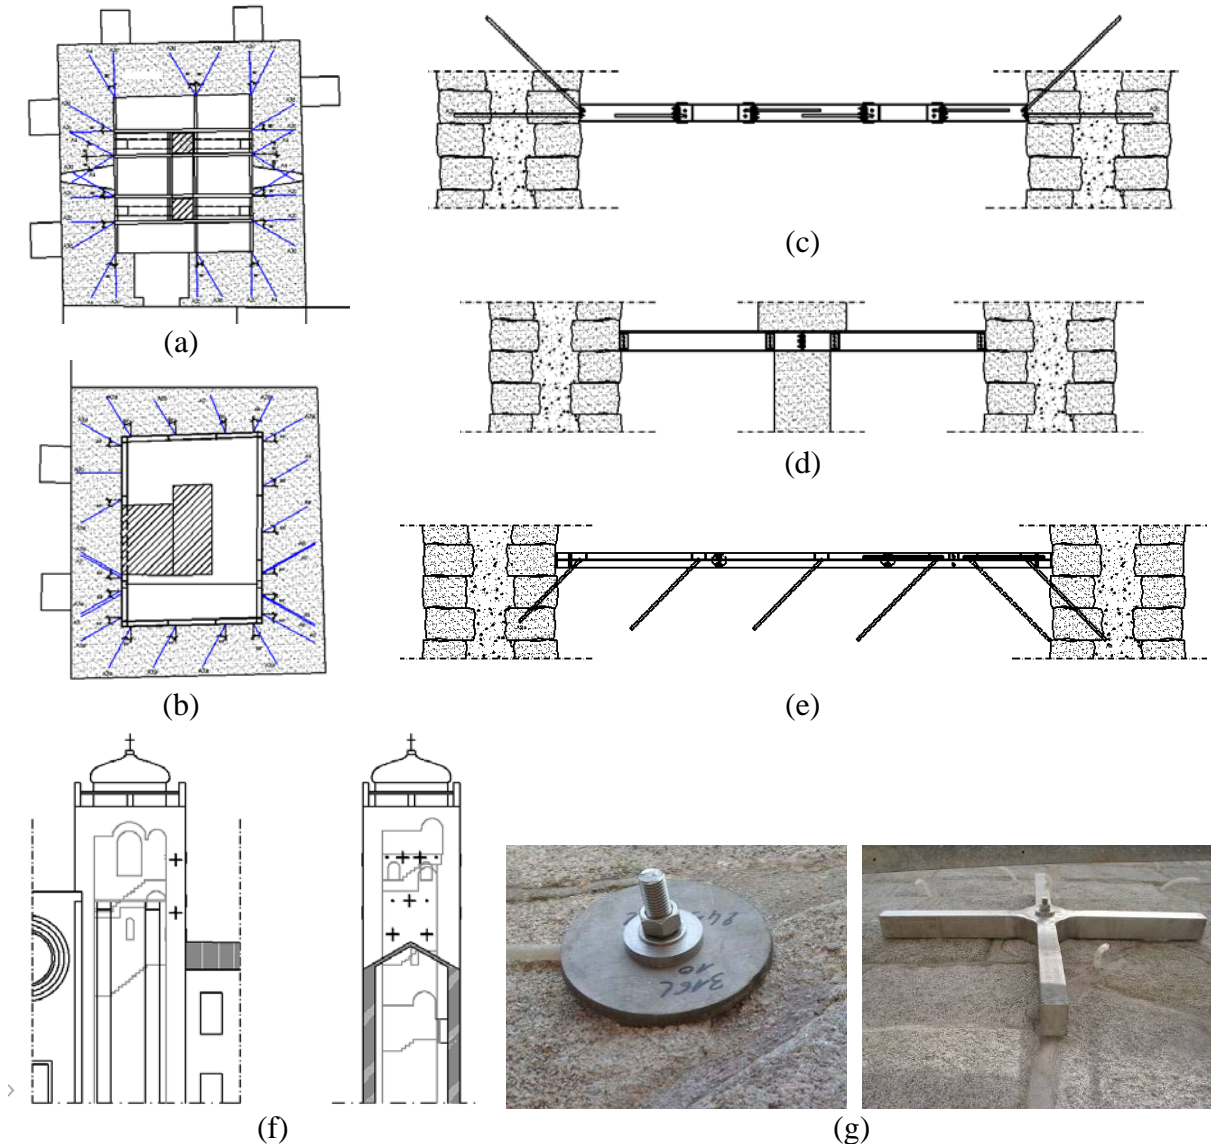
Figure 6: Aspect of the strengthening of the towers: (a) Ring for the north tower; (b) Ring for the south tower; (c) North-south section for north tower; (d) West-east section for north tower; (e) Typical section for south tower; (f) Additional ties in the west and south façades of the south tower; (g) Details of the anchorage plates.

The solution adopted for strengthening consists mostly of a steel ring in both towers, aiming at confining the structure along the two orthogonal directions, in the sole location possible, see Figure 6a,b. The rings are made with welded stainless steel plates (class AISI 316L), connected to the towers using long, inclined stainless steel anchorages inside of a cloth duct to prevent generalized injection, see Figure 6c-e. The length of the steel profiles is defined so that the elements can be transported to the location through the existing doors and can be easily assembled in situ, without any further welding. In the North tower, the ring also aims at providing a support for the stone pavement for the bells, as stone columns are much deteriorated and had no structural function and the stone struts have very deficient conception. The steel ring is made of channel profiles ( $240 \times 120$  mm and  $200 \times 100$  mm height). In the South tower, a set of two ties was provided to the ring, because it was possible for aesthetic reasons and they are a testimony of the ancient broken tie. The ring must cross the staircase at a selected location because the complex internal structure of the tower does not allow otherwise. Due to the lack of internal

stiffening elements, a much stiffer steel frame is needed and the steel ring is made of H profiles ( $180 \times 180$  mm). Due to the bulging outwards of the East and South façades, and the severe cracks in the corners, several short ties have been added to the structure to stitch the East and South façades, and two long ties through the core of the South façade have been added to connect the West and East façades, see Figure 6f. Figure 6g presents details of the two types of anchorage plates adopted (circular plates and specially designed crosses).

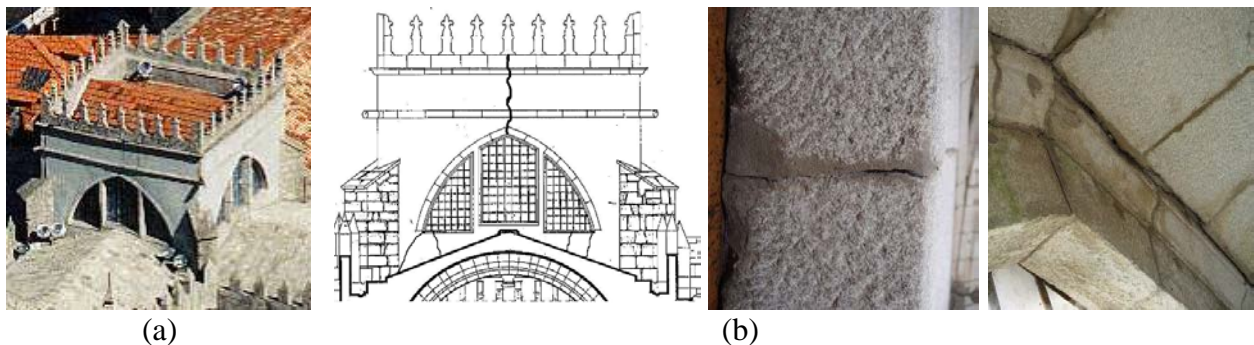
The three walls with windows are cracked at the arch key, with maximum crack widths of 10, 1 and  $<0.5$  mm, in the façades West, North and South, respectively. These walls are also bulging

outwards. Figure 7b shows the main crack in the West façade, which crosses the entire section of the wall. Smaller cracks can be also observed closer to the buttresses, under the opening, together with horizontal cracks in the window columns due to bending. The most severe crack in the interior has a width of 25 mm and shows that the vault is separated from the wall in the West façade. Due to this crack, the stone slabs of the vault are no longer supported in the side rib and a settlement of about 20 mm can be observed at the key of the vault.

The observation of the damage in the skylight, together with the local relief, the severe separation between the East façade and the chancel, the old documents indicating consolidation and enlargement of foundations and the bulging of the walls of the nave indicate that soil settlements

Figure 7: Skylight: (a) Aerial view; (b) Cracks in façades, windows columns and vaults.

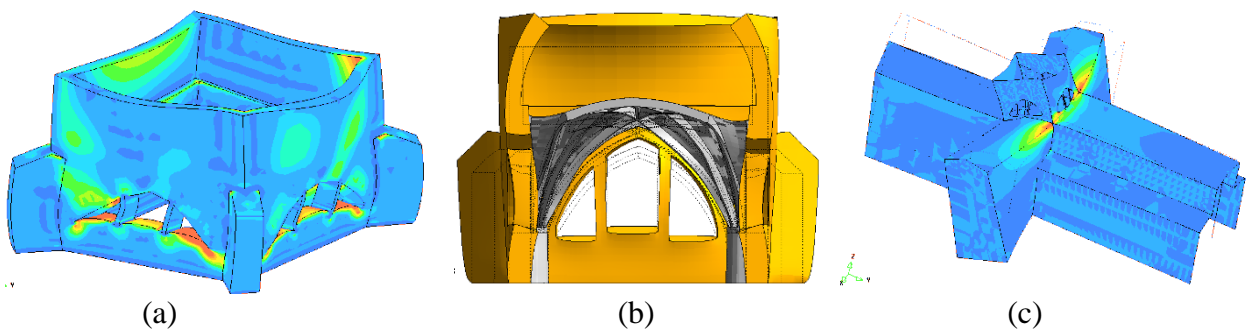
and weak foundations can be the main cause of damage. A finite element model of the skylight was used to understand and justify the existing damage. The actions considered include the self-weight of the structure, the weight of the infill, the seismic action and differential temperature. The results for the combination of self-weight plus rubble infill provided a maximum tensile stress found lower than  $0.1 \text{ N/mm}^2$  and located in the window-sills and ribs. The skylight should have minor or no damage under self-weight and infill. Seismic loading and temperature were then added to the structure, aiming at explaining the damage, see Figure 8a,b. Even if the deformation for seismic loading has some resemblance with the observed movements in the structure, the stresses found are too low to provoke any damage. The deformed mesh associated with the differential temperature indicates that the walls move to the exterior and suffer significant bending, with significant curvatures in the columns. Still moderate stresses are found and the deformation is not in agreement with the observed movements, meaning that the temperature effect is relevant but should not be the main cause of the damage. A full model of the church was then prepared to analyze the influence between the skylight, the adjacent structure and the soil, see Figure 8c. Very high tensile stresses are found in the skylight and the deformation is similar to the one observed in the structure, confirming that this is the major cause of damage. The remedial measures are given in Lourenço et al. (2004).

Figure 8: FEM analysis: (a) Live loads; (b) Temperature variation; (c) Dead load for full model.

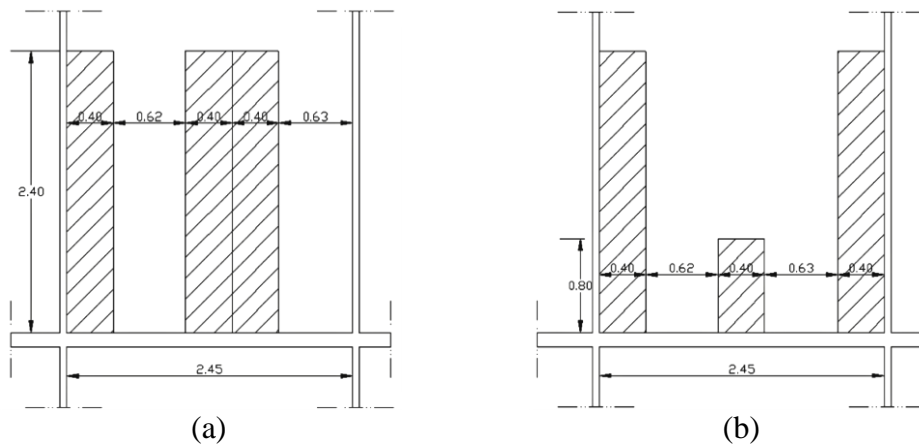
The reinforcement that is present in the slabs is adequate for the previous loads but it is clearly insufficient for the new loads. The proposal of the architect responsible for the works was to adopt three archive shelves with a height of 2.40 m and a base of 0.40 m, see Figure 10, which implies a reinforcement amount twice the existing. The original proposal is possible with a new supporting structure of steel profiles HEB 100, placed transversally in the rooms, and supported by steel angles placed close to the walls. On top of this structure, an OSB new floor would be placed, with a total cost for the solution of about  $100 \text{ USD/m}^2$ . The proposed alternative was to use two taller shelves close to the walls and a shorter shelf in the center, in order to reduce the bending moment, allowing even to provide more room for stocking.

Figure 10: Proposal for book archive: (a) Original; (b) New.

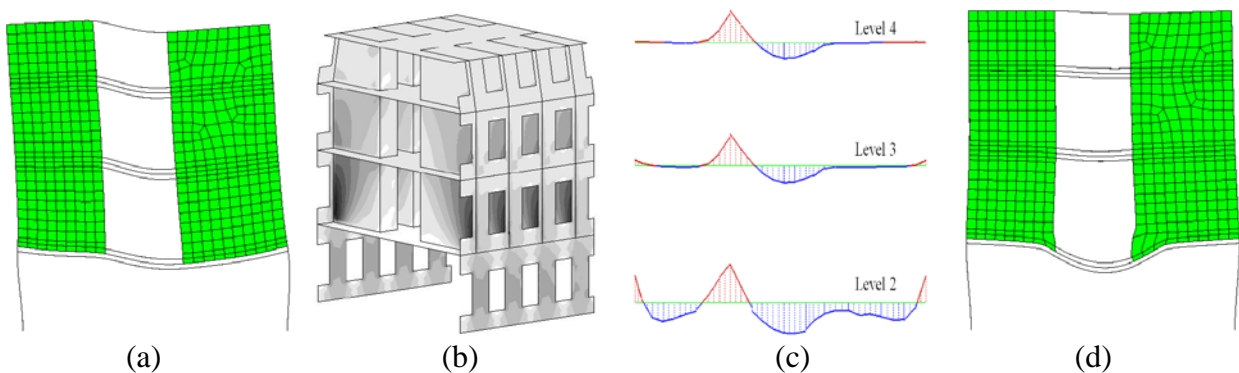
A finite element model was used for the global stability of the structure. The results allow confirming the large stiffness of the internal walls and the asymmetry of the response, see Figure 11a. The analysis of the principal compressive stresses shows that the load is transferred to the external walls, with a behavior similar to a deep beam and using the main beam of level 2 as a “tie” subjected to large flexure, see Figure 11b. The bending moment of the main beams obtained using a linear elastic approach and the failure of the structure using non-linear analysis is shown in Figures 11c,d. The asymmetric deformation and the large stiffness of the walls led to large bending moments producing tensile stress in the upper fibers (60 kN.m in the beam of level 2, in the connection with the left transverse wall). Therefore, the global stability is ensured by the flexural capacity of the nodes in the connection between beams and walls, in a zone where the amount of upper reinforcement is rather low. Figure 11d shows the attempt of the structure to follow a strong redistribution, with a fast progression of a horizontal crack between the walls and the beam in level 2. As the lower reinforcement in the beams is insufficient to carry out the load corresponding to the new use, the structure must be strengthened.

Figure 11: Results for the structural analysis: (a) Deformed mesh; (b) Compressive principal stresses; (c) Bending moments in main beams; (d) Failure from non-linear analysis.

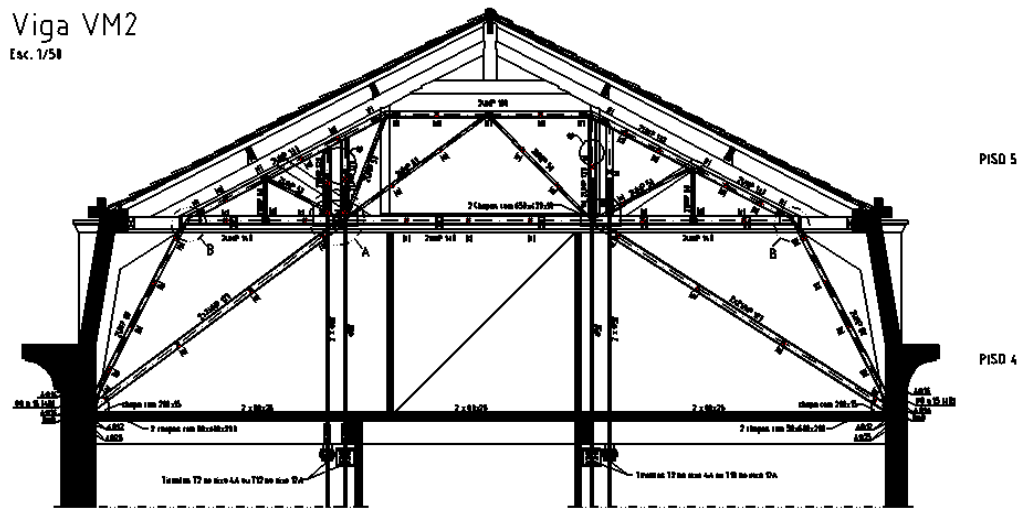
Figure 12: Adopted strengthening solution.

Two possibilities of strengthening were analyzed: (a) a steel beam grid and new columns supporting level 2; (b) a suspension structure for the main beams. Given the aesthetic implications, the usage limitation and the cost, the latter solution was adopted, see Figure 12.

Truss steel structures have been added between level 4 and the roof, in between the existing timber trusses, combined with  $\phi 40$  mm suspension bars. The system supports the beams of levels 2 to 4 and load was transferred using hydraulic jacks.
