## Conservation of cultural heritage buildings: Methodology and application to case studies

P.B. Lourenço

### ABSTRACT

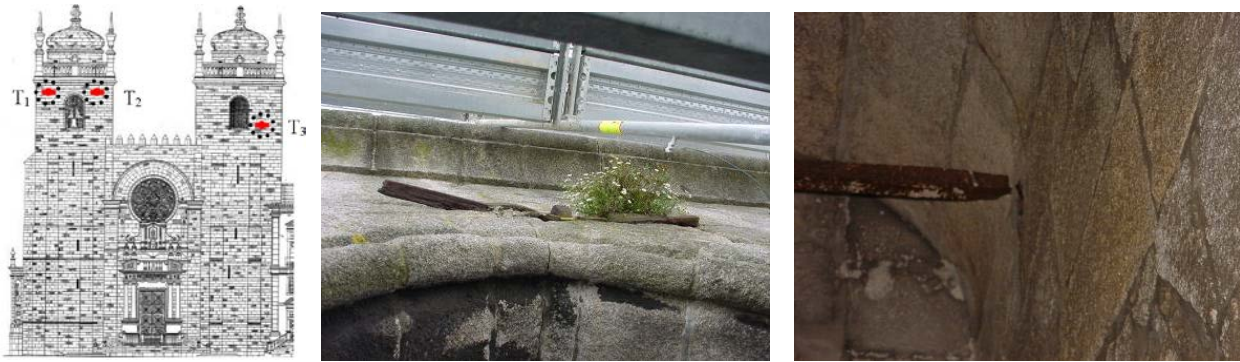
The towers exhibit distributed cracking and significant out-of-plane movements. The existing damage resulted in the past addition of three iron ties (date unknown), see Figure 5. Tie  $T_1$  presents a severely deformed anchorage and tie  $T_3$  is corroded and broken. The separation between the East and West façades of the South tower continued after tie  $T_3$  was broken. The masonry walls in the vicinity of the anchorages are also deformed, as expected due to the application of a large point load. The South tower is more damaged than the North tower, with severe cracks and out-of-plumb walls. Separation between the internal and external leaves of the walls is confirmed by the longitudinal cracking observed in most of the openings, with a maximum width of some centimeters.

Figure 5: Ancient tower ties, with deformed anchorage (T<sub>1</sub>) and broken tie (T<sub>3</sub>).

The solution adopted for strengthening consists mostly of a steel ring in both towers, aiming at confining the structure along the two orthogonal directions, in the sole location possible, see Figure 6a,b. The rings are made with welded stainless steel plates (class AISI 316L), connected to the towers using long, inclined stainless steel anchorages inside of a cloth duct to prevent generalized injection, see Figure 6c-e. The length of the steel profiles is defined so that the elements can be transported to the location through the existing doors and can be easily assembled in situ, without any further welding. In the North tower, the ring also aims at providing a support for the stone pavement for the bells, as stone columns are much deteriorated and had no structural function and the stone struts have very deficient conception. The steel ring is made of channel profiles ( $240 \times 120$  mm and  $200 \times 100$  mm height). In the South tower, a set of two ties was provided to the ring, because it was possible for aesthetic reasons and they are a testimony of the ancient broken tie. The ring must cross the staircase at a selected location because the complex internal structure of the tower does not allow otherwise. Due to the lack of internal stiffening elements, a much stiffer steel frame is needed and the steel ring is made of H profiles ( $180 \times 180$  mm). Due to the bulging outwards of the East and South façades, and the severe cracks in the corners, several short ties have been added to the structure to stitch the East and South façades, and two long ties through the core of the South façade have been added to connect the West and East façades, see Figure 6f. Figure 6g presents details of the two types of anchorage plates adopted (circular plates and specially designed crosses).

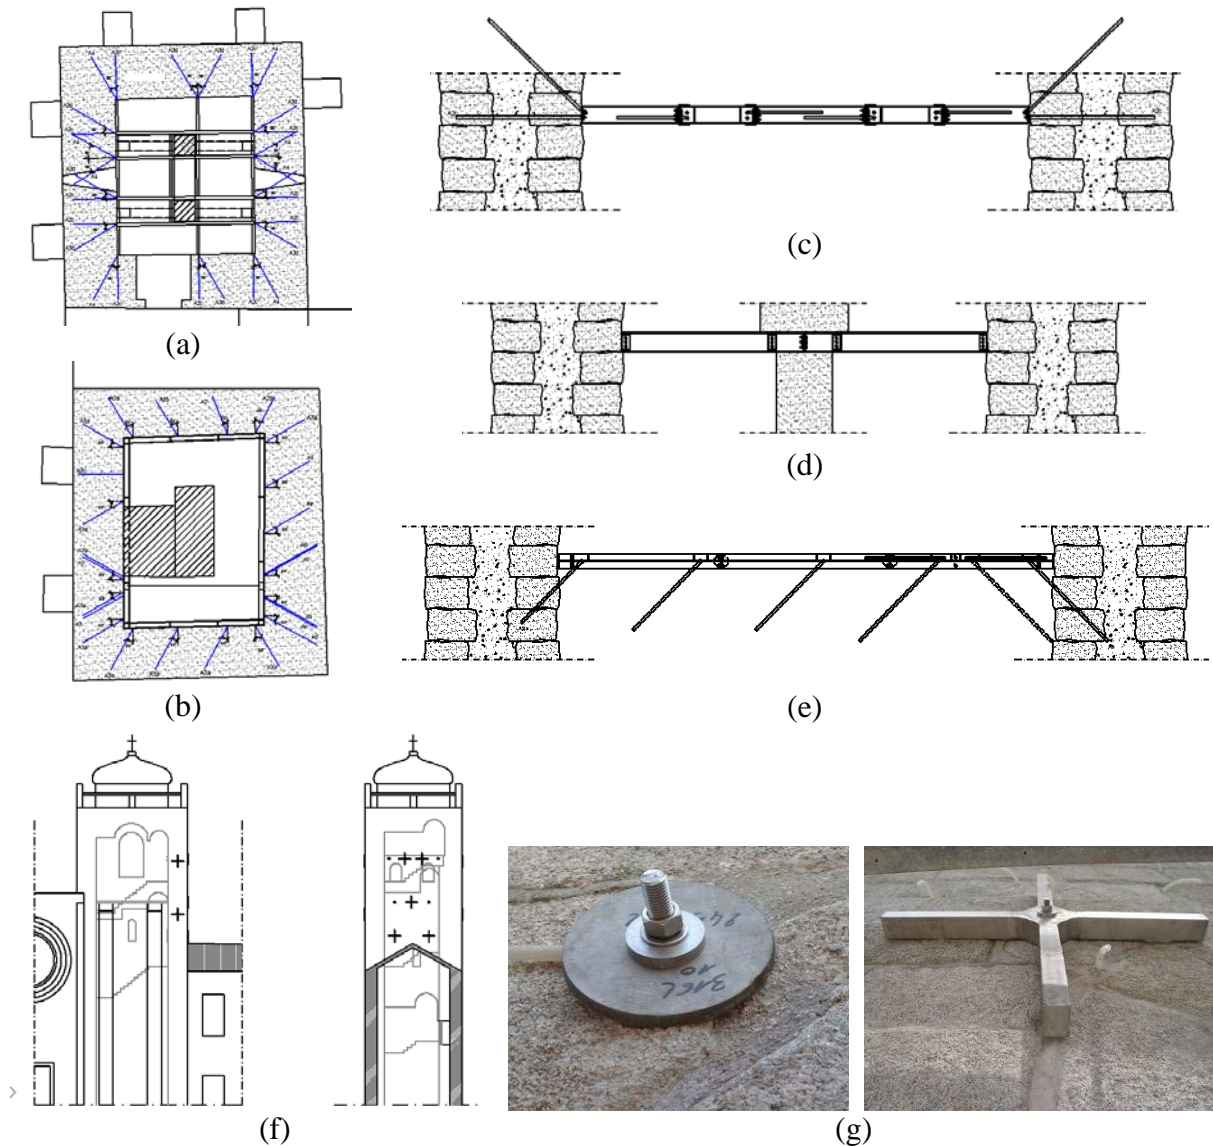
Figure 6: Aspect of the strengthening of the towers: (a) Ring for the north tower; (b) Ring for the south tower; (c) North-south section for north tower; (d) West-east section for north tower; (e) Typical section for south tower; (f) Additional ties in the west and south façades of the south tower; (g) Details of the anchorage plates.

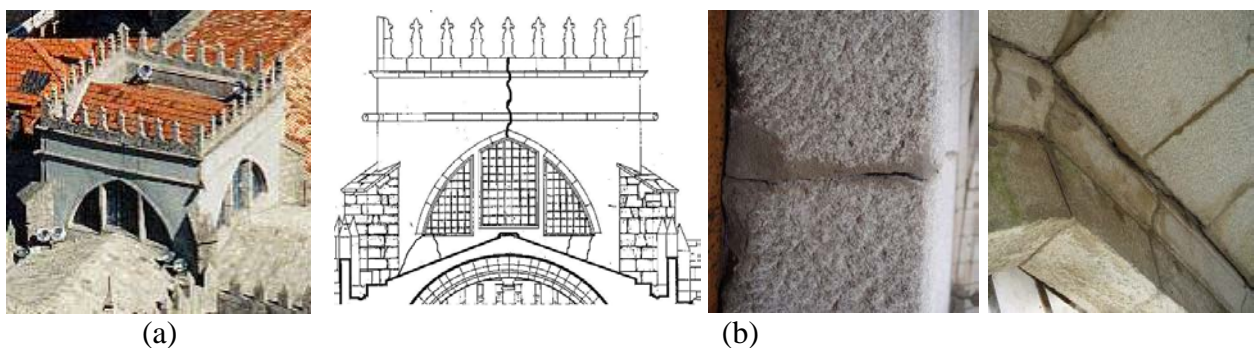
The skylight is located above the transept and presents different cracks, which occurred after the works carried out in the first half of the 20<sup>th</sup> century. In addition, infill material from the vault had recently fallen in the transept. The skylight is made of four walls supported in large arched windows opened in the 18<sup>th</sup> century, with the exception of the East façade with exhibits no opening, see Figure 7a. It has a square plan with 7.5 m side, walls with 6.5 height and 0.65 m thickness. The thickness is reduced to 0.4 m above the vaults and, again, to 0.2 m in the battlements. Buttresses can be found in each corner and a ribbed stone vault makes the ceiling, further topped by a timber double slope roof. The masonry in the walls is of very low quality, made of rubble stone and weak lime mortar. The openings form pointed arches, supported at the thirds of the span with T-shaped columns. The vault is made with stone slabs with a thickness between 0.14 and 0.54 m. Rubble loose infill was removed on top of the vault (about 10 m<sup>3</sup>).

The three walls with windows are cracked at the arch key, with maximum crack widths of 10, 1 and <0.5 mm, in the façades West, North and South, respectively. These walls are also bulging outwards. Figure 7b shows the main crack in the West façade, which crosses the entire section of the wall. Smaller cracks can be also observed closer to the buttresses, under the opening, together with horizontal cracks in the window columns due to bending. The most severe crack in the interior has a width of 25 mm and shows that the vault is separated from the wall in the West façade. Due to this crack, the stone slabs of the vault are no longer supported in the side rib and a settlement of about 20 mm can be observed at the key if the vault.

The observation of the damage in the skylight, together with the local relief, the severe separation between the East façade and the chancel, the old documents indicating consolidation and enlargement of foundations and the bulging of the walls of the nave indicate that soil settlements and weak foundations can be the main cause of damage. A finite element model of the skylight was used to understand and justify the existing damage. The actions considered include the self-weight of the structure, the weight of the infill, the seismic action and differential temperature. The results for the combination of self-weight plus rubble infill provided a maximum tensile stress found lower than  $0.1 \text{ N/mm}^2$  and located in the window-sills and ribs. The skylight should have minor or no damage under self-weight and infill. Seismic loading and temperature were then added to the structure, aiming at explaining the damage, see Figure 8a,b. Even if the deformation

Figure 7: Skylight: (a) Aerial view; (b) Cracks in façades, windows columns and vaults.

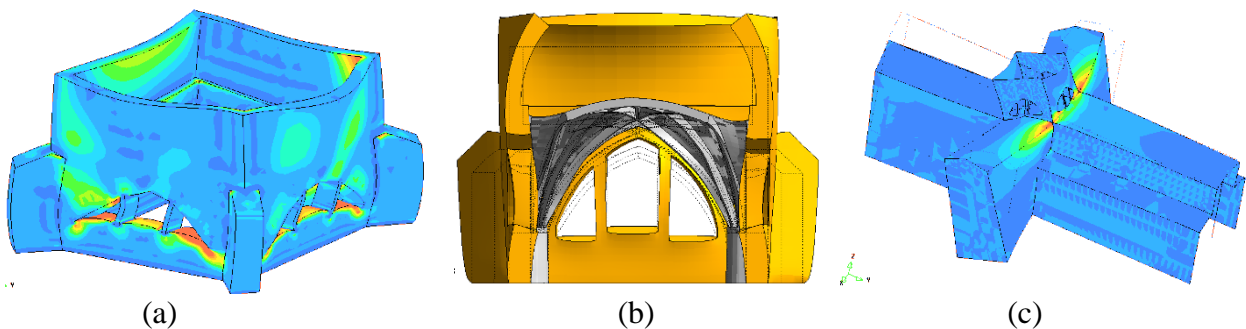
for seismic loading has some resemblance with the observed movements in the structure, the stresses found are too low to provoke any damage. The deformed mesh associated with the differential temperature indicates that the walls move to the exterior and suffer significant bending, with significant curvatures in the columns. Still moderate stresses are found and the deformation is not in agreement with the observed movements, meaning that the temperature effect is relevant but should not be the main cause of the damage. A full model of the church was then prepared to analyze the influence between the skylight, the adjacent structure and the soil, see Figure 8c. Very high tensile stresses are found in the skylight and the deformation is similar to the one observed in the structure, confirming that this is the major cause of damage. The remedial measures are given in Lourenço et al. (2004).

Figure 8: FEM analysis: (a) Live loads; (b) Temperature variation; (c) Dead load for full model.

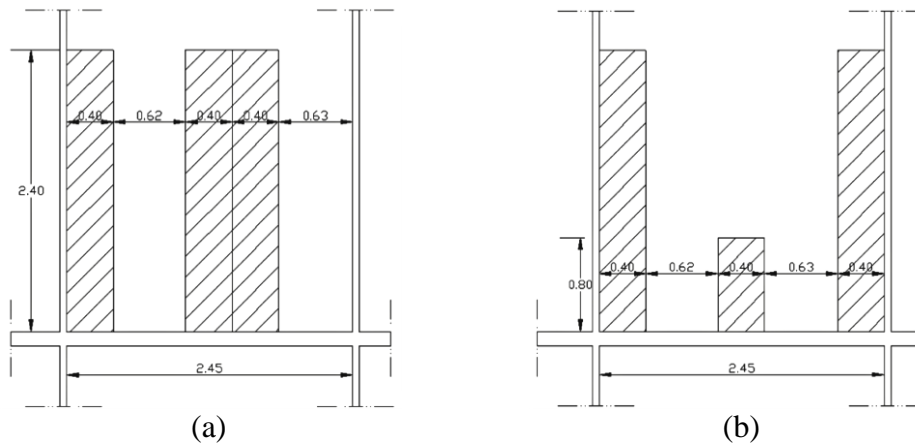
The reinforcement that is present in the slabs is adequate for the previous loads but it is clearly insufficient for the new loads. The proposal of the architect responsible for the works was to adopt three archive shelves with a height of 2.40 m and a base of 0.40 m, see Figure 10, which implies a reinforcement amount twice the existing. The original proposal is possible with a new supporting structure of steel profiles HEB 100, placed transversally in the rooms, and supported by steel angles placed close to the walls. On top of this structure, an OSB new floor would be placed, with a total cost for the solution of about  $100 \text{ USD/m}^2$ . The proposed alternative was to use two taller shelves close to the walls and a shorter shelf in the center, in order to reduce the bending moment, allowing even to provide more room for stocking.

Figure 10: Proposal for book archive: (a) Original; (b) New.

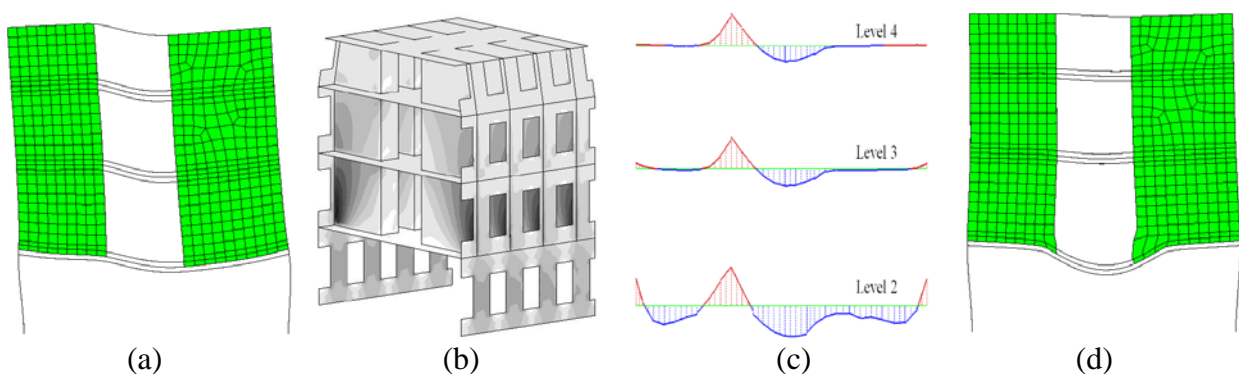
A finite element model was used for the global stability of the structure. The results allow confirming the large stiffness of the internal walls and the asymmetry of the response, see Figure 11a. The analysis of the principal compressive stresses shows that the load is transferred to the external walls, with a behavior similar to a deep beam and using the main beam of level 2 as a “tie” subjected to large flexure, see Figure 11b. The bending moment of the main beams obtained using a linear elastic approach and the failure of the structure using non-linear analysis is shown in Figures 11c,d. The asymmetric deformation and the large stiffness of the walls led to large bending moments producing tensile stress in the upper fibers (60 kN.m in the beam of level 2, in the connection with the left transverse wall). Therefore, the global stability is ensured by the flexural capacity of the nodes in the connection between beams and walls, in a zone where the amount of upper reinforcement is rather low. Figure 11d shows the attempt of the structure to follow a strong redistribution, with a fast progression of a horizontal crack between the walls and the beam in level 2. As the lower reinforcement in the beams is insufficient to carry out the load corresponding to the new use, the structure must be strengthened.

Figure 11: Results for the structural analysis: (a) Deformed mesh; (b) Compressive principal stresses; (c) Bending moments in main beams; (d) Failure from non-linear analysis.

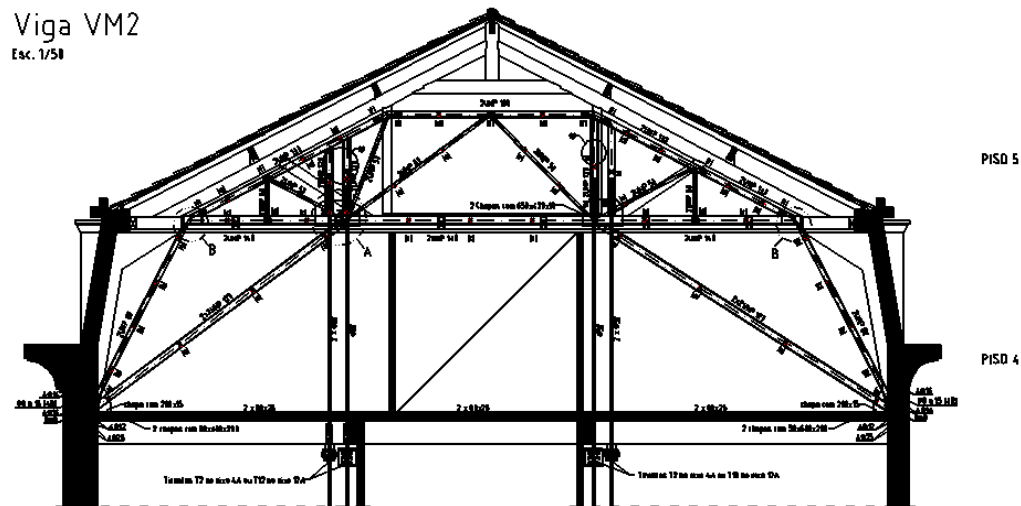
Figure 12: Adopted strengthening solution.

Two possibilities of strengthening were analyzed: (a) a steel beam grid and new columns supporting level 2; (b) a suspension structure for the main beams. Given the aesthetic implications, the usage limitation and the cost, the latter solution was adopted, see Figure 12. Truss steel structures have been added between level 4 and the roof, in between the existing

timber trusses, combined with  $\phi 40$  mm suspension bars. The system supports the beams of levels 2 to 4 and load was transferred using hydraulic jacks.
