# Structural Monitoring and Damage Identification on a Masonry Chimney by a Spectral-based Identification Technique

**ABSTRACT:** The present work deals with the damage identification of a historical masonry chimney located in Guimarães (Portugal), including a detailed survey, inspection and diagnosis. The chimney was object of a continuous monitoring campaign carried out to catch the evolution of the modal parameters and evaluate the success of the rehabilitation works planned after a lightning accident. Based on the dynamic features extracted from the OMA data, a damage identification analysis was performed making use of different damage identification techniques. Considering the explicit dependence of output-only power spectral densities on frequency contents, a spectral-based identification method was used to detect the damage. Finally, an appropriate localization index was defined combining evolutionary complex eigenvectors obtained from the decomposition of the power spectral density matrix. The results allow to conclude that the spectral-based dynamic identification method is a non-destructive tool able to capture the global behavior of a structure and may reveal itself of

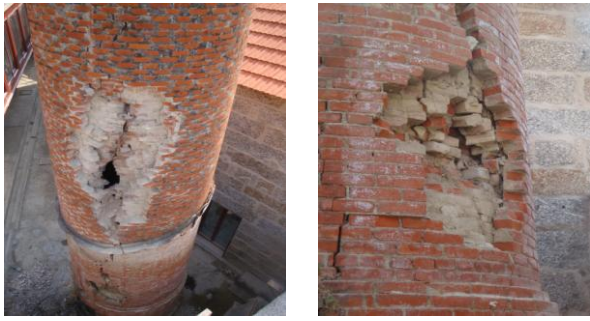
Figure 2. Openings caused by the lightning.

A new phase of inspection and diagnosis was again necessary after the accident occurred in July 2012, when the chimney was hit by a lightning and the situation made worse with the addition of two large openings to the existing cracks (Figure 2 **Errore. L'origine riferimento non è stata trovata.**). In order to reinstate the sound condition of the chimney, in-depth repair works were carried out between December 2012 and February 2013. The intervention was preceded by a first phase of data collection of the structure, including geometrical and damage surveys, material characterization by NDTs and global dynamic identification by ambient vibration tests. A second phase of dynamic monitoring was put into practice to follow the evolution of the modal properties during the works and a last phase marked again by OMA tests was performed. Hereafter a more detailed description of all the phases is presented.

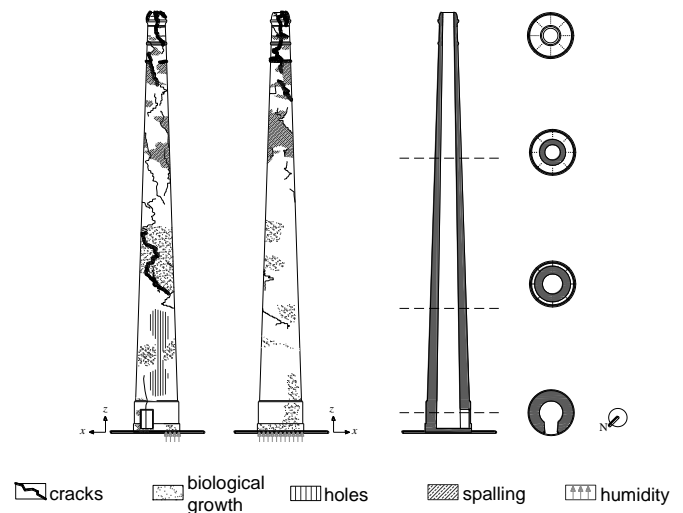
The last inspections highlighted the presence of two significant holes caused by the electrical discharge and the increase of the existing cracks, besides spotted spalling, widespread biological growth and rising humidity in the bottom part of the chimney (Figure 3). The two ‘new openings’ worsened the structural condition of the chimney already affected by a slight rigid rotation of the upper part of the chimney, a disconnection of the top of the structure with respect to the rest of the body, a permanent plastic deformation affecting the upper two thirds and a series of minor cracks. Urgent repair works were planned and executed to re-establish the chimney safety, including consolidation through reconstruction of damaged parts, cracks closing and mortar injections, chimney washing and waterproof protection. Details about the damage and the structural intervention are given in [1][1] e [3] [1].

Figure 3. Geometrical and damage survey: west front, east front, sections.

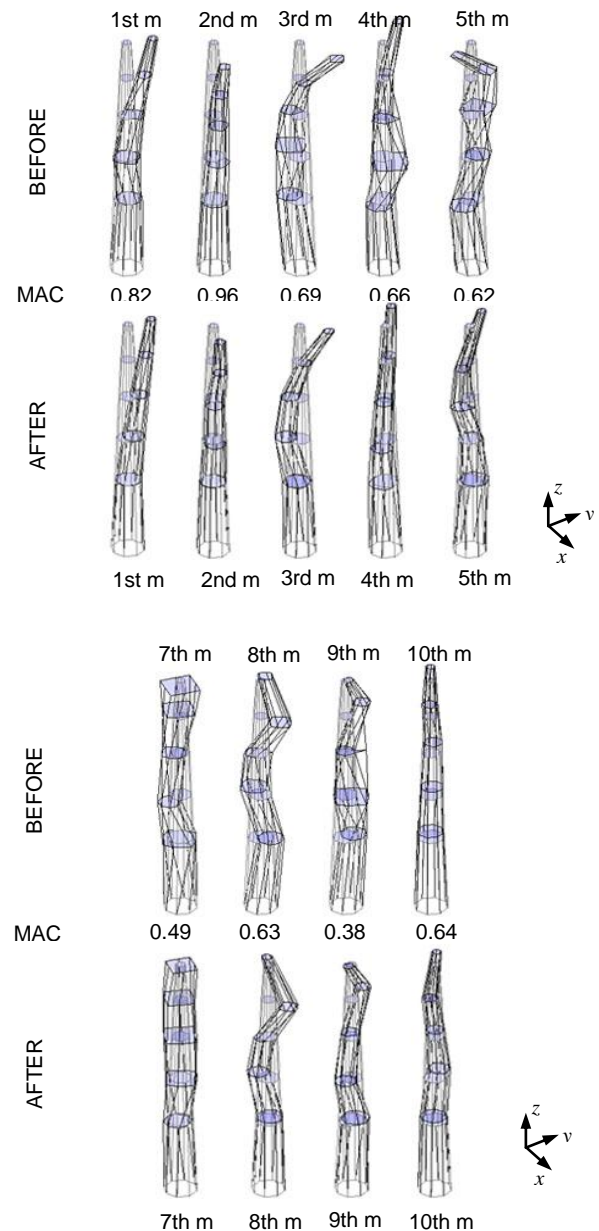
Regarding the mode shapes comparison between the two structural conditions, despite similarities in the mode configurations, it is possible to observe a weak correlation in terms of MAC values concerning all the modes except the lower ones (Figure 5). The existence of damage, especially referring to the two holes caused by the lightning besides all the cracks, is reflected in a series of local effects clearly deviating the response of the damaged structure from the monolithic (sound) behavior that characterizes the chimney after the works.

Figure 5. Experimental mode shapes and MAC values before and after rehabilitation works.

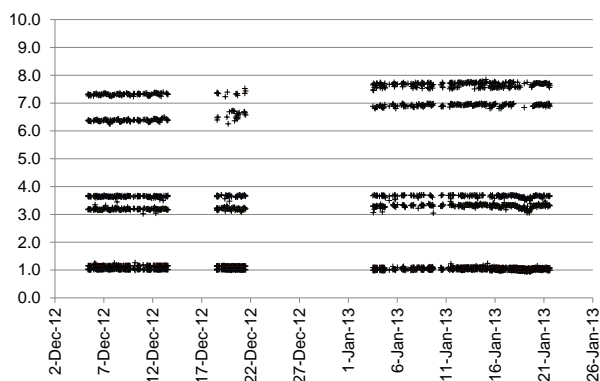
Aiming at following the evolution of the natural frequencies during the consolidation works, the dynamic monitoring task was performed using a limited number of sensors, namely the four acceleration transducers placed on the top. This task was carried out from December 2012 to February 2013 in three campaigns (Table 3) and particularly attention was paid during the reconstruction of the masonry panels in the areas where the lightning caused the holes. The first six eigen frequencies were taken into account. As shown in Figure 6, significant changes mostly involved the higher natural frequencies, whereas the lower ones did not suffer any considerable changes.

Figure 6. Structural health monitoring.

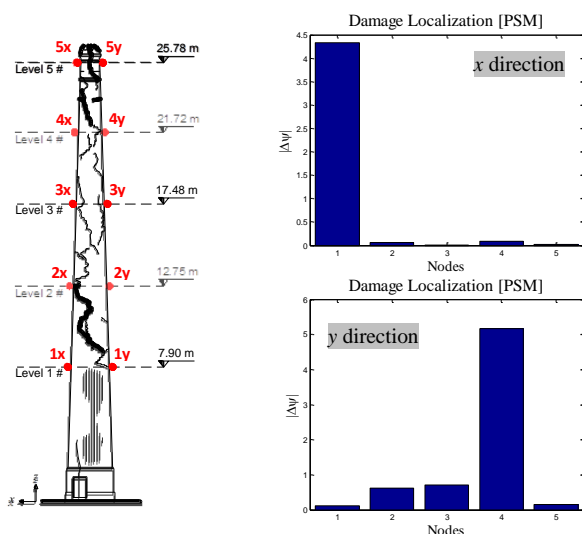
Figure 9. Damage localization in the chimney by PSM.

The bar graphs clearly indicate the presence of damage in nodes 1 and 4 that are exactly the nodes closest to the parts of the chimney most affected by the damage. Node 1 is located near the severe openings caused by the lightning and node 4 is located where both the disconnection and rigid rotation affecting the upper part of the chimney begin. In the former case, the damage altered the structural behavior in the  $x$ - $z$  plane, whereas in the latter case the dynamic response varied in the  $y$ - $z$  plane.
