## Seismic assessment of Christchurch Catholic Basilica, New Zealand

SILVA, LUIS C.<sup>1</sup>; LOURENÇO, PAULO B.<sup>2</sup>; MENDES, NUNO<sup>3</sup>

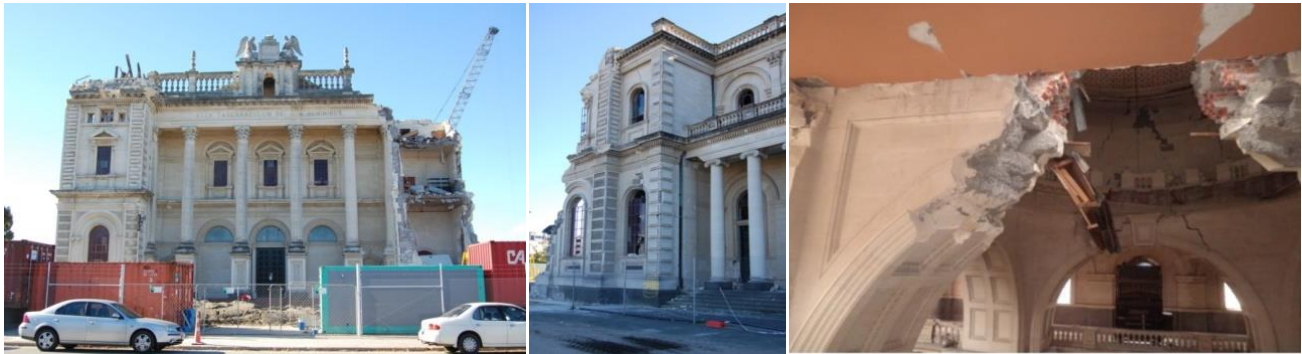
The earthquake of February 22 of 2011 was, quantitatively, less severe than the September 4 (2010) earthquake, with a magnitude of 6.3 instead of 7.1 (ML). However, qualitatively, the 2011 earthquake caused more damage in Christchurch, possibly due to the vulnerability of many buildings after the damage induced by the first earthquake. The higher damage can also be related, according to [16] [17], to the proximity of the site, to the shallowness of the rupture and to the weak underlying soils. The main damage induced by the February 22, 2011 earthquake in the Basilica are described next [12] [15][16][17][18], see Figure 3 and Figure 4: (i) North and South tower belfries collapsed. Failure occurred in a North-West and South-West direction, respectively; (ii) Similarity to the North and South elevation, severe shear cracking behind the bell towers is visible. Spalling of the ground piers (due to in-plane rocking), large displacements and cracking around the windows and doors also occurred; (iii) Cracking of the outward wall of the North and South transepts. The North wall had a shear crack

around one window on the ground level, which is not-significant comparatively to the South one; (iv) Significant damage at the main dome drum occurs, with a permanent lateral displacement of approximately 75 mm and a vertical settlement of 100-200 mm, together with collapse of the supporting North arch and severe damage to the South arch; (v) For the two levels that integrate the sanctuary, below the Dome and Rotunda, some concrete flat roof areas of the upper level (retrofitted in 2004), collapsed and present large shear cracks.

**Figure 3.** West façade of the Christchurch Catholic Basilica: damage at the two bell towers (left); Detail of the West wall collapse of the South bell tower (middle); Collapse occurred in the North arch of the sanctuary (right).

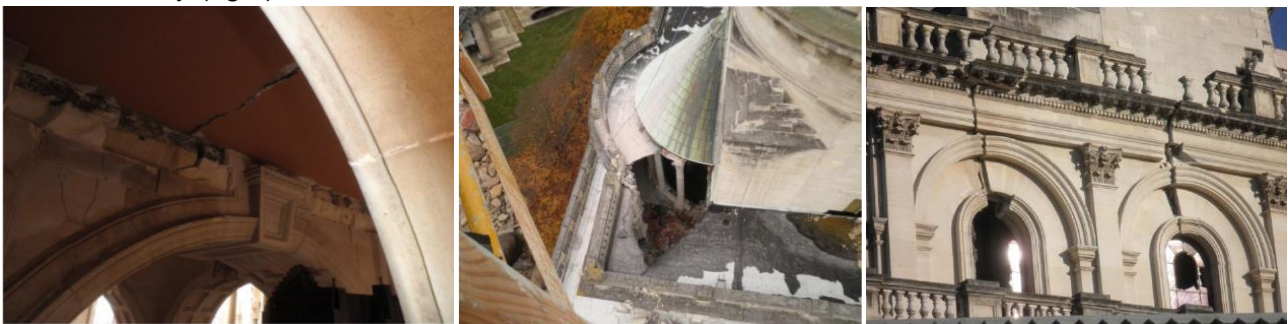
**Figure 4.** Severe damage to the South arch spandrel (left); Collapse of a part of the RC sanctuary flat (middle); Shear cracks around the upper arcade of the North elevation (right).

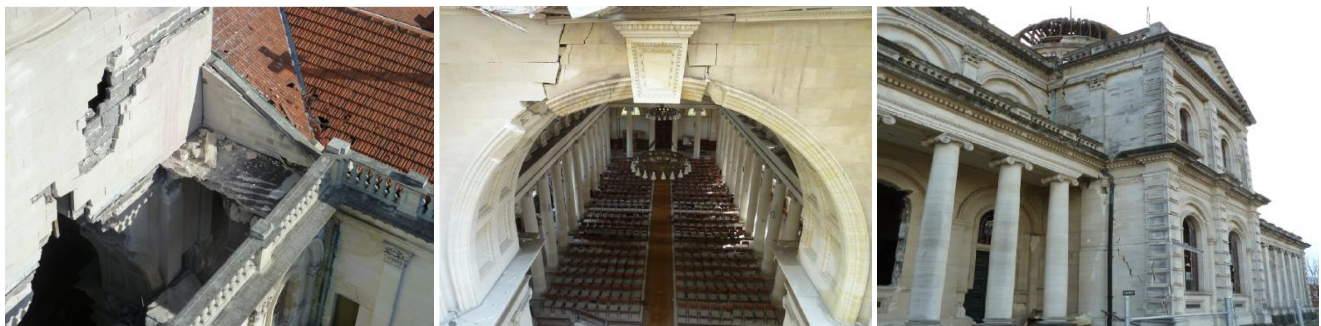
**Figure 5.** Collapse of a North of the adjacent RC flat roof and interior arch (left); Damage along the West arch (middle); Developing of a diagonal block failure in the South transept façade (right).

The main structural consequences of the aftershocks are described (see Figure 5) as: (i) A portion of the North Rotunda wall, parts of the adjacent reinforced concrete flat roof and the North interior arch, already with severe damaged, collapsed; (ii) The East and West arches suffered significant damage around the keystone; (iii) The South transept façade suffered additional damage, exhibiting cracking and developing a diagonal block failure. A crack across the transept roof level, with 25 mm of width, is now present.

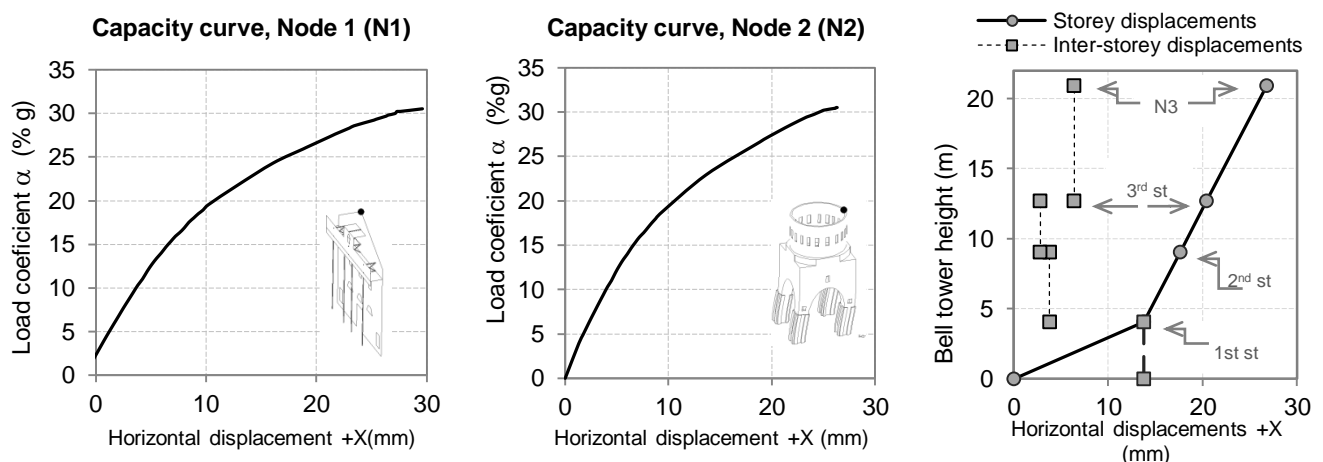
**Figure 7.** Capacity curve in +X direction for nodes 1 and 2 (left and middle); Bell tower stories' displacements for a horizontal load of 0.30g (+X; st.: storey; N3: node 3) (right).

In Figure 7 it is observed that the horizontal in-plane displacement is higher at the top (27 mm). However, the maximum inter-storey displacement (drift) occurs at the first floor, which justifies that the shear-cracks are only visible in bell towers' walls of the first and second storeys. On the other hand, the West tympanum wall develops horizontal cracks at the top of the RC slab reinforcement. This damage is in agreement with the expected failure mode, i.e. the out-of-plane movement of a slender element (bending) leads to high stresses, which cause a rotation line, with out-of-plane rocking of the tympanum.

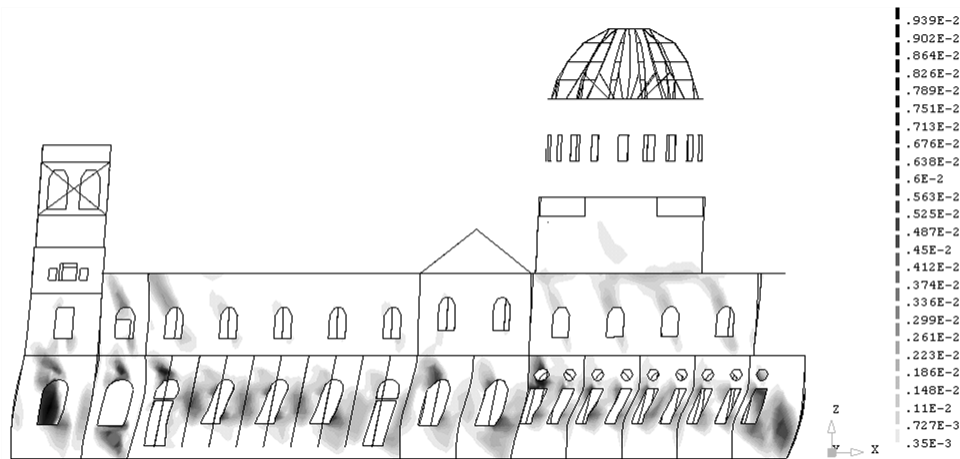
Figure 8 presents the deformed shape of the pushover analysis in the positive longitudinal direction with the principal tensile strains of the South façade walls. It is clear that the larger displacements are located on the top of the elements. However, the horizontal relative displacements do not have a linear increase through the structure height. The first floor walls present the most important in-plane

displacement (and damage). This aspect is particularly noted in the deformed shape of the bell tower, where the parabolic shape of the first floor is replaced in height by a linear one. This is due to the added elements in the 2004 strengthening works, i.e. the RC slabs in the bell towers and nave, as well as the steel braces and ring beams of the third bell tower floor which improves the seismic behavior of the structure. The principal tensile strains distribution leads to the same conclusion, in which it is observed that the damage concentrates at the first floor walls, i.e. in openings, walls connection (shell elements) and rotunda walls (solid elements).

**Figure 8.** Principal tensile strains of the South façade walls for a horizontal load of 0.30g in +X direction (the nave roof frame is not represented).

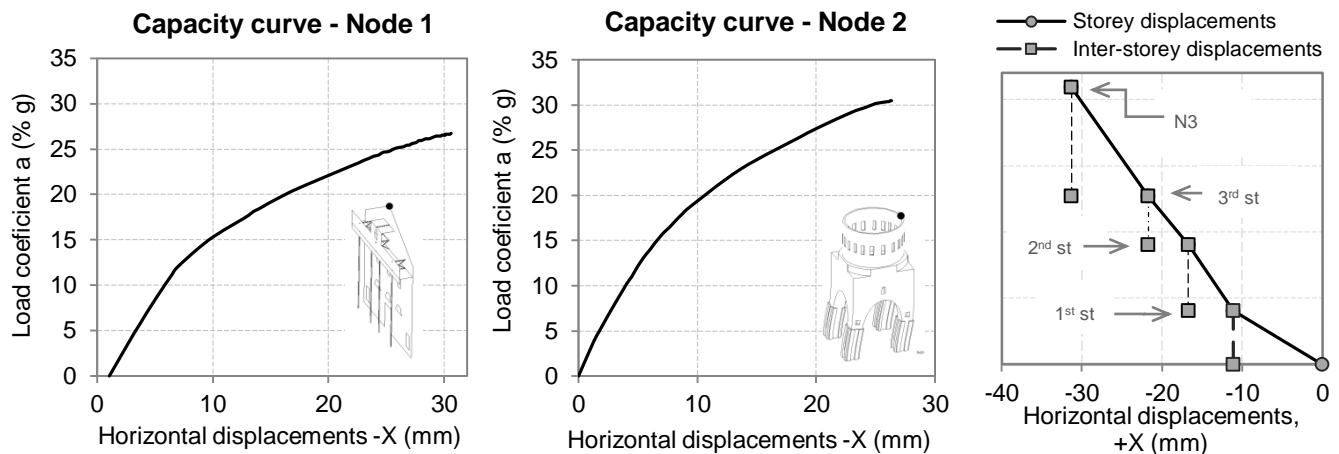
The maximum horizontal displacement of the pushover analysis in the direction  $-X$  occurs at the top of the bell tower and is equal to 30 mm. The horizontal displacements decrease to about the half for elements closer of the sacristy. Significant differences in the capacity curve of Node 1 are observed, in comparison to the  $+X$  direction. The node presents the same maximum displacement, but for a load coefficient approximately 5% lower. The same occurs for the initial cracking load, i.e with a coefficient of 13% rather than 16%, see Figure 9. These differences show that the West gable wall has less strength capacity in the  $-X$  direction and, consequently, more damage. This can be explained by the confinement action caused by the rotunda walls, which occur in the  $+X$  direction (the confinement is only possible due to the modeled roof trusses). This action does not occurred for the  $-X$  direction, because the out-of-plane movement of the West façade tympanum led to tensile stresses that cannot be withstand by the rotunda walls, due to the low tensile strength of masonry elements.

Similarly to the  $+X$  direction, the relative displacements between the storeys of the bell tower are higher between the first and second ones, as observed by the inter-storey displacements curve of Figure 9. However, even if the horizontal displacement that occurred at the top is 5 mm greater (30mm, in comparison to  $\approx 25$ mm), the differences are smaller for this direction and consequently the cracks due to in-plane shear stresses occur, but are not as clear as before. The crack pattern is similar to the one obtained for the  $+X$  direction, i.e. a high concentration of cracks in the North, South walls (nave and sacristy) near the openings. It is clear that the damage on the shell elements oriented in the load direction (façade walls) is caused by in-plane shear stresses. Thus, the difference in the  $-X$  direction corresponds to the way that cracks propagate (diagonal shear cracks) (Figure 10). Another difference in the damage pattern is highlighted in Figure 10 by a dashed circle located in the connection between the South nave and South stairwell wall.

**Figure 9.** Capacity curve in  $-X$  direction for nodes 1 and 2 (left and middle); Bell tower stories' displacements for a horizontal load of  $0.27g$  ( $-X$ ; st.: storey; N3: node 3) (right).

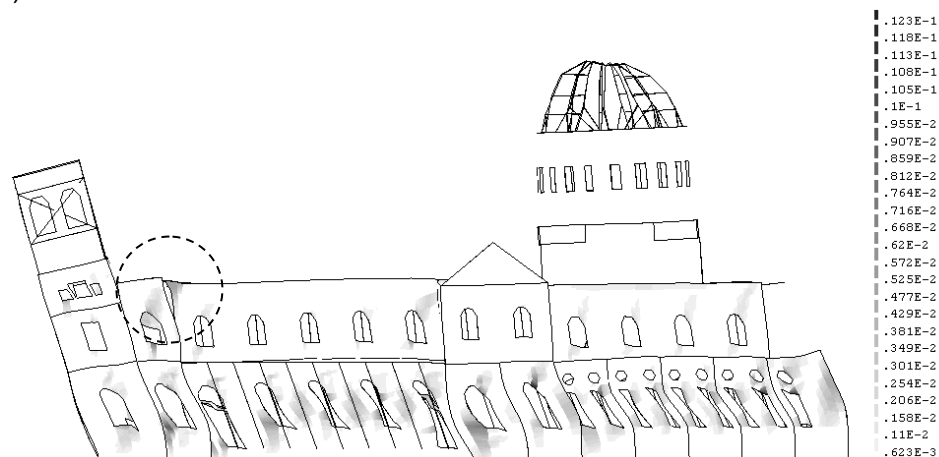
Thus, if the  $+X$  load direction is vulnerable for the bell tower walls, by creating a crack pattern prone to an out-of-plane mechanism, the  $-X$  load direction makes it more likely to happen. In fact, for the performed study, a horizontal load of  $0.20g$  is the value that initiates cracking at these connections. This is not related to a shear action but it is instead caused by the push-over action in these elements (tensile stresses).

**Figure 10.** Principal tensile strains of the South façade walls for a horizontal load of  $0.27g$  in  $-X$  direction (the nave roof frame is not represented).

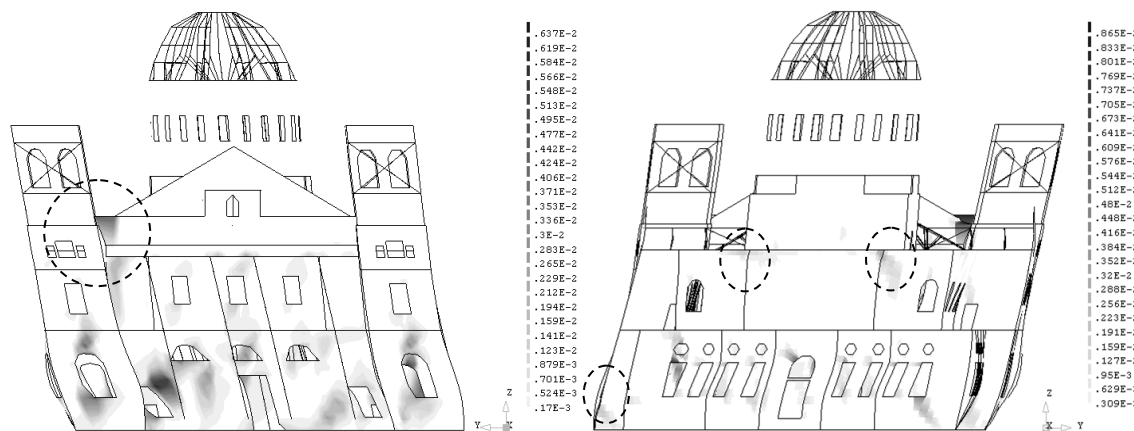
The main damage obtained from the +Y direction analysis is presented next. Figure 12 indicates with a dashed line the initial cracking occurrence, caused by the concentration of tensile stresses due to the difference of behavior between structural elements, i.e. the North bell tower has larger displacements than the main West façade wall (if the load had the -Y direction, it would be symmetric). This is valid to the North end of the West entablature and also for the finite elements at the connection between the West façade and North bell tower, where a vertical crack is prone to be active.

**Figure 12.** Principal tensile strains due to a horizontal load in +Y direction: West façade (left) and East façade (right).

Nevertheless, for a load coefficient of 22% of the self-weight the demand for tensile strength is small, in which the cracking do not have further repercussions on a macro-elements failure collapse. A set of diagonal cracks is also presented in Figure 12, due to in-plane shear stresses near the openings of the West and East elevations and near the walls connections, mainly in the transversal walls of the transepts and in the second floor of the East wall (dashed circles).

On the other hand, interior damage was also observed, for instance the damage in the first floor at the transversal bell tower wall, near the arch passage and near the aisle passage of the second floor. Furthermore, diagonal shear cracks are very clear at the transversal walls of the South and North façades. There is no occurrence of toe crushing and, similarly to what occurs in direction X, the difference between displacements of the first and second storeys is considerable, being the main cause of the concentration of shear cracks in both bell tower walls at the first floor level Figure 12.
