## Evaluation of structural intervention in the *Quartel das Esquadras*, Almeida (Portugal)

**ABSTRACT:** The *Quartel das Esquadras* is an 18th century infantry barrack located within the limits of the bulwarked fortress of Almeida, in Portugal. An ongoing adaptive reuse project of the building aims to recover its full capacity and also its importance to the fortified village of Almeida, by implementing a variety of new uses. While adaptive reuse projects of historical buildings are a very recommendable solution for maintaining those constructions whose use has become obsolete, these projects demand careful study because they may introduce changes in the structural behaviour of the buildings to preserve.

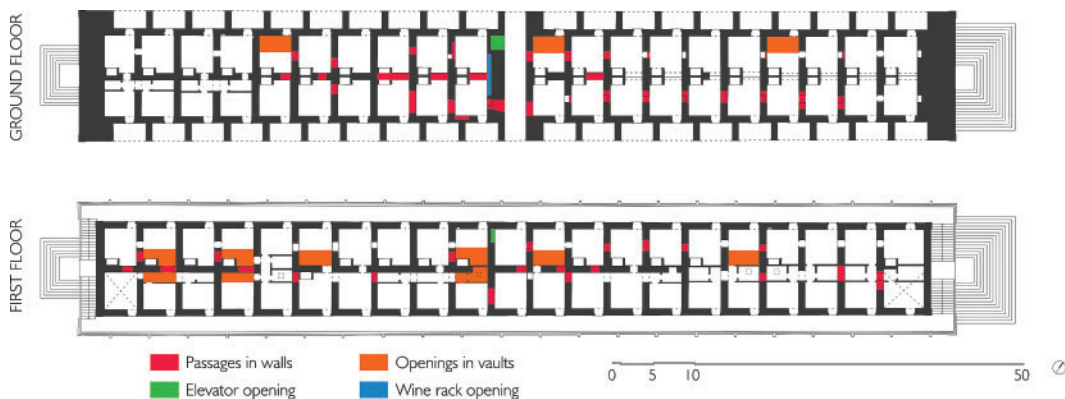
building codes. Therefore, the analysed intervention foresees the introduction of the required passages and communication systems for which some structural elements will have to be removed or modified, altering the current configuration of the structure (see Figure 3).

Certain points have been identified as possible sources of major structural problems: the influence of the addition of high live loads on top of the vaulted system of the first floor; the influence that the openings in walls and vaults might have in the overall structural safety of the building; the risk that an intervention (introduction of an elevator, wine rack and passage) in an intermediate thick wall supposes, especially considering the complete lack of information regarding its morphology; the compatibility between the proposed reinforced concrete structure and the original structure; the suitability of the designed steel lintels for their purpose; and the influence in the structural behaviour of the order in which the interventions will be performed.

Figure 3. Distribution of openings affecting the original structure of the *Quartel das Esquadras* resulting from the intervention proposed by the adaptive reuse project: openings in walls (red), openings in vaults (orange), elevator opening (green) and wine rack opening (blue).

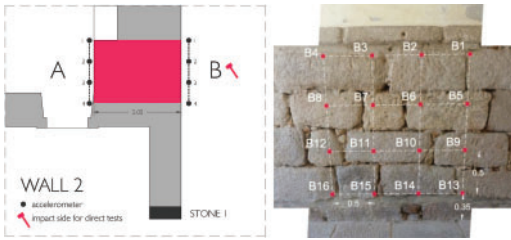
Three walls were selected to be studied by means of sonic testing: a ground floor standard wall (W1); the ground floor thicker middle wall (W2); and a first floor standard wall (W3). All walls had both faces rendered, but for the external face of wall W2. Indirect and direct tests were carried out over a surface of 2.25 m<sup>2</sup> in a 4 × 4 grid of points, separated from each other by 50 cm in vertical and horizontal directions (see Figure 4).

Figure 4. (left) Location plan of the sonic tests in wall W2; (right) location of the tested points in the  $4 \times 4$  grid for the direct tests.

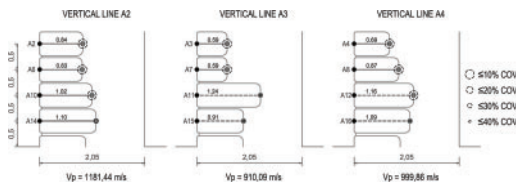
By means of studying the geometrical survey, an approximated value for leaf A thickness of at least 80 cm could be estimated. Knowing the depth of the leaf was essential for determining an estimated cross section and a Young's modulus of the infill of the wall. For this reason, a study of the frequency content of the direct tests signals based on the approach of impact echo, a wave propagation-based technique which uses frequency domain analysis for data interpretation, was carried out. The three most representative signals of each test, the ones closer to the average value, were analysed. By identifying the higher frequencies of each signal, and considering the relation between the frequency, depth and the velocity  $V_p$ , an estimative value of the depth of the leaf in each point could be calculated (see Figure 6).

Some of the signals showed less clear frequency content, maybe due to a very irregular surface of the stone (marked with dashed lines in Figure 6). Results showed an average value of 91 cm, greatly influenced by the possible presence of larger stones in the base of the wall, which was usual practice among the stone-masons. In order to exclude the values affected by the unclear signals, results with a coefficient of variation (COV) higher than 10% were discarded and a new average value of 82 cm was obtained. The initial hypothesis which considered that the investigated leaf could have a depth of 80 cm was then validated.

Figure 6. Possible disposition of stones in leaf A of wall W2. For each point stone, calculated values of depth in m and coefficient of variation are given (dashed lines indicate signals with unclear frequency content).

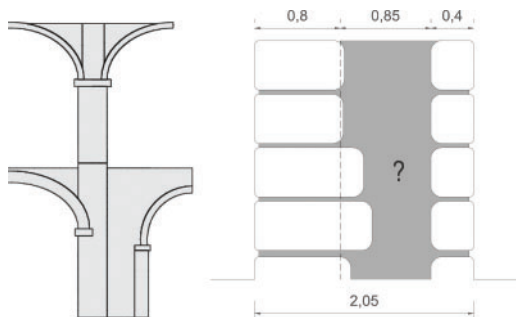
Known the thickness of both leaves thanks to the sonic and GPR testing, a correlation between the propagation velocities  $V_p$  obtained in the direct and indirect tests was done, and the propagation velocity across the infill was calculated. For guessing the Young's modulus of the infill the Equation 1 was used, obtaining a value of 0.31 GPa. This value is within the range of Young's Modulus of earthen materials, reason for which the infill of wall W2 is believed to be earth, confirming a hypothesis elaborated after finding presence of earth between two stones of one of the thicker

Figure 7. Possible cross sections of wall W2, in which the inner leaf has the thickness of a standard wall (80 cm), and the exterior leaf has a thickness of 40 cm. The infill is most probably an earthen material.

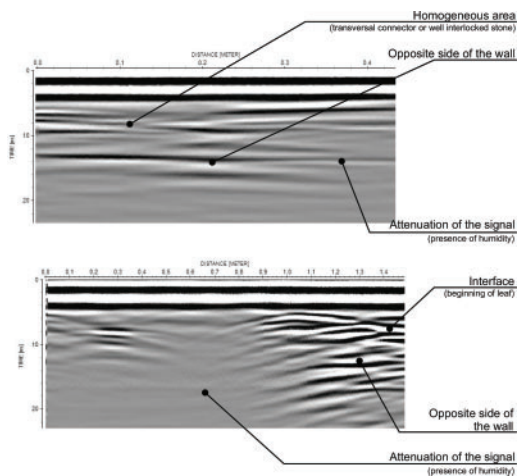
A ground floor standard wall, a first floor standard wall, the ground floor thick wall and barrel vaults in both floors were inspected. The load bearing standard masonry walls have been characterized as double leaf masonry walls with transversal connectors and no rubble between the leaves, showing presence of humidity in both levels.

Figure 8. Radargrams obtained in first floor wall: horizontal radargram (top); and vertical radargram with the ground level at the right side of the image (bottom).

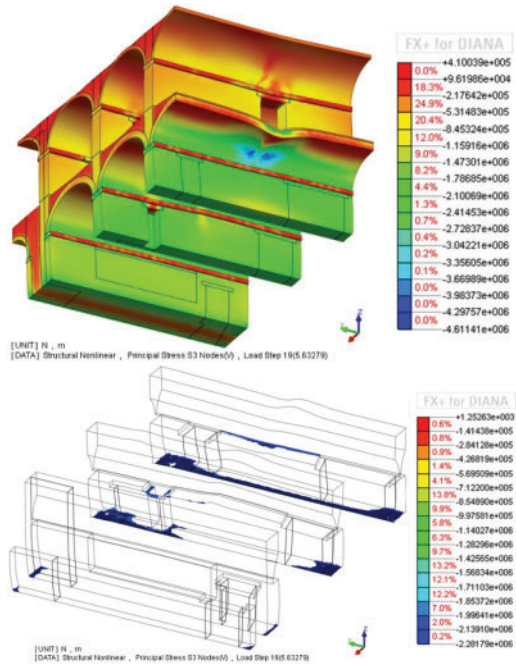
The main conclusion extracted from the comparative safety analysis is that the altered state of the structure presents a safety factor (2.00) lower than the one of the structure in its current condition (5.63). Crushing of the stone masonry at the base of the ground floors leads the structure to failure (see Figure 10).

Figure 10. Stresses in the current state model depicted on deformed shape: (top) minimum principal stresses at last load step (LF = 5.63); (bottom) detail of the ground floor walls showing the minimum principal stresses over the compressive strength of the stone masonry (2.0 MPa) in the last load step (LF = 5.63).

In the three different analyses, the crushing of the stone masonry walls at the base of the ground floor led the structure to failure, pointing them as the weakest point of the structure. In case of the altered state models, the obtained safety factor was reasonably lower because the increment of live loads and the execution of the openings performed in the walls aggravated the condition of the ground floor walls. Therefore, it can be stated that the intervention in the structure has decreased its capacity of withstanding loads. It can be recommended that, in the case that an increase on the load bearing capacity of the structure was needed, either in current or altered condition, the ground floor walls would be the structural element whose mechanical characteristics should be improved, particularly in the vicinity of the openings.

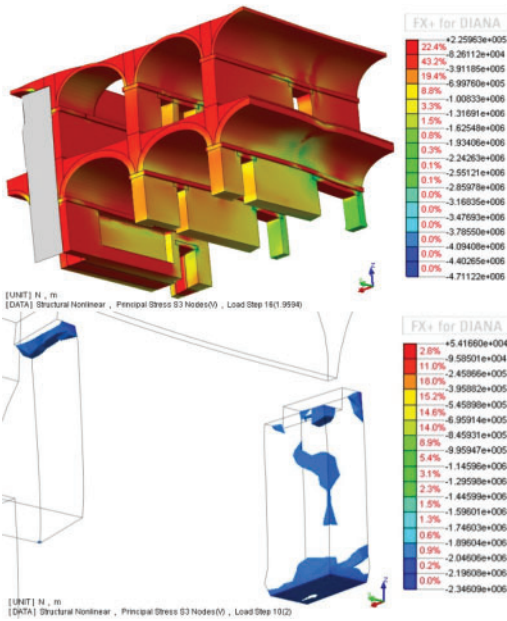
Figure 11. Stresses in the altered state model depicted on deformed shape: (top) minimum principal stresses at the highest load factor (LF = 2.0); (bottom) detail of affected pier showing the minimum principal stresses over the compressive strength of their stone masonry (2.0 MPa), at highest load factor applied (LF = 2.0).

leaf. If the cross section of the inner leaf is thinner in the area to be excavated, problems during the construction process might appear. For this reason, even though the structural analysis shows no damage due to the insertion of the wine rack, an impact-echo survey is recommended to define the depth of the inner masonry leaf in the exact area to be intervened, prior to the execution of the opening. The steel lintels designed in the structural project do not show any problems in withstanding the imposed loads, but they will cause a higher concentration of stresses in the masonry piers. Increasing the bearing length of the steel lintels would help reduce the stress concentrations in their supports.

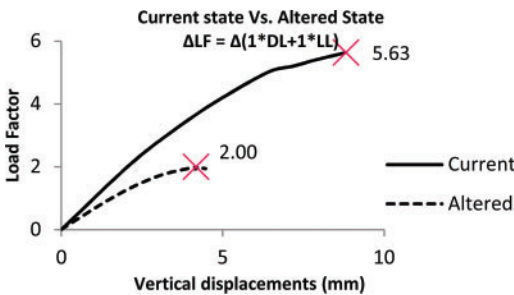
Figure 12. Load-displacement diagrams of the current and the altered state of the structure, plotted for the point with maximum vertical displacement in each case.
