# STRENGTHENING OF MASONRY ARCH BRIDGES: RESEARCH AND APPLICATIONS

Paulo B. Lourenço, Daniel V. Oliveira

University of Minho, Portugal

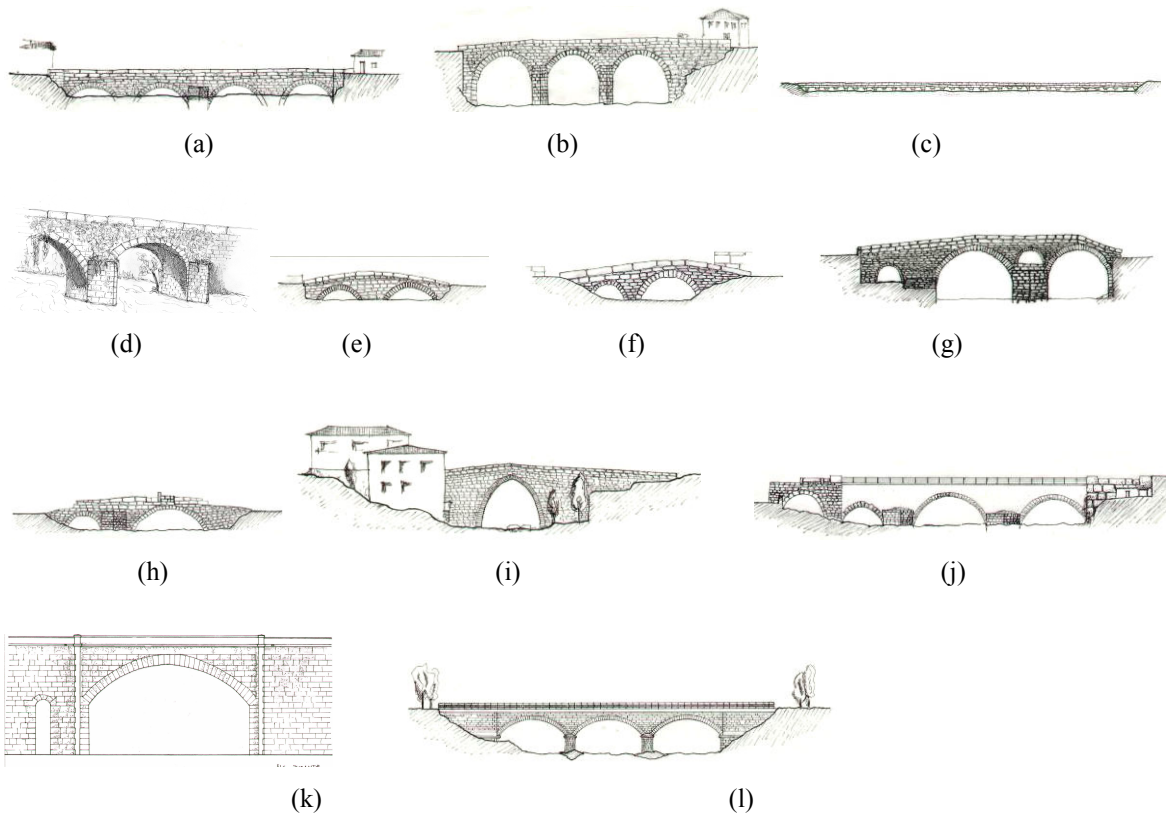
Name	Arches	Span	Bridge Length	Road Width	Cut-water	Flood Arches	Deck	Conservation
S. João	4 semi-circular	4 × 7.5 m	43 m	3.5 m	1	–	Horizontal	Regular
S. Martinho do Campo	3 semi-circular	2 × 7.6 + 8.0 m	40 m	3.2 m	2	–	Horizontal	Bad
Taipas	34 flat	34 × 1.2 m	62 m	3.9 m	–	–	Horizontal	Regular
Donim	3 semi-circular	9.4 + 11.8 + 6.6 m	63 m	3.4 m	2	1	Horizontal	Bad
Caneiros	2 semi-circular	6.4 + 5.8 m	13 m	2.3 m	–	–	Humpback	Good
Selho	2 semi-circular	2.4 + 4.4 m	17 m	2.4 m	–	–	Humpback	Regular
Velha	3 semi-circular	3.3 + 10.8 + 8.6 m	38 m	3.2 m	2	1	Humpback	Good
Pombeiro	2 segmental	4.3 + 10.5 m	29 m	3.4 m	1	–	Humpback	Regular
Domingoterres	1 pointed	16.7 m	44 m	3.0 m	–	–	Humpback	Regular
Serves	3 semi-circular	4.7 + 10.6 + 9.7 m	54 m	5.1 m	–	1	Horizontal	Good
EN205	1 segmental	18 m	35 m	4.5 m	–	1	Horizontal	Good
Silvares	3 segmental	6.4 m + 5.8 m + 6.2 m	40 m	2.3 m	–	–	Horizontal	Good

Fig. 2. View of the bridges: (a) S. João, (b) S.Martinho do Campo, (c) Taipas, (d) Donim, (e) Caneiros, (f) Selho, (g) Velha, (h) Pombeiro, (i) Domingoterres, (j) Serves, (k) EN205 and (l) Silvares.

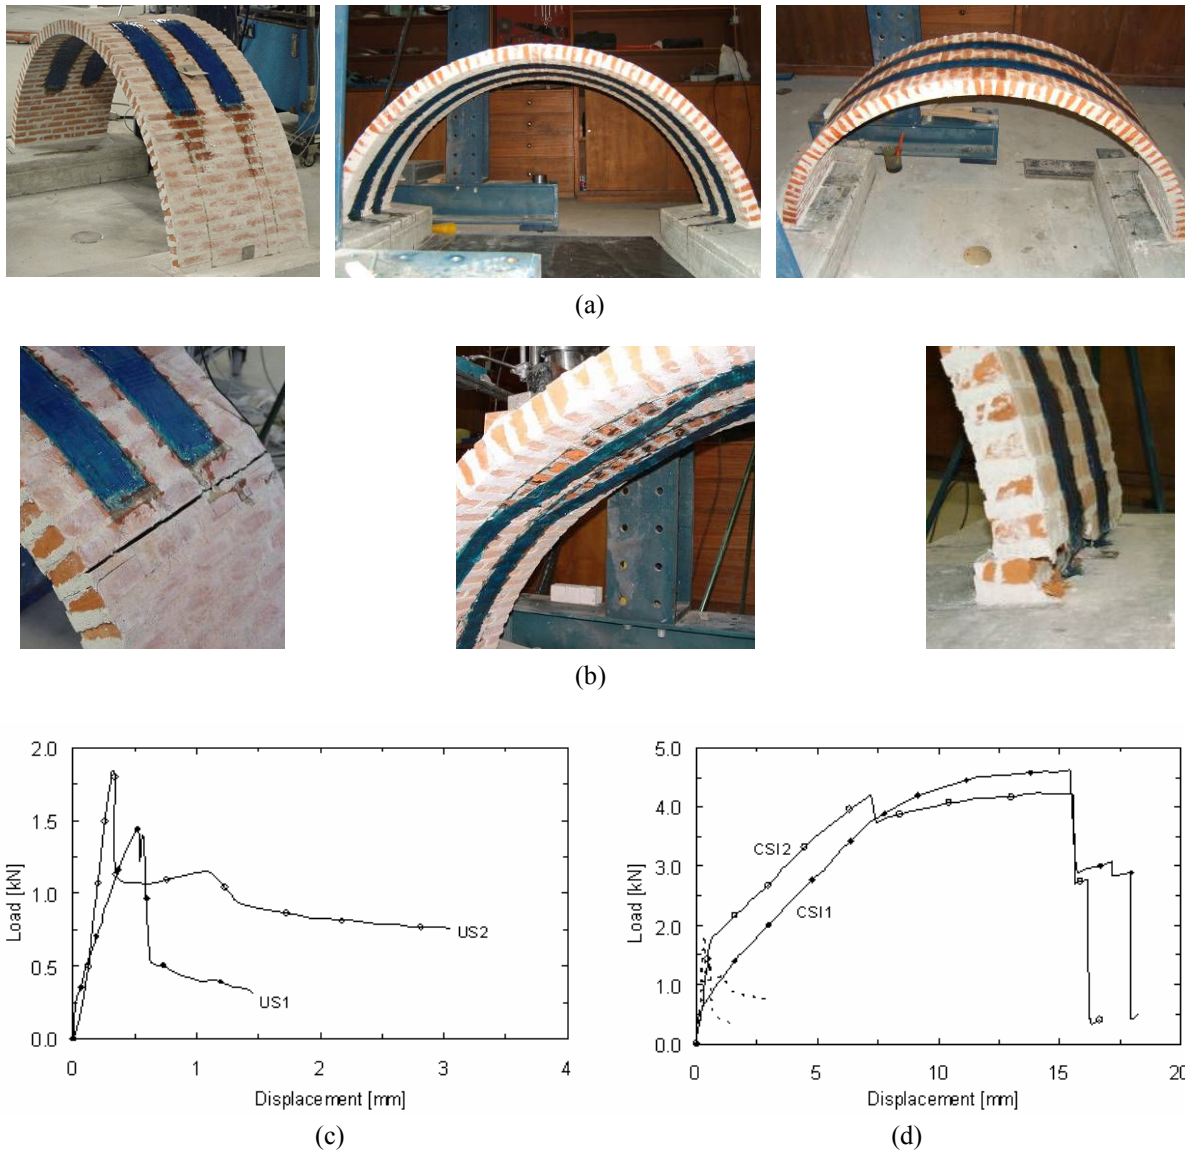
The unstrengthened specimens exhibited a structural behaviour characterized by the formation of the typical four-hinge mechanism, which occurred for small displacements and just after reaching the maximum load. On the other hand, all the adopted strengthening arrangements caused an increase in terms of load capacity. However, new dominant failure modes were observed, namely detachment of the fibres from the arch surface and sliding along a mortar joint, see Fig. 5b. The debonding phenomenon only affected the arches where the GFRP strips were placed at intrados, whereas for specimens strengthened at extrados failure occurred due to slipping of one part with respect to the other along a mortar joint. Another important feature of the continuously strengthened specimens is the large deformation capacity exhibited prior to failure, which provides the arches with important ductility behaviour. The experimental results show that the adopted continuous GFRP strengthening arrangements provided an enhanced arch behaviour, with respect to the unstrengthened specimens, both in terms of load capacity and in terms of ductility, see Fig. 5c. While specimens strengthened in the intrados got the maximum load increase, specimens strengthened in the extrados exhibited the larger ductility.

Fig. 5 FRP strengthened arches: (a) examples of location reinforcement; (b) examples of failure modes; load-displacement diagrams for (c) unreinforced arches and (d) arches strengthened in the

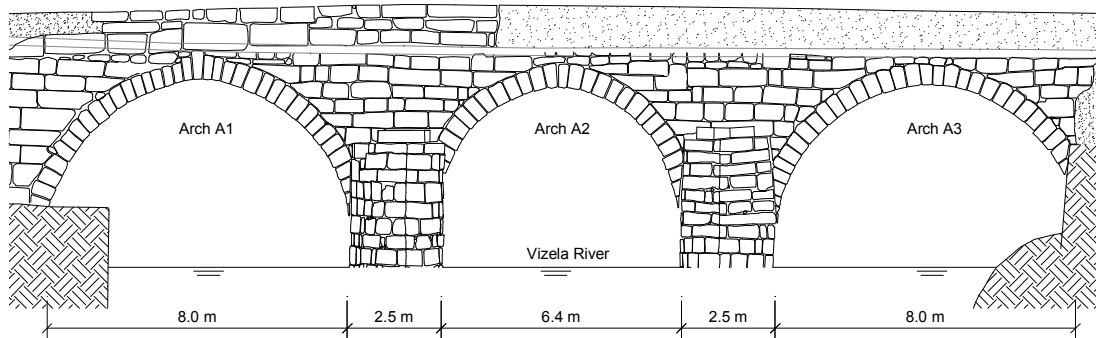
The multi-span Negrelos Bridge is located close to Guimarães over the Vizela river. With time, the bridge has lost its regional importance, though still assuming a great significance to the local network. The bridge has a flat roadway, supported by three semi-circular granite stone masonry arches, with different free spans (8.0 m + 6.4 m + 8.0 m), as schematically represented in Fig. 6. The bridge reaches a total length of approximately 30 m and has a roadway width of about 3.0 m. The central arch is supported by two massive piers, endowed with two triangular cutwaters at upstream and two rectangular cutwaters at downstream. Within a governmental program to clear the river from pollution, a drainage pipe was placed on the left shore, on top of an embankment made beneath arch A1 and close to the left abutment, see Fig. 6 (the pipe is not visible). Both the spandrel walls and

the parapets were built with stone masonry, but successive repair works carried out over the years have changed some original characteristics as it can be noticed by the parapet wall partially rebuilt with concrete blocks.

Fig. 6 Negrelos Bridge (upstream view).

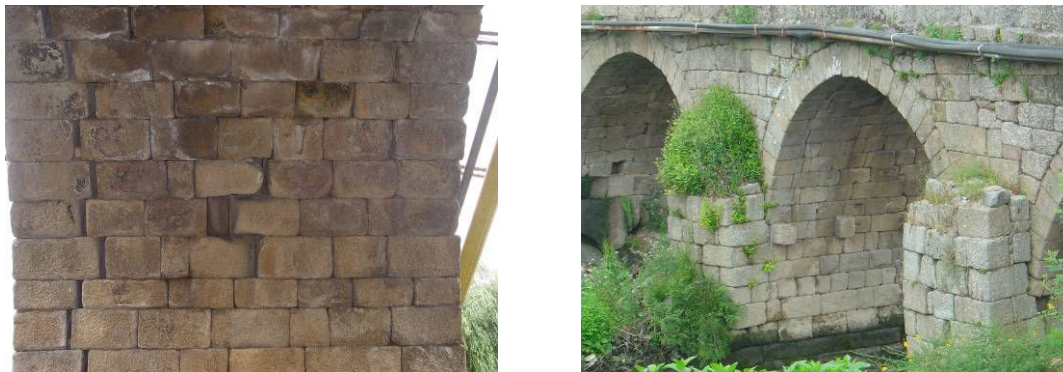
The survey carried out has showed that the bridge presented a pronounced damage state, where damage was mostly characterized by, see Fig. 7a: extensive longitudinal cracking exhibited by the central arch (A2), close to the downstream spandrel wall, clearly visible at the intrados. This is mainly caused by earth pressure in the spandrel walls; lateral movements of the spandrel walls near the left abutment, which became out of plumb, most likely originated by lack of maintenance in conjunction with increasingly heavy loads; generalized damage caused by vegetation, spread all over the bridge; extensive cracking in the left downstream cutwater and minor cracking in the other three cutwaters, mainly due to existing vegetation and the lack of adequate stone interlocking. Also, some stone blocks were cracked. Most probably, some of the cutwaters were built or extended after the construction of the bridge.

Fig. 7 Examples of damage: longitudinal cracking in the central arch and vegetation and cracks in the downstream cutwaters (downstream view).

The visual inspection carried out showed that a set of repair actions were necessary, namely to stop the progression of the longitudinal cracking along the central arch, to counteract the outward movement of the spandrel walls, to prevent the failure of the cutwaters and to clean all vegetation from masonry. Therefore, a set of four horizontal stainless steel anchors across the full bridge width, endowed with cylindrical steel anchorage plates at each side of the arch, were proposed, see Fig. 9. Two short stainless steel anchors were used close to each springing. In addition, it was recommended a light injection of the arch, at the intrados.

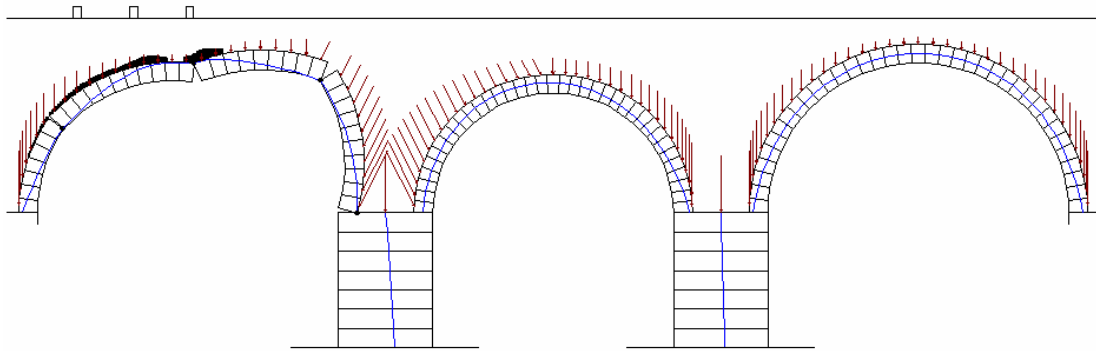
The bridge was modelled as an in-plane three-span semicircular arch bridge. The necessary geometrical data was obtained from topographic surveying and visual inspection. In the absence of in-situ test results, the material properties were considered to assume typical values found in similar structures, see [6] for details. Besides the self-weight of the materials (masonry and fill), a moving load was also considered, composed by three axles equally spaced by 1.5 m and with a 200 kN load per axle. Using a computer program developed within the rigid block limit analysis method [7], the minimum failure load factor is equal to 1.67. Fig. 8 illustrates the associated four hinges failure mechanism found, where both the dead and live load pressures applied to the arch, the hinges and the thrust-line are showed. Assuming that the vehicle crosses the bridge from left to right, the minimum

failure load factor was found for the vehicle central axle positioned at 31.9 % of the left arch free span (arch A1). Since symmetrical geometry and vehicle are used, the same result is obtained considering that the vehicle crosses the bridge from right to left instead.

Fig. 8 Minimum load failure mechanism of Negrelos Bridge.

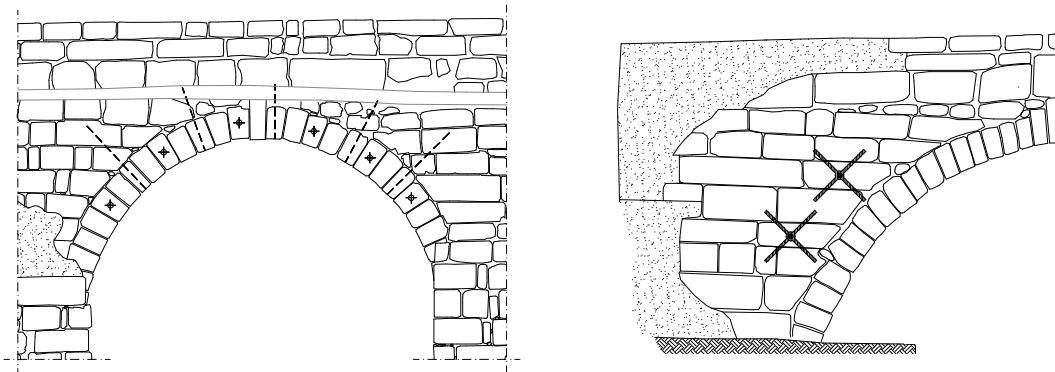
Fig. 9 Examples of adopted strengthening for central arch and spandrel wall.

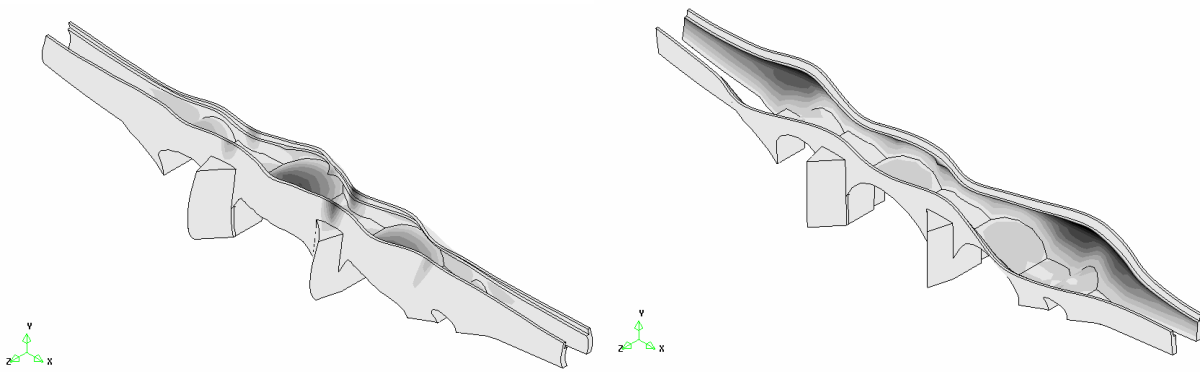
This structure presents a pronounced damage state, with extensive longitudinal cracking in the left arch and flood arch, clearly visible at the intrados, see Fig. 10. The right pier is very damaged, where some stone blocks are cracked and a foundation stone is missing. The vegetation, spread all over the bridge, caused severe damage to the right cutwater. The spandrel walls were subjected to lateral movement and are clearly out of plumb. Moreover, boroscopic inspection indicated that the infill is full with voids. In order to discuss the behaviour of the bridge and adopt an adequate model for the analysis, two different structural analysis models are shown, assuming that the truck is placed over the central, larger span arch. The models include the following features:

Structural fill and lateral soil pressure in the spandrel walls, and non-structural fill and lateral soil pressure in the spandrel walls. It is obvious that the lateral soil pressure could be obtained implicitly by considering inelastic soil behaviour but this would result in a significant number of additional parameters for the analyses. For this reason, the simplified lateral soil pressure coefficient was adopted. The results of a non-linear analysis for a unitary load factor are illustrated in Fig 10, see also [8]. Here, the maximum principal strains are a measure of cracking and can be assumed to indicate the expected damage in the bridge. The importance of the infill can be immediately observed from the deformed shapes and the predicted damage in the structure. If the lateral pressure from the infill is not considered as an external load, the spandrel walls move partly inwards, but, if the lateral pressure is considered, the spandrel walls move outwards. Damage in the structure is also localized in different areas. For the first model, damage occurs in the spandrel walls and, longitudinally, in the arches. For the second model, extensive damage occurs in the spandrel walls due to out-of-plane bending.

Fig.10 Examples of damage in Donim bridge, using a non-linear finite element analysis (arch splitting or spandrel collapse).

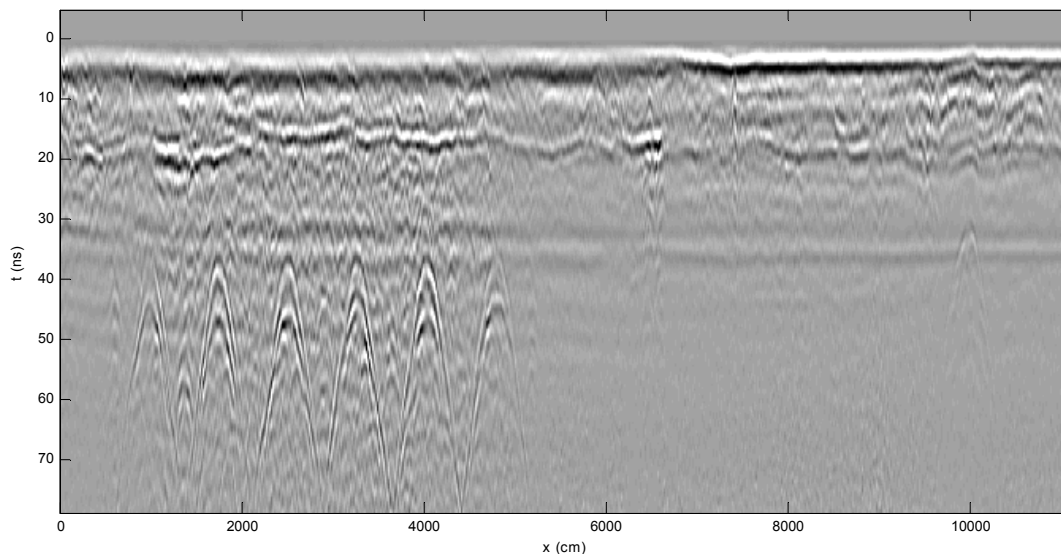
The Boutaca bridge has a flat roadway, supported by six pointed masonry arches equally spanned, as illustrated in Fig. 11. Lateral masonry walls, supported by a buttressing system, make the connection between the pointed arches and a semicircular masonry tunnel, belonging to the old railway network. The bridge reaches a total length of 60.0 m and has a roadway width of 7.0 m. At the ends, it is noticeable the existence of four box-houses used by road-menders. Diagnosis was carried out with the assistance of GPR, see Fig. 11. To prevent the outward movement of the masonry walls and to lighten the load in the buttresses, it was proposed the execution of a set of horizontal anchors across the full width of the road, endowed with plates, which have been designed to be aesthetically attractive. Four vertically aligned tie rods between each two buttresses were adopted. In order to reduce the lateral pressure on the walls and the appearance of humidity at the intrados of arches it was proposed to waterproof the pavement and the reconstruction of all the drainage system. Also, the cleaning and removal of infesting vegetation in the bridge should be periodically carried out. The missing plaster and painting should be replaced, using materials similar to those used in the construction.

Fig. 11 Boutaca Bridge: upstream view and detection of arch thickness and infill characteristics using GPR inspection.
