# ***Fábrica do Paleão: Structural Assessment of Iron in Portugal's Industrial Heritage***

KRICHKO Kori<sup>1,a</sup>, VALENTE Isabel B.<sup>2\*,b</sup>

*Fábrica do Paleão: Structural Assessment of Iron in Portugal's Industrial Heritage.*  
Paper submitted to Proceedings of the Institution of Civil Engineers –  
Engineering History and Heritage, ISSN 1757-9430.

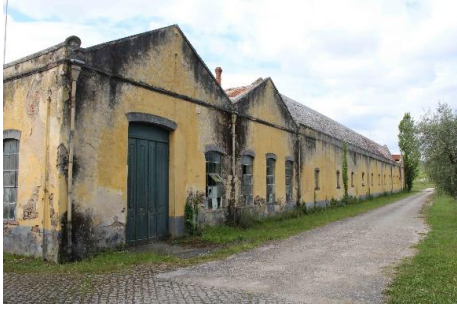
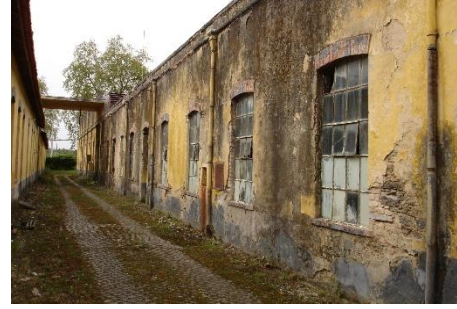
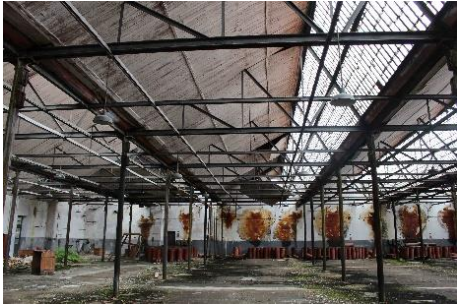
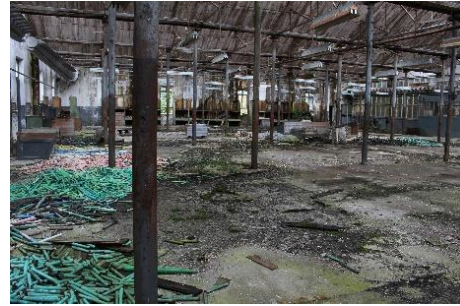
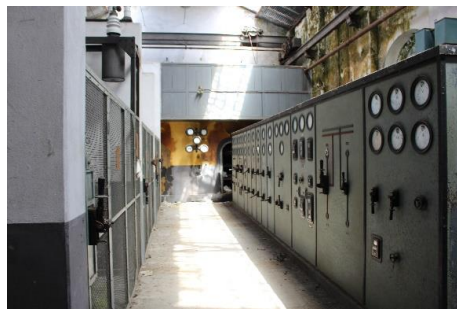
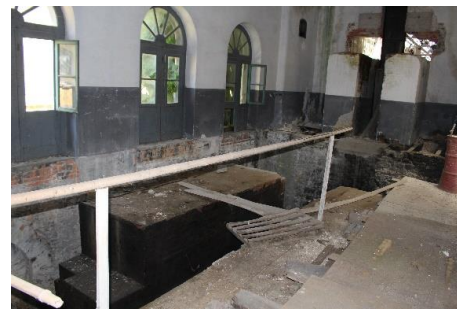
Figure 2 - Overview on the factory's main spaces

Photographs obtained during the inspection survey have been organized (**Error! Reference source not found.**). The display affirms the historic integrity of the existing structure, with few major alterations since the erection of the factory. However, the figures presented also highlight the result of 20 years of vacancy and lack of maintenance since closing its doors in 1994.

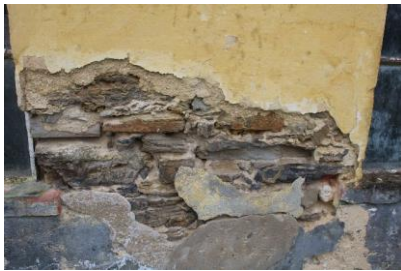
a) Rubble masonry

The exterior walls are finished with a layer of mortar applied as an aesthetic sacrificial layer. Spalling present in various locations exposes the rubble masonry beneath. The thick walls appear to be composed of stones varying in size and shape. The loss of the sacrificial layers also reveals timber inclusions within the walls.

Figure 5 – Damages in exterior and interior walls have exposed (a) Rubble masonry, (b) Timber inclusions concentrated around the window openings, (c) Diagonal bracing within a masonry wall

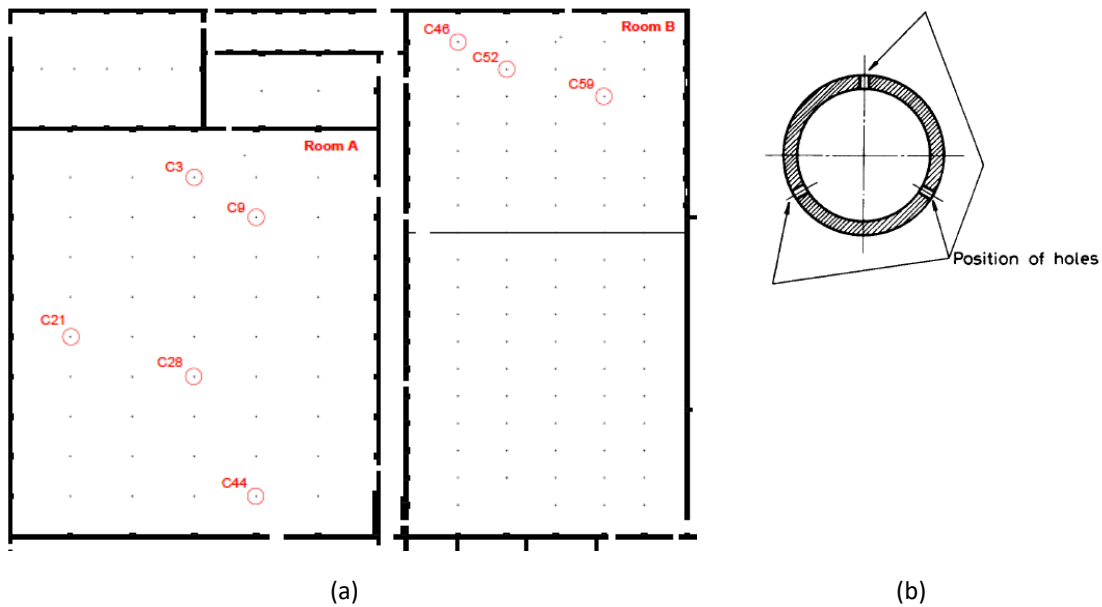
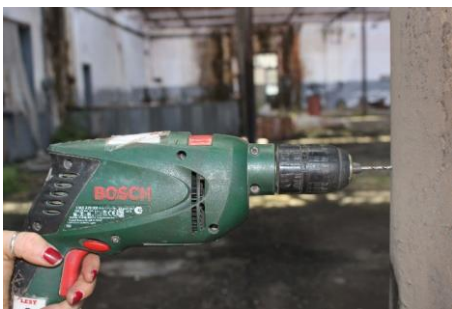
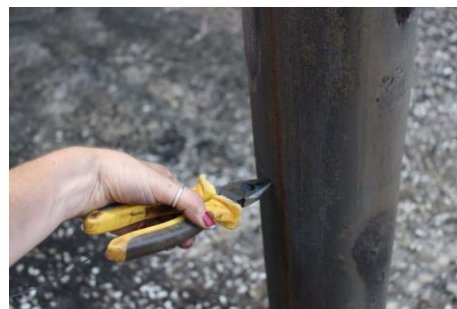
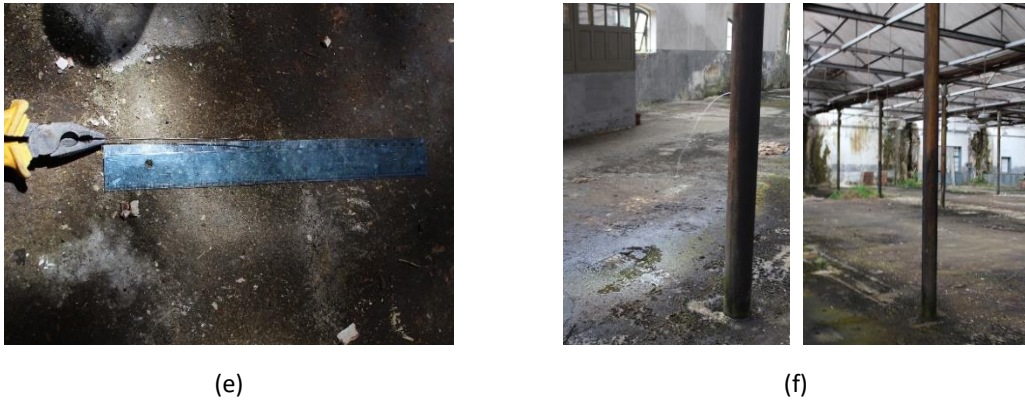
Figure 7 – (a) Location of tested columns; (b, c, d and e) Wall thickness measurement (Bussell, 1997): in-field demonstration of the procedure to measure the column thickness; (f) Water pouring out from the hole drilled and full discoloration of Column 6

Beyond obtaining necessary geometrical parameters and eccentricity detection, the drilling provided insight on the internal condition of the columns with various surface damages identified during the visual inspection. A visual inspection of column 3 revealed an external layer of corrosion and the presence of blowholes. Column 6 was noted as fully discolored, as depicted in Figure 7.f. Upon the removal of the drill from the first hole, water began to pour out of the opening. The stream of water displayed in Figure 7.f continued for a significant amount of time suggesting the interior of the column was full of water until the test was performed. It was decided not to continue drilling to avoid further compromising the column, but it was possible to gain one measurement. The wall thickness at this location was determined to be 19.9 mm, a value slightly higher than the average wall thickness of 18.1 mm. It is expected the section would increase with corrosion, however the wall thickness is not significantly higher than the average computed for the other tested columns. Despite the presence of water, the section does not appear to be significantly impacted. With the result of this test, it is also suspected that the full discoloration noted in a number of other columns, could be the result of water in the interior of the element.

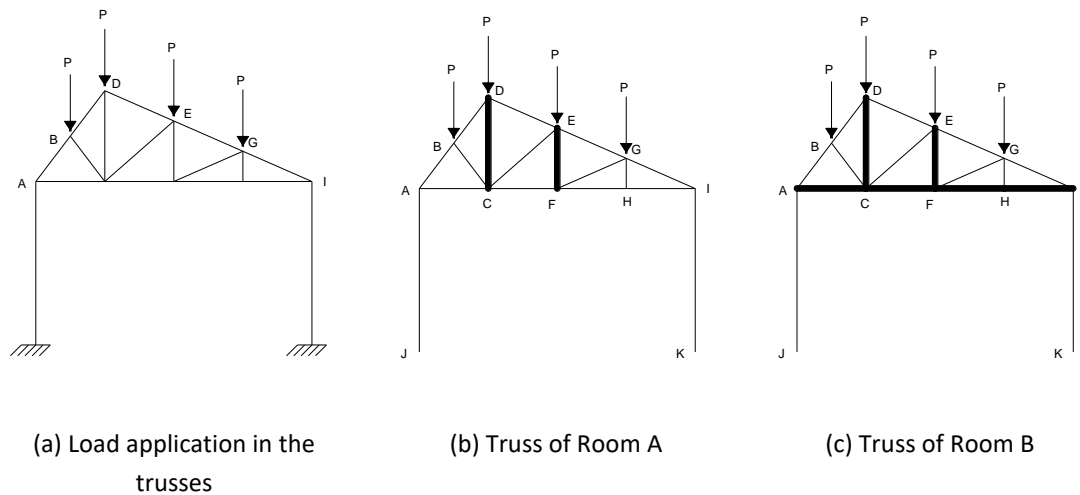
Figure 10 – Load application in the trusses and identification of unsafe bars

After performing the safety assessment for each member and load combination, it was found that the safety conditions were not met for the members. In Room A bars *CD* and *EF* (both flat bars, marked with a thicker line in Figure 10.b) were considered considerably unsafe due to out-of-plane buckling and relatively unsafe due to in plane buckling.

In the trusses of Room B, the safety condition was not met for bars *CD*, *EF*, *AC*, *CF*, *FH* and *HI* (marked with a thicker line in Figure 10.c). All bars that failed the safety assessment were flat bars in load case 2, where the main issue is buckling behavior. All other bars (T sections and channel sections) are considered safe.

The main cause of structural damage observed is lack of maintenance in recent years, allowing moisture to penetrate the structure. It appears that the internal metallic structure has not been significantly impacted, however if the system continues to be exposed, adverse structural effects will appear. To avoid these effects, the entrance of water should be prevented. Effective immediate action would be to clear and repair the drainage system, however eventually a new roof will be required.
