Characterization of masonry under uniaxial tension

Paulo B. Lourenço, Joaquim O. Barros, José C. Almeida

Report 02-DEC/E-12

Date: October 2002

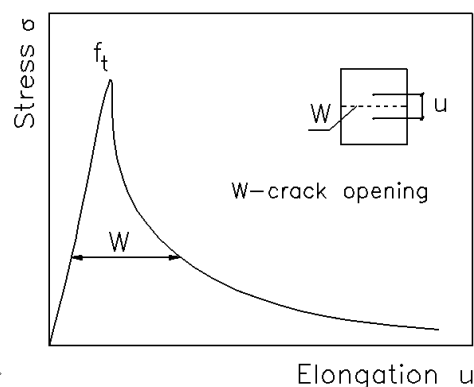
Fig. 1 – Stress-elongation diagram

The illustrated behavior indicates that, after reaching the peak load, the strength does not drop immediately to zero. Instead the strength is gradually reduced in a process denoted as “softening”. The behavior up to peak can be considered linear, but after peak significant non-linearity is found in the response. According to Van Mier (1997), the post-peak behavior can assume two different shapes, as illustrated in Fig. 2, depending on the end restraints of the tested specimen. The behavior in Fig. 2a (rotating platens or hinges) is justified by the rotation of the specimen during the loading operation, where the crack proceeds from one side of the specimen to the other side. In case of Fig. 2b, fixed (non-rotating) platens, a bending moment is introduced and multiple cracks will appear. This results in a slightly larger tensile strength and a higher value of energy dissipated (fracture energy) for materials tested using fixed platens equipment.

In a tensile test of a quasi-brittle material, such as brick, it is possible to obtain a stress-elongation diagram $\sigma-u$ in the form indicated in Fig. 1, provided that the test is carried out under displacement control.

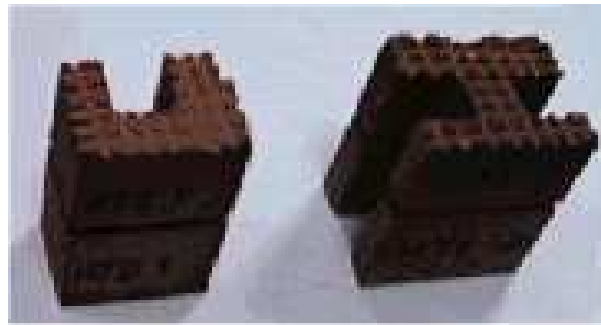
Fig. 3 – Specimens for HSH Units

This brick has four horizontal holes and a rough top surface. Fig. 3 shows the specimens adopted to characterize the shell and web of the brick, respectively, to the left and right of the figure.

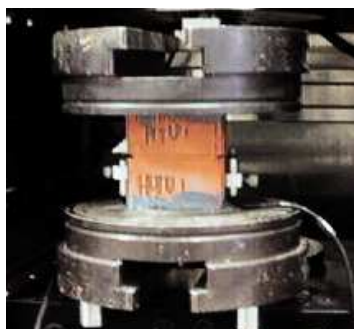
Fig. 7 – Brick specimens
