INFILL MASONRY: SEISMIC BEHAVIOUR OF REINFORCED SOLUTIONS

Abstract

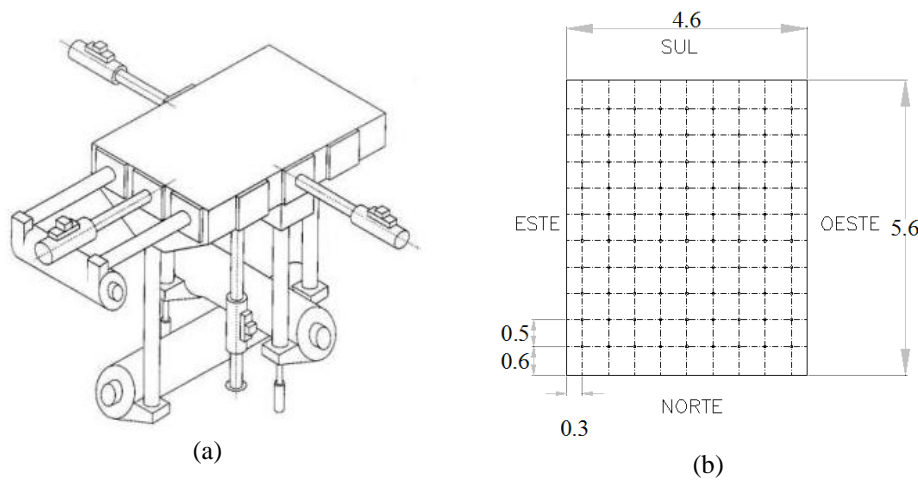
Figure 1: Shaking table of the National Laboratory for Civil Engineering: (a) general view; (b) dimensions of the platform in meters.

Three different models were designed to be tested in the shaking table of the LNEC, see Figure 1, and hereafter the details of the first two models (already tested) will be presented.

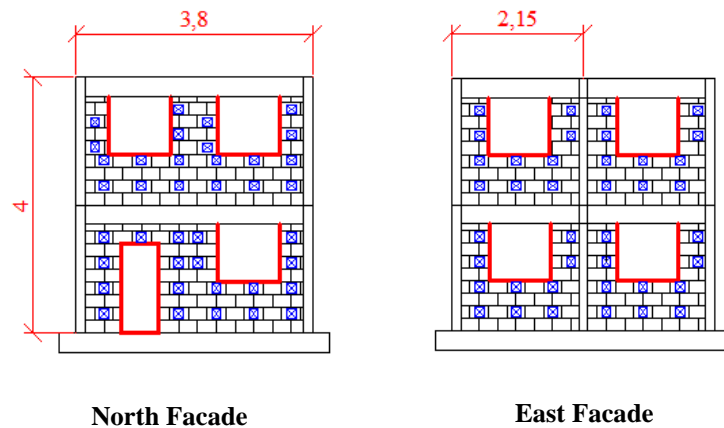
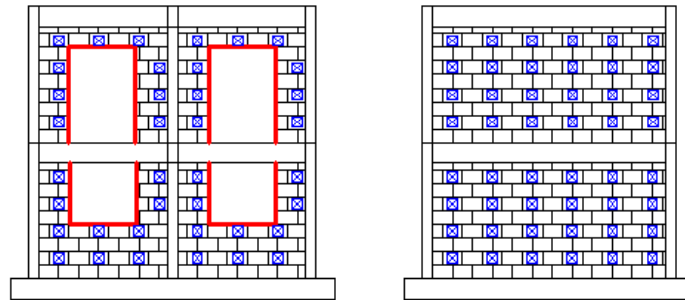
Figure 2: Facades and dimensions, in meters, of the tested models.

The reduction of the dimensions, and all other parameters needed to design the models, was done using Cauchy-Froude's similitude law, see Table 1, for a scale of 1:1,5 which means $\lambda = 1,5$. The dimensions of the models can be seen in Figure 2.

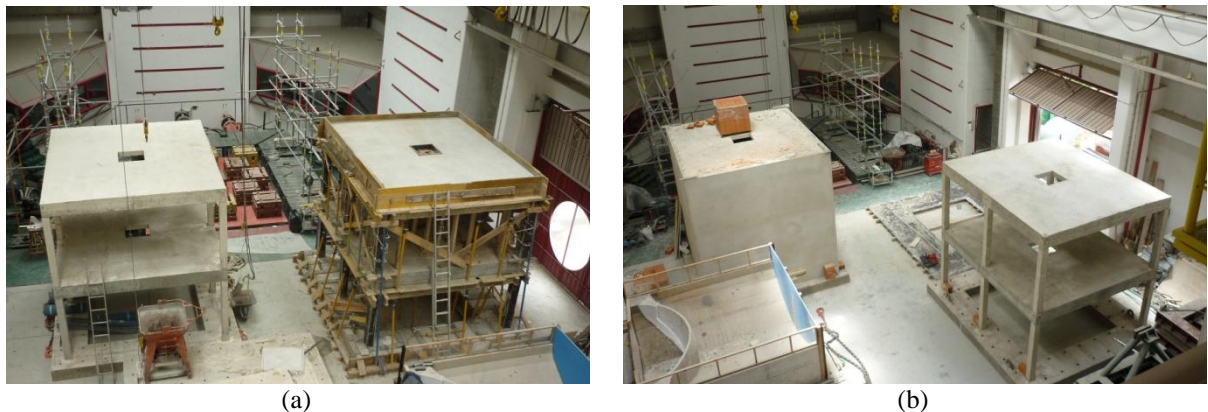
Figure 3: Construction of models 1 and 2: (a) concrete structure; (b) infill walls.

Due to space limitations in LNEC, the three models were not constructed at the same time, but only the first two were built in a first phase, see Figure 3.

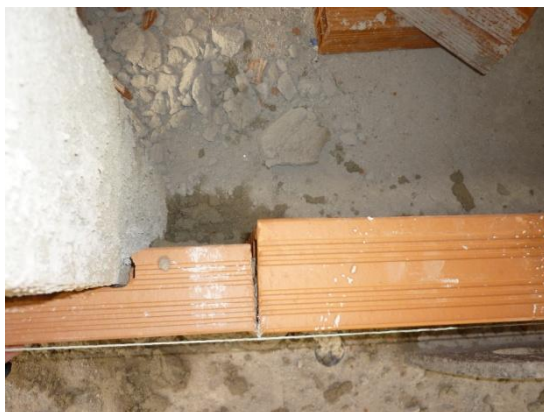
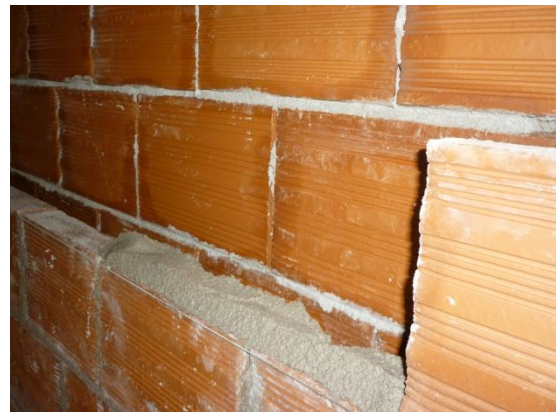
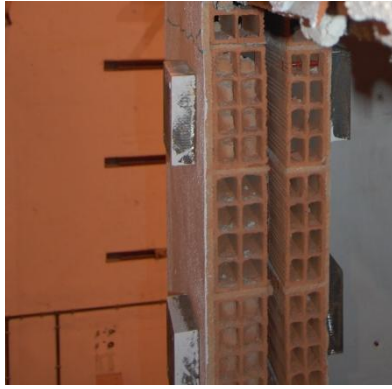
It was stated above that two different infill solutions were used for models one and two. Figure 4 shows the details of the solution of model one and its construction. It is a double leaf clay brick cavity wall, unreinforced, and with pre-batched mortar in the bed joints and outer rendering, and it is the most common infill solution used in Portugal in the last two decades.

Figure 4: Infill solution of model one, a double leaf clay brick cavity wall with pre-batched mortar: (a) outer leaf; (b) inner leaf; (c) final work with mortar rendering outside and plaster inside.

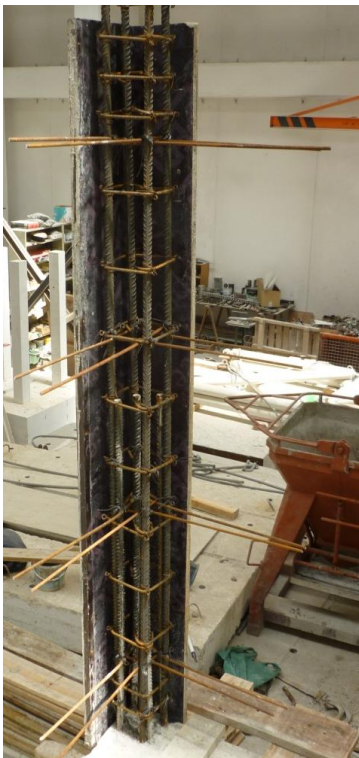
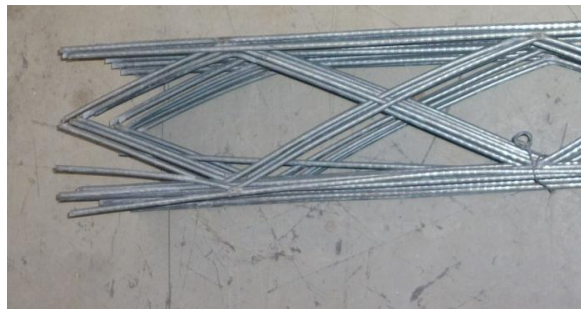
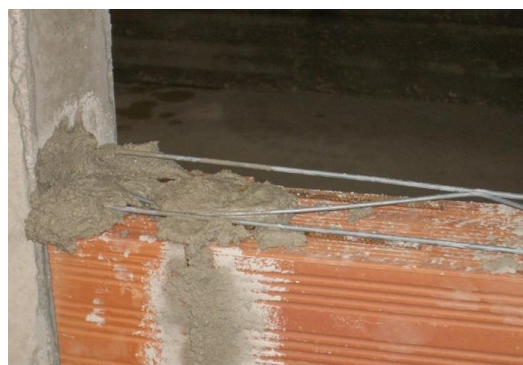
The infill solution of model two is single leaf, also with clay bricks and pre-batched mortar, but with bed joint reinforcement connected to the columns of the reinforced concrete frame. The connectors (standard ribbed bars) used were attached to the longitudinal reinforcement steel bars of the columns during construction phase, see Figure 5 (a). The bed joint reinforcement chosen was BEKAERT – MURFOR RND.4/100, see Figure 5 (b), every two courses. The amount of reinforcement was defined following articles 8.2.2, 8.2.3 and 8.2.7 of EC8 [1].

Figure 5: Infill solution of model two, a single leaf clay brick wall with pre-batched mortar and bed joint reinforcement: (a) connectors of the bed joint reinforcement to the longitudinal reinforcement steel bars of the columns; (b) Bekaert Murfor RND.4/100; (c) bed joint reinforcement over the connectors in the bed joint layer.

During stage four, some infill walls of the first floor became completely disconnected from the concrete frame, see Figure 13 (c), but due to the bed joint reinforcement's connection to the concrete frame, see Figure 5, the out-of-plane collapse was prevented. The infills in the second storey also experienced some damage.

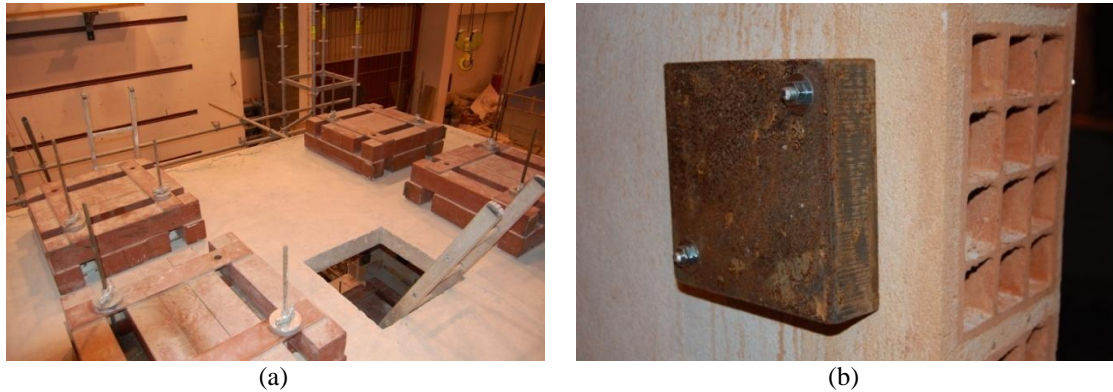
Figure 6 (a) shows the masses used for the concrete structure. Each one has approximately 1200 kg and $82 \times 82 \times 26 \text{ cm}^3$, and six were attached to each floor. Figure 6 (b) shows the

masses used for the infill masonry walls. Each one has approximately 7,2 kg and 15x15x4 cm³. With these dimensions, one steel plate can be attached to a single block and will not connect blocks mechanically. A total number of 334 steel plates were used in each model, half in the inside part of the model and the other half externally. In total, each model weighted about 41 tons.

Figure 6: Additional masses: (a) for the concrete structure and floor loads; (b) for the infill masonry walls.

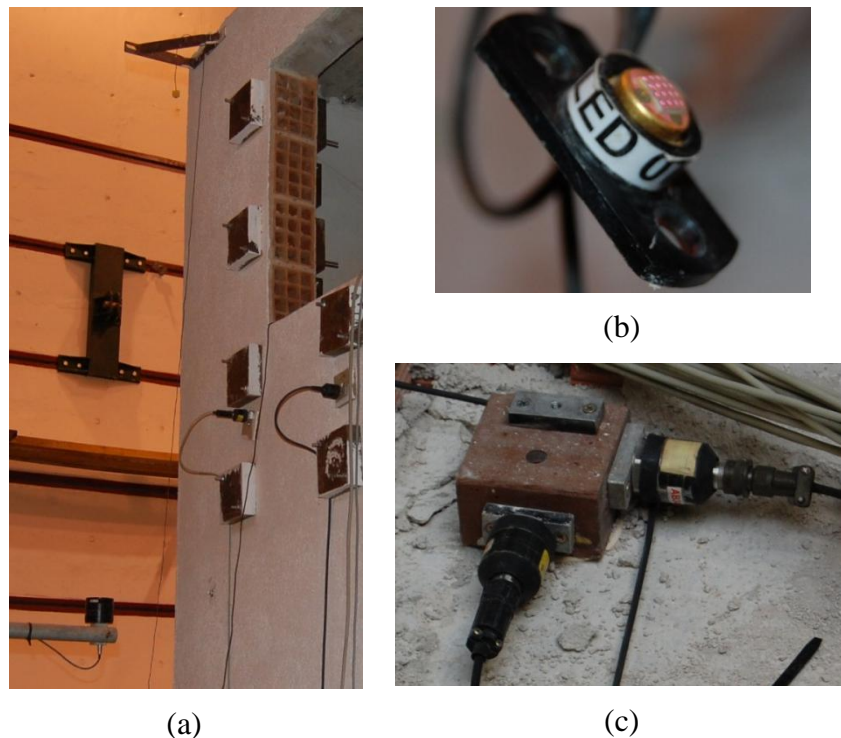
Two different types of behaviour needed to be analysed in the tests: i) the global behaviour of the concrete structure; ii) the local behaviour of the infills. The first was captured using with Hamamatsu cameras at the corners of the building, see Figure 7 (a) and (b), and accelerometers in two corners of each slab, see Figure 7 (c). The local behaviour of the infill walls was measured using accelerometers and in model one, because of the double leaf infill solution constructed, accelerometers had to be placed in the inside and outside, in opposite positions. A total number of 48 accelerometers and 8 Hamamatsu cameras, measuring two in-plane directions, were used.

Figure 7: Instrumentation equipments: (a) camera and infra-red led measuring the corner of the second storey slab; (b) detail of the infra-red led; (c) accelerometers in the corner of the

slab measuring transversal directions.

Hamamatsu cameras, model Photonics C5949, are a high resolution position measuring system based on a non-discrete camera and an infra-red led. The camera measures the planar movement of the led. The accelerometer measures unidirectional accelerations within a certain range. The PCB Piezotronics models attached to the structure had a measurement range of $\pm 5g$.

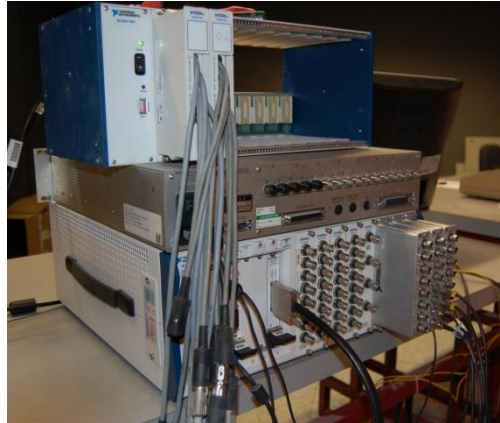
All the measuring instruments were conditioned with cards from PCB Piezotronics (481A02) and National Instruments (series 1300 SCXI modules) inserted into a PXI-1052 from National Instruments, see Figure 8.

Figure 8: From top to bottom: NI-SCXI-1001 for extra slots, PCB Piezotronics 481A02 and PXI-1052.

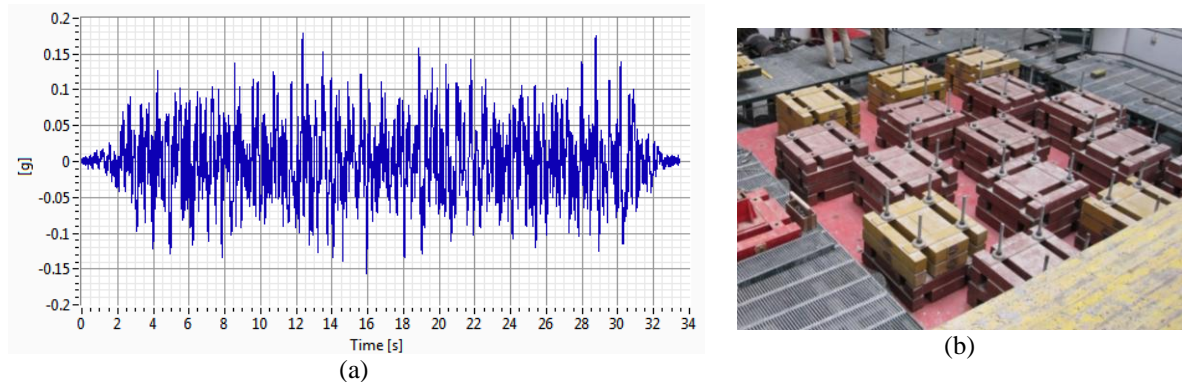
The stages of the shaking table tests, see Table 2, were defined regarding these Limit States. For each stage, an artificial accelerogram, based on the response spectrum, was generated and used as the input signal, see Figure 9 (a). The last stage, number four, was defined as the maximum capacity of the table for the mass of the studied structure. At the beginning, between each stage and at the end, a modal characterization was carried out using a white noise low signal as input. The objective is to determine the dynamic parameters of the structure and their evolution.

Each stage was tested with masses attached to the table before the actual test, see Figure 9 (b), in order to understand the behaviour of the tri-axial platform and make the necessary calibration. The vertical component was not used.

Figure 9: Definition of the experimental test stages: (a) artificial accelerogram generated; (b) calibration of the input signal with masses.

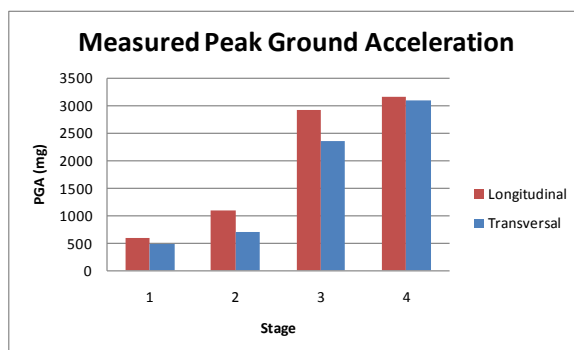
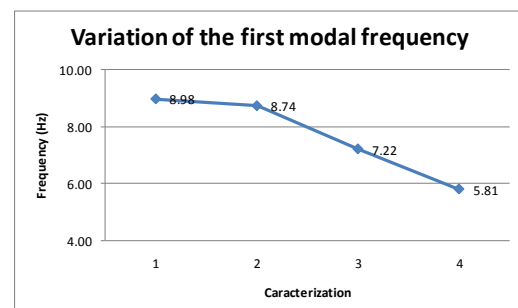
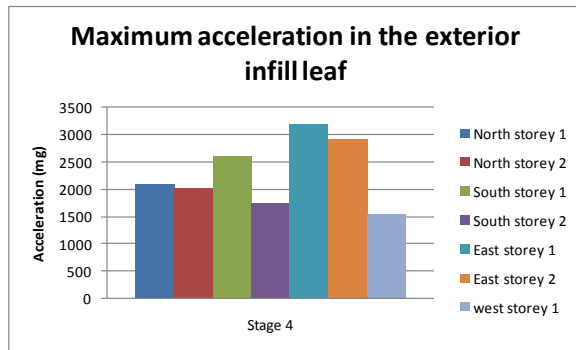
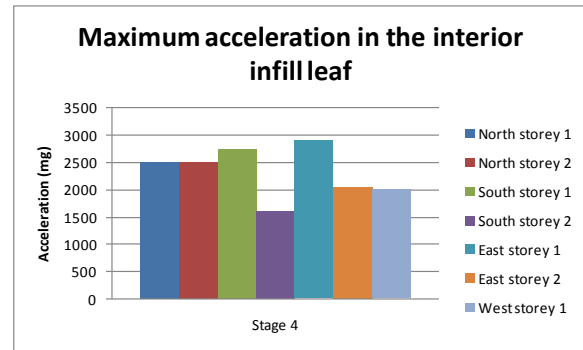
The values displayed in Figure 10 (a) were obtained from the accelerometers placed inside the tri-axial platform and are the highest value measured in each stage of the test of model one. These peaks are due to the attempt of the actuators of the shaking table to follow the input in high frequencies. The size and mass of the structure are near the limit values of the table, meaning that the capacity of the table to keep up with the input are compromised for higher frequencies.

Figure 10: Results of model one: (a) maximum value of acceleration measured in the tri-axial platform during the four stages of the test; (b) variation of the first modal frequency; (c) maximum acceleration measured by the accelerometers placed in the exterior infill leaf; (d) maximum acceleration measured by the accelerometers placed in the interior infill leaf.

The frequencies in Figure 10 (b) were obtained from peak picking in the frequency response functions. The first characterization was done before stage one, but due to the collapse of the structure, there was no final characterization. The first mode is mainly a transversal (East-West direction) translation, although there is a small torsion component due the non symmetrical distribution of the openings in the infill walls. The first three stages led to a decrease of 35% of the frequency, meaning that the frames in the transversal direction lost a high amount of stiffness. This was a premonition of the collapse recorded for the last stage.

The inner leaf of the infill wall has a thinner block, therefore with higher slenderness, than the outer leaf. Figure 10 (c) and (d) shows that the maximum accelerations of both leaves is similar, even if these cannot be compared directly since the support conditions are different. The outer leaf is 2 to 3 centimetres out of the plane of the frame. All of the walls of the first storey recorded higher peak accelerations than the ones on the second storey.

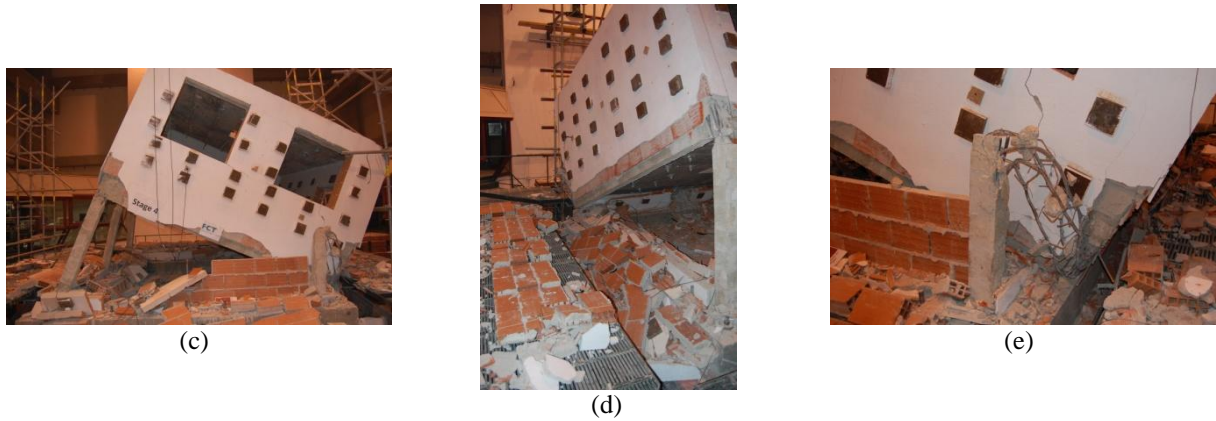
Although the concrete structure presented some damage after the third stage, found also in the decrease of the first modal frequency, the infills had, until this point, only some cracks at the openings and at the connection to frames, see Figure 11 (a) and (b).

In stage four, the columns of the first floor of the West facade failed due to excessive torsion. Before this happened, all of the infill walls of the first storey had already collapsed out-of-plane, see Figure 11 (c,d). One of the column had all reinforcement stripped off. The infills of the second storey of the model had little damage.

Figure 11: Observed damage in model one: (a) evolution of the cracks in the exterior of facade West; (b) evolution of the cracks in the interior of facade West; (c) North Facade after stage 4; (d) out-of-plane expulsion of the first floor infill wall in the South facade; (e) failure of a corner column of the first floor.

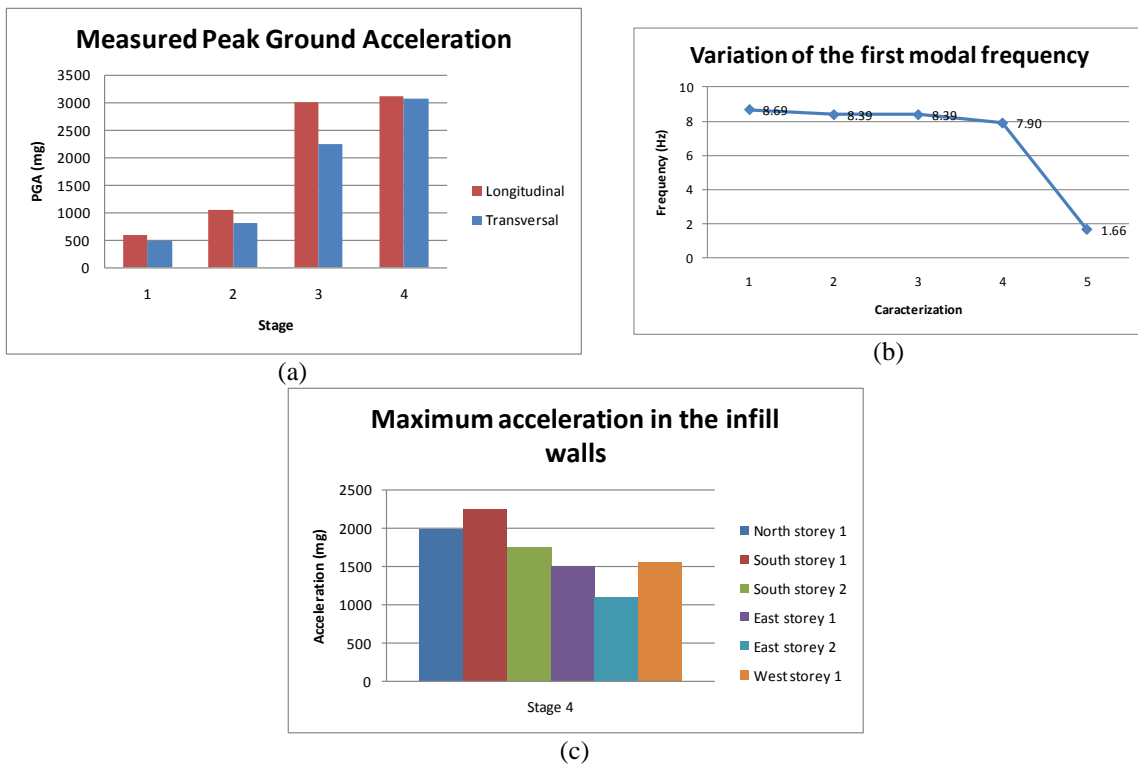
The measured PGA of the test of model two was no different from model one, as the mass and geometry of the structure were the same, see Figure 12.

Figure 12: Results of model two: (a) maximum value of acceleration measured in the tri-axial platform during the four stages of the test; (b) variation of the first modal frequency; (c) maximum acceleration measured by the accelerometers placed in the infill wall.

The first modal shape is the same as the previous model, a translation in the transverse direction with a slight torsional component. In this model there are five characterizations, one more than in the previous model, done after stage four. The first three stages led to a decrease of only 10% of the frequency, but the last one clearly damaged the structure beyond repair, with a total decrease of 80% of the modal frequency.

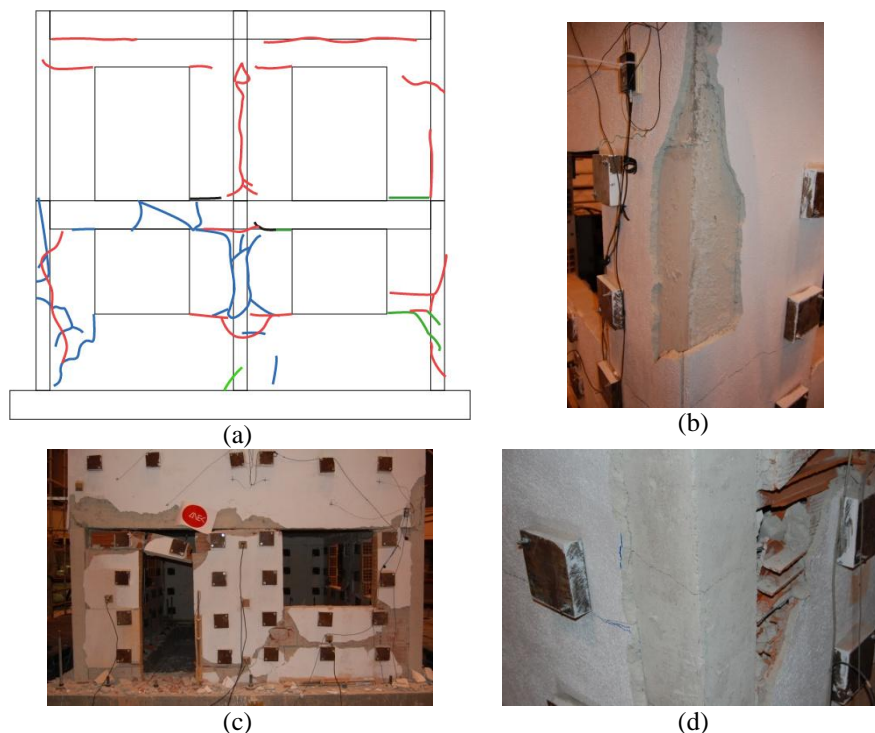
This damage is also clear when analysing Figure 13. In the West facade the cracks followed the same pattern as in the previous model, starting from the corners of the openings and from the connection of the infills with the frames. In stage three, the rendering around the concrete frame felt, mainly at the corners, see Figure 13 (b).

Figure 13: Observed damage in model two: (a) evolution of the cracks in the West facade; (b) expulsion of the mortar rendering in the Northwest corner after stage 3; (c) North Facade after stage 4; (d) shear crack of a corner column of the first floor at mid-height.

The concrete structure was visibly damaged, with shear cracks at mid height, see Figure 13 (d), and with the detachment of the cover concrete at the beam/column connection in the first floor. It is reasonable to claim that this second model, despite its higher capacity to withstand the fourth stage of the test, was developing an undesirable soft storey failure mode due to the presence of the masonry infills and their collapse at the lower storey.
