OPERATIVE CONDITIONS EVALUATION FOR EFFICIENT BUILDING RETROFIT – CASE STUDY

Sandra M. Silva^{a*}, Pedro P. Silva^b, Manuela Almeida^c and Luís Bragança^d

^{a,b,c,d}*University of Minho, Department of Civil Engineering, Campus de Azurém, 4800-058 Guimarães, Portugal*

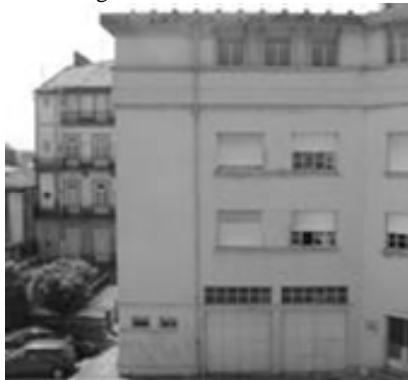
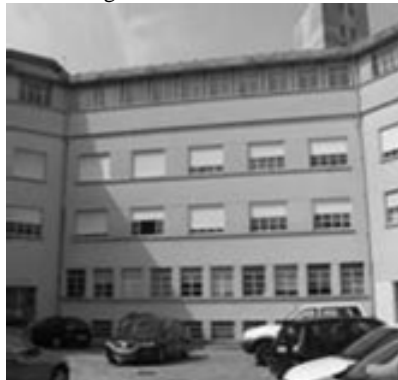
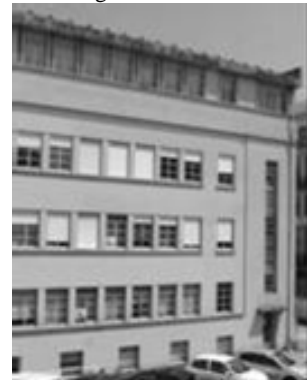
Figure 2. General view of the building

The ground floor's north wing is a storage area and a Laboratory is located in the east wing. The offices and meeting rooms are located in the first, second and third floors. The last floor is a cafeteria.

All the windows are single glazed with metallic frame. The ground floor windows do not have any shading devices and the first floor windows have venetian blinds placed inside. The

windows in the second and third floor have roller shutters and the windows in the fourth floor have curtains.

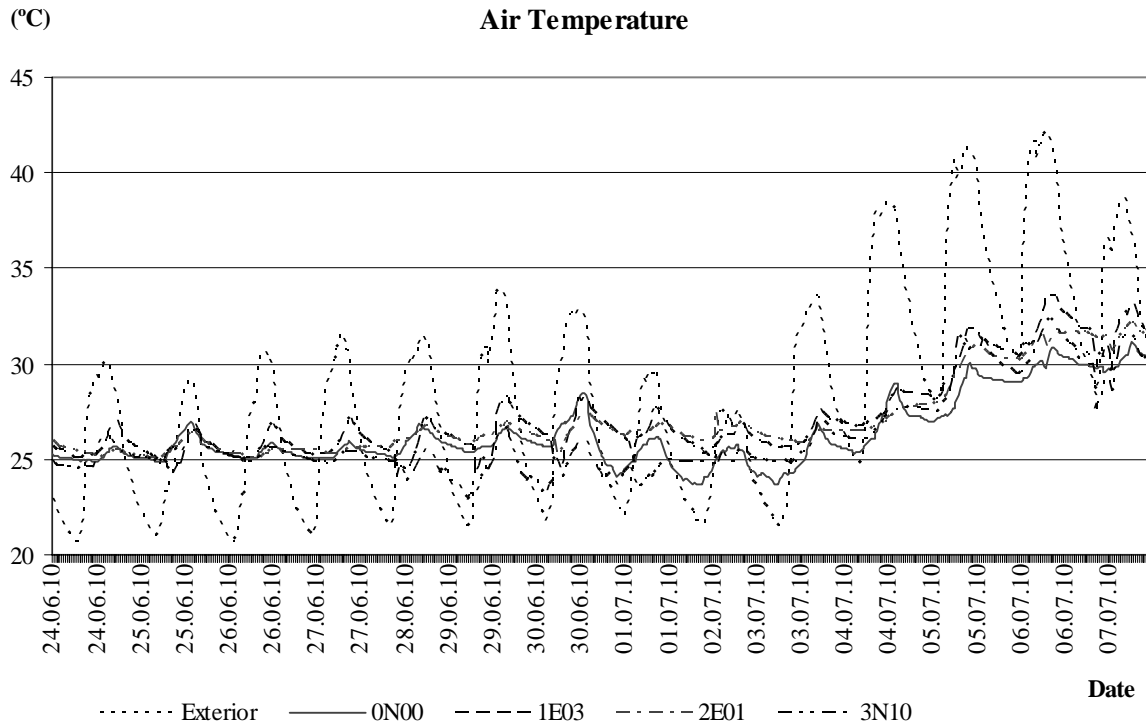
Figure 5. Air temperature (T_a) of some of the office rooms monitored (from 0 am of 24th of June to 0 am of 8th of July)

The air temperature in the office rooms were in general over 23°C, and reached 33°C in periods when the outdoor temperature reached 41°C (Figure 5). The lower temperatures measured were in the partially underground floor and in the rooms with split type systems for cooling.

During most of the occupied period, the temperatures were above the comfort temperature (25°C) according to the Portuguese thermal regulation [24, 25].

It was also observed that the occupants do not leave the windows open during the night (when outdoor air temperature is approximately 20°C) and the warmer air temperature could be used to cool the heavy thermal inertia of the building.

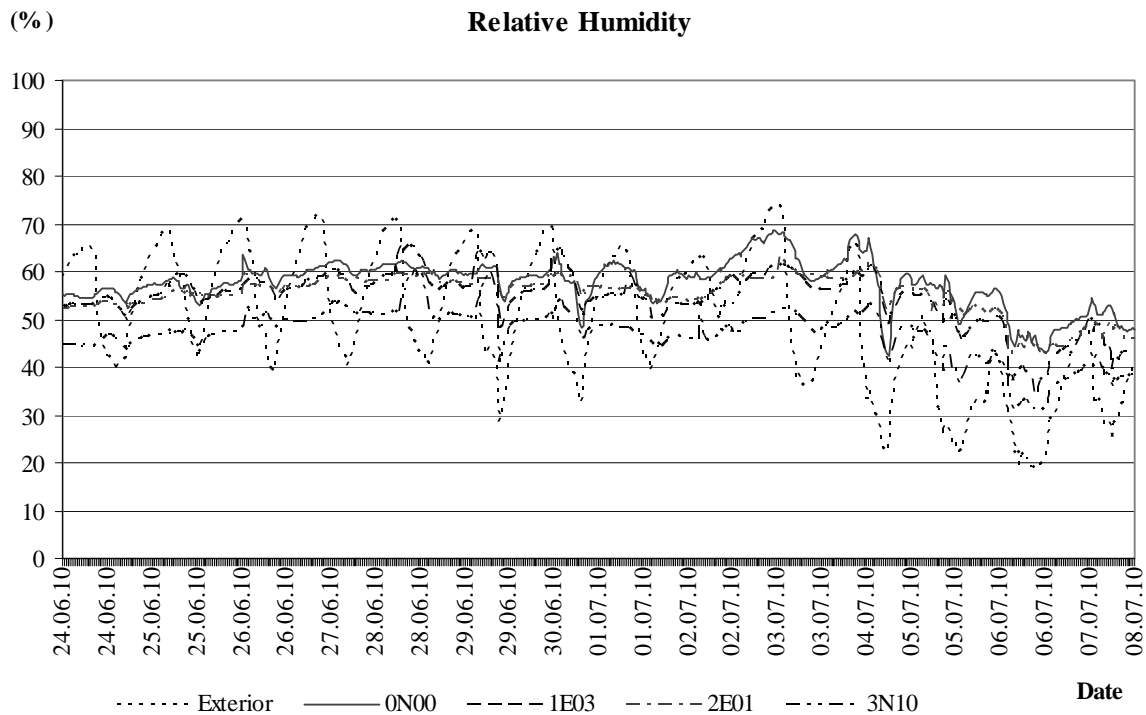
Figure 6. Relative humidity (RH) of some office rooms (from 0 am of 24th of June to 0 am of 8th of July)

The relative humidity measured was between 30% and 60% (Figure 6). According to the current standards, indoor relative humidity should be within the range 30-50% [20, 22].

Although the relative humidity does not have a strong impact on thermal comfort in the comfortable range of temperatures, it is known that it may negatively affect the perceived air quality [11]. Moreover, high relative humidity indoors means an increasing risk of mould growth, which can be associated with serious health problems [31].

From the results obtained in the measurement campaign, the comfort conditions defined in EN 15251 standard for naturally ventilated buildings are exceeded in what concerns the air temperature and relative humidity (22°C to 27°C and 50% RH) [20].

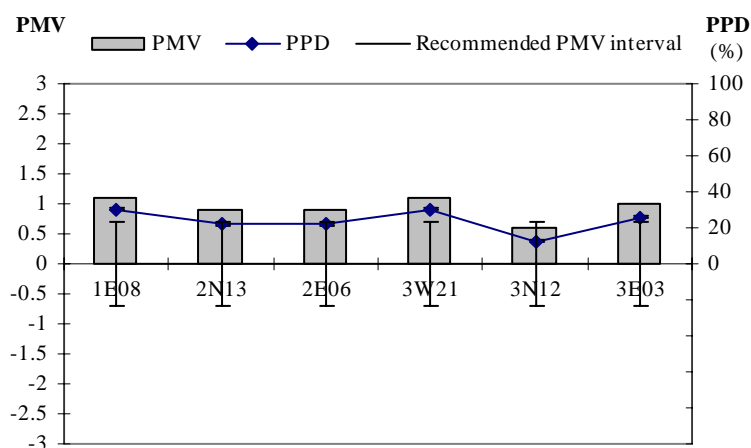
Figure 7. PMV and PPD in some of the office rooms

The thermal comfort conditions were also assessed through the calculation of the PPD – percentage of people dissatisfied – and the PMV – predicted mean value. The measurements were performed in the 8th of July and it was verified that in these circumstances, comfort conditions were not reached for the most part of the office rooms (Figure 7).

According to EN 7730 [22] and EN 15251 [20] standards, the desired thermal environment in a space of an existing building (category C or III buildings, respectively) are: PPD less than 15%; and PMV from +/- 0.7. These conditions were only met in office 3N12, as Figure 7 shows. In the other assessed offices, PPD is over 30% and PMV varies from 0.9 to 1.1.

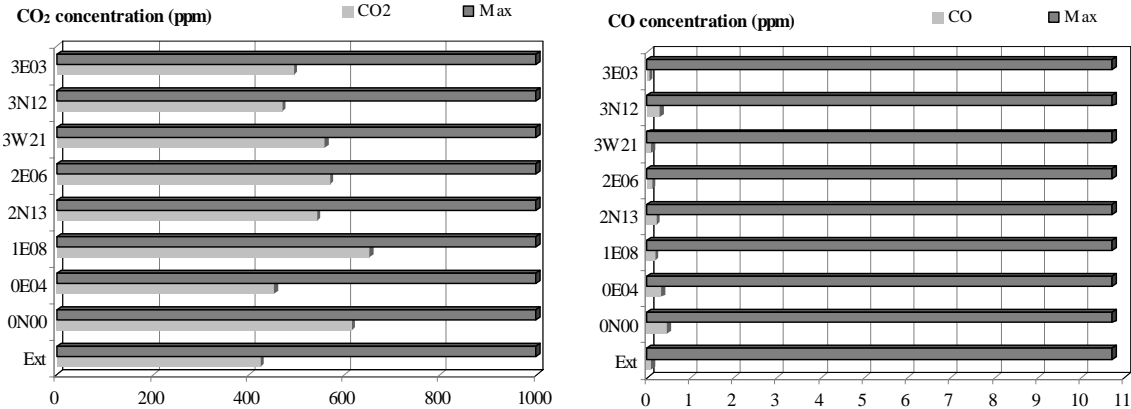
Figure 10. CO₂ and CO concentration and maximum reference values

Figure 10 shows the results of the carbon dioxide and monoxide (CO₂ and CO) measurements for the different studied office rooms of the building.

The measurements show that the concentrations of CO₂ and CO are considerably lower than the limits due to the fact that the occupants open the windows and the outdoor concentration is also low.
