Seismic performance of the St. George of the Latins church: Lessons learned from studying masonry ruins

*Paulo B. Lourenço^{1, *}, Alejandro Trujillo², Nuno Mendes³, Luís F. Ramos⁴*

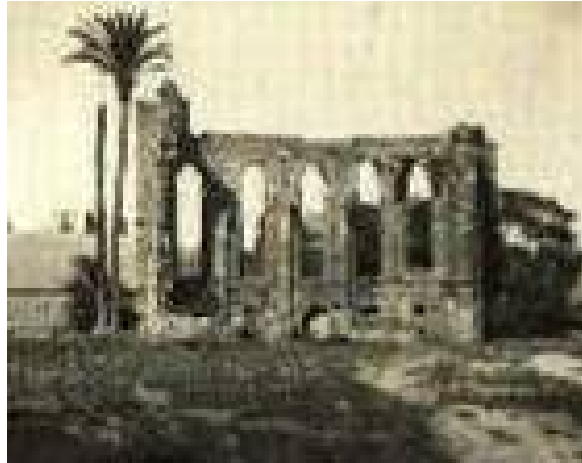
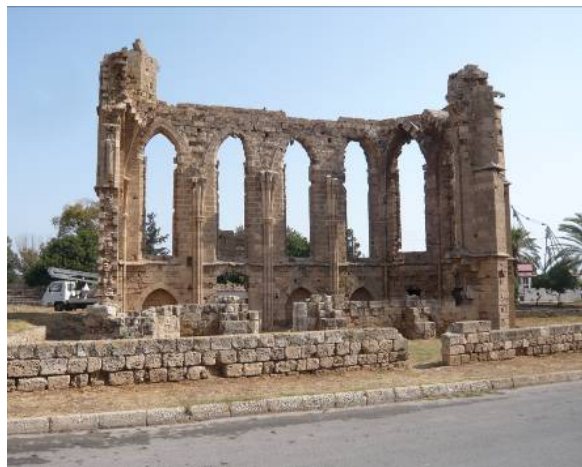
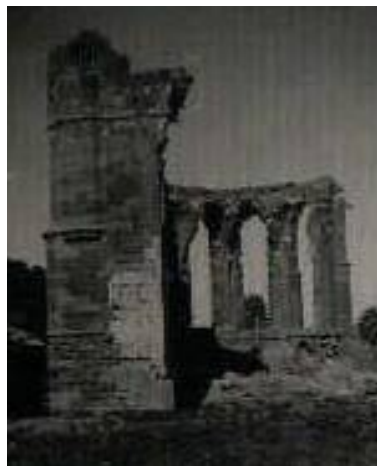
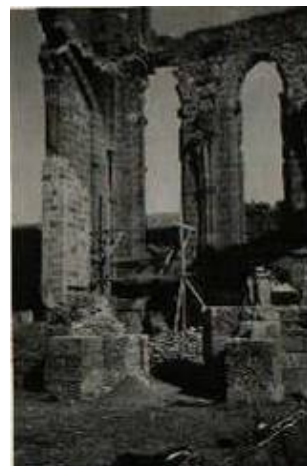
Figure 2 – Historical photographs: (a) 1939-1941 situation vs. current condition;
(b) clear presence of new (lighter) stone.

The church has some impressive gargoyles depicting human figures and winged dragons. A small conch adorned with richly decorated pediments is formed in the church's apse and was probably used to receive a sculpture. Figure 2a indicates that the present condition of the church seems not to differ significantly from the condition around 1940. Severe deterioration of the stones is reported in drawings from 1882 and several stones have been replaced in the conservation works around 1940, see Figure 2b. The present condition is characterized by, see Figure 3 and Figure 4: (a) lack of cleaning / possible misuse of the sacristy; (b) severe stone deterioration; (c) loose stone

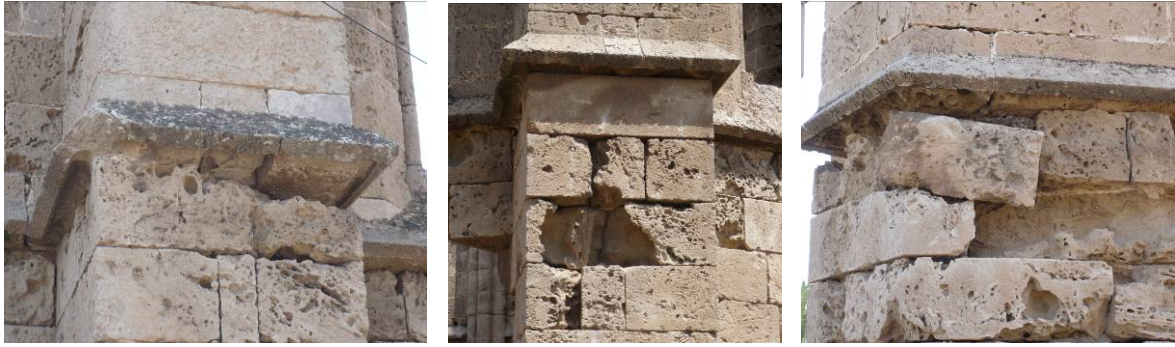
Figure 4 – Details on current structural condition: (a) mostly inefficient buttresses due to stone deterioration; (b) a crack / rotation of the tower, possibly due to a previous earthquake / foundation problems.

elements, which must be consolidated or removed; (d) highly corroded reinforced concrete lintel in main door; (e) inefficient buttresses due to stone deterioration; (f) a crack / rotation of the tower, possibly due to a previous earthquake / foundation problems.

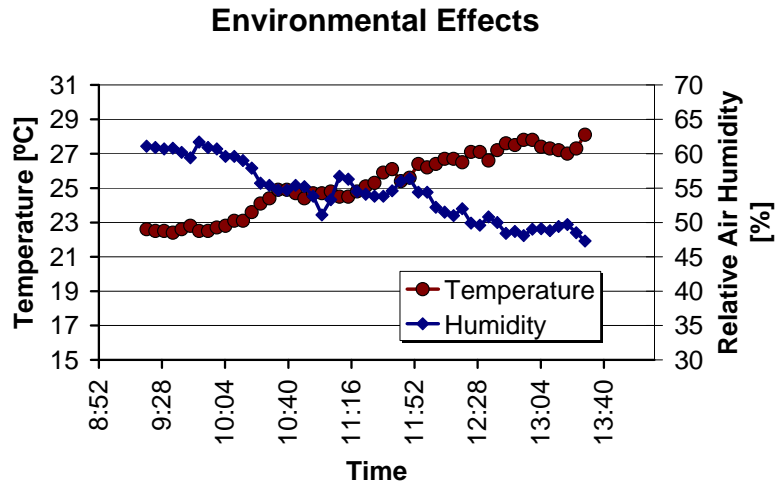
Figure 5 – Environmental effects recorded during modal identification tests in St. George of the Latins Church.

environmental factors in the modal parameters is well known, e.g. Ramos et al. (2010b). Figure 5 presents the variation of the environmental effects during the testing hours. The ambient temperature increased from 22 to 28°C, while the relative air humidity decreased from 61 to 47%. The variations occurred linearly and slowly. As there are no significant changes in the environmental effects, it is expected that these parameters will not affect significantly the dynamic response of the structure.

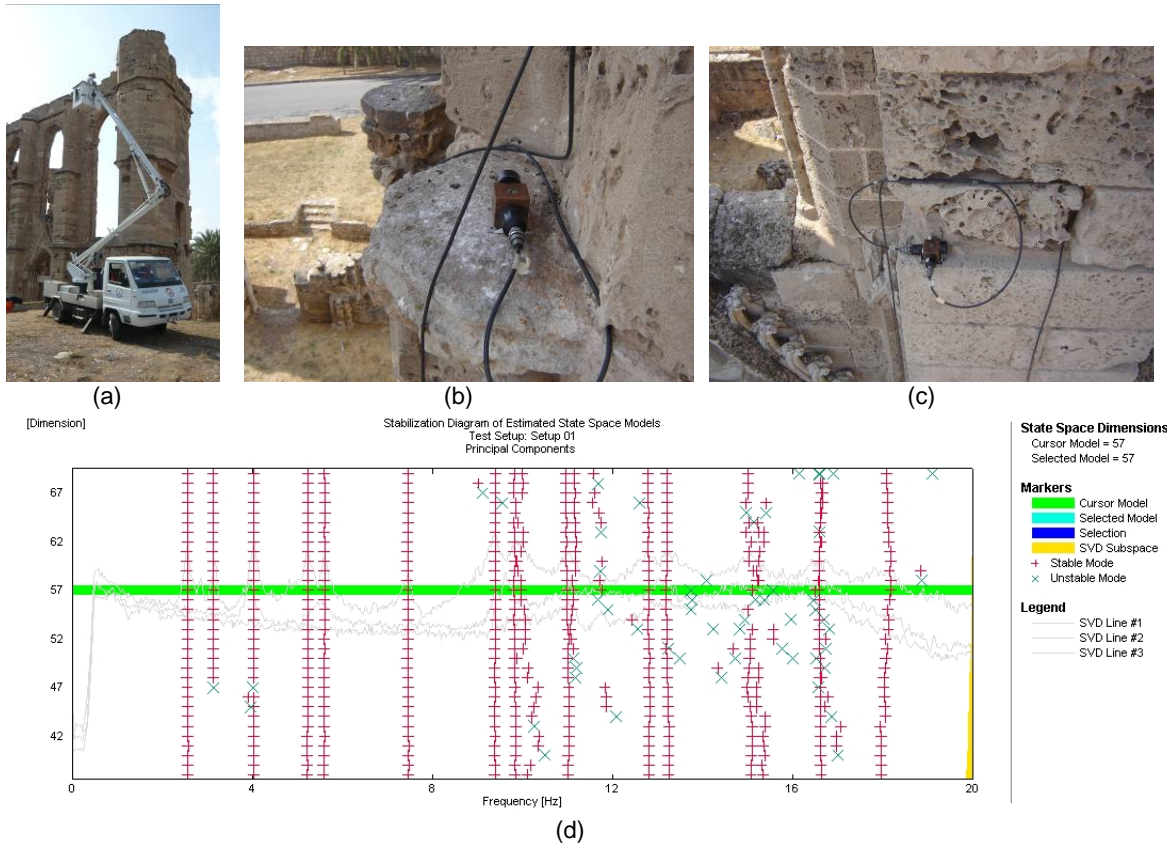
Figure 7 – Dynamic test at St. George of the Latins church: (a) lorry used to fix the sensors in the structure; (b) accelerometer at position A1; (c) accelerometers at position A2; and (d) stabilization diagram.

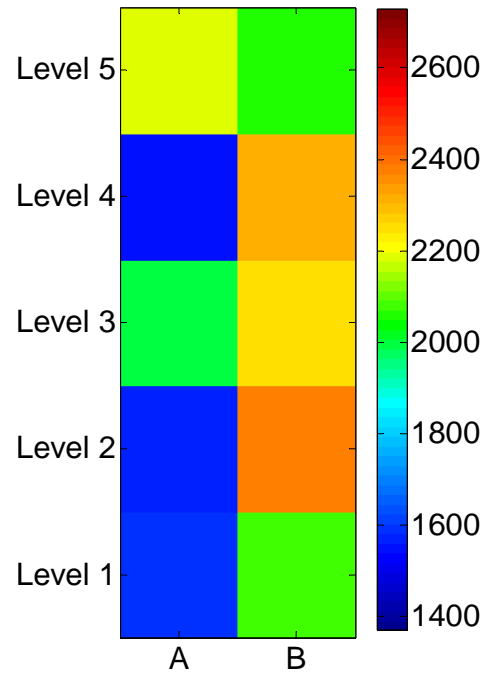
Figure 9 – Sonic tests in the north buttress: (a) location of the measuring points; and (b) velocity map (m/s).

results indicate that the stones in the outer column were probably replaced by new ones in the recent past, while the internal part of the buttresses are in worse condition.

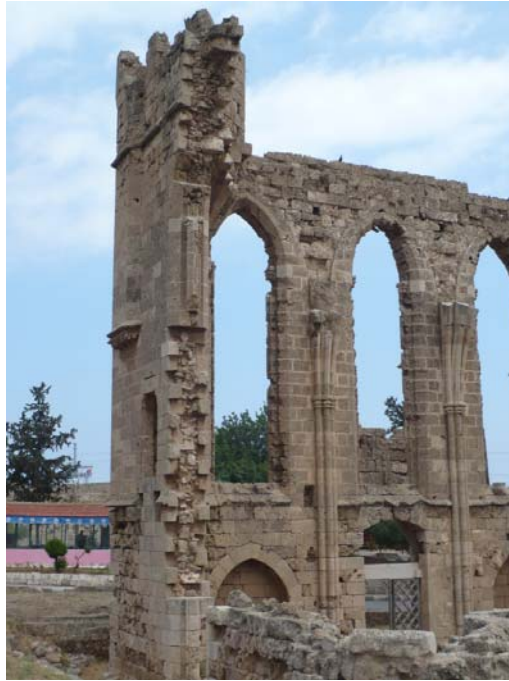
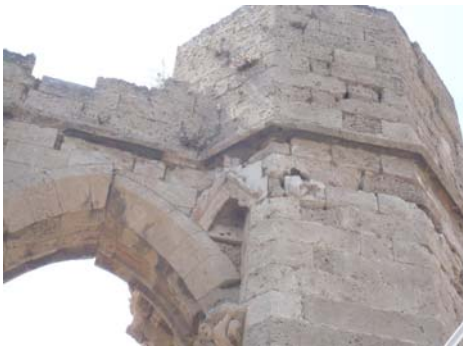
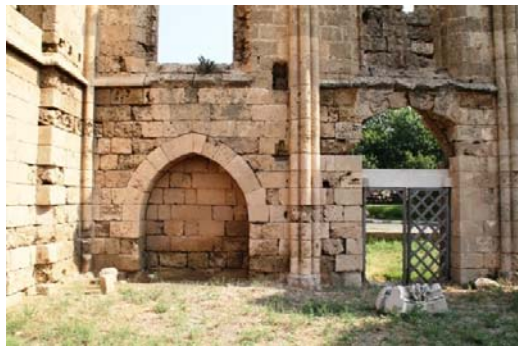
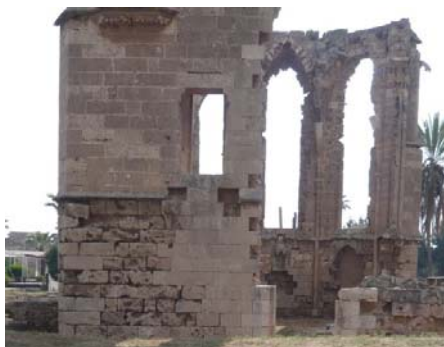
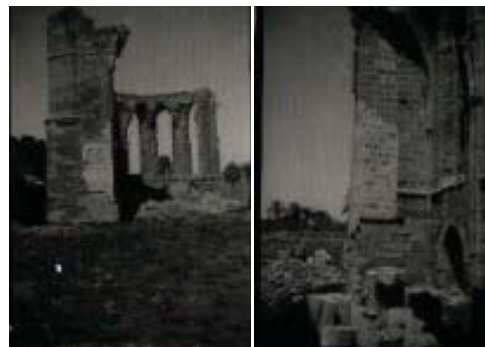
Figure 10 – West façade: (a) general view, (b) weak connection in upper part due to tower rotation, (c) severe deterioration of stones in the connection with north façade, (d) severe stone deterioration in lower part and (e) replaced (lighter) stones during conservation works in 1940.

This façade is composed by a small portion of wall about 5.0 m long and 18.0 m high, with a small boxed tower (void inside) at the top, see Figure 10a. The tower suffered a rotation in the past due to a settlement or earthquake and the crack opening is shown in

Figure 10b. Also there is a stone deteriorated region in the lower part of the connection between north and west façades, see Figure 10c, which could be a possible sign of weakness in this connection. Despite restoration works carried out during 1940, see Figure 10d,e, with several stone replacements, stone deterioration concentrated in the lower part at the corner is still found, Figure 10d.

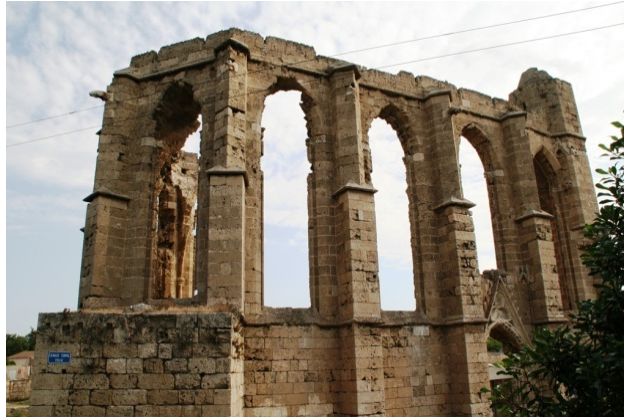
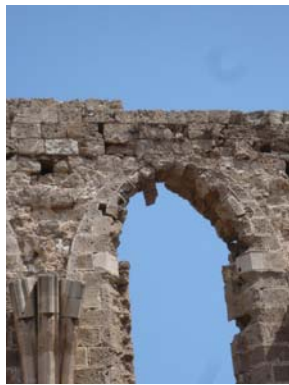
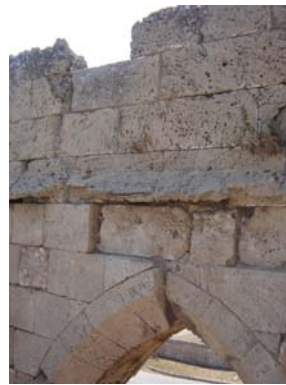
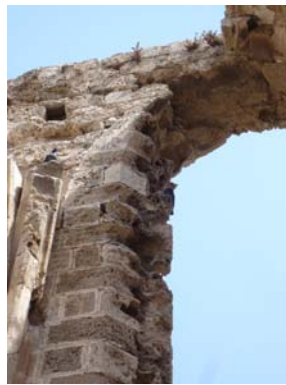
Figure 12 – North façade: (a) external view, (b) upper part of the second window; (c) crack opening and sliding in the connection with west façade; (d) crack opening and sliding in the connection with the apse.

This façade is composed by four large windows about 7.0 m high and three pier walls, see Figure 12a. Its lower part is completely massive, except for one door. There were several stone replacements in both sides of the walls, especially in the outer side of the wall. The buttresses show loss of stone elements and severe stone deterioration. In the upper part of the inner face, the stones are deteriorated and some of them are detached, see Figure 12b. This also occurs in some areas of the wall lower part. Some stones of the buttresses were replaced during 1940's restoration works; nevertheless their internal conditions are damaged, as shown by the sonic testing. The assumed failure mechanism for this part of the structure includes the three pier walls from the cornice to the top part

of the wall, and the assumed plastic hinges are shown in Figure 12c,d, where cracks are clearly defined (opening and sliding).

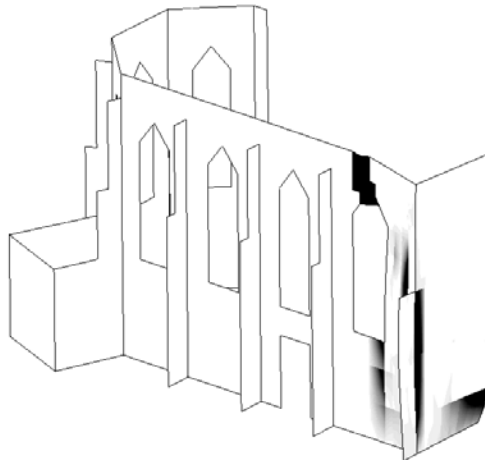
Figure 19 – Failure modes for first mode proportional loading along global axis, with representation of maximum principal strains (as a measure of crack width): (a) +X;

(b) -Y.

The collapse mechanisms for the principal axes (X',Y') are similar to the ones for the global axes (X,Y) and are not shown here, see Trujillo (2009) for details. Figure 19 shows the first mode proportional loading results, for the controlling failure mechanisms in each direction, where it is clear that the deformation is much more localized and the final damage pattern configurations represent slightly better the formation of the hinges assumed in the limit analysis.
