Using simplified indices to forecast the seismic vulnerability of New Zealand unreinforced masonry churches

Jason M. Ingham¹, Paulo B. Lourenço², João Leite³, Saahil Castelino⁴ and Edlyn Colaco⁵

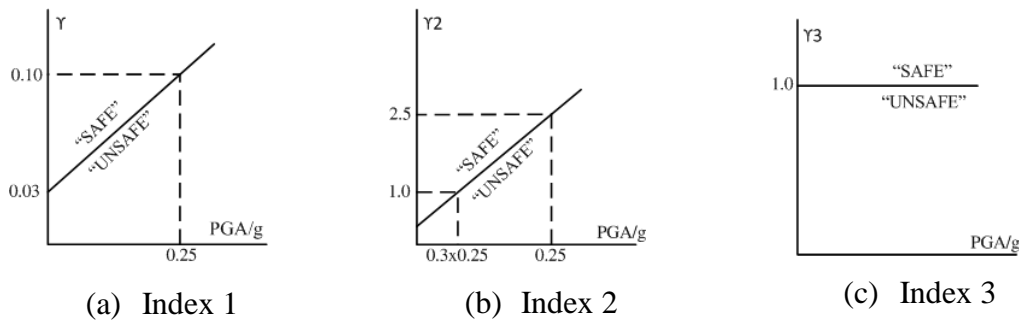
Figure 1. Assumed thresholds for indices 1, 2 and 3 as a function of PGA/g

For indices 1 and 2, the seismicity is taken into account by considering that the threshold value given above is valid for a PGA/g value of 0.25 and assuming a linear variation with PGA/g, as illustrated in Figure 1. Conversely, Index 3 should be constant in different seismic zones, as the effect of seismicity is incorporated. This index format is close to the traditional safety approach adopted for structural design, with a threshold value equal to 1 (see Figure 1).

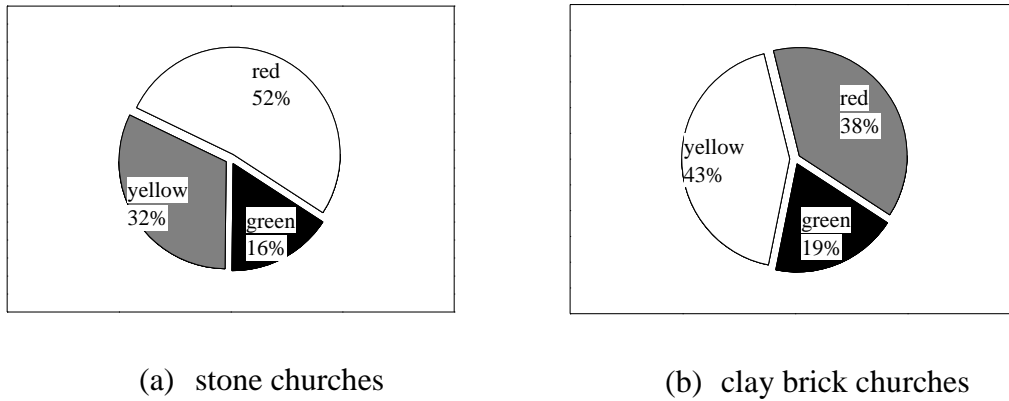
Figure 3. Placard classification for assessed URM churches following the Canterbury earthquakes

A comprehensive statistical analysis of the performance of churches in the Canterbury earthquakes is reported by Leite et al. (2012), including the in situ damage observed, the structural assessment classification assigned by the local authorities and a comparison with the structural classification used in Italy, where a specific survey form for churches is used. For stone URM churches, more than half of the churches (52%) were assigned a red placard and only 16% of the churches had a green placard assigned (see Figure 3(a)). Figure 3(b) shows that a red placard was assigned to 38% of the clay brick URM churches, while a yellow placard was assigned to 42% of those churches. The percentage of red placards assigned for the clay brick typology was smaller than the percentage assigned for the stone churches, but the sum of the red and yellow placards was similar for both masonry typologies and exceeded 80%.

From Figure 7 it may be established that all URM churches in Wellington failed Index 1, for both loading directions. This outcome is largely a result of the high PGA for the region. For Index 2 82% (9 of 11) of Wellington URM churches failed in the x (transversal) direction and 45% (5 of 11) failed in the y (longitudinal direction). For Index 3 100% and 73% (8 of 11) failed in the x and y directions respectively. From this data it is evident that most Wellington URM churches can be expected to perform poorly in a design level earthquake. Recognising that Wellington is a region of high seismicity, this finding is in general agreement with the damage reported to Christchurch URM churches as shown in Figure 3.

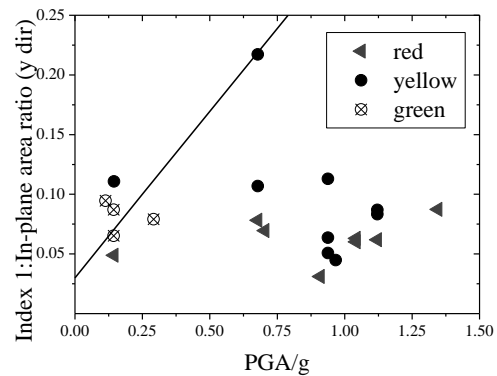
Figure 4. Indices for clay brick URM churches in the Canterbury earthquakes

The indices related to the above mentioned simplified method of analysis were computed for all the stone and clay brick URM churches that were surveyed following the Canterbury earthquakes. Figure 4 presents the scatter plots of each index and the horizontal PGA of the 22 February 2011 event interpolated at each site for clay brick URM churches, as well as the proposed thresholds from Figure 1. The threshold for Index 1 is excellent, with all the green tagged churches falling above or near the line and one yellow and one red church incorrectly identified. The yellow tagged church had only minor cracking with the exception of a large shear crack on one longitudinal wall of the main nave. The red tagged church was also a particular case, as it had pinnacles overhanging from the transversal walls. The thresholds for Index 2 and Index 3 also have acceptable results. The x (transverse) direction provides better results for all three indices, and this is the critical direction. Index 3 exhibits the worse correlation if cohesion is taken into consideration, with better results obtained for zero cohesion.

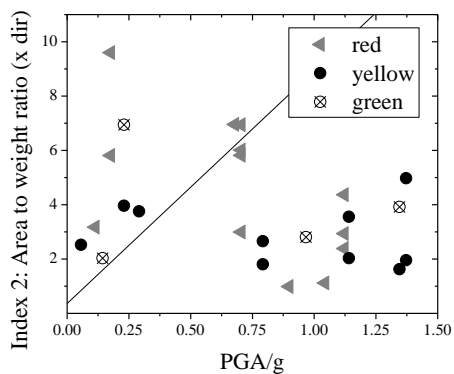
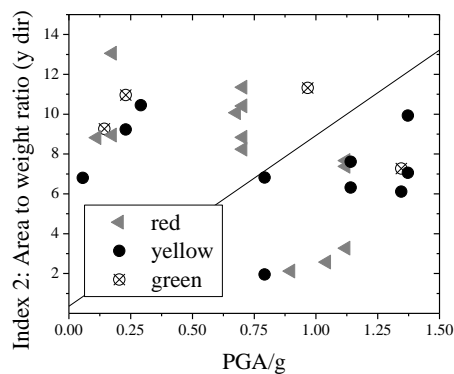
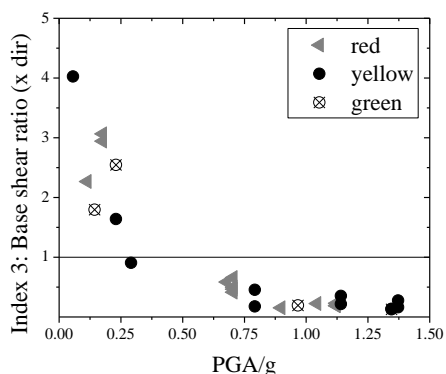
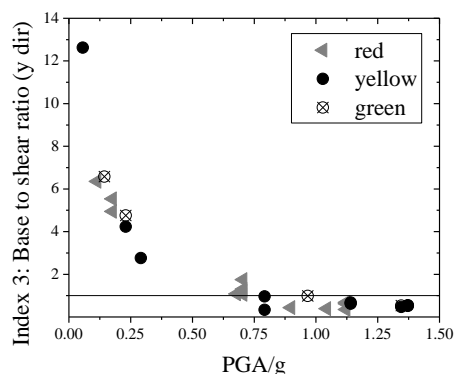
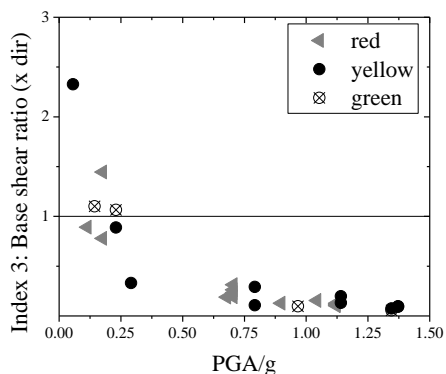
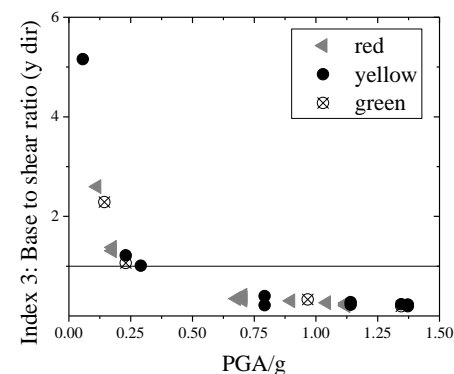
Figure 5. Indices for stone URM churches in the Canterbury earthquakes

The thresholds for the stone URM churches are not as good as those for the clay brick URM churches (see Figure 5). For all indices in both directions, there are green tagged churches that lie under the threshold, and red tagged churches that lie above the threshold. The lack of homogeneity of the stone URM churches justifies the lack of agreement with the thresholds, as the seismic behavior of these churches is rather different. Monumental good quality stone URM churches can present a seismic behavior similar to clay brick URM churches, while weak rubble stone URM masonry lacks interlocking and disaggregates, even for low PGA values, suggesting that it could be helpful to consider sub-sets of typologies for this class of church. Also, the data merits revisiting to establish if any of the stone URM churches had received prior seismic improvements. As for the clay brick URM churches, there is a better agreement with the threshold of Index 3 if cohesion is not taken into consideration.

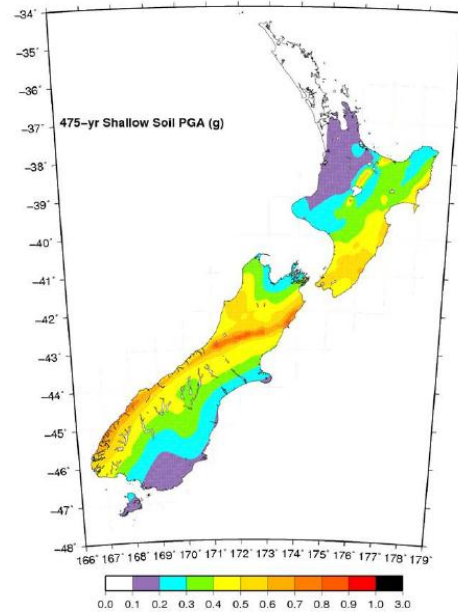
Figure 6. PGA/g values for a 500 year return period earthquake (from Stirling et al. (2012))

development of the city was somewhat comparable to that of Christchurch, with an expectation that the stock of URM churches in Dunedin was analogous to that of Christchurch. 29 URM churches were inspected in Dunedin. Christophersen et al. (2011) report that for a 500 year return period, the 2010 New Zealand National Seismic Hazard Model (2010 NSHM) results in values of PGA/g of 0.540 for Wellington and of 0.192 for Dunedin. The PGA data is also shown in Figure 6.

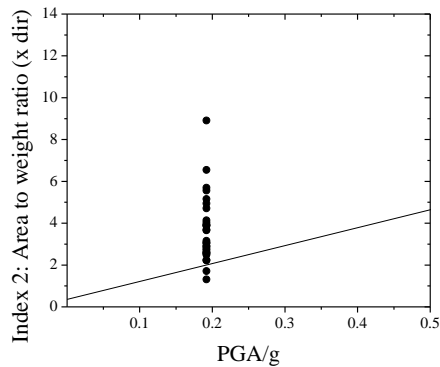
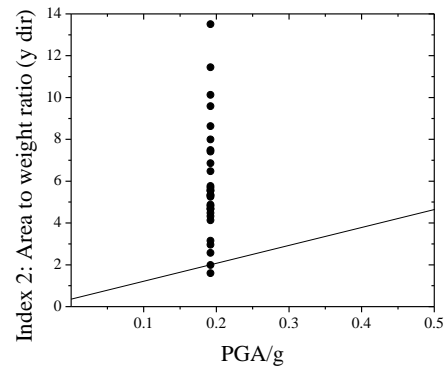
Figure 8. Indices for URM churches in Dunedin

From Figure 8 it is evident that 93% (27 of 29) of Dunedin URM churches fail Index 1 in the x direction and 72% (21 of 29) fail Index 1 in the y direction. However, this finding is in contrast with Index 2 where only 7% (2 of 29) fail in each of the two directions. For Index 3 only 7% (2 of 29) of Dunedin URM churches fail for each orientation. Overall the results from the Dunedin study are an excellent endorsement of the simplified index method, as the procedure has resulted in the identification of a small subset of URM churches that specifically merit priority attention for seismic improvement in a region that by New Zealand standards is of moderate/low seismicity. Images of the three churches that were identified using the simplified index method as most seismically vulnerable are shown in Figure 9.
