## SOLUTIONS FOR INFILLED MASONRY BUILDINGS: SHAKING TABLE TESTS

**Leite, Joao<sup>1</sup>; Lourenco, Paulo B.<sup>2</sup>**

*Keywords: infill, concrete frame, reinforcement, shaking table, collapse mode*

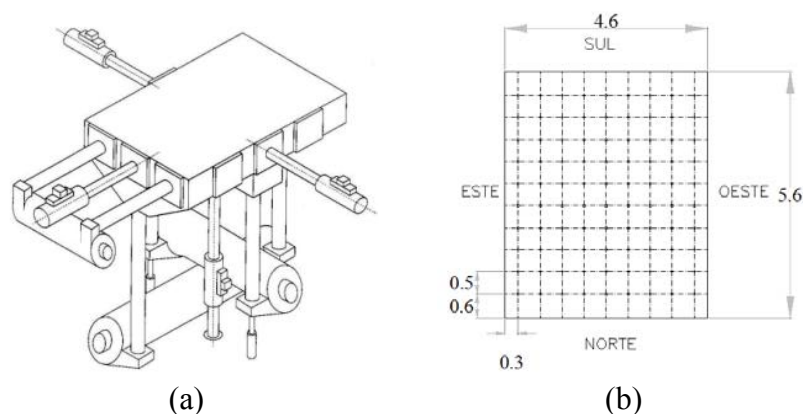
**Figure 1: Shaking table of the National Laboratory for Civil Engineering: (a) general view; (b) dimensions of the platform in meters**

The geometry of the tested models was based on a previous study where the average number of storeys, number of bays, and dimensions of the frames and infills was determined. Also, the physical limitations of the shaking table in use had to be taken into account so that the scaled model would fit on the platform, see Figure 1, and would not be excessively heavy.

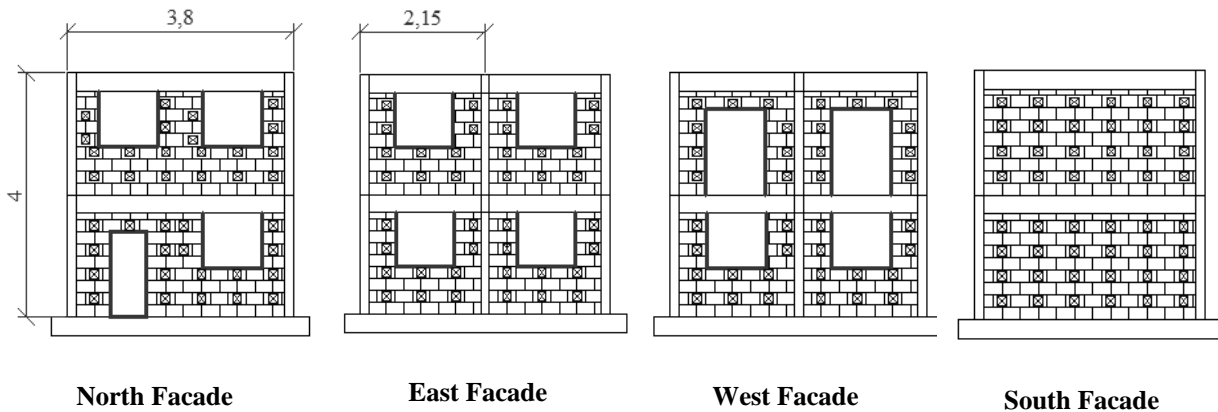
**Figure 2: Facades and dimensions, in meters, of the tested models.**

Table 1, for a scale of 1:1,5 ( $\lambda = 1,5$ ), with the final geometry resumed in Figure 2. Cauchy is adequate when the restoring forces are derived from the stress-strain relationships and Froude is adequate when the gravity forces are important. For highly non-linear dynamic responses, both laws need to be taken into account (Carvalho, 1998), which is the case of the presented experimental tests.

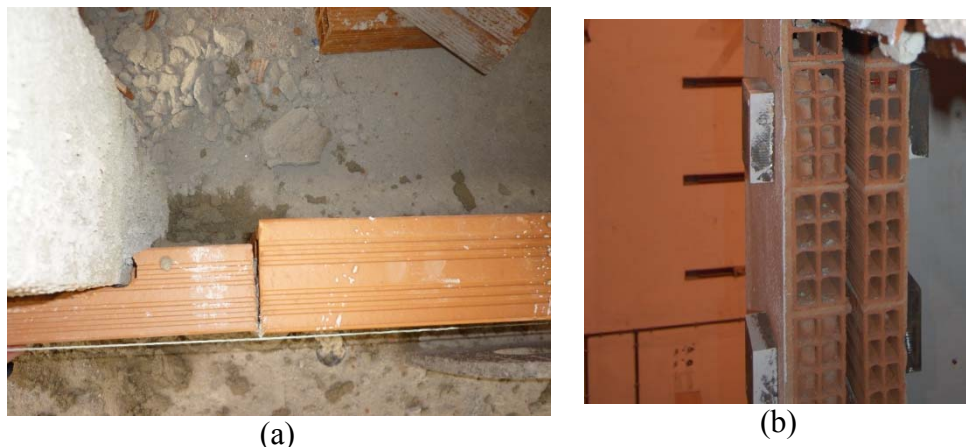
**Figure 3: Infill solution of model one, a double leaf clay brick cavity wall with pre-batched mortar: (a) outer leaf; (b) final work with mortar rendering outside and plaster inside**

It was stated above that two different infill solutions were used for models one and two. Figure 3 shows the details of the solution of model one and its construction. It is a double leaf clay brick cavity wall, unreinforced, and with pre-batched mortar in the bed joints and outer rendering, and it is the most common infill solution used in Portugal in the last two decades.

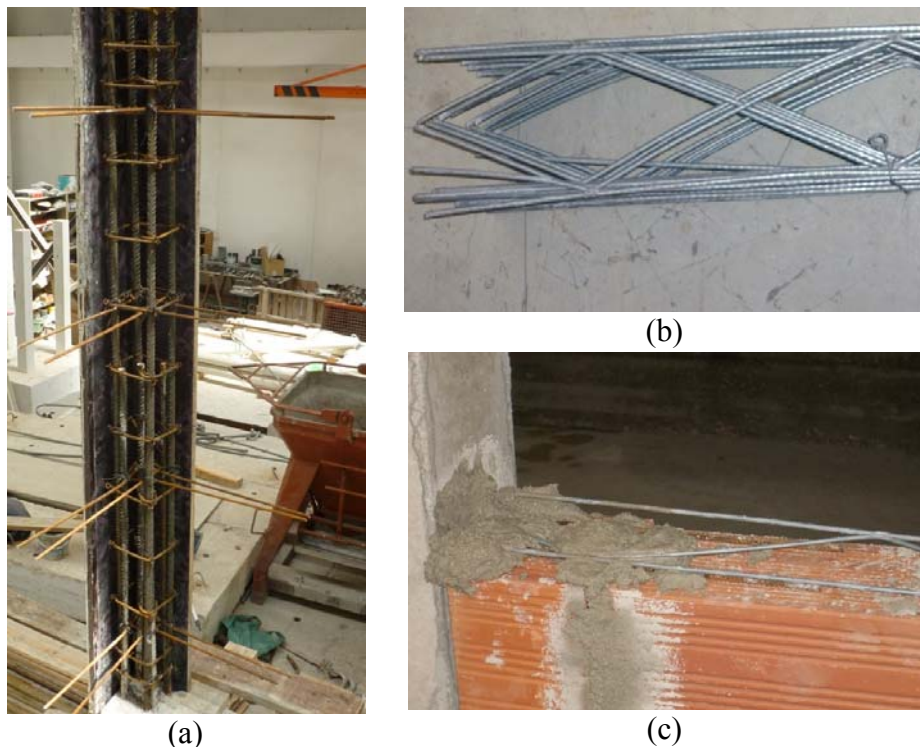
**Figure 4: Infill solution of model two, a single leaf clay brick wall with pre-batched mortar and bed joint reinforcement: (a) connectors of the bed joint reinforcement to the longitudinal reinforcement steel bars of the columns; (b) Bekaert Murfor RND.4/100; (c) bed joint reinforcement over the connectors in the bed joint layer**

The infill solution of model two is single leaf, also with clay bricks and pre-batched mortar, but with bed joint reinforcement connected to the columns of the reinforced concrete frame. The connectors (standard ribbed bars) used were attached to the longitudinal reinforcement steel bars of the columns during construction phase, see Figure 4 (a). The bed joint reinforcement chosen was BEKAERT – MURFOR RND.4/100, see Figure 4 (b), every two courses. The amount of reinforcement was defined following articles 8.2.2, 8.2.3 and 8.2.7 of EC8 (Eurocode-8, 2004). The extra mass needed for the concrete structure, due to similarity law, was obtained by attaching the calibration masses of the shaking table. Each one has approximately 1200 kg and 82x82x26 cm<sup>3</sup>, and six were attached to each floor. Figure 3 (b) shows the masses used for the infill masonry walls. Each one has approximately 7,2 kg and 15x15x4 cm<sup>3</sup>. With these dimensions, one steel plate can be attached to a single block and will not connect blocks mechanically. A total number of 334 steel plates were used in each

Two different types of behaviour needed to be analysed in the tests: i) the global behaviour of the concrete structure; ii) the local behaviour of the infills. The first was captured using with Hamamatsu cameras at the corners of the building and accelerometers in two corners of each slab, see Figure 4 (a). The local behaviour of the infill walls was measured using accelerometers, see Figure 5 (b), and in model one, because of the double leaf infill solution constructed, accelerometers had to be placed in the inside and outside, in opposite positions. A total number of 48 accelerometers and 8 Hamamatsu cameras, measuring two in-plane directions, were used.

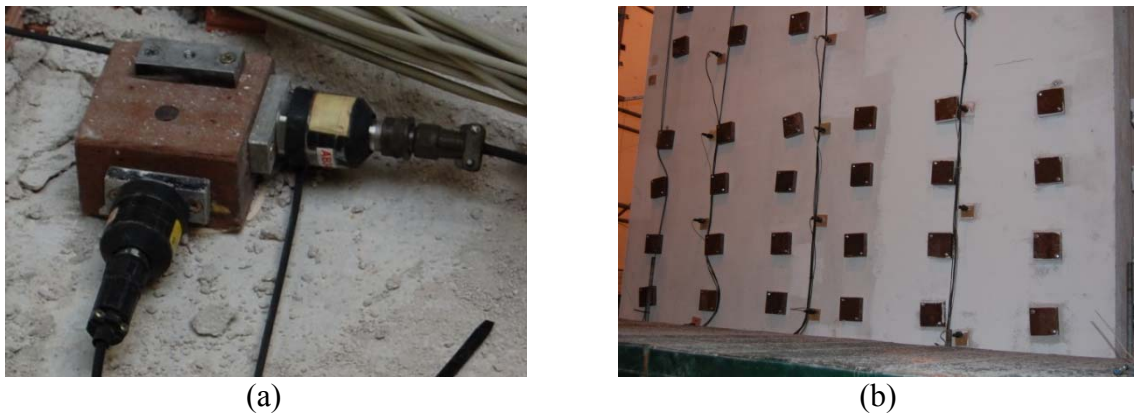
**Figure 5: Instrumentation of the model using accelerometers: (a) in the concrete structure (corner of the slab measuring transversal directions); (b) infill walls (South wall, storey 1)**

The infill walls' acceleration was measured using accelerometers, see Figure 5 (b), and in model 1, due to the double leaf solution used, they were placed on both sides of the wall. The geometrical position of the accelerometers was the same in both models, so the values could be compared. Figure 7 presents the highest value, measured by the group of accelerometers of each infill wall, during the last stage for both models and on both leaves in model 1 (the second storey of the North facade was not measured in model 2). Except for the East walls, the inner leaf of model 1 presents the highest values, while the outer leaf of the same model presents values slightly higher (16.5% at the most on S-1) than the infills of model 2. Comparing the inner and outer leaves of model 1, except for the East walls, the highest difference is 20% (N-2). It is interesting to notice that the infills in the lower storey register higher accelerations,

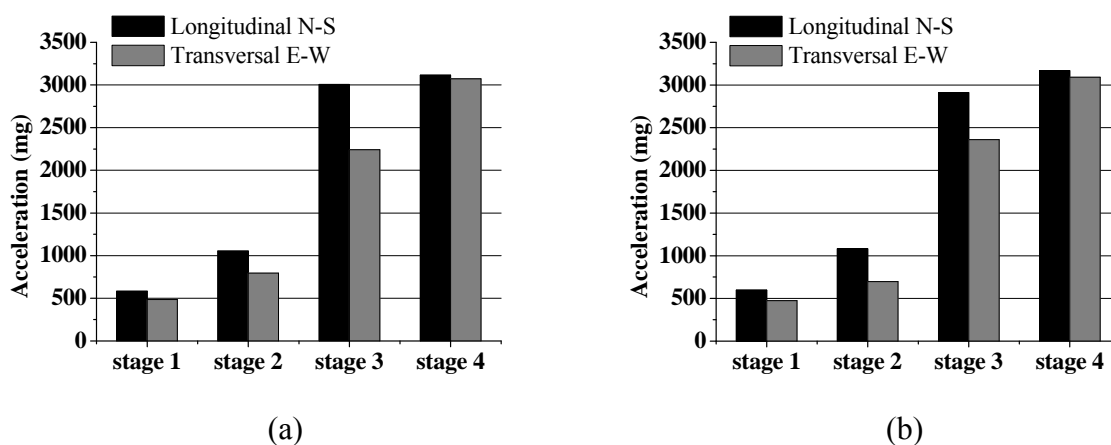
**Figure 6: Peak Ground Acceleration in each stage: (a) Model 1; (b) Model 2**

The values displayed in Figure 6 were obtained from the accelerometers placed inside the tri-axial platform and are the highest values measured in each stage of the tests. These peaks are due to the attempt of the actuators of the shaking table to follow the input at high frequencies. The size and mass of the structure are near the limit values of the equipment, meaning the tri-axial shaking table can slightly underperform and not completely follow the input. This fact is clearer in the longitudinal (N-S) direction which has only one actuator, on the South side, instead of one on each side, as in the transversal (E-W) direction. Therefore, sensitivity is lost when upper levels of demand are reached, as in stage three, so the actuator compensates by excess. The same happens in stage four, so similar values of acceleration were recorded. As for the acceleration values reached, both models were subjected to a similar input, even though the artificial accelerogram generated was based on different spectra. Comparing the recorded values with the design ones (converting them using the Cauchy-Froude's similarity law, see Table 1), therefore in stage two, the transversal values are similar (about 2% lower) and the longitudinal ones are higher (about 30%).

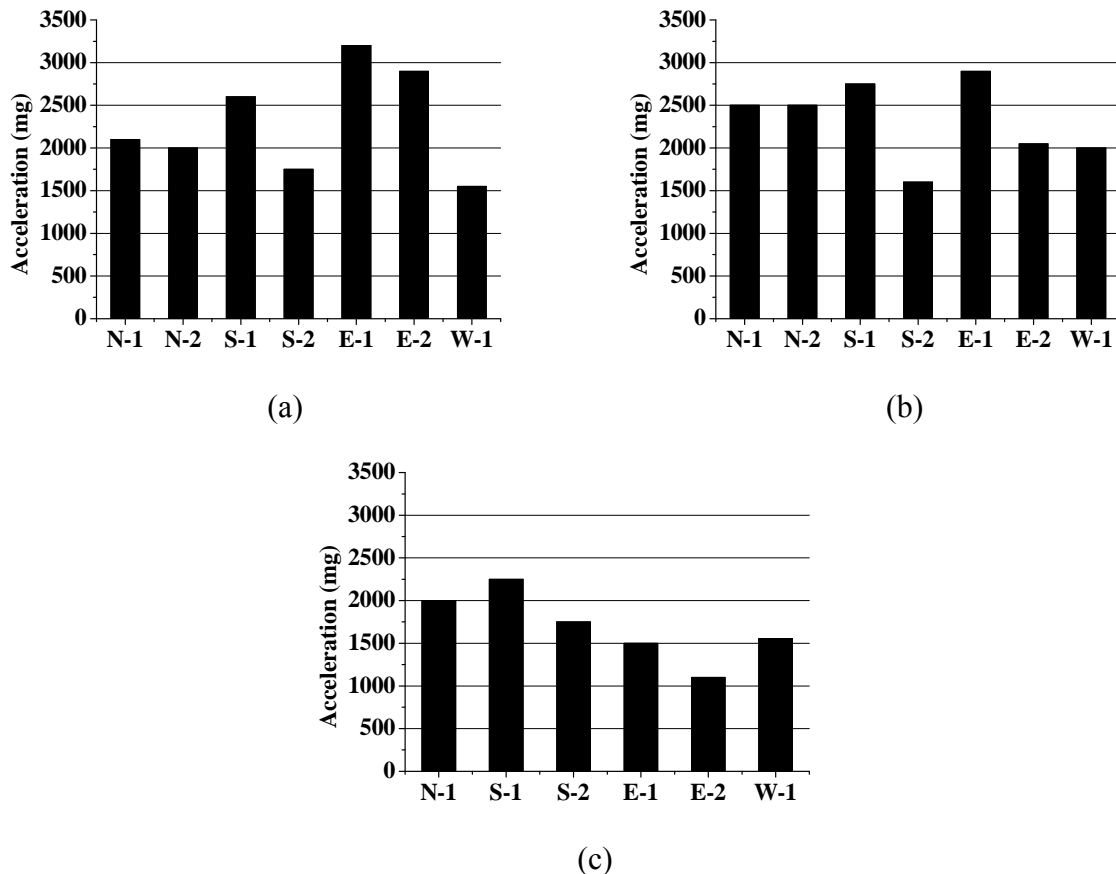
**Figure 7: Peak Acceleration measured in the infill walls in stage 4: (a) Model 1 – exterior leaf; (b) Model 1 – interior leaf; (c) Model 2**

which is due to the greater amount of damage sustained, leading to a substantial loss of stiffness.

None of the infills of model 2 were expelled out-of-plane during the last stage, even though they were subjected to similar accelerations, see Figure 7, as a result of the use of bed joint reinforcement connected to the reinforced concrete frame. The South wall presented cracks, mainly at the connection with the concrete frame, see Figure 9 (a), while the other three sides

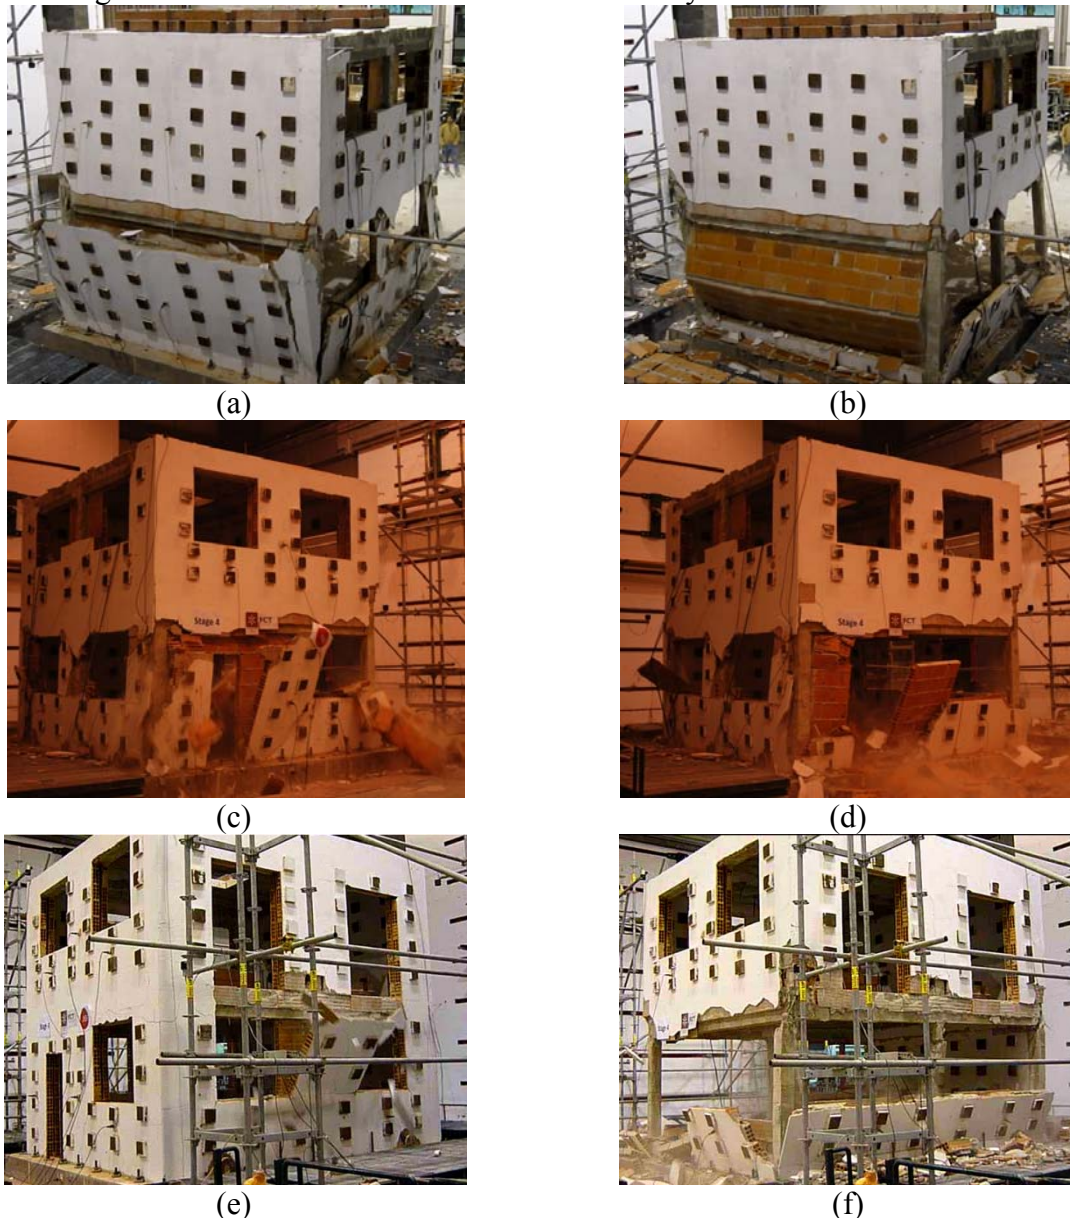
**Figure 8: Collapse (out-of-plane expulsion) of the infill walls in model 1 during the last stage: (a) outer leaf of the South wall; (b) inner leaf of the South wall; (c) and (d) North wall; (e) threshold of the West wall; (f) lintel of the West wall**

As it was stated above, all the infill walls of the ground storey of model 1 were expelled out-of-plane. The outer leaf of the South wall was the first to collapse, completely detaching itself from the upper beam of the concrete frame and rotating around the base as a rigid body, see Figure 8 (a), shortly followed by the inner leaf which opened a crack parallel to the bed mortar joints, at mid-height and along the complete length, and then both upper and lower parts rotated out-of-plane around the upper and lower beams of the concrete frame, respectively, see Figure 8 (b). In the North wall, due the existence of openings, the collapse was in phases, but also with a rigid body rotation around the base for the central part of the wall, see Figure 8 (c) and Figure 8 (d). The threshold was expelled first and has a whole, see Figure 8 (a). The East and West walls had the exact same behaviour: first the central and lateral thresholds were expelled, as whole also, Figure 8 (e), followed by the lower lintel, which rotated around the base as rigid body, see Figure 8 (f).

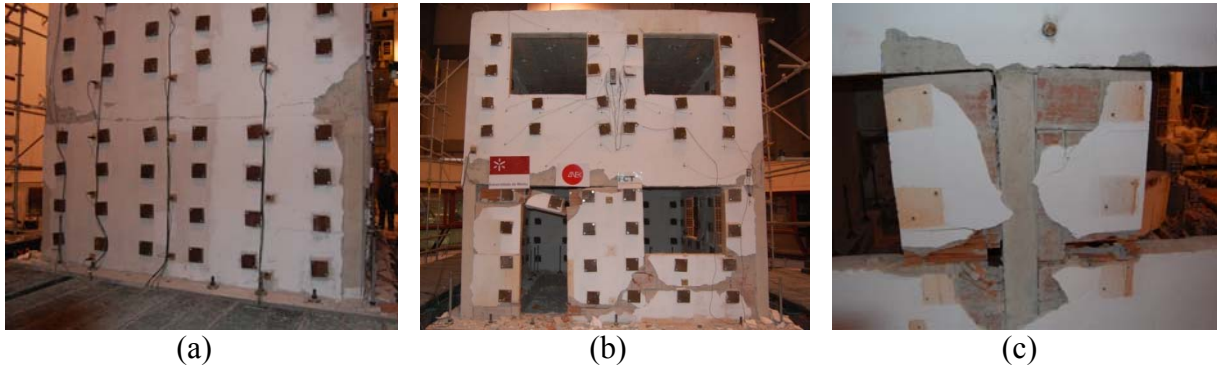
**Figure 9: Infill walls after stage 4: (a) South wall; (b) North wall; (c) detail of the threshold in the East wall**

were heavily damaged and beyond repair. The central portion of the infill in the North wall was completely disconnected from the concrete frame at the top, see Figure 9 (b), just as the thresholds in the East and West walls, see Figure 9 (c). In both cases the bed joint reinforcement was the only connection to the concrete frame, preventing the expulsion. All the rendering around the concrete frame in the lower storey fell.
