Experimental study on the seismic behavior of masonry wall-to-floor connections

SUMMARY:

Keywords: wall-to-floor connections, 'Pombalino', 'Gaioleiro', pull-out test, failure modes

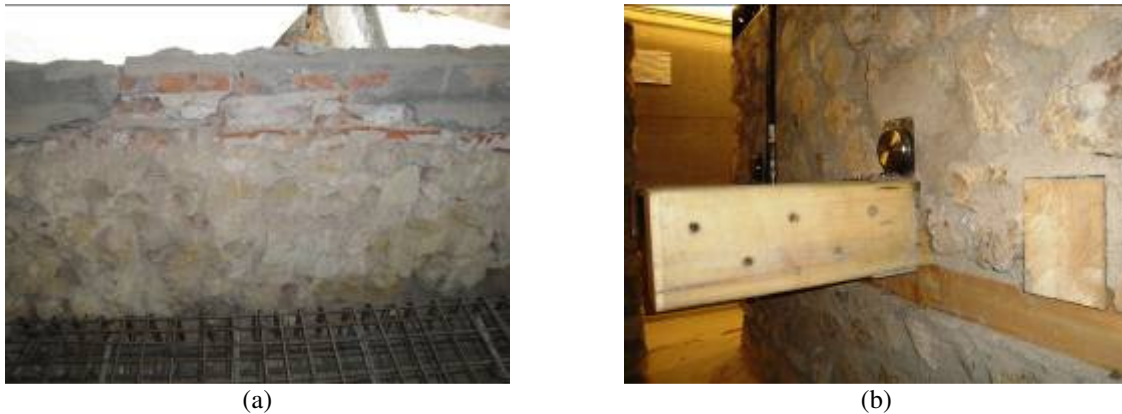
Figure 2 Masonry wall: (a) from a 'Pombalino' building; (b) detail of the connection built in the laboratory

Stone masonry was mainly used in the confining walls of each building (external, party and light shaft walls) but it could also work as infill of the half-timbered walls. As shown in Figure 2a, the rubble masonry of the walls is composed by irregular limestone units of different sizes and bound together by a poor mortar to form an unorganized mixture. These walls were hand built with the units placed to as much as possible avoid voids with mortar. The mortar resulted from the mixture of air lime and sand, usually in the proportion of 1:2, but could take other ratios like 1:2.5, 2:5 or 5:9. Existing material descriptions specify that the sand should be of good quality, without clay and from a specific place of pine trees, probably referring to Leiria. They also prescribed that the stone should be soft (like limestone), of good quality, and should come from the nearby regions of Monsanto or Sacavém.

The specimens consist of a masonry wall with a pavement beam placed perpendicular to the wall and nailed to an embedded beam (see Figure 2b). The typologies and materials presented previously guided the entire design process of the specimens. Of the three specimens built to represent wall-to-floor (WF) connections, two were strengthened (A) and one was left unstrengthened (U). The strengthening solution is a tie rod anchoring the wall (anchor plate) to the pavement beam through a steel angle, as shown in Figure 3b. The particularity of this strengthening resides on the use of two hinges, one at each end of the tie rod, which helps the application of the tie rod with an angle. In this case, it was chosen a 15° angle. As part of the strengthening solution, the timber beam was confined with a GFRP sheet.

Rubble masonry walls were hand constructed by professional masons, using limestone with a maximum dimension of 200 mm and at most 50 mm joints. A timber beam of $95 \times 95 \text{ mm}^2$ was built in along the wall ('frechal') and connected to the perpendicular timber joists of $130 \times 180 \text{ mm}^2$, which are spaced of 380 mm. The anchorage length of the timber beam is 150 mm and the nails are located at approximately 80 mm of the edge of the pavement beam inside the wall. Only two of the perpendicular pavement timber beams are extended beyond the walls, since only 2 tests will be performed per wall (see Figure 2b). In total 3 specimens were built, which gives a total of 6 tests.

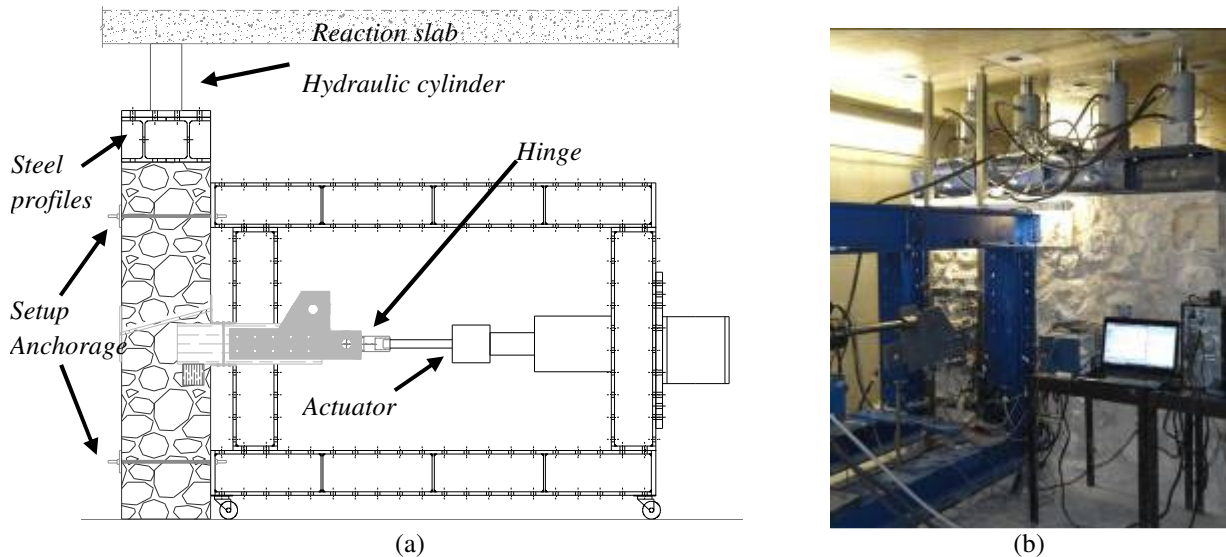
Figure 4 Set-up for the pull-out test: (a) sketch with the main components; (b) photograph taken during WF.40.A.1A test

Considering laboratory limitations in terms of space as well as the size of specimens, it was possible to develop an auto-balanced set-up capable of redirecting the pull-out force back to the specimen, as shown in Figure 4. The pull-out load, which intended to recreate the main seismic action, was applied perpendicular to the wall in order to simulate a horizontal seismic force. A hinge was used between the actuator and the specimen to accommodate small rotations. As previously stated, a distributed vertical load was applied on the top of the wall to simulate the effect of permanent loads on the structure. This was achieved by placing HE200B steel profiles on top of the wall, which distributed the load provided by four hydraulic cylinders compressed against a reaction slab (see Figure 4). The distributed vertical load was kept constant during the entire test by using a manual control. A metallic clamp was designed for this connection, rigid enough to apply the force to the specimen without interfering on the test results.

The horizontal load was applied directly on the timber pavement beam. The monotonic tests were carried out under displacement control at a rate of $10 \mu\text{m/s}$. The stopping criteria adopted were: a 50% decrease in load, a maximum displacement of 150 mm, which is the anchorage length of the pavement beam inside the wall or a propagation of cracks beyond the expected area of damage.

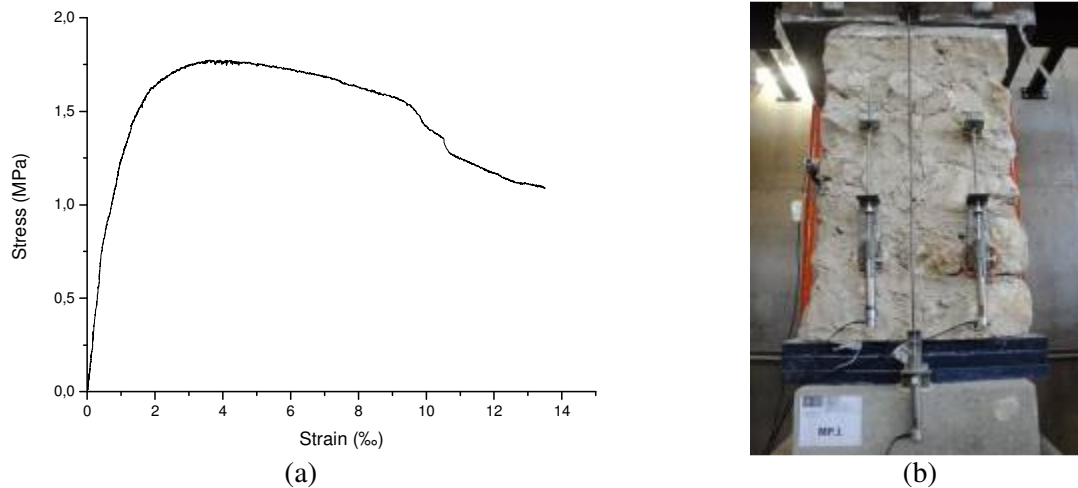
Figure 5 Compressive test: (a) Stress-strain diagram of a masonry prism; (b) instrumentation detail.

The masonry prisms were defined according to EN 1052-1, with dimensions of 0.40×0.50×0.80 m³. Initially, a monotonic test was performed, which was followed by a cyclic test on a similar specimen built at the same time. Vertical cracks and lateral separation of the prism were observed on both specimens, as it was expected. The average compressive strength of the 2 prisms was around 1.60 MPa. Values found in literature range between 0.50 and 1.50 MPa, thus placing the tested specimens slightly above the range. Prisms reached an elastic modulus approximately equal to 1000 MPa. The stress-strain diagram of one of the prisms tested and a detail on the position of the

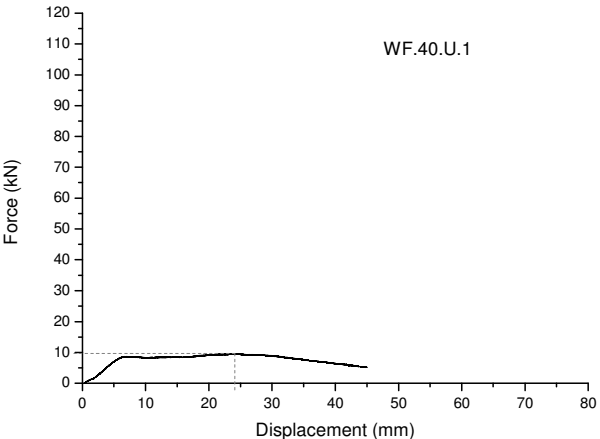
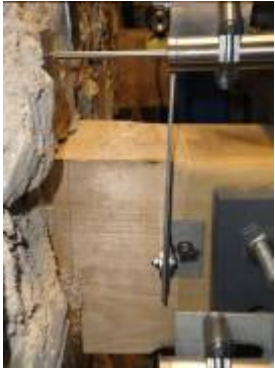
Specimen	Failure mode	Force-displacement curve	Photographic survey
(a) WF.40.U.1.A	FM5 – Pull-out of the nails connecting the pavement beam and the embedded beam.

The test performed on WF.40.U.1A showed the beam sliding out of the wall, reaching the peak force around 10 kN for 25 mm of displacement (see Table 2a). This length is coincident with the anchorage length of the nails connecting the timber beams. As the beam slid, it also started rotating taking more advantage of friction. For the first strengthened specimen, WT.40.A.1A, 4 $\phi 6$ bolts were used to connect the steel angle to the pavement beam, which failed in shear as can be seen in Table 2b. Each of the drops of the force-displacement curve corresponds to the failure of each bolt. In total, the bolts ripped the timber beam approximately 50 mm. The majority of the displacement obtained is due to sliding of the beam, since small displacements were measured on the wall, below 1 mm.

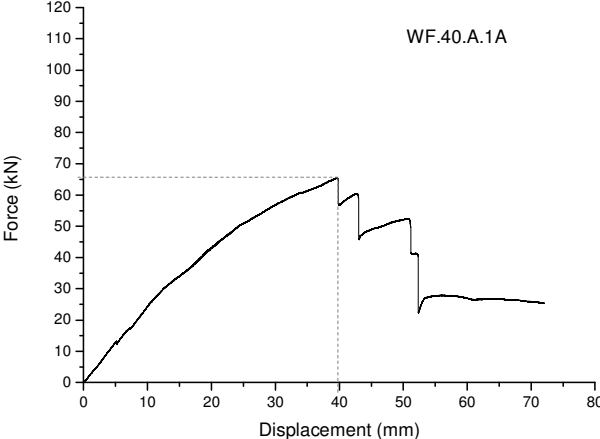
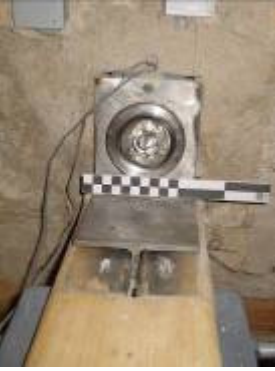
(b) WF.40.A.1.A	FM4 – Bolts connecting the steel angle and the timber beam crushed the timber beam, until they bent and failed due to shear.

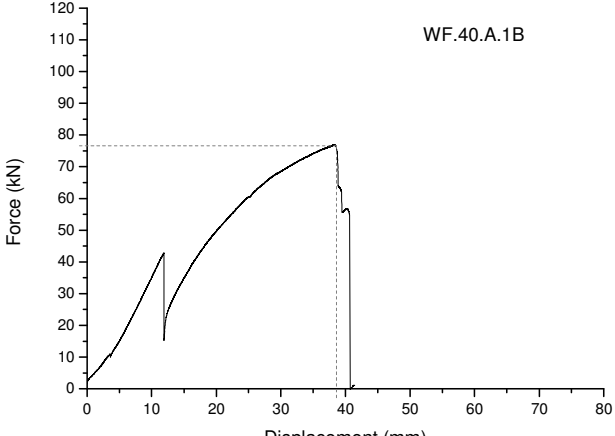
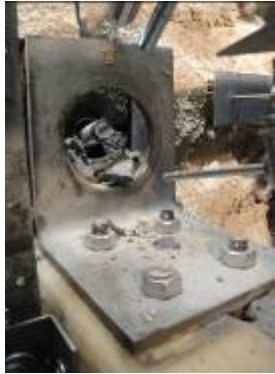
<p>WF.40.A.1B</p>

(c) WF.40.A.1B	FM3 – The nut stripped the threads of the steel tie rod.

For the following specimen, WF.40.A.1B, the $\phi 6$ bolts were substituted by $\phi 10$, to prevent the failure of the bolts. Consequently, another failure mode was found for a higher load – this one associated with the tie rod. At each end of the tie rod only one nut was used to tighten it onto the hinges, which surprisingly proved to be insufficient when tested with the large diameter bolts. As shown in Table 2c, there was a sudden drop of the force, defining this failure mode as brittle. Again large displacements were caused by sliding of the pavement beam.

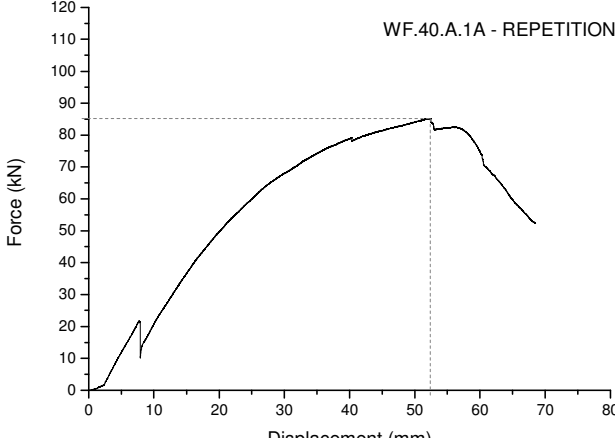
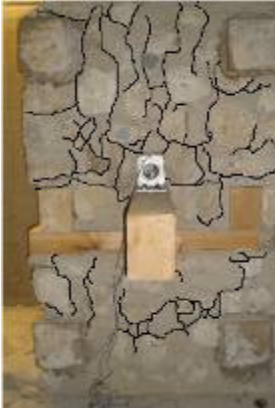
<p>WF.40.A.1A - REPETITION</p>

(d) WF.40.A.1C	FM1 – The masonry wall failed forming the pull-out cone.

Since small displacements were measured during the test of WF.40.A.1A and no visible damage was observed on the wall and embedded beam, it was performed another test on the same location of the specimen. Only the timber pavement beam was replaced and the strengthening reapplied (WF.40.A.1C). The only disregarded detail was the nails connecting both timber beams, which was considered acceptable due to their small impact in the previous tests. To avoid the failure mode of the previous test, the tie rod was tightened with 3 nuts on each end. With this one exception the test was otherwise conducted identically to the previous. This test resulted in the formation of the pull-out cone

on the masonry wall. As shown in Table 2d, general diffused cracks starting from the anchor position were observed, in parallel with the internal separation of the wall “leaves” and crushing of the masonry under the anchor plate.

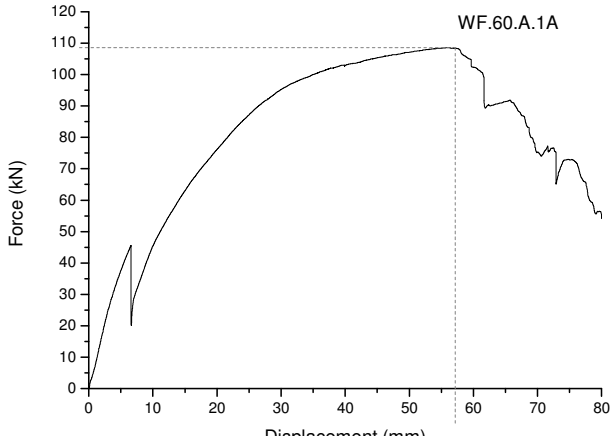
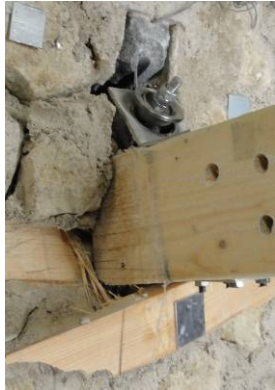
<p>WF.60.A.1A</p>

(e) WF.60.A.1A	FM5 – Sliding and rotation of the pavement beam crushed the embedded beam, ripping it from one end to another.

After obtaining the formation of the pull-out cone for a 40 cm thick specimen, it was decided to replicate the same strengthening details on a 60 cm specimen. As depicted in Table 2e, the results were notably different. The connection failed by cracking and ripping the embedded beam from along the full length of the beam due to the compression exerted by the pavement beam. It was observed that the ripping pattern followed the plan of the nails and also during the test was observed a significant rotation of the pavement beam. It is possible that the pavement beam rotated when being pulled due to the 15° angle of the tie rod, which in association with an increase of the compressive stress of the wall (0.5 MPa) led the embedded beam to rip along the nails plan.

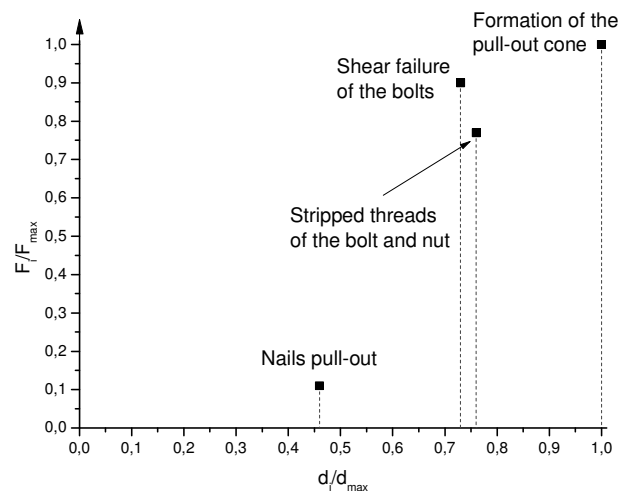
Figure 6 Relationship between the different failure modes

Knowing the different failure modes and what can cause their appearance is very important when designing strengthening. Each failure mode obtained experimentally gave a threshold of the resistance (see Figure 6) and also showed what kind of damage to expect. In Figure 6 are presented the maximum pull-out forces obtained for 40 cm walls versus the respective displacement. The formation of the pull-out cone requires the highest force, but at the same time is the failure mode causing the most damage to the masonry wall. Retrofitting of masonry walls requires more expertise and is more time consuming than simply replacing the strengthening. So one must consider if is more appropriate to favour other failure mode with less impact on the wall when proposing strengthening connections.

above the failure modes found. In this case, it was used $\phi 16$ bars with 8.8 steel grade, which places the limit beyond FM1, at 1.89 (160.85kN). This is a good way of controlling the failure of the connection, since the behaviour of steel is well known and it also presents a ductile behaviour.
