## The vernacular house between the Cávado and the Ave, Portugal

C.E. Barroso, D.V. Oliveira, L.F. Ramos & P.B. Lourenço

ISISE, Universidade do Minho, Guimarães, Portugal

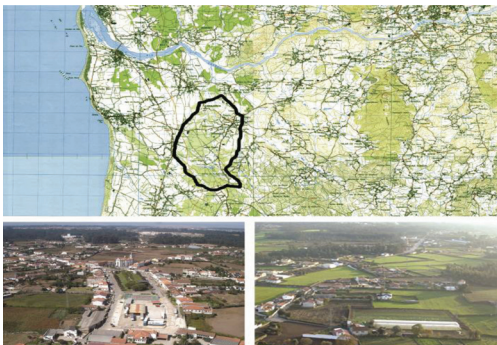
Figure 1. Study area's limits on Portuguese military chart (41°29'6.46"N, 8°43'43.43"W). Northeast views. (Credits: C.E. Barroso et al.).

The selected territory to carry out the study, see Figure 1, corresponds to the limits of Barqueiros, a village of 8 km<sup>2</sup> of the Municipality of Barcelos near the Cávado river, located in the coastal strip of the Entre-Douro-e-Minho (Ribeiro, 1945).

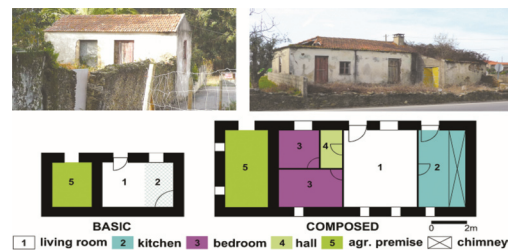
Figure 3. Examples of basic and composed elementary farmhouses. Schematic representations of common dwellings' layout. (Credits: C.E. Barroso et al.).

As seen in Figure 3, Elementary Farmhouses were small, a one floor building, with simplified partitioning and constructed in small plots of land. Basic models were of low construction quality buildings, divided by a masonry wall in a single dwelling compartment, sometimes divided by timber frame walls into living room and bedroom, and a small agricultural compartment to support survival agriculture.

Construction areas were of about 20 m<sup>2</sup> to 40 m<sup>2</sup>, with 2.5 m height, with gable roofs, no ceilings, with openings in the plot façade, complemented with small ventilation openings on the opposite wall.

Composed models presented better construction quality and larger areas that allowed more openings and independent compartments for bedrooms and a kitchen with independent access from the complex. In these larger models, the agricultural complex takes shape with specialized premises, occupying around 50% of constructed area.

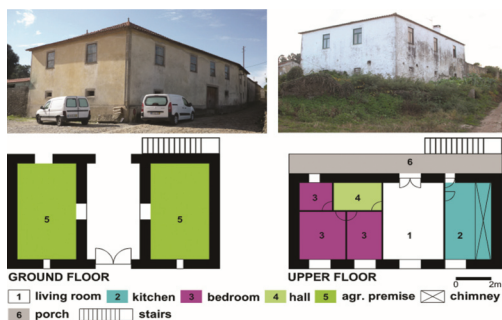
Figure 4. Examples of block farmhouse. Schematic representation of most common dwellings' layout. (Credits: C.E. Barroso et al.).

Block Farmhouses, locally named *casas torre*, see Figure 4, were characterized by the vertical presence of a two-floors building composed by the dwelling, now in the upper floor, and storage and cattle premises in the ground floor, placing in the same horizontal area two different functions (Oliveira & Galhano, 1992). Thus, the dwelling had better moister protection, it gained the warmth produced by the cattle below and visual domain over the farm.

Overall construction quality was improved and dwelling's area was larger with widths of around 6 m, allowing more complex internal organizations

that included the kitchen also in the upper floor. An exterior granite stair, parallel or perpendicular to the rear façade, connected the external enclosed area to the upper floor porch or entrance of the dwelling.

The agricultural complex was organized in an L configuration, occupying over 50% of the constructed area, and included specialized agricultural premises like the *varandão*, a two-floor outbuilding independent or next to the main building, for grain and cereal storage and drying, the winery or the 30 m<sup>2</sup> granite threshing floor or *eira*.

The following constructive description is based on the typical block farmhouse (Fig. 4) and it is representative of most common construction techniques used in the studied buildings. As seen in Figure 11, these buildings were structurally composed of external two-floor height schist masonries, forming a "structural box", interlinked to each other, to ground floor partition masonry walls, and to horizontal structural timber elements of pavements and roofs (Barroso, 2012).

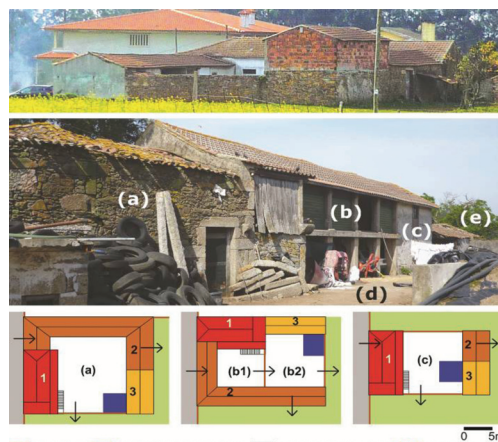
Figure 5. Example of a courtyard farmhouse. Example of agricultural outbuilding: (a) shed; (b) *varandão* (c) workers' accommodations; (d) *eira*; (f) watermill. Schematic representations of courtyard complexes configurations: (a) U; (b1; b2) multi courtyard; (c) opposite sides. (Credits: C.E. Barroso et al.).

The Courtyard Farmhouses, very common in isolated or larger complexes, were composed by an elementary composed or block dwelling, and as seen in Figure 5, inserted in an agricultural complex organized in one or multiple U, O, or opposite sides of the courtyard complex. Their agricultural premises and outbuildings had high independence and very specialized functions like the workers' accommodations, production kitchens, water and windmills, etc.

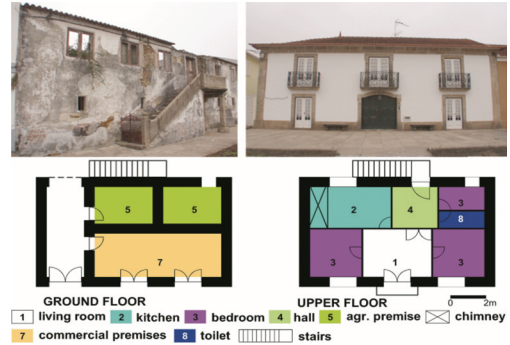
Figure 7. Examples of adapted and mixed farmhouses. Schematic representation of most common dwellings' layout. (Credits: C.E. Barroso et al.).

Adapted Street Farmhouses, see Figure 7, were the result of the adaptation of existing farmhouses to accommodate commercial premises. A process of internal functional reorganization was performed, and elements like ground floor doors and windows, even façade stairs and entire new sectors, were constructed, resulting frequently in buildings' aesthetic incoherence. Mixed Street Farmhouses were overall aesthetic and functional coherent buildings, built from scratch to incorporate all three functions.

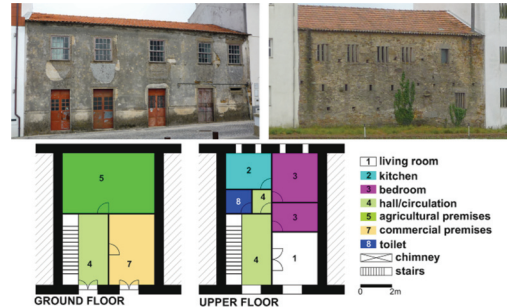
Figure 8. Example of a row house. Schematic representations of most common dwellings' layout. (Credits: C.E. Barroso et al.).

As seen in Figure 8, Row Street Houses were two-floors buildings, frequently with an added third floor. They were built in 6 m wide modules, with two openings per floor, and an average 10 m depth, occupying the entire plot of land, with gable roofs and sharing structural partition walls. Entrance hall, commercial and small agricultural premises occupied the ground floor, and the dwelling the remaining ones. Toilets were very frequent in these buildings.

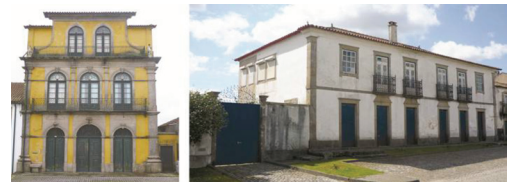
Figure 9. Examples of "*brasileiro*" and *bourgeois* street houses. (Credits: C.E. Barroso et al.).

*Bourgeois* and "*Brasileiro*" Street Houses, see Figure 9, were two or three floors buildings, with strong urban influence, superior construction quality, larger constructed areas, heights of average 4 m by floor, good habitability conditions, and aesthetic diversity.

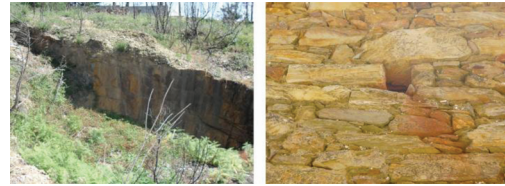
Figure 10. Example of abandoned schist quarry. Example of ochre, red and brown schist masonry. (Credits: C.E. Barroso et al.).

As seen in Figure 10, due to its superficial or low depth availability, schist was the main structural masonry material. From metamorphic to sedimentary, from hard to claylike rocks (Costa, 2008), existing schist presents a great mineralogical and color diversity, originating different masonry performances.

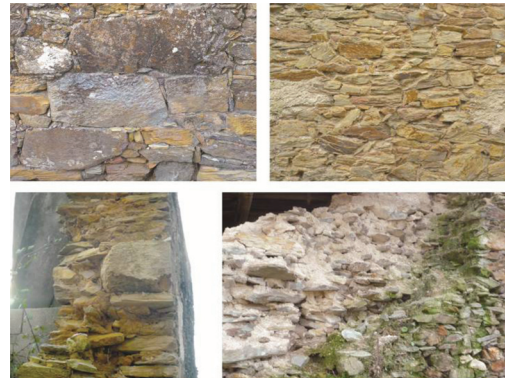
Figure 12. Examples of regular and irregular masonry. Examples of masonry's section and core. (Credits: C.E. Barroso et al.).

Structural masonry walls were composed by shallow foundations of 0.3 m deep, sometimes 0.1 m wider to each side of the wall, double masonry leaves enclosing a rubble internal core, and in more elaborated buildings, a granite or mortar cornice. As seen in Figure 12, wall's leaves were constituted of mortar bounded regular or irregular masonry, laid out in layers with larger masonry units placed at the lower part, and using small schist units as leveling wedges.

In order to increase walls' cohesion, units with more irregular faces were placed in the inner side of the wall, as opposed to external leaves, which were connected either by transversal stones, or attached to the core by deeply penetrating masonry units.

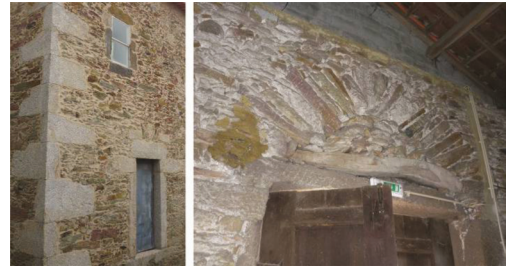
Figure 13. Examples of reinforced masonry walls with stoned worked granite and schist. Example of relieving arch. (Credits: C.E. Barroso et al.).

To minimize risks, connections between perpendicular walls were reinforced with bondstones, as seen in Figure 13, in granite on corners. Fragilities introduced by openings in masonry walls' structural continuity were resolved by reinforcements in granite or schist curbs and by constructing relieving arches (Appleton, 2011).

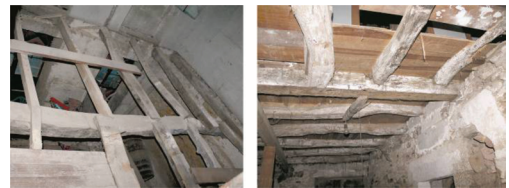
Figure 14. Example of a structural timber pavement. (Credits: C.E. Barroso et al.).

Horizontal structural timber elements were connected by embedment into walls, to a depth of 2/3 of section (Teixeira, 2004). As seen in Figure 14, pavements were built with wooden beams, covering an average of 6 m span, embedded in ground floor masonry walls and reinforced with wooden billets.

These were placed transversally between beams, and allowed better support for upper floor light timber frame walls and openings for stairs.

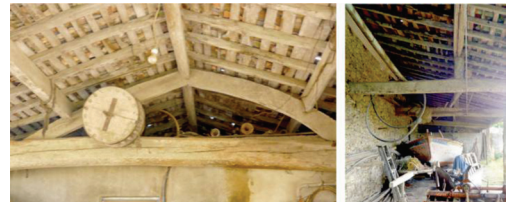
Figure 15. Examples of double and single pitched roofs. (Credits: C.E. Barroso et al.).

To allow the installation of the fireplace's granite slab (0.2 m × 1 m × 2 m) and oven, some extra beams were added to the pavement. The floorboards were applied directly over the beams, or over the battens. As seen in Figure 15, wooden roofs were structurally composed of trusses that supported ridges and purlins, and were embedded into the masonry walls. Rafters were placed over the purlins and were either embedded into the masonry walls or connected to the wooden beams. Battens were attached over the rafters and supported the tiles.

Due to the low resistance and less water tightness of the handcraft tiles, roofs were very ventilated and permeable, with slopes of around 20%, not allowing attics and requiring constant maintenance. Single pitched roofs were built in simplified buildings, double pitched roofs in smaller buildings, and triple or more pitched roofs in larger buildings.
