Figure 1: Details of adopted configurations for the interior RC beam-column connections.

Figure 5: Details of the schemes used for the retrofitting of the damaged specimens (dimensions in mm)

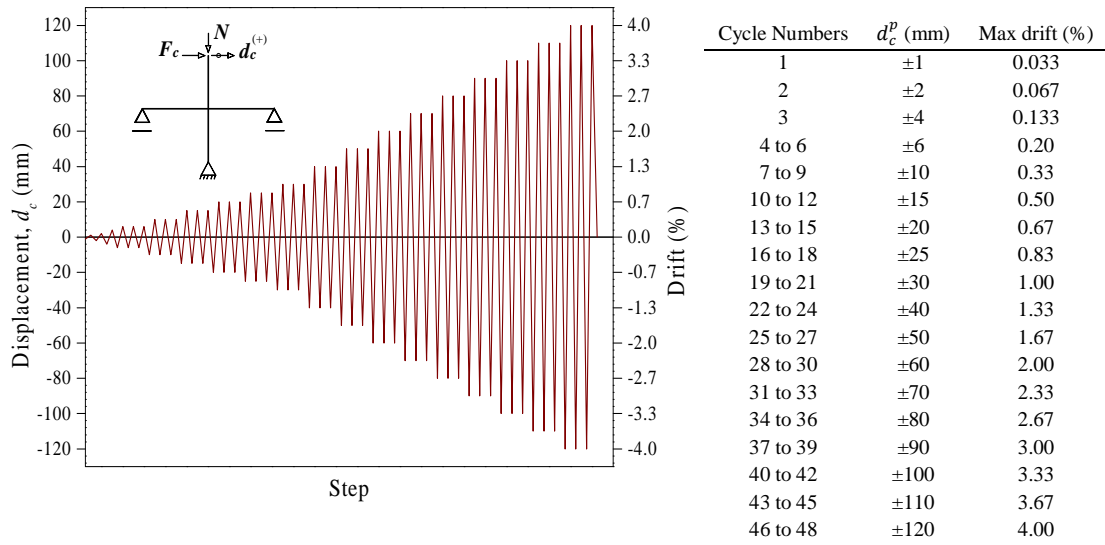
Figure 2: Loading history adopted for the lateral displacement cycles (d_c^p : peak displacement for the corresponding cycle or set of cycles).

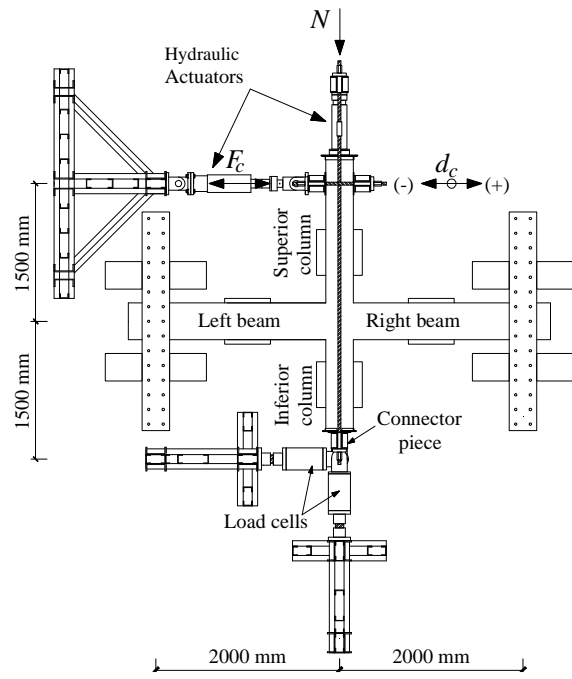
Figure 3: Test setup adopted for the horizontally placed specimens [20]

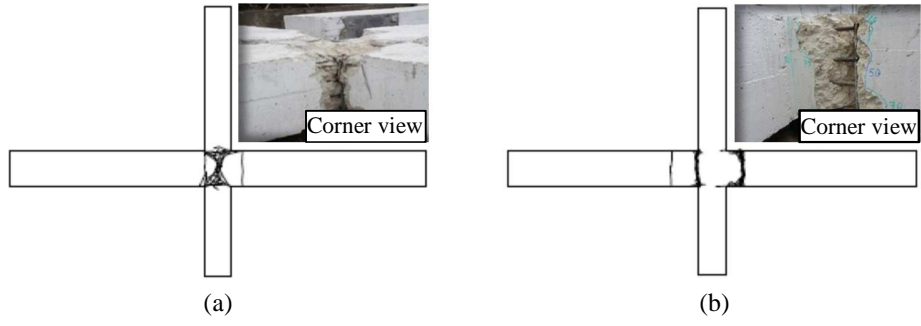
Figure 4: The extent of damages before retrofitting a) JPA3 and b) JPB.

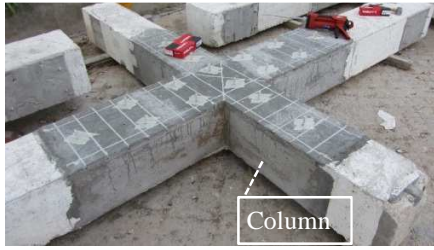
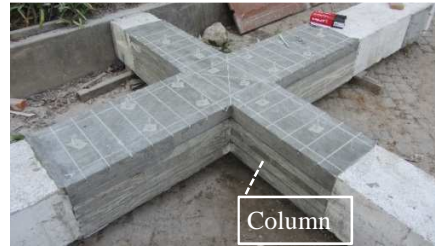
Figure 6: View of the retrofitted specimens a) JPA3-R and b) JPB-R.

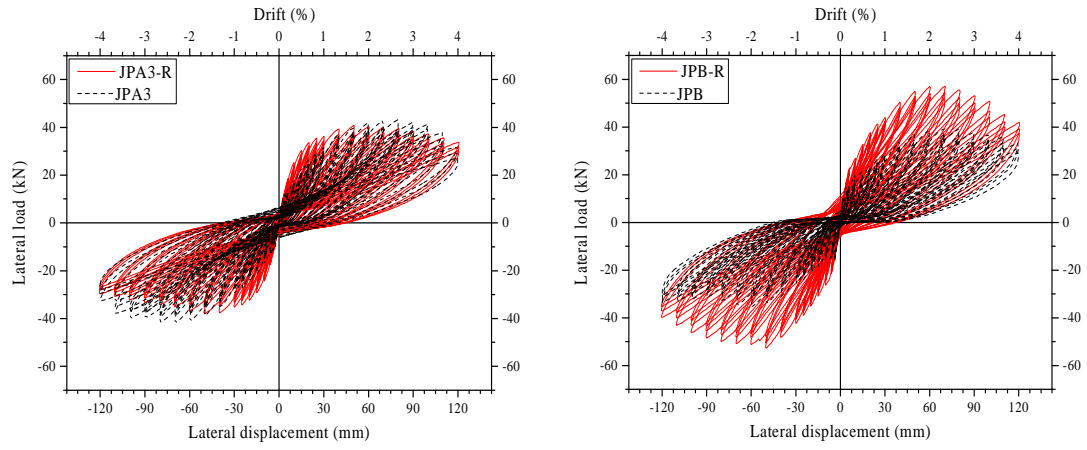
Figure 7: Hysteretic responses of the specimens in the strengthened and virgin states

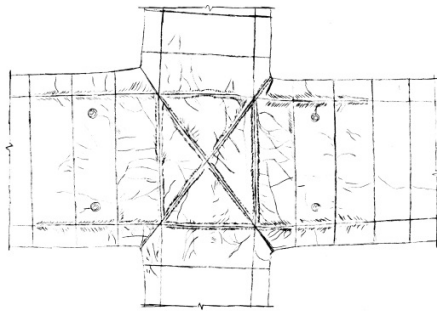
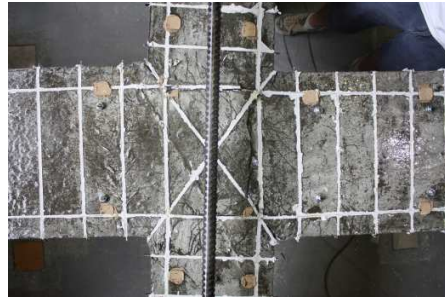
Figure 8: Damage propagation and concentration at the failure of (a) JPA3-R and (b) JPB-R

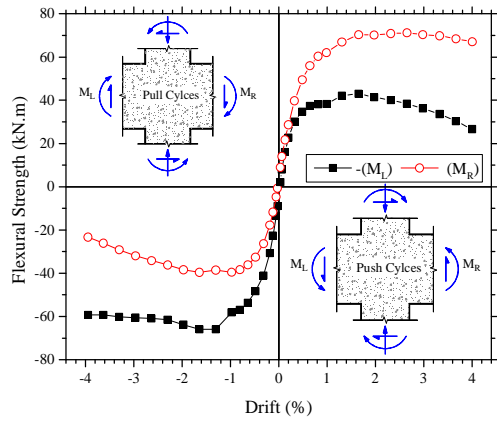
Figure 9: Development of the resisting bending moment at the interfaces of the beams with columns a) JPA3-R and b) JPB-R

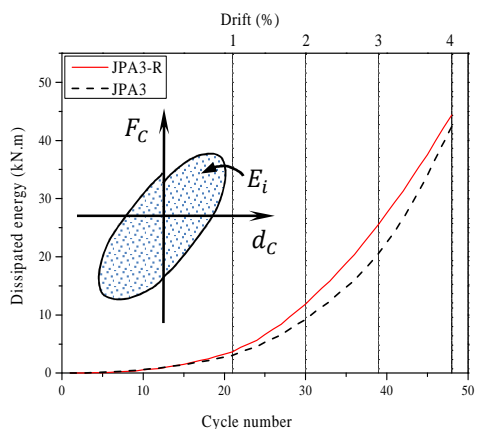
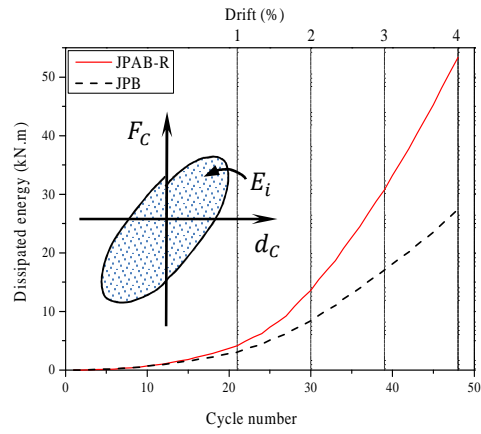
Figure 10: Evolution of the dissipated energy during the cyclic loading a) JPA3-R and JPA3, and b) JPAB-R and JPB.

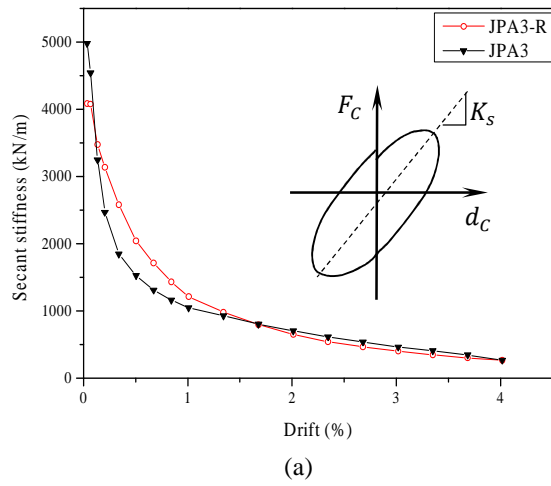
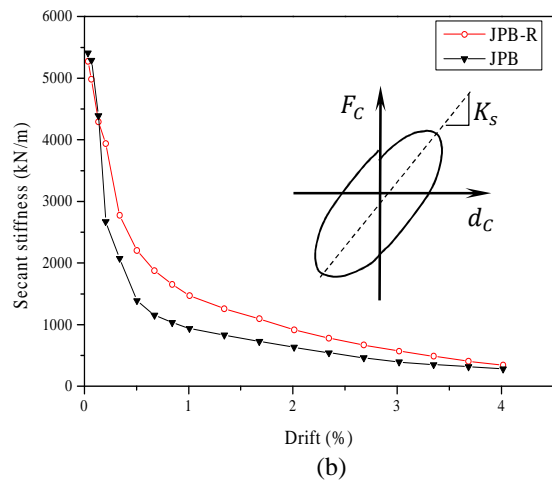
Figure 11: Secant stiffness evolution in a) JPA3-R and JPA3, and b) JPB-R and JPB.

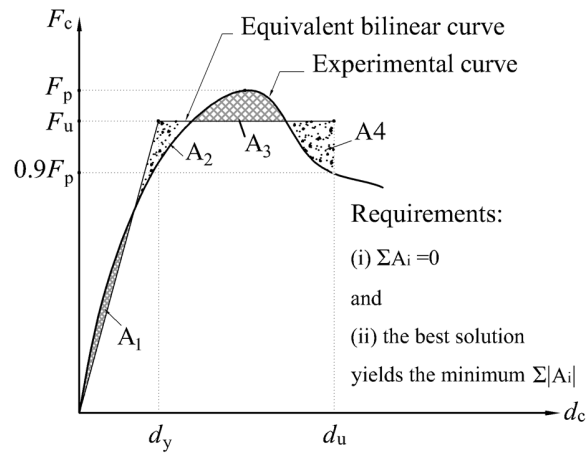
Figure 12: Schematic representation of the definition of the equivalent bilinear curve for the evaluation of the displacement ductility index.

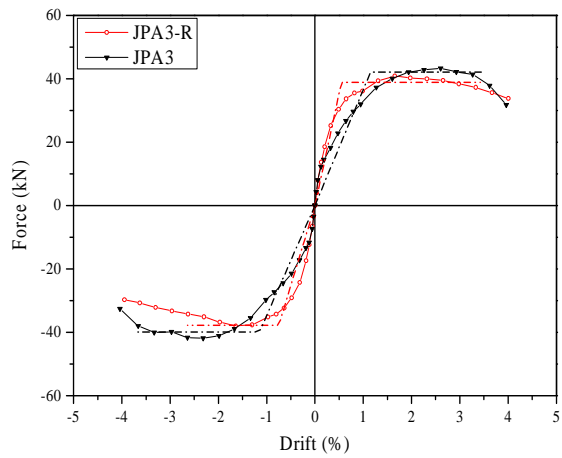
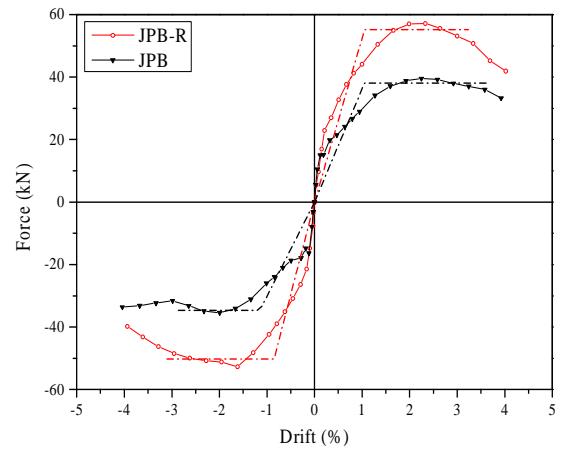
Figure 13: Envelope of the load versus drift for both the repaired and virgin specimens along with the equivalent elastic-perfectly plastic curves a) JPA3-R and JPA3, and b) JPB-R and JPB.
