Traditional timber frame walls: mechanical behavior analysis and retrofitting

G. Vasconcelos, E. Poletti

Abstract

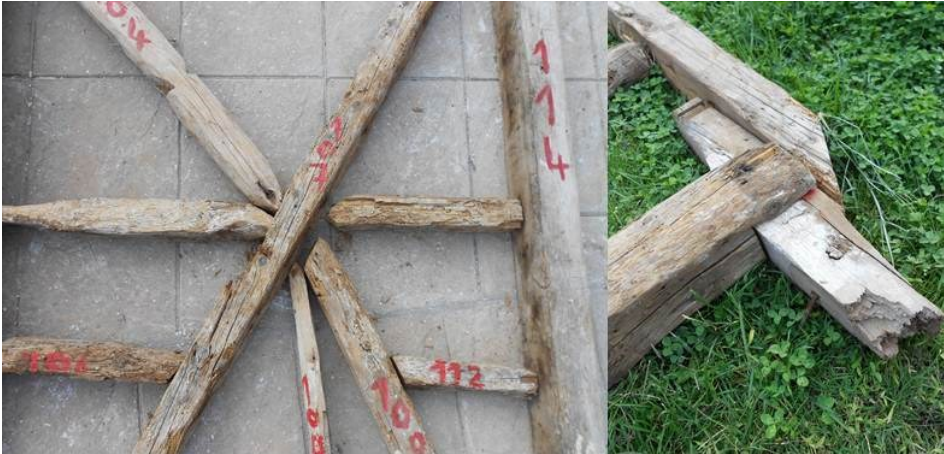
Fig. 2
 Different geometries of timber frame walls encountered: (a) geometry variability in frontal walls (Cóias, 2007); (b) examples of connections used in Lisbon (Mascarenhas, 2004); (c) connections of timber frame wall in Chalkida, Greece

Usually, mechanical connections such as half-lap joints or adopted were adopted, particularly when timber frames were specifically built with seismic resistant purposes (see the examples of Portugal and Lefkas, Figure 2). Generally, the diagonals were connected with simple notched connections or were simply nailed (Figure 2c).

Bracings disposition varies greatly, Figure 2a, as well as the dimensions of bracings and their regularity. If in frontal walls they are generally sturdy, thinner elements are used in *dhajji dewari* construction or even in traditional buildings found in Greece (as little as 25mm in the case of *dhajji dewari*). In *himis* construction a great number of timber frame wall typologies can be identified (Aktas, 2011), with a great variability in terms of spacing of the posts (varying from 15 to 60cm), while diagonal elements are present only at corners. Also in *dhajji-dewari* walls the disposition of the bracings varies greatly, going from a regular disposition (similar to that of frontal walls) to a highly irregular one, with random layouts based on the builder's skill and the available timber elements (Langenbach, 2009).

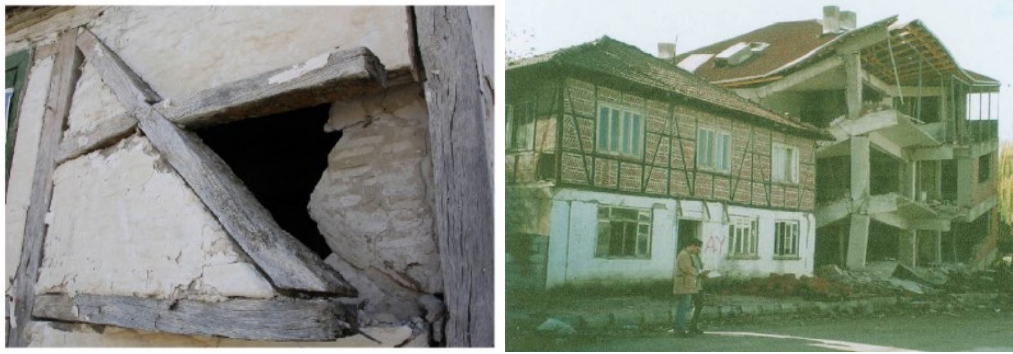
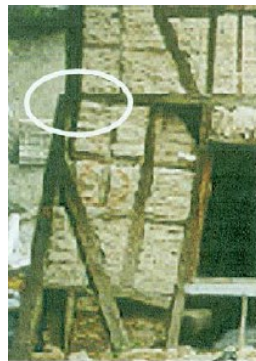
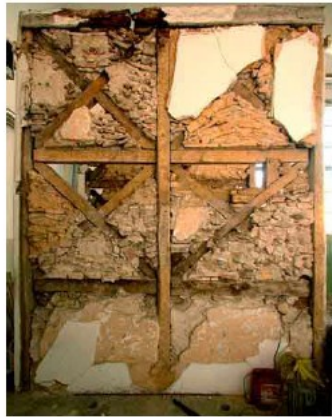
Fig. 3

Examples of damages in timber frame buildings; (a) out-of-plane collapse of masonry infill (Lefkada, Greece) (Makarios, 2006); (b) comparison of damages to traditional and modern building after the 1999 Duzce earthquake; (c) failure of connection in timber frame (1999 Kocaeli earthquake (Gülhan and Güney, 2000).

Figure 3. Examples of damages in timber frame buildings; (a) out-of-plane collapse of masonry infill (Lefkada, Greece) (Makarios, 2006); (b) comparison of damages to traditional and modern building after the 1999 Duzce earthquake; (c) failure of connection in timber frame (1999 Kocaeli earthquake (Gülhan and Güney, 2000).

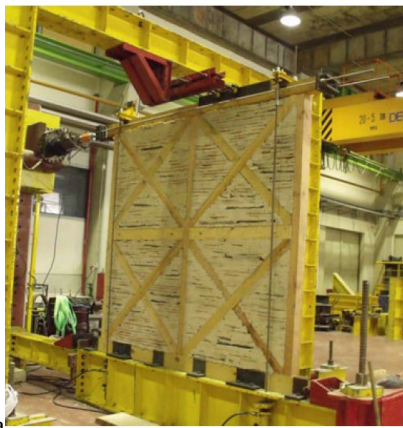
Fig. 4
Experimental testing of Pombalino frontal walls; (a) Santos (1997); (b) Meireles et al. (2012)

Cyclic tests were also carried out by Meireles *et al.* (2012) on walls similar to the ones tested by Santos (1997), see Figure 4b. The wood specie selected was pinus pinaster, a typical Portuguese softwood, and modern nails were adopted, but assembled according to what is seen in existing walls (number and positioning). For the beams and posts a cross section of 12x8cm² was used and for the diagonals a section of 10x7cm² was adopted. Half-lap connections were considered between beams and vertical posts and between diagonal bars, additionally secured with two nails. The diagonal bars were connected to the beams and posts through nails. For the infill material it was decided to use brick masonry made with low strength hydraulic lime mortar. The walls were tested under a cantilever boundary configuration, as the top of the wall could rotate. The bottom beam was fixed to the reaction structure so that uplift was avoided. The vertical load applied was of about 80kN by means of

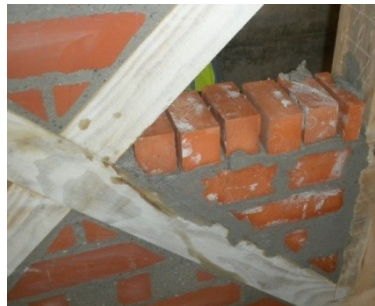
Fig. 5
Timber frame walls tested by Poletti (2013); (a) timber frame wall without infill; (b) timber frame wall with brick masonry infill brick; (c) timber frame wall with lath and plaster covering

In-plane cyclic tests were carried out by Poletti and Vasconcelos (2014) in timber frame walls with the same geometrical configuration and connections (half-lap connections) but in this case, the dimension of the braced diagonal cell is lower, leading to a total height and a length of the wall 8% lower. Only one nail was used in all half-lap connections and regular brick masonry was considered as infill material, even if timber frame walls without infill were also considered, see Figure 5a,b. In some specimens lath and plaster covering was adopted as infill material, see Figure 5c. The vertical load was applied directly on the posts. Two levels of vertical loads were considered, namely 25kN and 50kN per post, and the tests were carried out under displacement control following a cyclic increasing displacement history, according to the ISO protocol (ISO 21581, 2010). The typical load-displacement diagrams are presented in Figure 6 for timber frame walls with brick masonry infill and empty timber frame walls for the two levels of vertical load. From the analysis of these diagrams, it is possible to observe that: (1) the timber frames filled with brick masonry and lath and plaster covering present similar behaviour, being the predominant resisting mechanism characterized by flexure, corresponding to the uplift of the lateral posts and rotation of the wall, as can be seen also through the diagrams of Figure 6, where the vertical displacements measured at the bottom

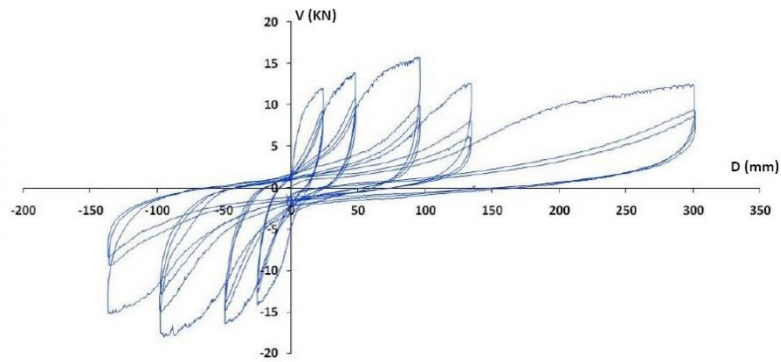
Fig. 7

Force-displacement diagrams obtained in distinct types of timber frame walls; (a) Vieux-Champagne et al. (2014); (b) Torrealva and Vicente (2012).

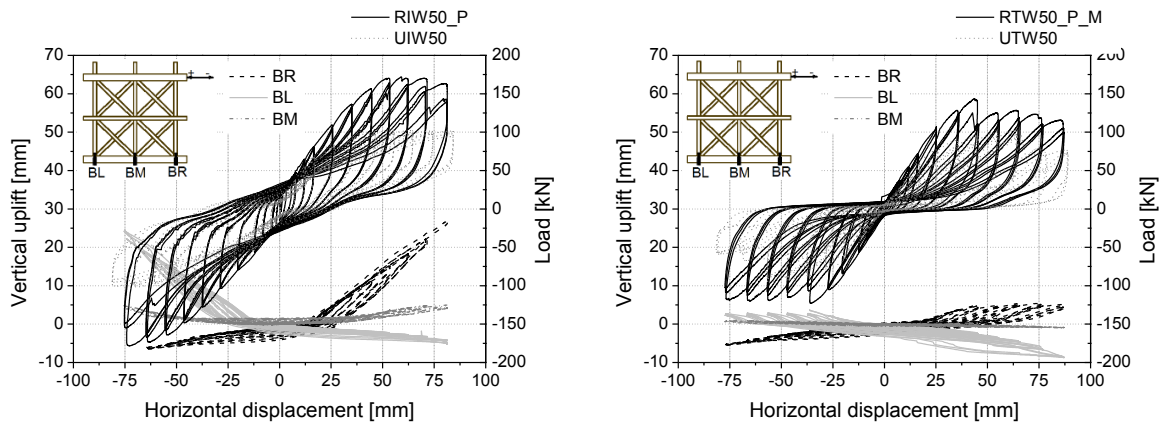
Fig. 12

Comparison of force-displacement diagrams between unreinforced and retrofitted timber frame walls; (a) timber frame wall with brick masonry infill custom steel plates and unreinforced timber frame wall; (a) timber frame wall without infill with commercial steel plates and unreinforced timber frame walls (Poletti and Vasconcelos, 2013); (c) retrofitted timber frame walls with steel plates (MW 6 and MW6) and unreinforced walls (MW1) (Gonçalves et al., 2014)

The comparison between the hysteresis diagrams found in unreinforced walls and after retrofitting with steel plates can be made through the analysis of Figure 12a, where results are shown for the walls tested with the higher vertical pre-compression (RIW50_P – timber frame

The performance of the retrofitting with custom star shape steel plates was also evaluated by Gonçalves et al. (2014), being observed that the retrofitting resulted in the considerable increase on the lateral strength and on the energy dissipation, see Figure 12c.
