Chapter 16

Assessment of Innovative Solutions for Non-Load Bearing Masonry Enclosures

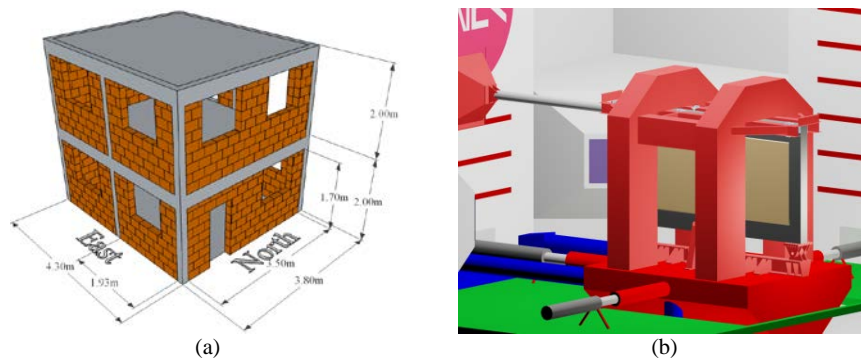
Fig. 16.1 Schematic representation of: (a) building model; (b) wall panels' test setup.

The first phase of the research activity involved the seismic testing of a two-storey RC frame building designed according to Eurocodes 2 and 8 (2010) and built at a 1:1.5 scale, schematically shown in Fig. 16.1 (a). As a follow-up of previous tests performed at LNEC, using RC buildings either with double leaf unreinforced masonry infill walls or with single leaf masonry plus bed joint reinforcement, this reduced scale model was built with single leaf clay bricks and a reinforced mortar coating: wire mesh reinforcement was placed within the mortar coating on both sides of the infill walls and anchored to the RC frame and masonry units. From these tests it was possible to assess the evolution of the seismic behaviour of infills and their influence on the RC structure through several acceleration inputs of increasing amplitude, associated to cumulative damage limit states.

The geometry of the reduced scale building model is shown in Fig. 16.1 (a). The dimensions of all models respect the typical dimensions for RC frames according to the survey in Pereira (2013). Moreover, traditional clay brick units, horizontally perforated, were used in all models.

As mentioned in the introduction, the test setup for the wall panels simultaneously uses the shake table, one reaction wall and the Testing device for Innovative Masonry infills (TIM), as represented in Fig. 16.1 (b).

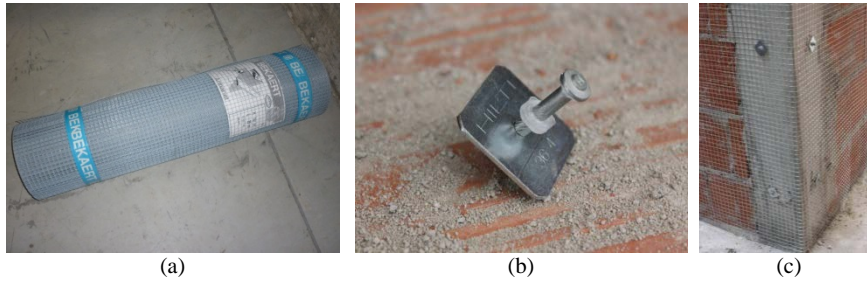
Fig. 16.3 Details of the wire mesh reinforcement application.

The reinforced mortar coating adopted was composed of the reinforcement mesh Bekaert Armanet $\phi 1.05$ mm 12.7 mm x 12.7 mm, a pre-batched M5 class mortar and the Hilti X-M8H10-37-P8 connectors for attaching the wire mesh to the RC elements, as illustrated in Fig. 16.3.

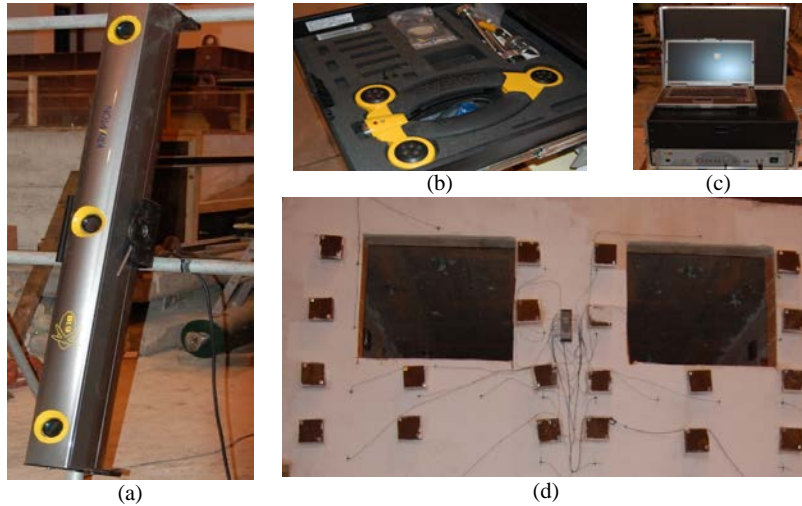
Fig. 16.6 K600 camera system by Krypton (2003): (a) CCD cameras; (b) calibration equipment; (c) acquisition system; (d) LEDs distributed on the upper floor infill wall of the North façade.

Additional measurements of out-of-plane motions at the North façade infill wall were carried out using the K600 camera system by Krypton (2003), composed of three CCD cameras that are able to track the 3D displacement of a set of infrared LEDs. The latter were spread on the upper floor wall, see Fig. 16.6.

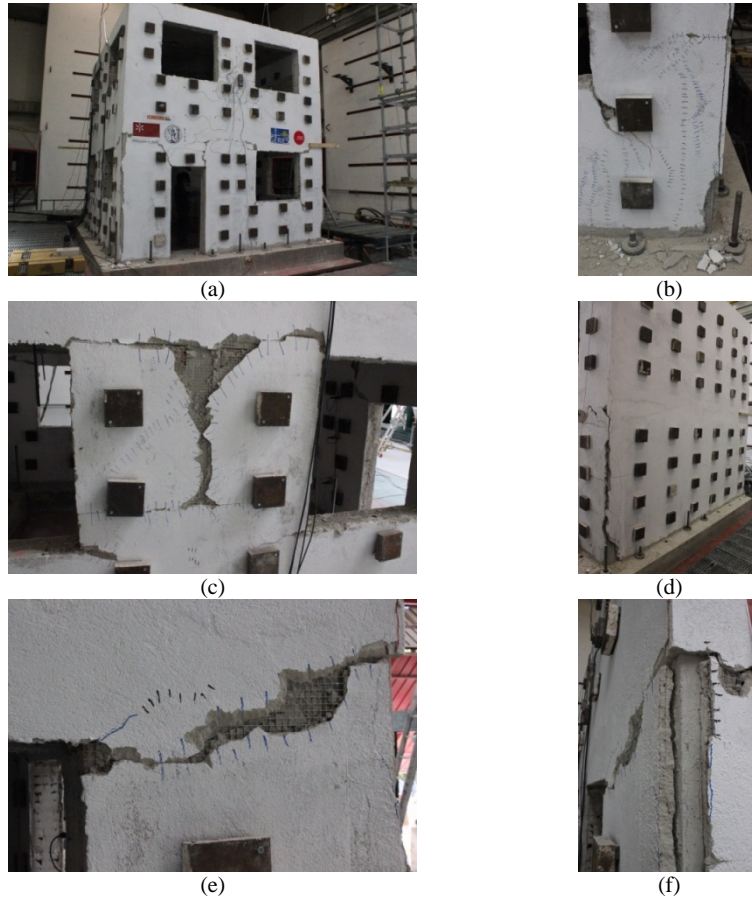
Fig. 16.11 Damage after additional seismic tests: (a) North façade; (b) crack and mortar rendering loss at the Northwest corner; (c) crack at the interior jambs in the infill wall at the ground floor of the East façade; (d) South façade; (e) crack at a lateral jamb in the infill wall at the ground floor of the East façade; (f) crack and mortar rendering loss at Northeast corner.

After the additional three test stages, the specimen did not develop new cracking patterns but the existing ones widened considerably, see Fig. 16.11. On the other hand, the mortar coating became increasingly detached from the infill walls, apparently depending completely on the connection provided by the additional masses. These results highlight the importance of establishing a good connection of the reinforced coating to the infill walls. Regarding the upper storey, it presented no significant damage, with nothing but small cracks forming at the corners of the openings.

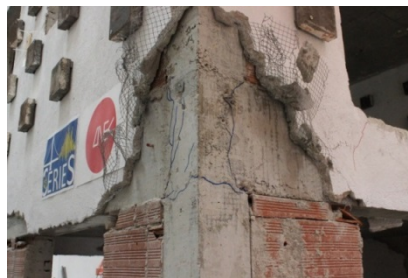
Fig. 16.12 Extensive cracking observed upon reinforced coating removal at the beam-column connection in the Northwest corner.

Upon removal of the additional masses, it was apparent that the reinforced coating was completely detached from the infill walls and that the supports of the additional masses worked as connectors, thus preventing the mortar coating from collapsing. Moreover, a careful analysis of the infill walls showed that, although these presented limited damage, they were overall disconnected from the RC frame. This implies that there was a major contribution of the reinforced coating in preventing the out-of-plane collapse of the infill walls. Regarding the RC structure, extensive cracking was detected at some of the beam-column connections, as shown in Fig. 16.12. The RC frame was very flexible under these conditions, meaning that the reinforced coating may have contributed significantly to prevent the collapse of the entire specimen.

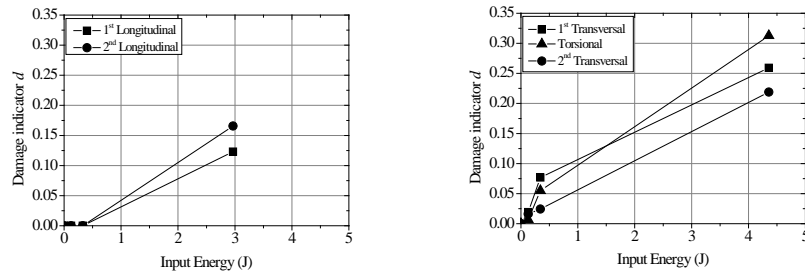
Fig. 16.15 Seismic vulnerability curves using the input energy as intensity measure.

Fig. 16.15 depicts seismic vulnerability curves, for each vibration mode of the building specimen, in terms of relative frequency decrease versus the seismic input energy as intensity measure. These confirm that the longitudinal direction presented no considerable damage until stage 3. After this stage, the transverse direction presented considerably more damage when compared to the longitudinal one, which is clearly associated to a larger energy input.

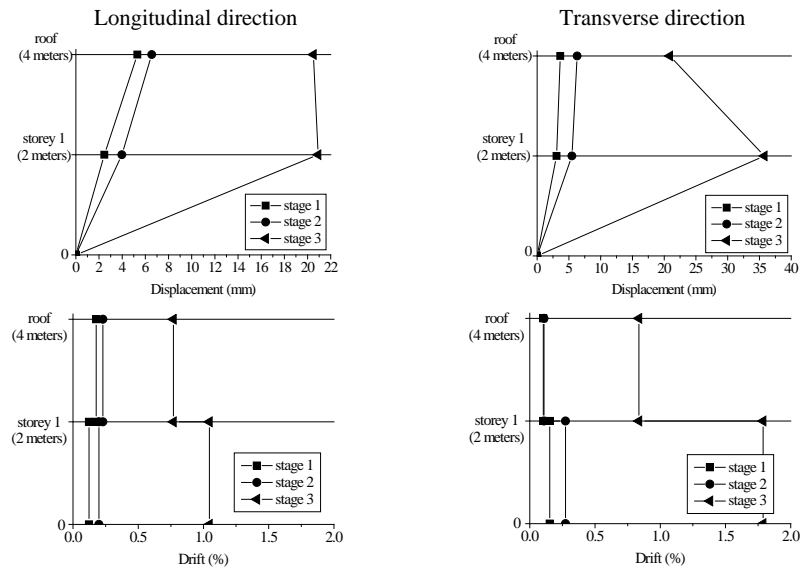
Fig. 16.17 Maximum interstorey displacements and drifts for the additional tests.

Similar comments can be made on the basis of the results obtained in the additional seismic tests, presented in Fig. 16.17. Nevertheless, the maximum values of the floor displacements and interstorey drifts were significantly larger than the ones obtained on the first set of three test stages.

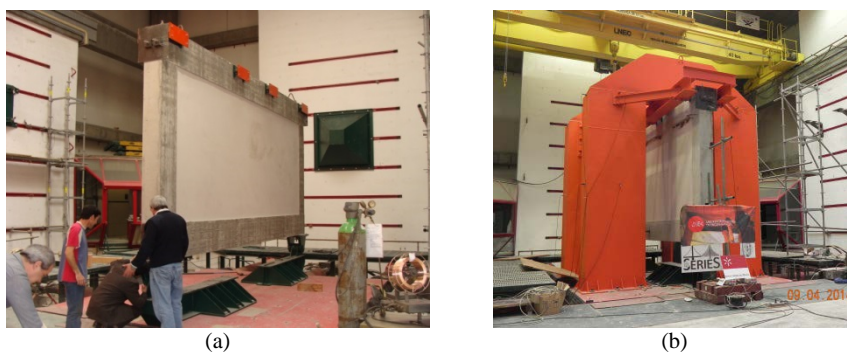
Fig. 16.20 Wall panels test setup: (a) Hinged base and pyramidal support; (b) complete setup.

The in-plane motion enforces an inter-storey drift time-history on the frame by restraining the upper beam and by imposing the displacement of the shake table on the lower beam. The upper beam, which also has 360 kN of centred prestress for withstanding push-pull actions, is prevented from moving in the longitudinal direction through a strut connection to the reaction wall. This connection between the strut and the reaction wall is performed via a pyramidal support, as depicted in Fig. 16.20 (a), which distributes the strut reaction on the wall. A long rod then links the pyramidal support to the RC frame upper beam through hinged connectors. All beam-column joints are free to rotate in the plane of the infill, through special hinged base supports, visible in Fig. 16.20 (a).

On the other hand, the out-of-plane motion consists on a rigid-body vibration of both the upper and lower beams, reproducing the storey absolute accelerations and thus inducing high-frequency inertia forces perpendicular to the masonry panel and leading to a local vibration of the infill wall. Note that this shake table motion is transmitted to the top beam through the rigid steel caisson structure of TIM. The design of TIM was thus controlled by the requirement of a very stiff behaviour in the transverse direction, which was ensured by a vibration frequency for the first mode of vibration above 20 Hz. The entire test setup is shown in Fig. 16.20 (b).

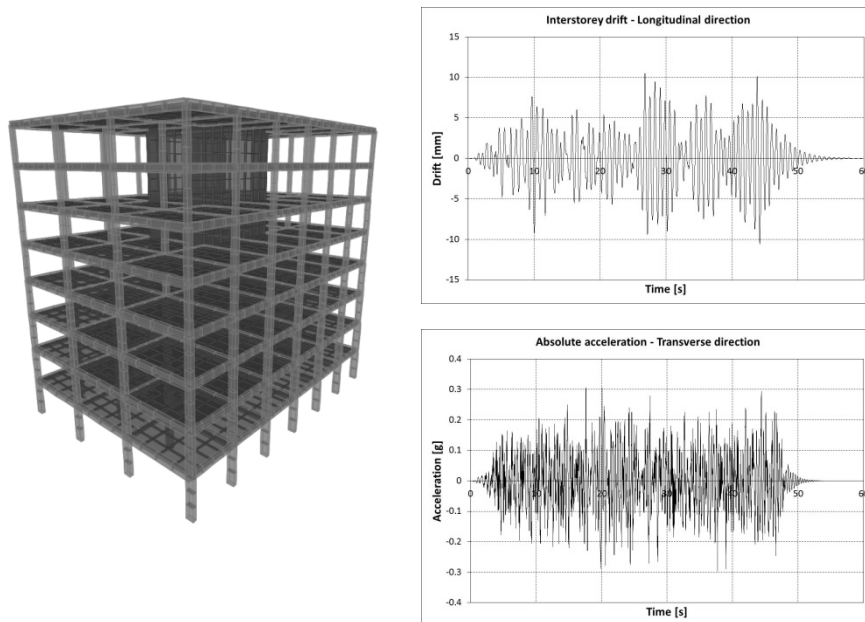
Fig. 16.25 Representative building model for wall panel input time-histories definition and resulting in-plane (longitudinal) and out-of-plane (transverse) time-histories.

The response time-history in terms of interstorey drift at the 4th floor for the seismic input considered corresponds to the shake table motion to be applied in the longitudinal direction. On the other hand, the absolute acceleration observed in the out-of-plane direction corresponds to the shake table motion transmitted by TIM to the masonry panel inside the RC frame. Both longitudinal and transverse motions are represented in Fig. 16.25.
