# congresso da **reabilitação** do património

## Estudo do desempenho térmico e avaliação das condições de conforto em edifícios antigos: casos de estudo do município de Ovar

### Study of thermal performance and evaluation of comfort conditions in ancient buildings: case studies from the Portuguese municipality of Ovar

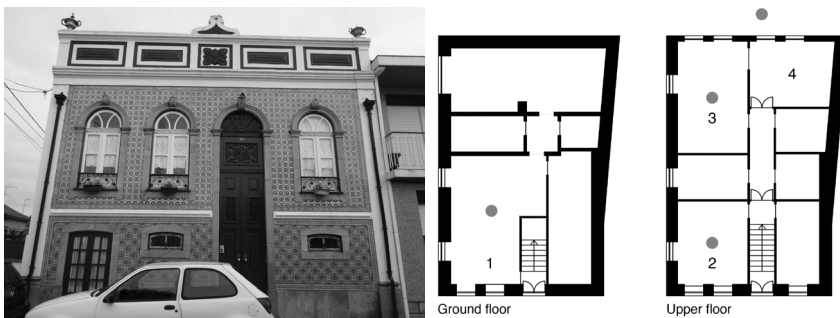
Figure 2. (left) External view; (right) Floor plans showing the position of measuring instruments (1—living room; 2—bedroom; 3—dining room; 4—kitchen).

Case study 1 is on the East side of the town. The building is integrated into the urban mesh, in a group of buildings forming a small public square. Its facades are facing north, west (street) and east (courtyard). The gross floor area is approximately 250 square meters divided into two storeys. In the ground floor, there are the living room, the garage and storage rooms. In the first floor, at West are the bedrooms and at East the dining room and the kitchen (Fig. 2). It was not possible to determine exactly the date of construction but, according to the owners, it is probably from the 19th century. Regarding the building systems, it was not possible to determine the materials used in the building. Nevertheless, it is highly probable that the materials used are the most common in this type of buildings in Ovar, as above mentioned. Thus, the building envelope consists of walls built with a mix of small stones and clay (average thickness of 60cm), with a pitched roof, wooden doors and wooden framed single glazed windows in the main façade and aluminium framed double glazed windows in the rear facade. Indoors, the partitions walls are in *tabique* – a wooden framed structure where the spaces between studs are fulfilled with small stones, bricks or clay.

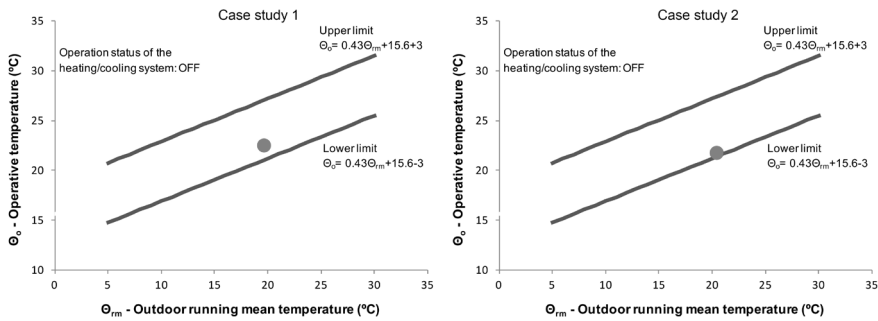
Figure 6. Adaptive comfort chart for summer monitoring without heating/cooling systems. (left) Case study 1 – Thermal comfort temperature (operative temperature) in the dining room/kitchen; (right) Case study 2 – Thermal comfort temperature (operative temperature) in the living room.

The assessment of the summer season comfort conditions was done in case study 1 for the kitchen/dining room and in case study 2 for the living room (Fig. 6). In both cases, from the analysis of the charts, it was found that the rooms had a comfortable thermal environment, within the comfort range but close to the lower limit. In the subjective assessment carried out, two occupants showed to be “neutral” (comfortable) and one as “slightly cool” in the thermal sensation scale, confirming the objective measurements. Although the results from the short-term measurements represent one day, the conditions of thermal comfort can be extrapolated to almost all days, since there is a strong relation of dependency between the air temperature and the operative temperature [13].

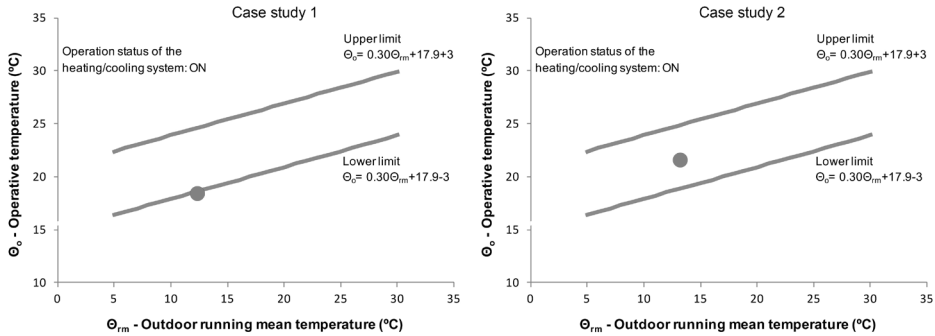
Figure 9. Adaptive comfort chart for winter monitoring with heating system. (left) Case study 1 – Thermal comfort temperature (operative temperature) in the dining room/kitchen; (right) Case study 2 – Thermal comfort temperature (operative temperature) in the living room.

The assessment of the winter season comfort conditions was done in case study 1 for the kitchen/dining room and in case study 2 for the living room (Fig. 9). In case study 1, the kitchen/dining room had a thermal environment in the lower limit of the comfort range, even with heating equipment turned on. In the subjective assessment, three occupants answered as being “neutral” (comfortable) and two as “slightly warm”. Although the objective measurements show that room’s environment is in the lower limit of the comfort range, two occupants answered as being “slightly warm”, in the opposite limit. The explanation for this result is that these occupants were the ones closest to the electric heater. In case study 2, with the heating system activated, the living room had a good thermal environment (Fig. 9). In the subjective assessment, two occupants answered as being “slightly warm”, one as being “hot” and one as being “slightly cool” in the thermal sensation scale. Although the objective measurements showed that the room had a good thermal environment, almost in the middle of the comfort range, none of the occupants answered as being comfortable. This result has several explanations. The first is the thermal resistance of clothes, the second is that one occupant was closest to the heat radiator and the other was the closest to the external wall, being the two influenced by the radiation effect, one receiving heat from the radiator and the other losing heat to the cool wall. The measurements in the two cases reflect the complexity of assessing thermal comfort and the importance of choosing an adequate point for performing the measurements, they also show the difference between occupants and the need to perform longer measurements in order to force occupants to adapt their clothes to the environment they are in.

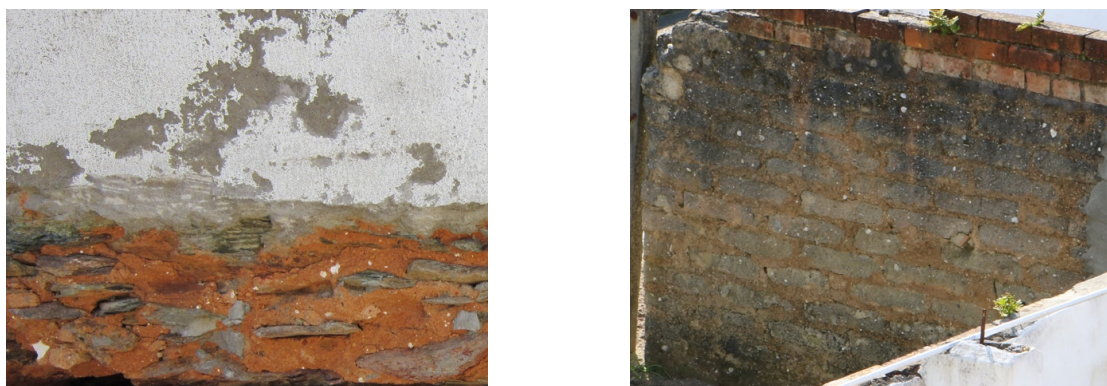
Figure 1. Materials used in Ovar's constructions. (left) mix of stone gravel and clay wall; (right) adobe wall.

The town is implanted on sandy soil. However, the soils from nearby areas at East are not only very fertile but characterized by the presence of gravel, phyllite, and schists associated to luvisols (i.e. soils that are rich in clay) [8]. In the absence of proper stone for building conventional masonry [6], local population had to use the locally-available resources as building materials. Soil's features determined the materials and the building's systems used. Thus, the most widespread materials/building systems in Ovar's architecture are walls built with adobe or with a mix of small stones (or gravel) with clay (Fig. 1).

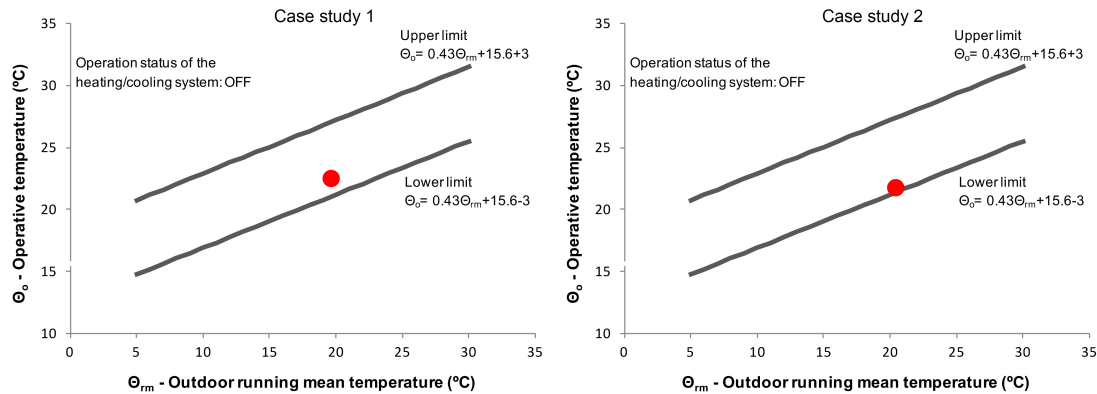
Figure 6. Adaptive comfort chart for summer monitoring without heating/cooling systems. (left) Case study 1 – Thermal comfort temperature (operative temperature) in the dining room/kitchen; (right) Case study 2 – Thermal comfort temperature (operative temperature) in the living room.

The assessment of the summer season comfort conditions was done in case study 1 for the kitchen/dining room and in case study 2 for the living room (Fig. 6). In both cases, from the analysis of the charts, it was found that the rooms had a comfortable thermal environment, within the comfort range but close to the lower limit. In the subjective assessment carried out, two occupants showed to be “neutral” (comfortable) and one as “slightly cool” in the thermal sensation scale, confirming the objective measurements. Although the results from the short-term measurements represent one day, the conditions of thermal comfort can be extrapolated to almost all days, since there is a strong relation of dependency between the air temperature and the operative temperature [13].

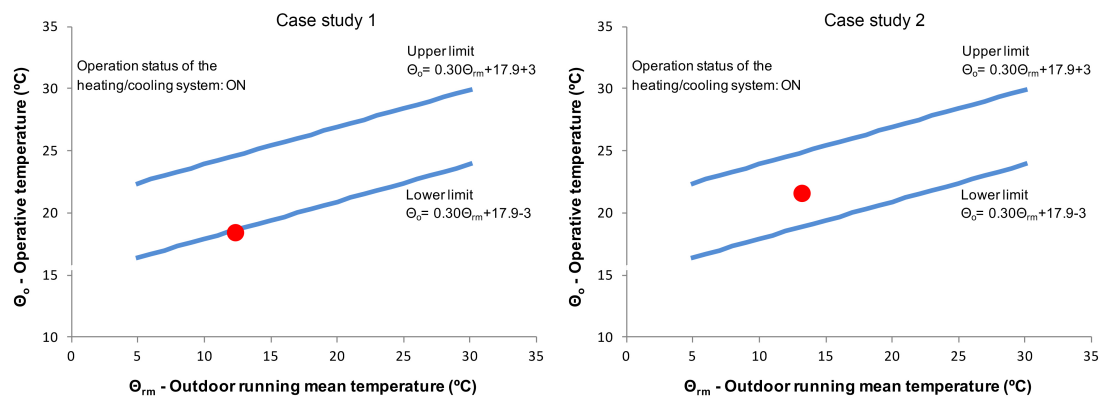
Figure 9. Adaptive comfort chart for winter monitoring with heating system. (left) Case study 1 – Thermal comfort temperature (operative temperature) in the dining room/kitchen; (right) Case study 2 – Thermal comfort temperature (operative temperature) in the living room.

The assessment of the winter season comfort conditions was done in case study 1 for the kitchen/dining room and in case study 2 for the living room (Fig. 9). In case study 1, the kitchen/dining room had a thermal environment in the lower limit of the comfort range, even with heating equipment turned on. In the subjective assessment, three occupants answered as being “neutral” (comfortable) and two as “slightly warm”. Although the objective measurements show that room’s environment is in the lower limit of the comfort range, two occupants answered as being

“slightly warm”, in the opposite limit. The explanation for this result is that these occupants were the ones closest to the electric heater. In case study 2, with the heating system activated, the living room had a good thermal environment (Fig. 9). In the subjective assessment, two occupants answered as being “slightly warm”, one as being “hot” and one as being “slightly cool” in the thermal sensation scale. Although the objective measurements showed that the room had a good thermal environment, almost in the middle of the comfort range, none of the occupants answered as being comfortable. This result has several explanations. The first is the thermal resistance of clothes, the second is that one occupant was closest to the heat radiator and the other was the closest to the external wall, being the two influenced by the radiation effect, one receiving heat from the radiator and the other losing heat to the cool wall. The measurements in the two cases reflect the complexity of assessing thermal comfort and the importance of choosing an adequate point for performing the measurements, they also show the difference between occupants and the need to perform longer measurements in order to force occupants to adapt their clothes to the environment they are in.
