1 Mechanical Behaviour of Two Leaves Masonry Walls Strengthening using Different  
2 Grouts

20 The present research aims to investigate the mechanical performance of schist masonry walls before and after  
21 injection. Six masonry walls of typical schist stone constructions from the North of Portugal were constructed  
22 in accordance with the original construction materials and were tested under compressive load. Two different  
23 grouts were chosen to inject the wall specimens (one commercially available and another prescribed). The  
24 results obtained showed that these strengthening techniques were successful in increasing the compressive  
25 strength of the walls and in improving their behaviour under compressive loads.

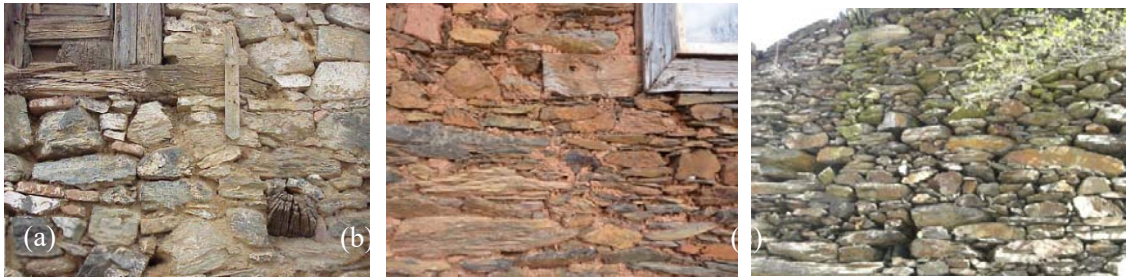
Figure 1 – Schist masonry walls: (a) and (b) with mortar joints; (c) with dry joints

31 Schist constructions are an important cultural, architectural and historical legacy in Europe, and particularly in  
32 Portugal, whose preservation is of importance. There are many buildings in schist masonry spread all over  
33 Portugal, varying in terms of buildings typology, constructive techniques and even type of schist (Barros *et al.*  
34 2010). Schist masonry in North-eastern Portugal typically has two types of constructions: with mortar joints,  
35 usually with mixtures based on clay or lime; or with dry joints, normally used in encircling walls, mills and  
36 shelters (see Figure 1).

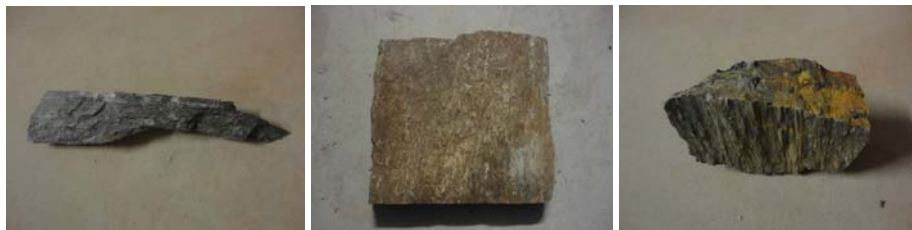
Figure 2 - Appearance of schist stones after cutting with hammer and pointer

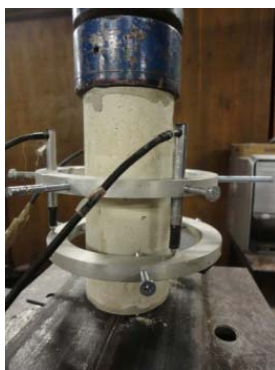
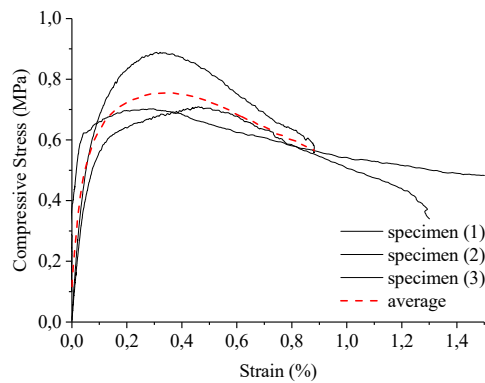
Figure 3 – (a) Compression test; (b) Stress-strain graph obtained in compression test

78 specimens (in average 20°C of temperature and 70% of relative humidity), which were subsequently tested  
79 under compression at the ages 28, 90 and 150 days, for the prismatic specimens. Three prismatic specimens of  
80 each age were tested, as well, for cylinders specimens (see Figure 3 (b)).

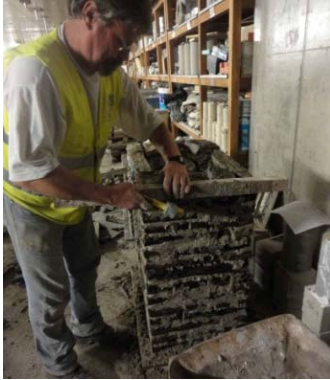
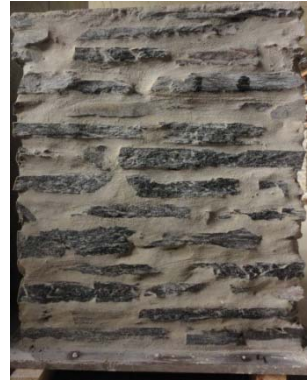
Figure 5 – (a) Construction of the walls (b) Final aspect of the wallet P4

106 The wall specimens are 0.70m wide, 0.89m high and 0.45m thick. The final aspect of one of the walls can be  
107 seen in Figure 5 (b). For details on the construction sequence, height of courses, average thickness of horizontal  
108 joints and geometrical details of the walls, see Luso (2012). The walls remained in place after construction for  
109 ten weeks curing and then the grouting work began.

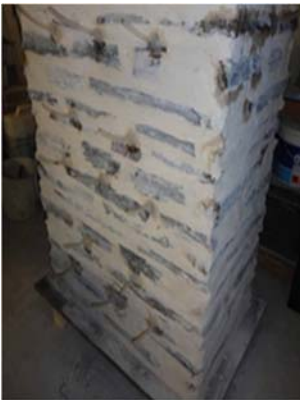
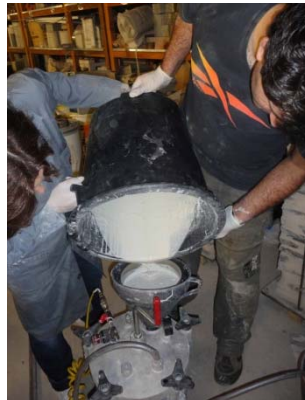
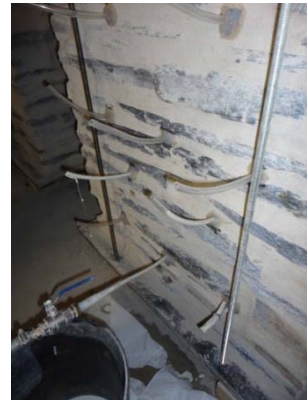
Figure 6 – (a) Wallet final aspect before grouting; (b) Introduction of grout in the pressure pot; (c) Injection of the walls

143 The grouts were mixed using a mechanical device of low turbulence for about 10 minutes. Each type of grout  
144 was injected into two walls (*P2* and *P6* with *Grout A*, *P1* and *P3* with *Grout B*), (see Figure 6). Hereafter, the  
145 walls are designated as *P4 nI* and *P5 nI*, for the walls not injected, *P2 IA* and *P6 IA* for the walls injected with  
146 *grout A* and finally *P1 IB* and *P3 IB* for the walls injected with *grout B*. During the injection procedure the  
147 active and inactive holes were identify, as well as the volume of grout introduced, the appearance of cracks or  
148 not, and the quantity of grout lost in leaks. On average, 50dm<sup>3</sup> and 42.5dm<sup>3</sup> of *grout A* and *grout B* respectively  
149 were injected per wall (grout leakage was negligible), corresponding to a volume of 12%, on average, of the  
150 total volume specified for the walls. Additional details on the procedure can be found in Luso (2012).

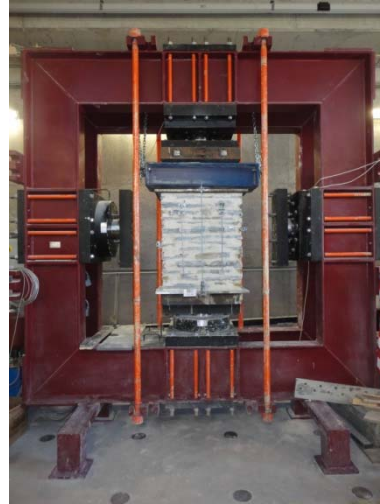
**Figure 7 – Test setup of the walls: scheme and testing machine**

153 All wall specimens were tested under monotonic compression using a 2MN closed-loop servo-controlled testing  
154 machine (see Figure 7). The tests were performed under displacement control at a constant rate of 5  $\mu\text{m/s}$ .  
155 During the tests, the displacements in the walls were measured by means of linear variable displacement  
156 transducers (lvdt's) disposed according to Figure 8. The lvdt layout in the walls aimed at measuring vertical,  
157 horizontal and transversal displacements directly on the walls, in order to compute mechanical parameters. One  
158 external lvdt (lvdt, v5) was used to measure the displacement between the plates of the testing machine and to  
159 control the tests.

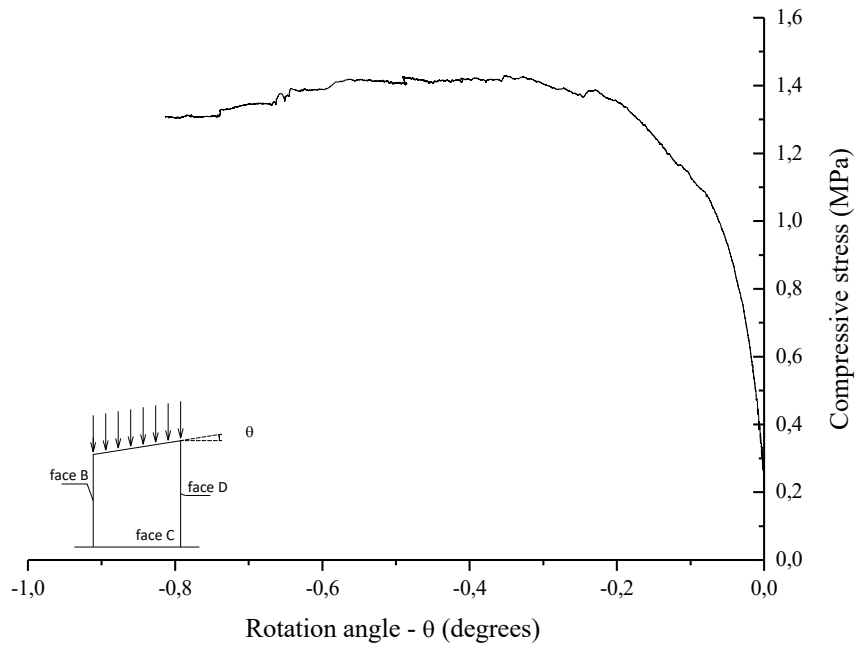
Figure 10 – Compressive stress vs angle of rotation of the walls: (a)  $P4\ nI$ ; (b)  $P5\ nI$

177 type of tests due to inevitable rotation, or non-symmetric failure, of the specimen in the post-peak regimen.  
178 Figure 10 shows the variation of the angle of rotation with the stress level installed.

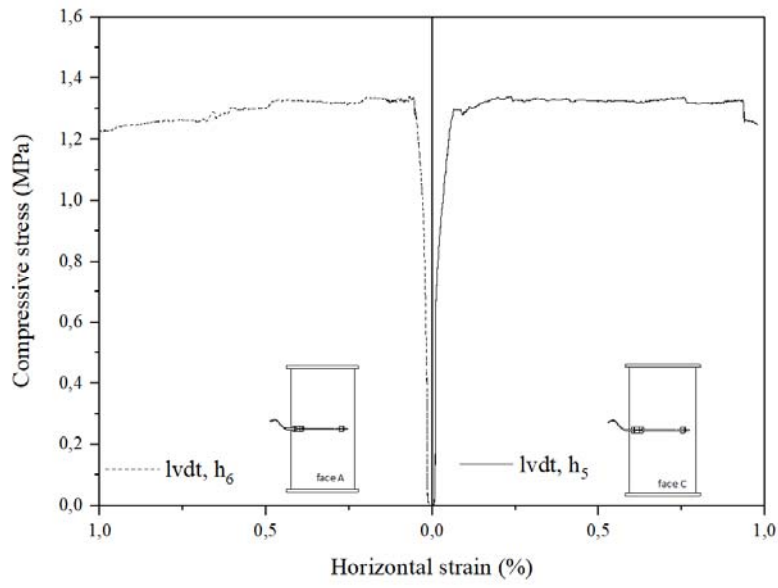
Figure 11 – Compressive stress/horizontal strain graphs on faces A and C: (a) *P4 nR* e (b) *P5 nR*

179 In relation to the horizontal deformation recorded on the transverse faces A and C, (see Figure 11), values of  
180 the same order of magnitude were observed in both walls (face B and D), (see Figure 12), since the number of  
181 joints in the measuring field is identical (at most, one or two joints between the lvdt's). The graphs of Figure 11  
182 show that the transverse deformation occurs, fundamentally, and abruptly, at load values close to the peak load  
183 and increases significantly after rupture. These results are similar to most failures of single leafs masonry walls,  
184 which occur in the transverse direction.

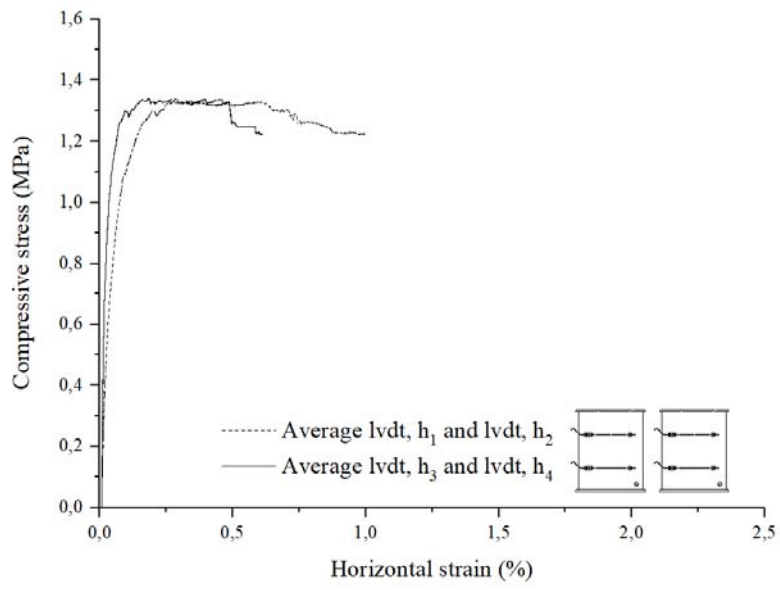
Figure 12 - Compressive stress/horizontal strain graphs on faces B and D: (a) *P4 nI* e (b) *P5 nI*

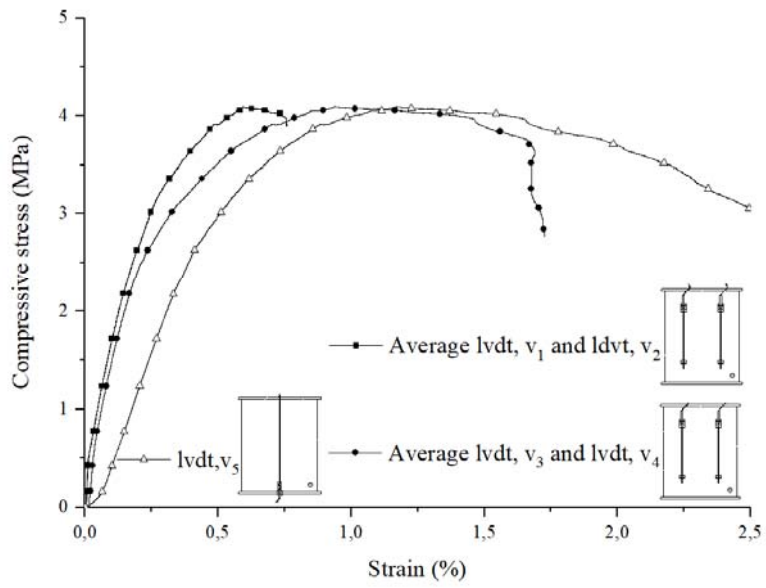
Figure 13 – Compressive stress/vertical extension graphs: (a) *PI IB* e (b) *P3 IB*

201 In the stress-vertical strain graphs of Figure 13 it can be verified that there is no significant difference between  
202 the vertical displacements in the internal scheme (average of values obtained in lvdt, v1 and v2) and in the  
203 external scheme (lvdt, v5) in face B for walls *P1 IB* and *P6 IA*. However, in the walls *P3 IB* and *P2 IA* there  
204 was some difference, (see Figure 14). In these two walls, the curvature of the graph at the initial phase of the  
205 test shows a more pronounced concavity associated with some adjustment of the steel plates to the test wall  
206 specimen. Comparing the measurements on face B and face D with respect to the vertical deformation, an  
207 increase in wall rotation from about 60% of the maximum load is observed on wall *P3 IB*. The evolution of the  
208 rotation of the strengthened walls with the applied stress level can be seen in Figure 15 and Figure 16.

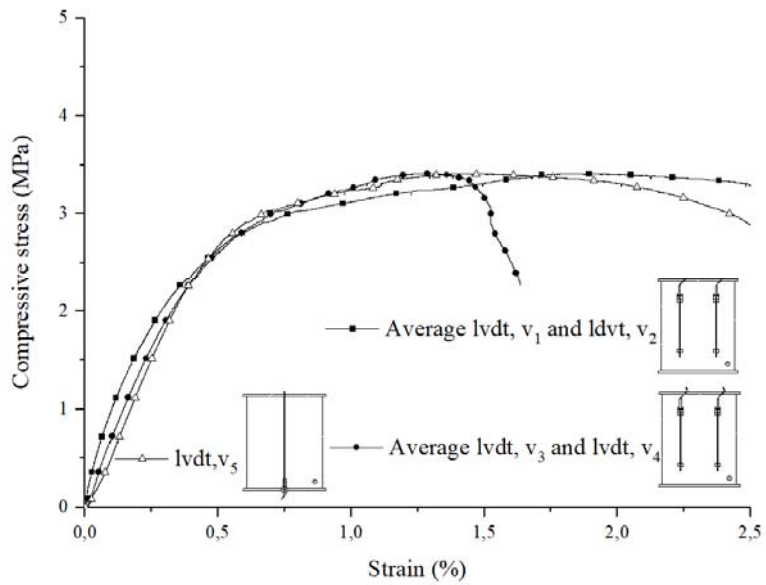
Figure 14 – Compressive stress-vertically extension graphs: (a) P2 IA e (b) P6 IA

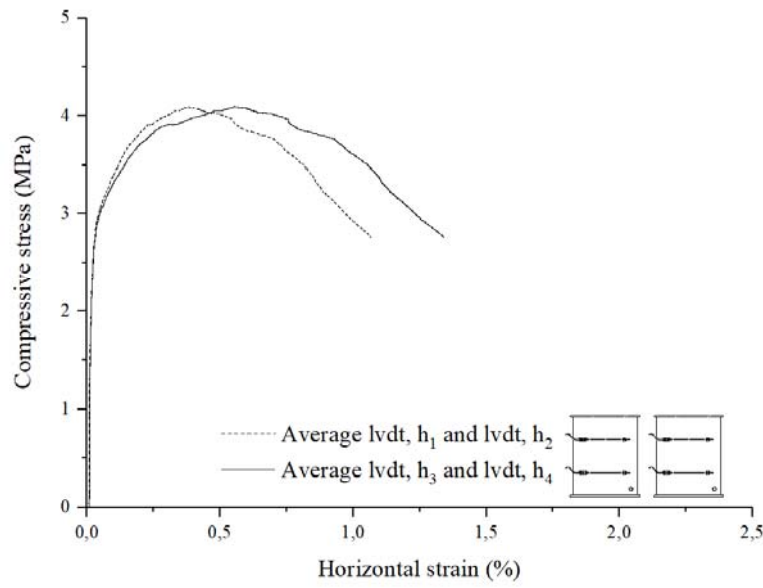
Figure 17 – Compressive stress-horizontal extension graphs: (a) *PI IB*; (b) *P3 IB*

209 Regarding the horizontal deformation, the deformations of the transverse faces A and C, (see Figure 17 and  
210 Figure 18), are similar to those of faces B and D, (see Figure 19 and Figure 20).

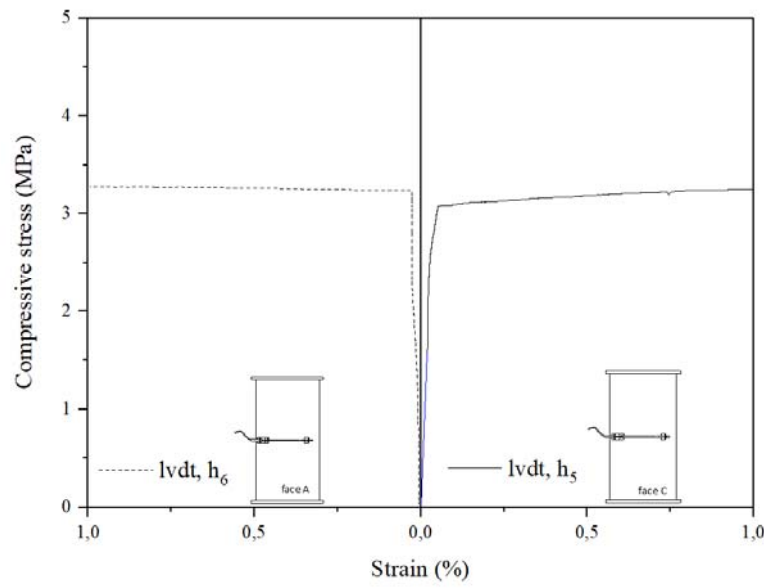
Figure 20 – Graphs compressive stress-horizontal strain on the transverse faces A and C: (a) P2 IA e (b) P6 IA

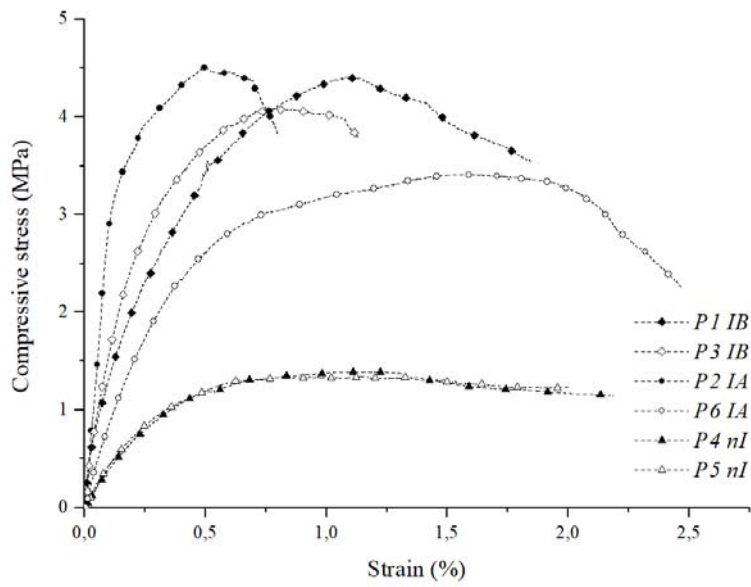
Figure 21 – Compressive stress-strain graphs for all tested walls

213 Following the analysis of the results of each wall, Figure 21 shows the vertical stress-strain diagrams for the six  
214 walls tested, with and without grouting, in order to facilitate comparison. In Table 6, the average values obtained  
215 in each type of strengthened wall are compared with the mean values obtained on the unstrengthened walls. It  
216 is found that the injection has significantly increased the compressive strength of the walls (about three times),  
217 and also the stiffness of the walls, about five times. The two grouts seem to have performed similarly in terms  
218 of strength and initial stiffness.
