# Thermal Performance and Comfort Conditions Analysis of a Vernacular Palafitic Timber Building in Portuguese Coastline Context

**Abstract:** The palafitic timber constructions of the central Portuguese coastline are an example of the adaptation to site-specific conditions (climate and sand landscape morphodynamics) using the available endogenous resources. Thus, in a context of environmental awareness and climate change, it is relevant to understand their features/strategies and how they perform. This work analyses the energy performance and thermal condition evaluation of a vernacular timber building—*palheiro*—from Praia de Mira, through in situ measurements, subjective analysis and energy simulation provided by DesignBuilder/EnergyPlus. The results show a good or satisfactory thermal performance during most of the seasons by passive means only. Despite, it was not possible to guarantee thermal comfort conditions for the occupants during winter. In the energy performance analysis, five scenarios, with different external walls, were compared. In the two scenarios that satisfy the maximum U-value for the climate zone, the current conventional building had a slightly better perfor

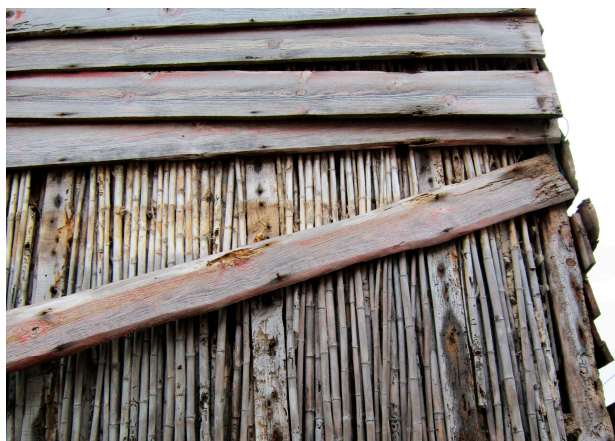
**Figure 2.** Reeds used as a thermal insulation layer of a timber wall (Leirosa, Figueira da Foz).

The transposition of the Energy Performance Building Directive (EPBD-recast) [14] into national legislation [15] has defined requirements which can limit and constrain the use of vernacular building elements as they had so far been used. Stricter thermal requirements, namely the thermal transmittance coefficient (U-value) and the low thermal inertia that characterizes the timber structures, hinders buildings' thermal performance in Southern European countries, mainly during the cooling season due to the overheating risk. Thus, the study of the real thermal performance of such buildings is necessary to understand whether this type of constructions can meet current energy and comfort requirements. As an example, according to the Portuguese legal requirements for external vertical opaque elements, the U-values must be lower than 0.35–0.50 W/(m<sup>2</sup>·°C), depending on the climatic zone [5]. For a timber wall (pine) to achieve this thermal performance, without an additional thermal insulation layer, it is necessary to have a 33 cm-thick massive timber wall (U = 0.50 W/(m<sup>2</sup>·°C) [16]). By using a thermal insulation layer (e.g., ≈8 cm of ICB-Insulation Cork Board), it is possible to reduce the wall's thickness at least by half. This solution is compatible with the traditional timber-framed cavity walls. Although most of these vernacular timber cavity walls have just an air gap, there are records of *palheiros* in Leirosa (near Figueira da Foz), in which the cavity was filled with reeds to provide an "insulation" layer (Figure 2).

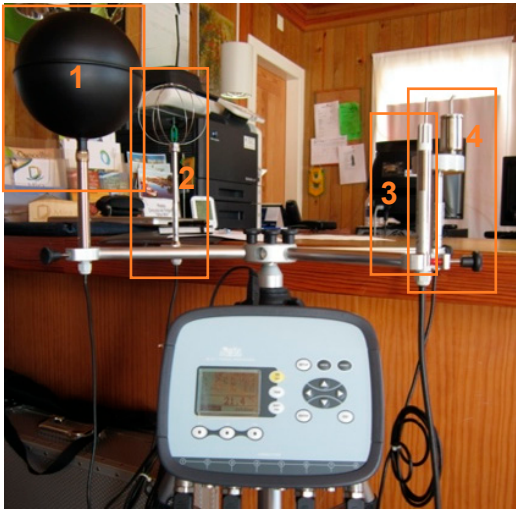
<p>Probes installed:</p> <ol style="list-style-type: none"> <li>1. Globe temperature probe Ø150 mm (range from −10 to 100 °C);</li> <li>2. Omnidirectional hot-wire probe for wind speed measurement (range from 0 to 5 m/s);</li> <li>3. Combined temperature and relative humidity probe (range from −10 to 80 °C and 5–98% RH);</li> <li>4. Two-sensor probe for measuring natural wet bulb temperature and dry bulb temperature (range from 4 to 80 °C).</li> </ol>	Reception
<p>Thermo-hygrometer and datalogger (Klimalogg Pro, TFA 30.3039.IT) + Wireless thermo-hygrometer transmitters (model TFA 30.3180.IT) connected to the datalogger</p>	<p>Datalogger:</p> <ul style="list-style-type: none"> <li>• Temperature accuracy of ±1 °C and a measuring range between 0 and 50 °C with 0.1 °C resolution;</li> <li>• Relative humidity accuracy of ± 3% and measuring range between 1 and 99% with 1% resolution.</li> </ul> <p>Transmitters:</p> <ul style="list-style-type: none"> <li>• Temperature accuracy of ±1 °C and measuring range between 39.6 °C and +59.9 °C with 0.1 °C resolution;</li> <li>• Relative humidity accuracy of ± 3% and measuring range of 1–99% with 1% resolution.</li> </ul>	<p><b>Datalogger:</b> Reception</p> <p><b>Transmitters:</b> Exhibition room “Classroom” “Dining room”</p>

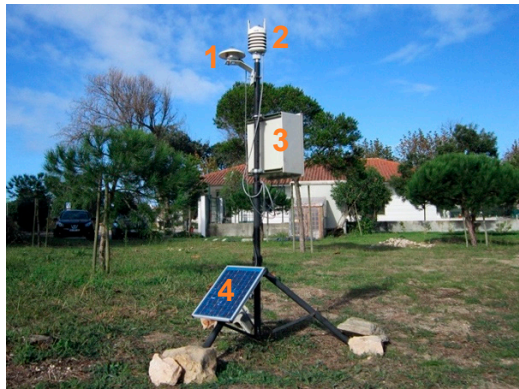
Probes installed: <ol style="list-style-type: none"> <li>1. Pyranometer (solar radiation sensor) CMP3-L, Kipp and Zonen</li> <li>2. Air temperature, relative humidity, wind speed and direction, precipitation and absolute pressure sensor (WXT520, Vaisala)</li> <li>3. Datalogger (CR800, Campbell Scientific, Inc.)</li> <li>4. Photovoltaic panel + battery (power source)</li> </ol>	Outdoor

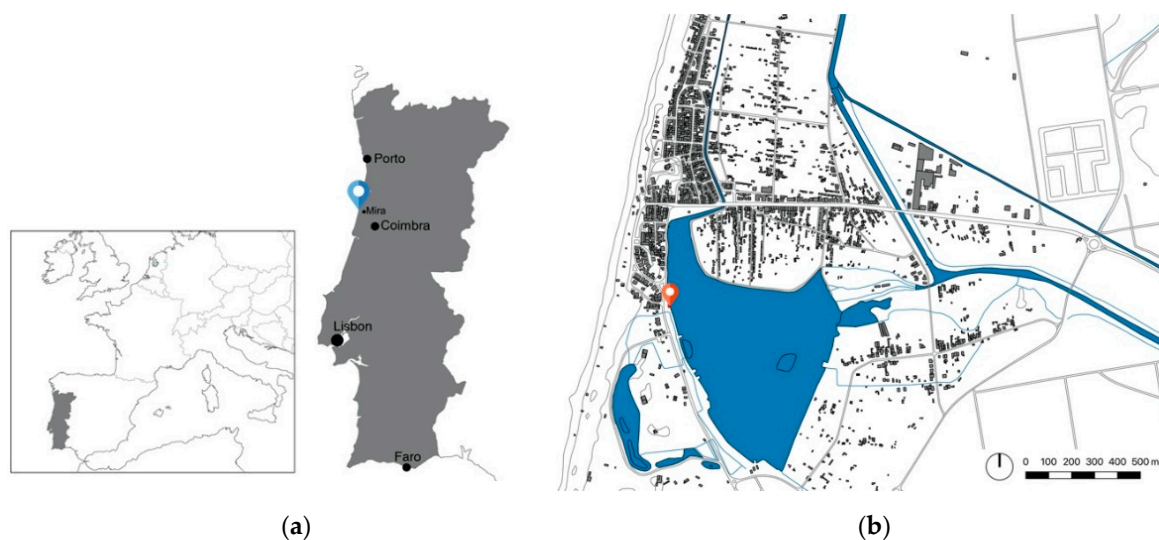
**Figure 3.** Case study's location. (a) country context; (b) case study position in Praia de Mira's current urban layout.

The case study is located in the village of Praia de Mira, in Mira's municipality, district of Coimbra, Portugal (Figure 3a). Praia de Mira, as other coastline settlements from the 19th century, had at first a seasonal occupation of fishermen during the fishing season (from Spring to Autumn) [28].

The village was strategically implanted next to a freshwater lagoon and sheltered by the dunes from north and west quadrants (Figure 3b). Praia de Mira was the shoreline settlement where timber construction had its best expression, due to the dimension of the village and for the size of the buildings (with three storeys in some cases) [28,30]. In the construction technique (“Type of Mira” [33]) used in the coastline between Costa Nova and Leirosa, the plumbs of the structure were built on a frame or a grid of beams, that in turn was on a dense mesh of pillars inserted in the ground (Figure 1a).

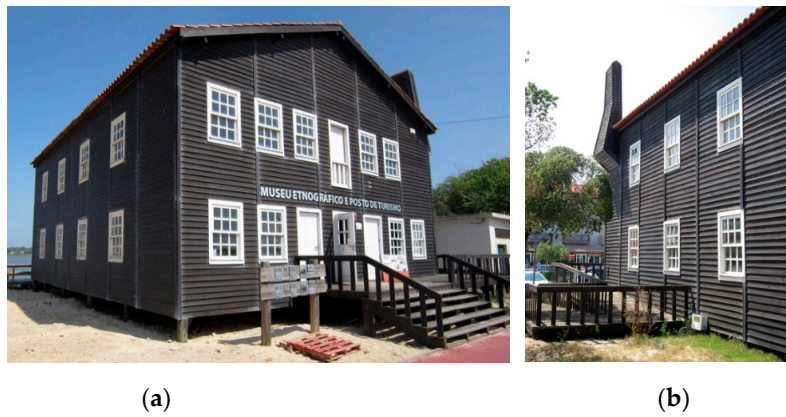
Figure 6. External views of the case study: (a) west and north façades; (b) south façade.

The case study is implanted near the lagoon and in an isolated position to emphasize its presence due to its purpose (Figure 3b). It has main and rear façades facing west (street) and east (lagoon), respectively (Figure 6).

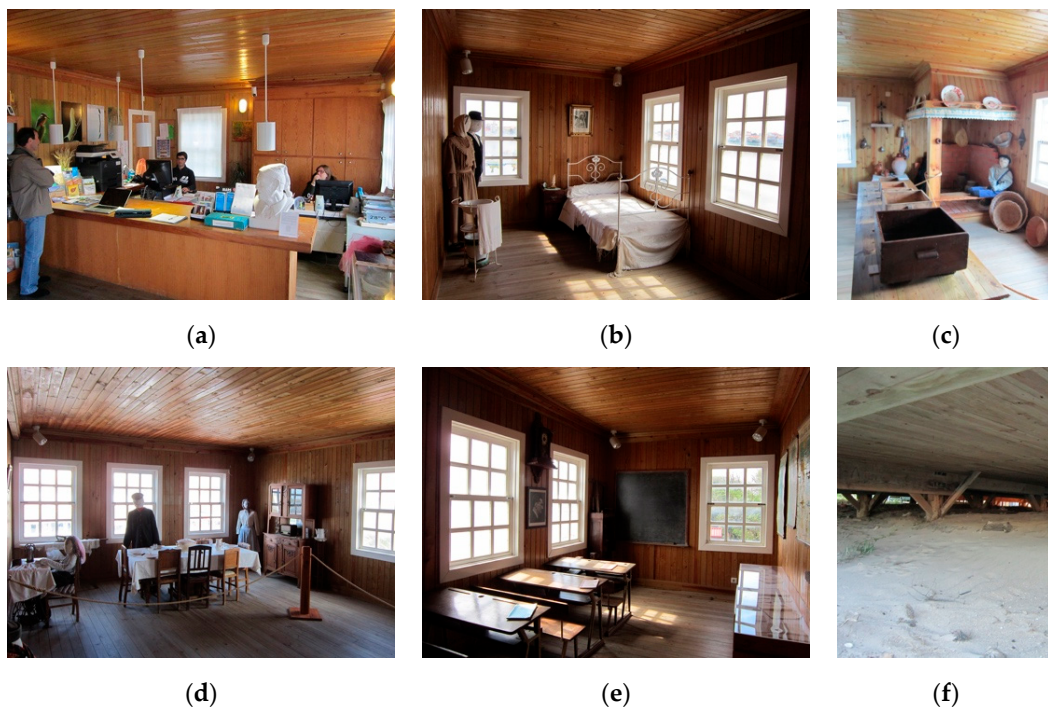
Figure 8. (a) Reception view; (b) “Bedroom” view; (c) “Kitchen” view; (d) “Dining room” view; (e) “Classroom”; (f) View from under the building.

The gross floor area is of approximately 340 m<sup>2</sup> divided into two floors (Figure 7). On the ground floor, next to the entrance is the Tourist Office. The remaining area is the Ethnographic Museum with exhibitions of content related to the daily work of the population in the sea, lagoon and in the agriculture (Figures 7 and 8). On the ground floor was also added a toilet (hidden beneath the staircase, only for the staff), a space that did not exist in the traditional buildings. On the upper floor is represented a dwelling with a kitchen, a dining room and bedrooms and an additional room to show how a 1950s classroom was (Figures 7 and 8).

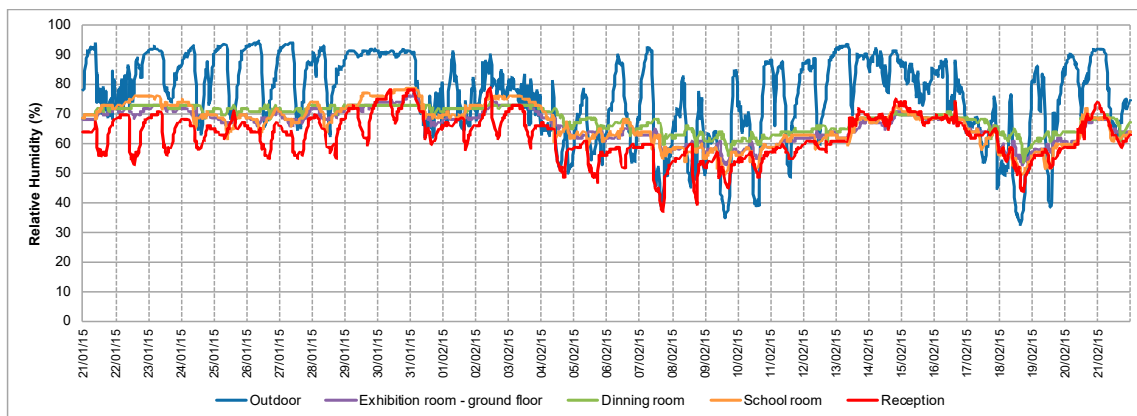
**Figure 11.** Winter monitoring: (a) Indoor and outdoor air temperature profiles; (b) Indoor and outdoor air relative humidity profiles.

In what relative humidity is concerned, maximum outdoor values were high and frequently around 90% (Figure 11b), with a mean value of 76.3%. Indoors, the relative humidity profiles are similar for all rooms, being relatively stable (with mean values below 70%) and with low daily variation, except for the reception (Figure 11b). The reception, due to the occupation, heating during the museum’s opening hours but also for being in contact with the main entrance, shows a higher daily variation on the relative humidity. The influence of using the portable dehumidifier to reduce moisture content indoors during the winter is not perceptible, being the profile very similar to the other seasons, as it will be shown below.

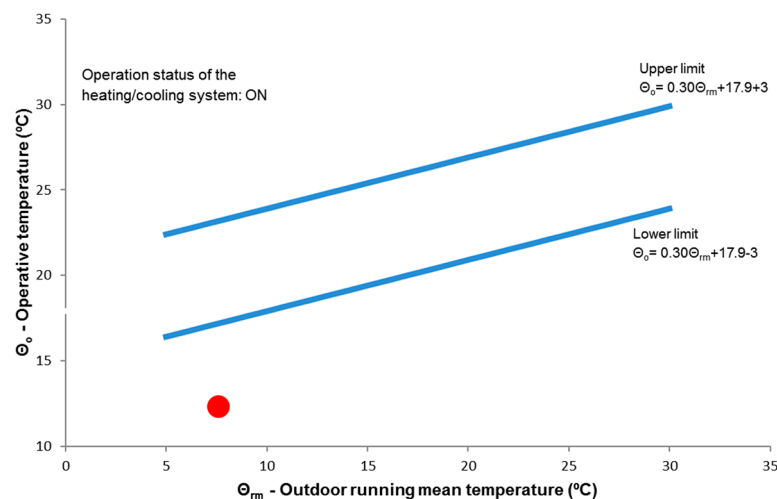
**Figure 12.** Adaptive comfort chart. Thermal comfort temperature (operative temperature) in the reception during one representative winter day (red dot).

Concerning thermal comfort, during the measurement, the occupants were using the oil-filled radiators to heat the reception area. The results showed low thermal comfort conditions in the reception, below the lower limit (Figure 12). In the context of a cold week ( $\Theta_{rm}$  of 7.6 °C), even when the heating system was on, it was not possible to reach adequate thermal comfort conditions. From the measurements, it was also possible to conclude that the other rooms were also below the thermal comfort limits.

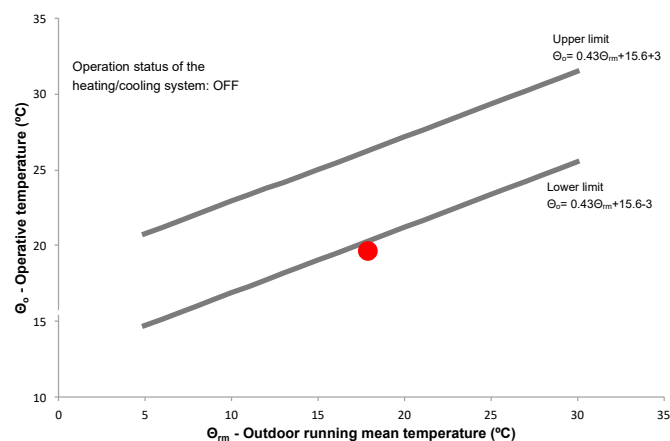
**Figure 18.** Adaptive comfort chart. Thermal comfort temperature (operative temperature) in the reception during one representative autumn day.

In the thermal comfort assessment, the results for Autumn show that the reception had a thermal comfort condition below but close to, the lower limit of the comfort range (Figure 18). In the survey, the two occupants answered as being “neutral” (comfortable) (1.2–1.6 met; 0.86 and 0.69 clo, respectively). Although the survey results do not confirm the objective measurement, the thermal condition point is close to the limit. The inversely proportional relationship between the metabolic rate and the cloth insulation of the two occupants has influenced their thermal sensation, showing the adaptation of the two to satisfy their comfort needs. A decrease of one of these variables could have been sufficient to change their answers. In this measurement, the occupant that has a physiological disorder was not working.

Additionally, as in Spring, it must also be noted that even with an operative temperature of 19.6 °C, the thermal condition measured (Figure 18) was below the lower limit of the comfort range. This condition shows that the design value of 18 °C for heating (Category III), is a minimum and that is not always sufficient to assure a comfort condition, being dependent on the external conditions.

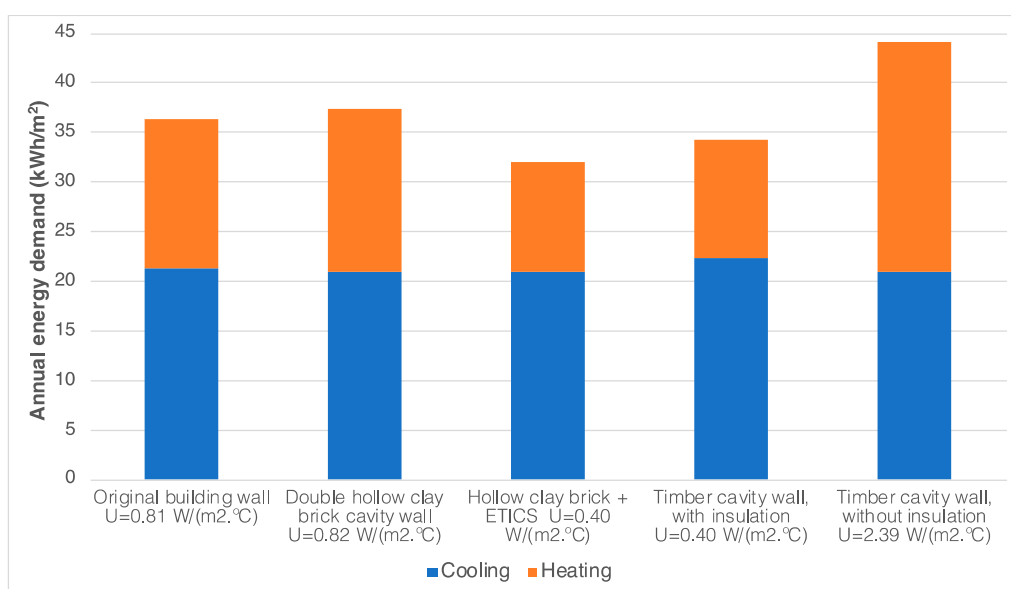
Figure 20. Annual energy demand for heating and cooling.

The analysis of the simulation results shows that regarding the annual energy demand for heating and cooling (Figure 20), the solution with the best overall performance is the “Hollow clay brick + ETICS wall (U = 0.40 W/(m<sup>2</sup>·°C)),” requiring 27.7% less energy than the worst solution, the “Timber cavity wall, without insulation (U = 2.39 W/(m<sup>2</sup>·°C)).”
