Safety of Containment of Facades in Urban Rehabilitation Works

Keywords Safety · Containment of facades · Risks · Prevention

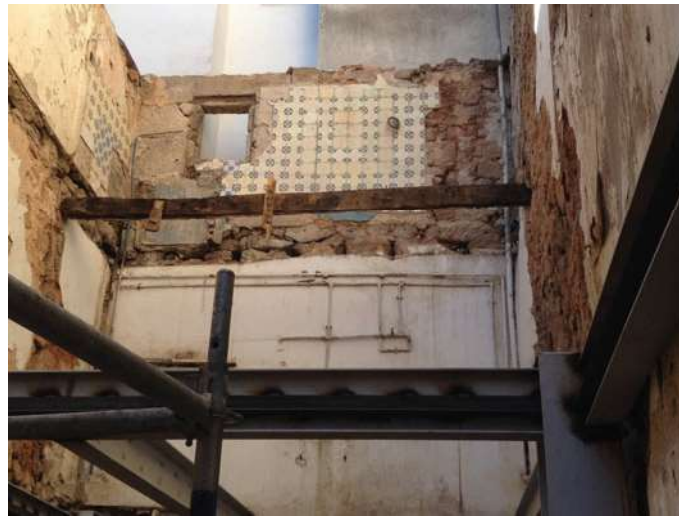
Fig. 1 General appearance of the interior of the building after demolition of its interior

Figure 1 shows the general appearance of the building, after demolishing the interior, by the manual demolition method.

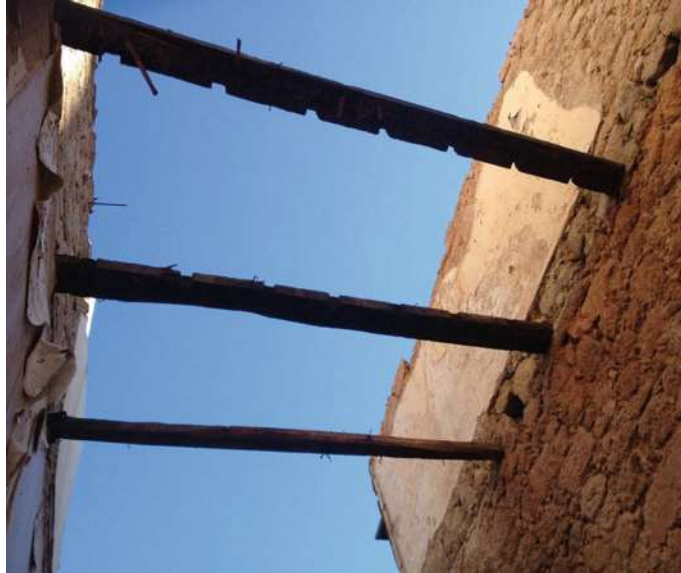
Fig. 2 Containment of facades with two existing beams

In a preliminary phase and to allow the containment of the facade in a safe way, since the beams were in good condition and nailed to the facade, they remained until the end of the construction of the work, as it can be seen in Fig. 2.

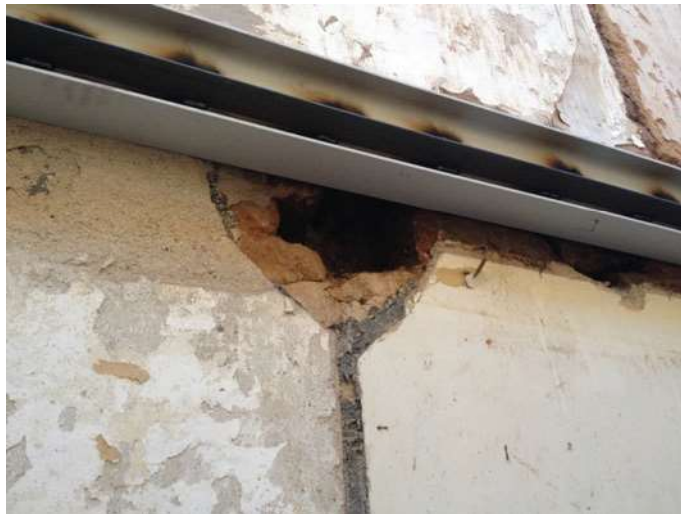
Fig. 3 Metal beam and facade containment

Only after the containment of the building facade (Fig. 3) it is possible to work safely, so as to offer no additional risk to the workers. Then the concrete slabs were made using reinforced concrete. As the slabs were being executed, they increased the stability of the building, allowing the work to be carried out safely and without any kind of accident.
