Thermomechanical behaviour of refractory dry-stacked masonry walls under uniaxial compression

Abstract

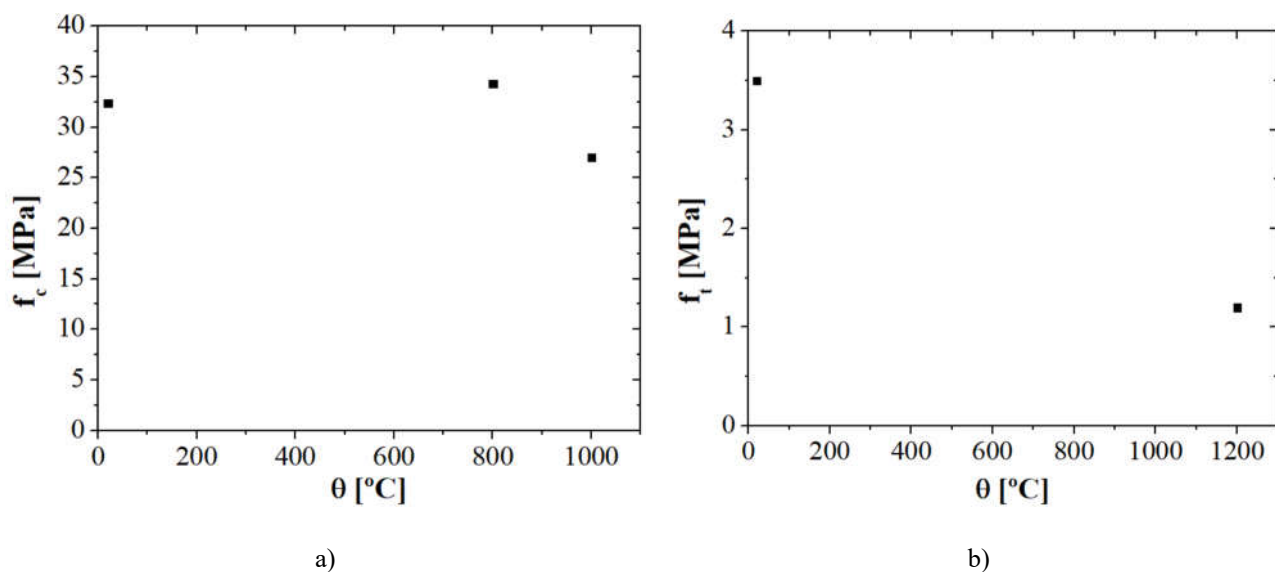
Figure 1 – Mechanical properties of alumina spinel: a) Compressive strength [33]; b) Tensile strength [34]

density is 3.13 g/cm^3 and its apparent porosity measured according to EN 993-1 [32] is 19%. The compressive strength [33] and the tensile strength [34] are presented in Figure 1 for different temperatures. The characterization of the material in compression was performed at room temperature, 800 °C and 1000 °C. In the numerical studies, the material behaviour was assumed to be linear between these points. The variation of the Young's modulus with the temperature (measured by ultrasonic pulse velocity tests [34]) is presented in

dependent as shown in Figure 1 and

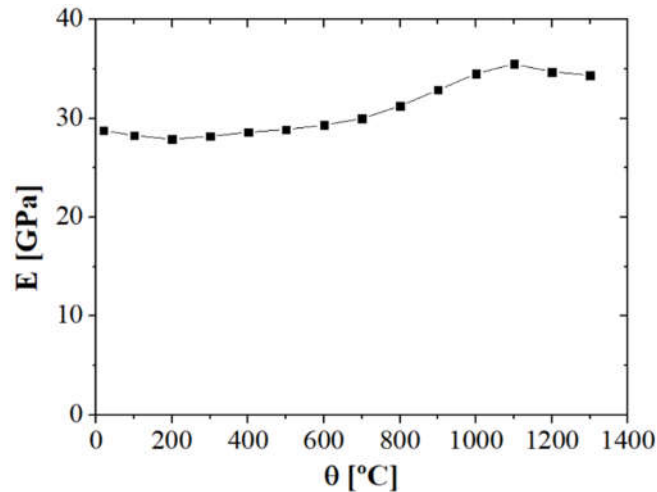
Figure 2 – Alumina spinel Young's modulus [34]

Figure 2. The expansion coefficient of the materials is $8.59 \times 10^{-6}/^\circ\text{C}$ [34].

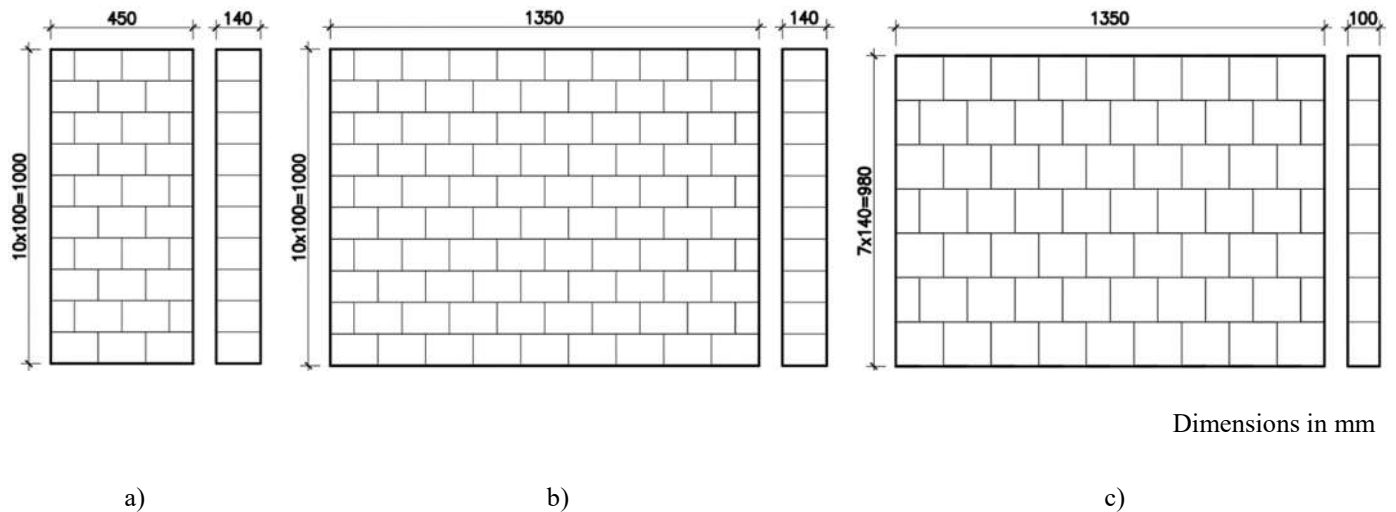
Figure 3 – Specimens dimensions: a) Series S01; b) Series S02, S03 and S04; c) Series S05

The specimens consisted of dry-stacked masonry walls made of high-alumina bricks. The properties of the material and the dimensions of the bricks were described in section 2.1. In order to fully characterize the masonry thermomechanical behaviour, three different configurations were used in the tests. Figure 3 presents the general arrangement of the specimens. The choice of the thickness for S01 to S04 (140 mm) was based on the usual thickness of the working lining of steel ladles. For S05, a smaller thickness (100 mm) was used aiming to increase the slenderness of the wall. The length of the wall for series S01 (450 mm) was chosen based on the structural capacity of the loading frame and the maximum capacity of the hydraulic jack, as this series aims to assess the loadbearing capacity of the wall. The length of the specimens used in S02 to S05 (1350 mm) was chosen based on the dimensions of the electric furnace used.

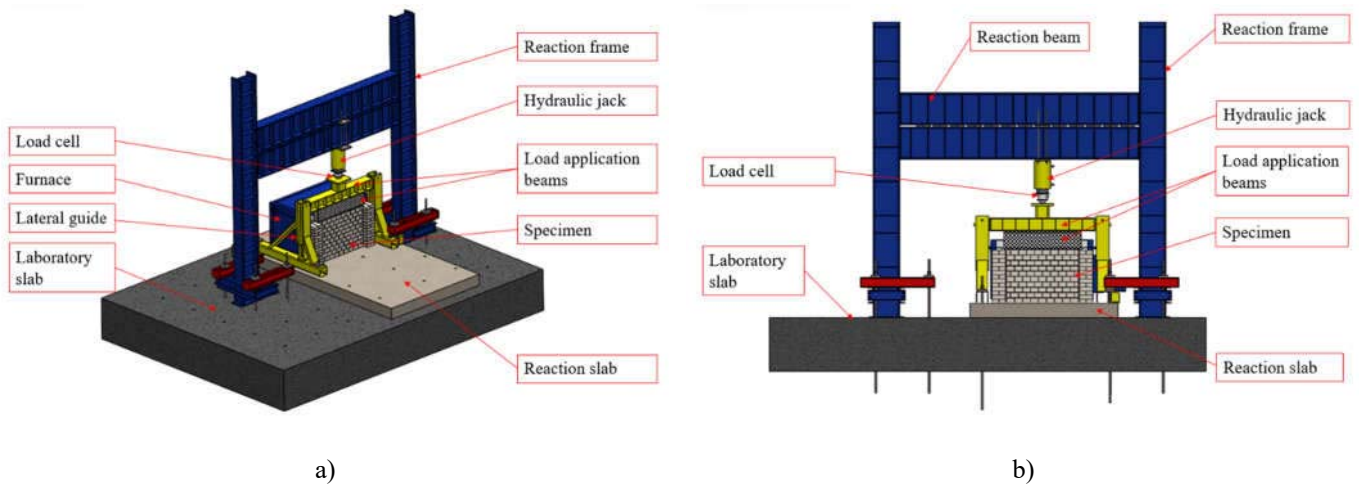
Figure 4 – Test set-up: a) Isometric view; b) Front view

The load cell used to measure the loading applied to the specimen was placed between the hydraulic jack's head and the loading beams (Figure 4). Three LVDTs placed at the top of the loading beam were used to measure the in-plane displacements (LVDT-IP). Five LVDTs were used to measure the out-of-plane displacements (LVDT-OoP). The position of the LVDTs are detailed in Figure 6.

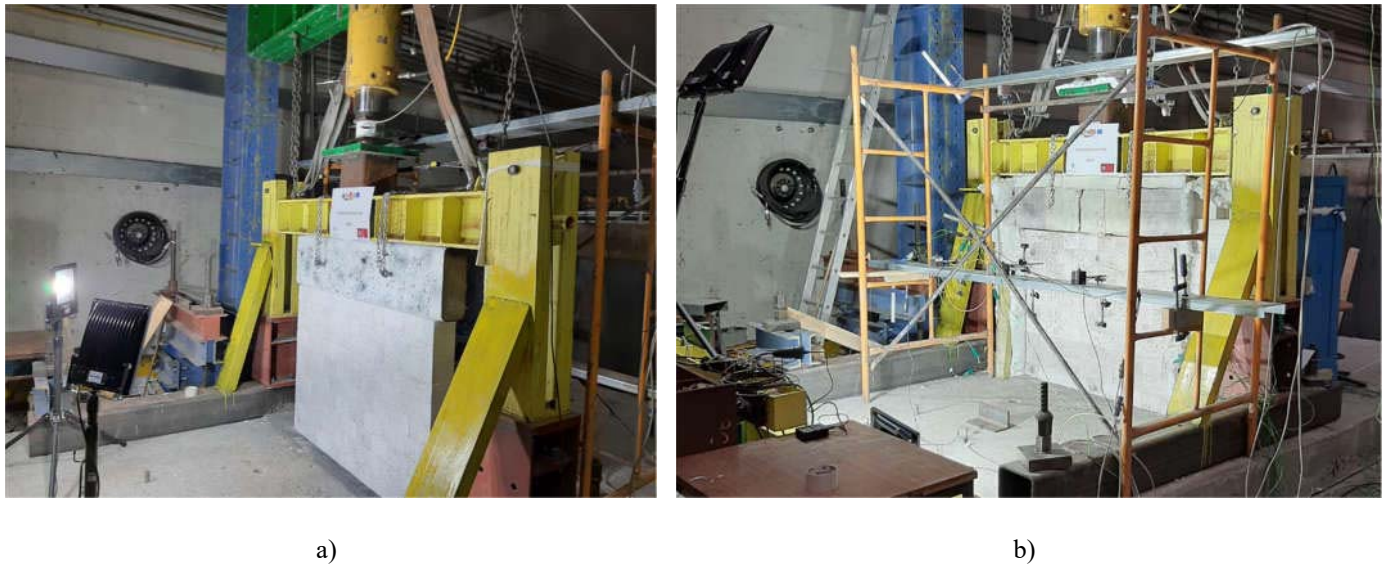
Figure 5 – Test set-up: a) Ambient temperatures; b) High temperatures

The reaction frame was bolted to the laboratory slab by steel anchors. The specimens were built in the reaction slab over a grout layer. Rockwool was used for the thermal insulation of the reaction slab and to fill the gap between the specimens and the lateral masonry columns. The pictures of the experimental set-up are presented in Figure 5a and Figure 5b for the tests at ambient and high temperatures, respectively.

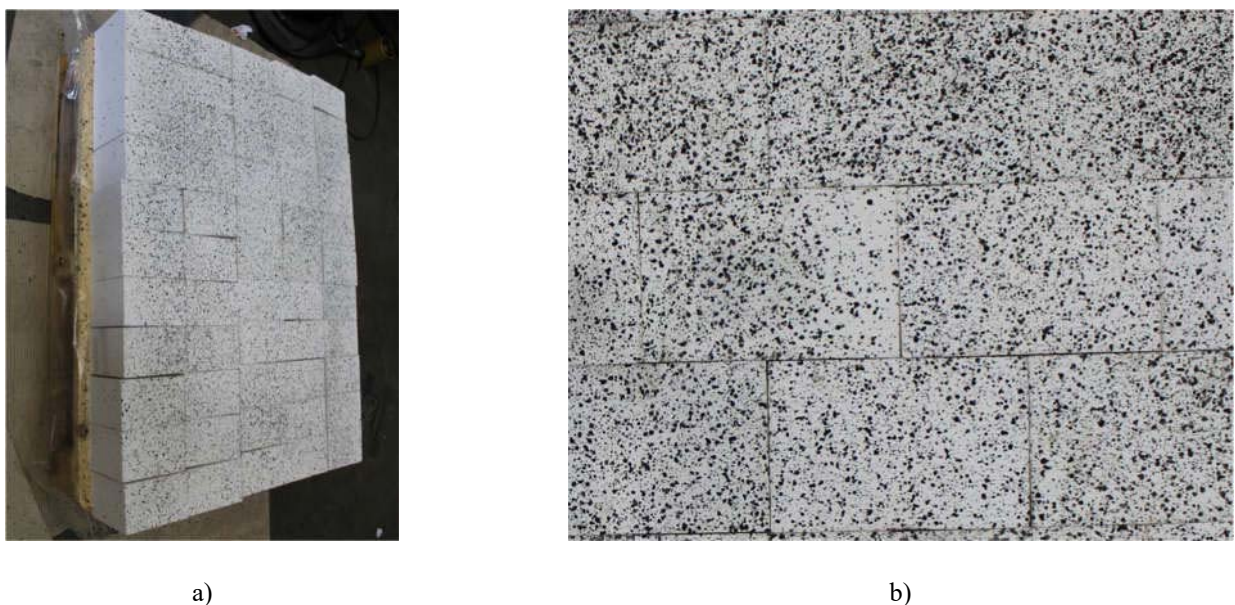
Figure 7 – Digital Image Correlation: a) Speckle pattern preparation; b) Details of the speckle pattern

Digital image correlation (DIC), which is a contactless measurement technique, was used to measure the full-field of displacements and strains. This technique was developed in the beginning of the 1980's and improved over the time. The basic principle is to compare two images that represent different states of the specimen, a reference and a deformed condition. The technique assumes that the grey level distribution follows the material strains and remains homogenous in the subset [38, 39]. An 18 MPx (5184x3486) camera was used for image acquisition. The bricks were laid on a horizontal plane and the speckle pattern was applied by means of an aerograph. The speckle pattern application and its details are shown in Figure 7. The image processing was performed using subsets of 100x100 pixels. The technique was used to measure the strains in all the tests.

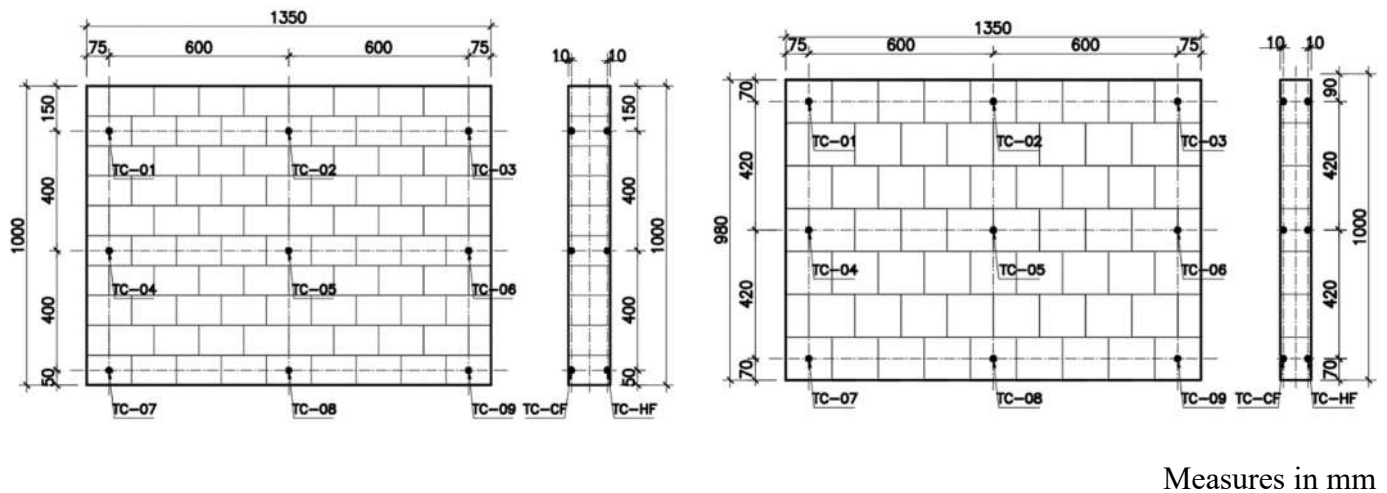
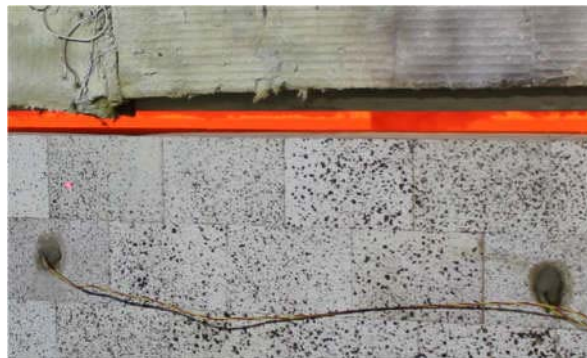
Figure 8 – Thermal instrumentation: a) Series S03 and S04; b) Series S05; c) View of thermocouples embedded in the bricks

The thermal instrumentation comprised eighteen type K thermocouples embedded in the bricks (10 mm depth), nine installed in the hot face and nine in the cold face, as detailed in Figure 8. The holes ($\varnothing 6$ mm) were made in the bricks using diamond crown drills. Subsequently, the thermocouples were placed in the holes and grout was used to close them. Additionally, one type K thermocouple was used in the furnace controller and one type K thermocouple was used to record the temperature in the furnace.

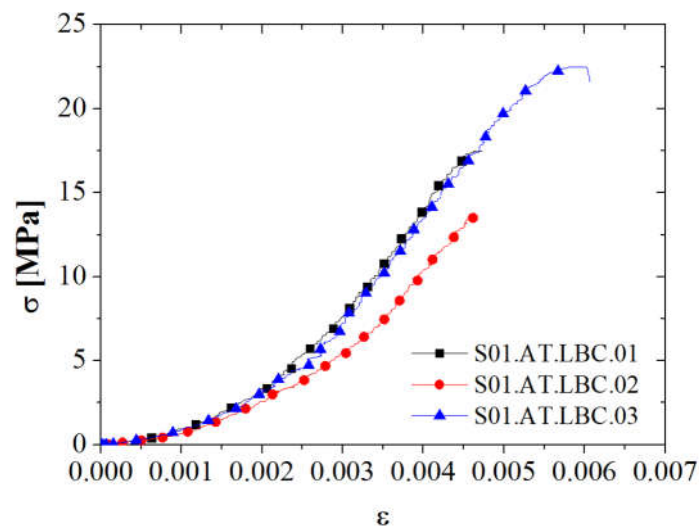
Figure 9 – Test series S01.AT.LBC – Stress-strain curves

The stress-strain curves of test series S01.AT.LBC are presented in Figure 9. The strains were calculated using the mean displacement of the three LVDTs divided by the height of the specimen. Three different stages were observed: *i*) joint closure; *ii*) linear behaviour; *iii*) damage plasticity and failure. During stage *i*, the Young's modulus of the wall increased from almost zero up to 6.2 GPa. In this stage crushing of brick's initial non-plane surfaces occurs [3,6,14]. The joint closure behaviour is strongly heterogeneous along the joints as it is influenced by the bricks shape imperfections, bricks surface roughness and construction errors [3,6,11,12,14].

During stage *ii*, a linear behaviour was observed in the stress-strain curves, however the Young's modulus of the wall ($E_{wall} = 6.2$ GPa) was significant smaller than the Young's modulus of the brick ($E_{brick} = 28.8$ GPa), indicating a non-homogeneous stress distribution in the wall, mostly caused by the bricks' shape imperfections. It is worth mentioning that the modulus of elasticity was obtained by ultrasonic pulse velocity tests, this method usually gives higher values than the ones obtained by a classical compression tests.

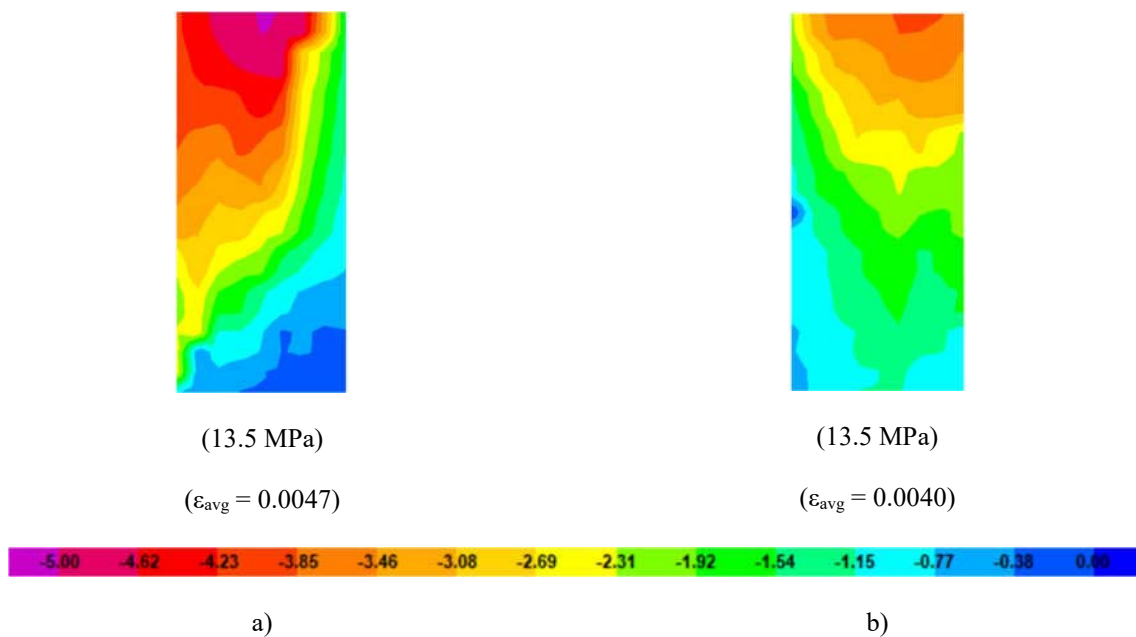
Figure 10 – Test series S01 – In-plane displacement fields: a) S01.AT.LBC.02; b) S01.AT. LBC.03 (in mm)

Nevertheless, the stresses concentrations are evidenced. Ngapeya et al [11] evaluated the influence of the bricks' shape imperfections on the loadbearing capacity of dry-stacked masonry. The authors observed that the non-homogeneous stress distributions along the wall leads to a reduction of its structural capacity. The non-homogeneous stress distribution in the wall was also evidenced by the DIC analysis. Figure 10 presents the measured in-plane displacement fields (vertical direction) for specimens S01.AT.LBC.02 and S01.AT.LBC.03, the stress level and the average strains measured by the LVDTs are also presented.

(Figure 10a), therefore, its experimental curve was expected to be much lower than the other two specimens. The good agreement between the experimental and numerical results ensures the adequacy of the developed finite element model. The developed model is able to represent all of the three stages described in section 3.1: *i*) joint closure; *ii*) linear behaviour; *iii*) plastic behaviour and failure. Besides the stress-strain curves, also the failure mode was compared. The failure mode observed experimentally and numerically is compared in Figure 26b, where it is possible to observe a similar behaviour, the brick in the centre of the fifth masonry course crushed. Moreover, it was possible to identify a pattern of head joints opening in the rows bellow and above the crushing area, due to the restraint to lateral movement provided by the top and bottom supports.

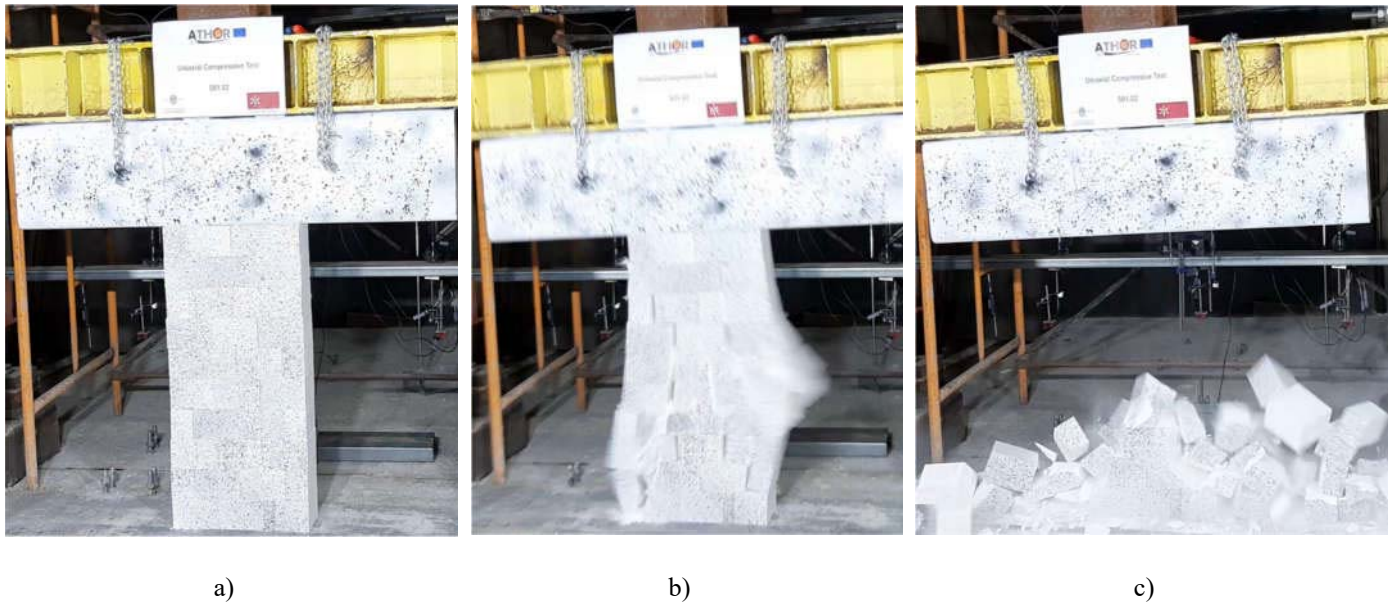
Figure 11 – Test series S01 – Images of testing sequence: a) Before testing; b) Failure; c) After testing

During stage *iii*, a slightly decrease of the wall's Young's modulus was observed, which is typical of masonry due to the development of cracks in the material. These cracks are mostly thin and distributed in the specimen, with very brittle failure. The compressive strength for specimens S01.AT. LBC.01, S01.AT. LBC.02 and S01.AT. LBC.03 was 17.5 MPa, 13.5 MPa and 22.5 MPa, respectively. Specimen S01.AT.LBC.02, presented a low compressive strength due to an uneven load distribution in the specimen, caused by a large shape imperfection, as observed in the DIC analysis (Figure 10a). The average compressive strength was 17.8 MPa (20.0 MPa if specimen S01.AT.LBC.02 is disregarded). The failure sequence is presented in Figure 11.

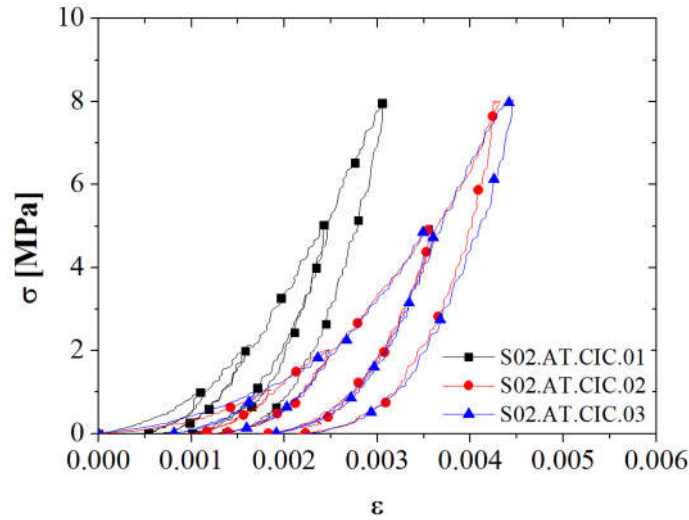
Figure 12 – Test series S02.AT.CIC – stress-strain curves

Figure 12 presents the stress-strain curves obtained experimentally for test series S02.AT.CIC. An increasing residual strain was observed after each loading cycle, as a result of the initial crushing of the non-flat surfaces in contact at the bed joints (Figure 13a). This crushing happened during the loading cycles and resulted in the increasing of the contact area between the bricks, consequently also increasing the Young's modulus of the wall. The evolution of the Young's modulus of specimen S02.AT.CIC.02, determined from the tangent curves, with the load cycles can be observed in Figure 13b. The values presented are the maximum Young's modulus measured for the respective cycle. The values measured during the loading and unloading stages are presented in blue and red, respectively. The numbers in the subscript stand for the load cycle and the letter L and U stand for loading and unloading stages, respectively. The Young's modulus of the wall (13.0 GPa in the last unloading cycle) was, again, much smaller than the one of the material (28.8 GPa).

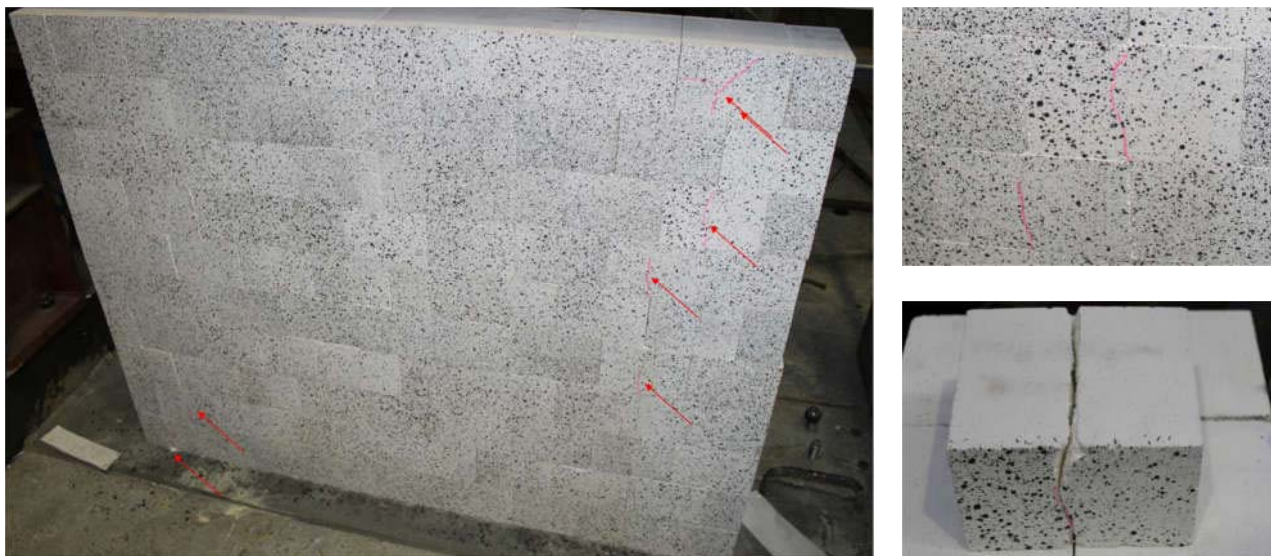
Figure 15 – Test series S02.AT.CIC: Cracks patterns observed by the end of the test

The bricks' shape imperfections in dry-stacked masonry leads to stress concentrations in the wall [11]. Consequently, it was possible to observe cracks even for low load levels (Figure 15). The cracks were mostly located in the middle of the bricks and caused by the non-uniform loading and support conditions of the blocks.

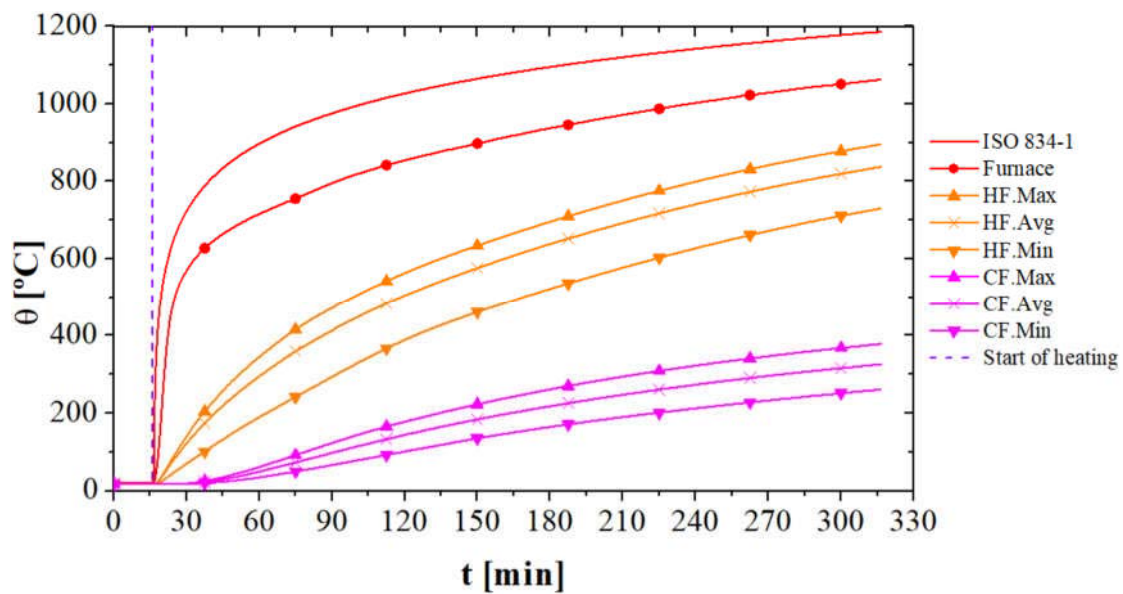
Figure 16 – Test series S03.HT.LL8: Temperature evolution

The temperatures measured by the thermocouples embedded in the bricks are presented in Figure 16. The curves presented in red, ISO 834-1 and Furnace, are the standard fire curve and the temperature measured in the furnace, respectively. The curves presented in orange and magenta are the measured temperatures in the hot face (HF) and in the cold face (CF), respectively. The maximum (Max), minimum (Min) and average (Avg) measured values in each face were presented. The purple dashed line stands for the beginning of the heating process.

The temperature fields for this test series were similar to the ones found for test series S03.HT.LL8 (Figure 16). The measured vertical strains are presented in Figure 19a. At the beginning of the test, from 0 to 20 minutes, the mechanical load of 5 MPa was applied and a negative displacement was observed, as a result of the joint closure and brick's strain. The maximum displacements after load application were -2.53 mm ($\epsilon = -0.0025$), -3.22 mm ($\epsilon = -0.0032$) and -4.15 mm ($\epsilon = -0.0042$) for test specimens S04.HT.RTE.01, S04.HT.RTE.02 and S04.HT.RTE.03, respectively.

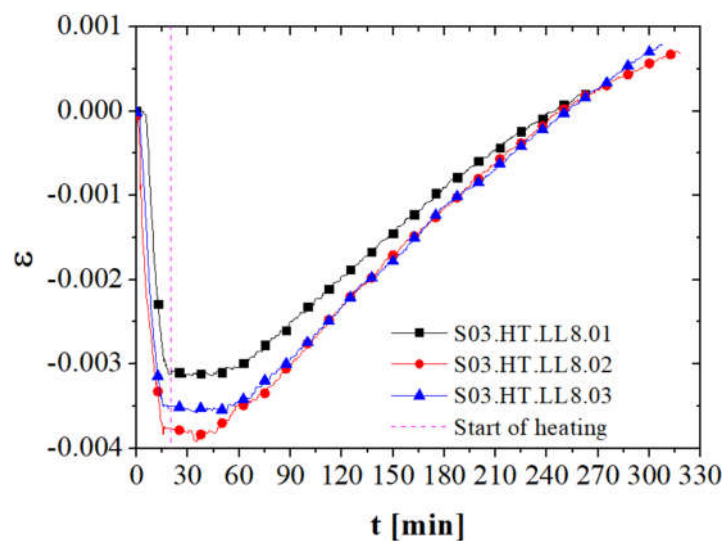
Figure 17 – Test series S03.HT.LL8 – In-plane strains

The average of the measured in-plane strains is presented in Figure 17. At the beginning of the test, from 0 to 20 minutes, the pre-compression stress of 8 MPa was applied and negative displacements were observed, as a result of the joint closure and brick's deformation. The maximum displacements after load application were -3.12 mm ($\epsilon = -0.0031$), -3.76 mm ($\epsilon = -0.0038$) and -3.49 mm ($\epsilon = -0.0035$) for specimens S03.HT.LL8.01, S03.HT.LL8.02 and S03.HT.LL8.03, respectively.

At 20 minutes after the beginning of the test, the furnace was turned on and the temperatures at the hot face started to increase. After 45 to 60 minutes of the beginning of the test, the effects of the thermal elongation started to rise and the wall presented a positive strain rate. The thermal elongation surpassed the displacements caused by the mechanical loading after 244 min, 249 min and 252 min of the beginning of the test, for specimens S03.HT.LL8.01, S03.HT.LL8.02 and S03.HT.LL8.03, respectively. Test S03.HT.LL8.01 was stopped after 265 minutes, with a positive displacement of 0.24 mm ($\epsilon = 0.0002$). Tests S03.HT.LL8.02 and S03.HT.LL8.03 were stopped after 300 minutes, with maximum displacements of 0.61 mm ($\epsilon = 0.0006$) and 0.80 mm ($\epsilon = 0.0008$), respectively.

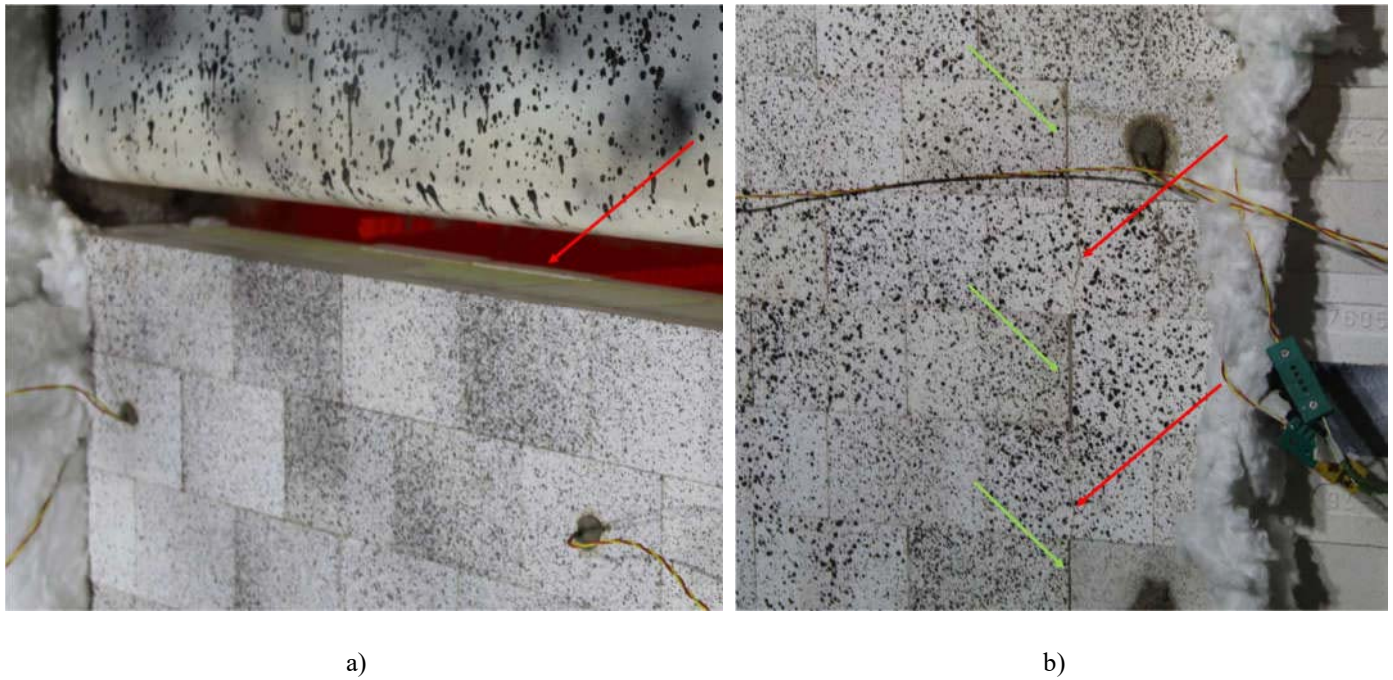
Figure 18 – Test series S03 – Damage in the wall upon completion of the test: a) Cracks in the interface between load application beam and wall (S03.HT.LL8.01), b) Vertical cracks in bricks and joints openings (S03. HT.LL8.03)

In spite of the relatively low load level in the wall, some cracks were observed in the specimen upon completion of the test. Figure 18a shows the cracks observed in the interface between the load application

beam and the wall's top surface. These cracks were caused by a high stress state formed in this region, due to the temperature gradient in the wall. Figure 18b shows vertical cracks observed in the middle of the bricks (indicated by the red arrows), caused by the unevenness stress distribution, as discussed in Series S02.AT.CIC. The cracks of the bricks, resulted in rigid body motion on a few bricks, leading to head joint opening (indicated by the green arrows).

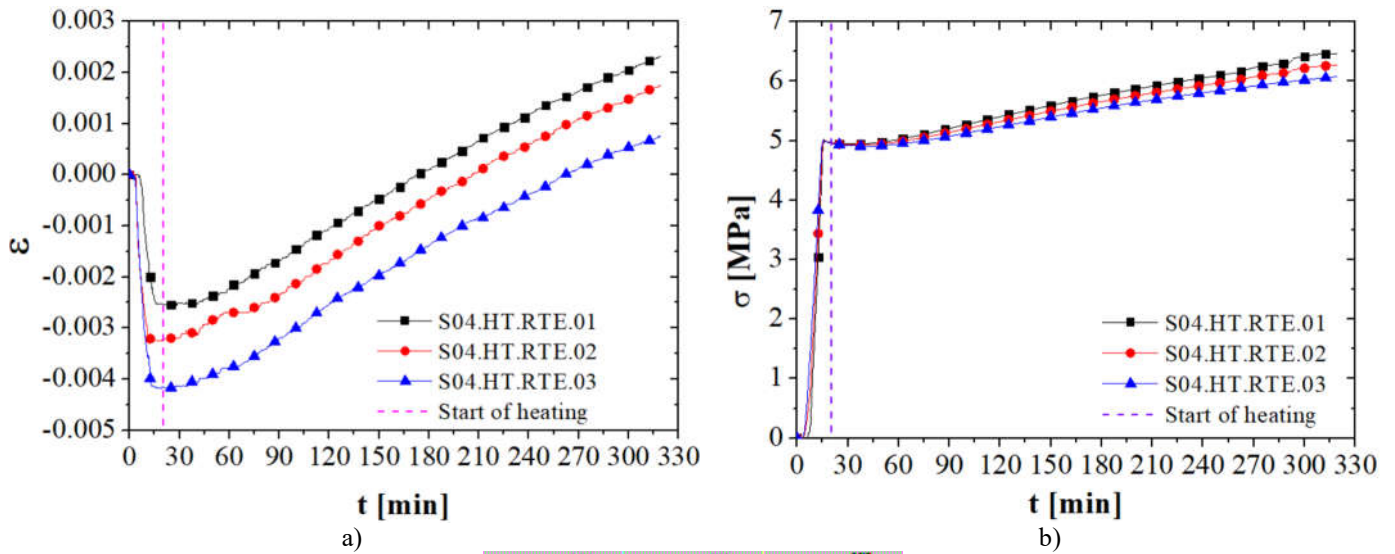
Figure 19 – Test series S04.HT.RTE a) In-plane strains, b) Stresses; c) Structural schematics

During the heating stage of series S04.HT.RTE the hydraulic jack was set to be blocked at its current position, in fact the LVDT used to feed the servo-controller unit of the jack did not present measurements during the heating stage. However, the reaction frame (composed by two HEB500 columns and two HEB600 beams) worked as a spring with axial stiffness K_B (see Fig.19 c). The increasing of the vertical load in the wall caused

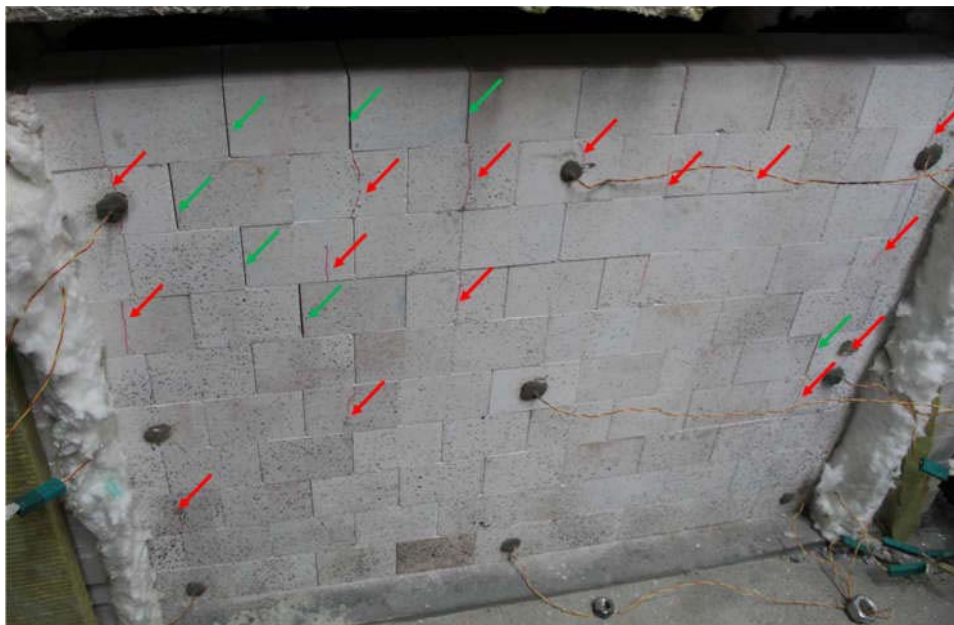
Figure 20 – Test series S04.HT.RTE – Failures in the wall: Vertical cracks in bricks and joints openings (S04.HT.RTE.02)

Despite the relatively low load level in the wall, again some cracks were observed, as for example the ones between the load application beam and the wall's top surface in specimen S03.HT.LL8. Figure 20 presents vertical cracks observed in the middle of the bricks (indicated by the red arrows), caused by an unevenness stress distribution, as discussed in test series S02.AT.CIC and S03.HT.LL8. Rigid body motions caused by the cracks in the bricks were also observed, leading to head joint opening (indicated by the green arrows).

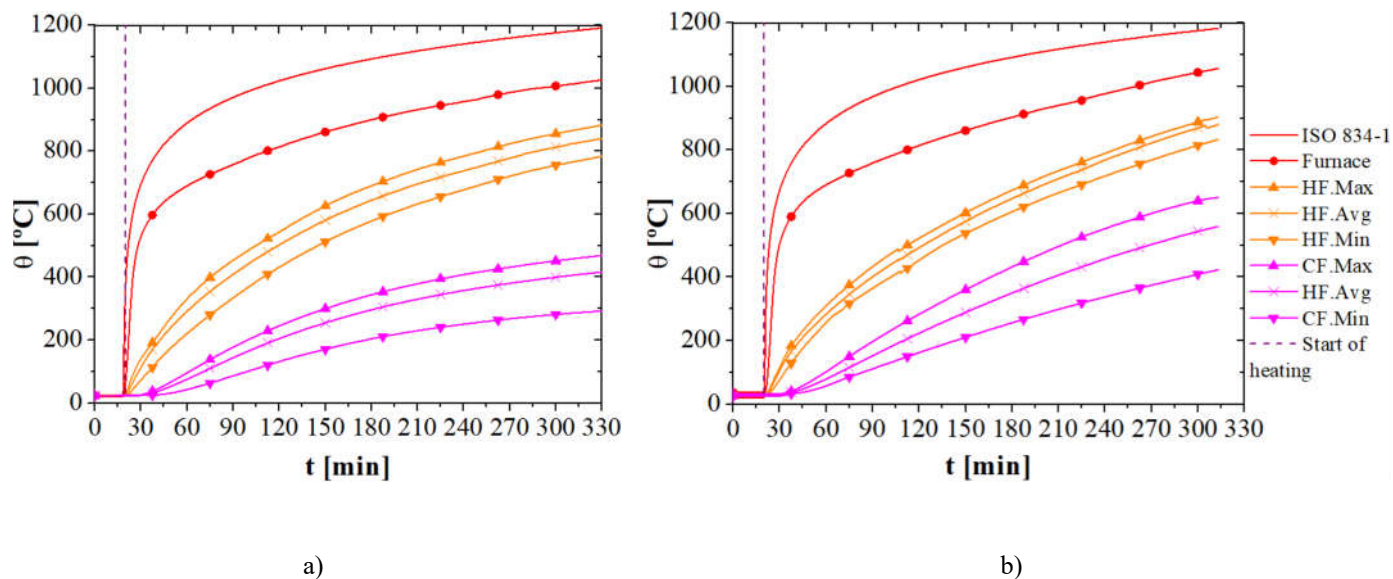
Figure 21 – Test series S05.HT.LL10 – Temperatures a) S05.HT.LL10.01; b) S05.HT.LL10.02

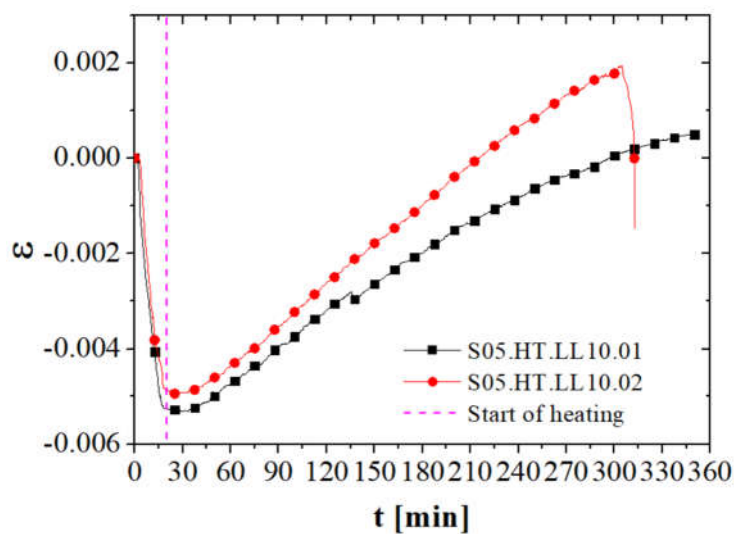
Figure 22 – Test series S05.HT.LL10: Vertical strains

The average of the measured in-plane strains is presented in Figure 22. At the beginning of the test, from 0 to 20 minutes, the load was applied and a negative displacement was again observed. The displacements after load application were -5.25 mm ($\epsilon = -0.0053$) and -4.86 ($\epsilon = -0.0049$) mm for specimens S05.HT.LL10.01 and S05.HT.LL10.02, respectively.

When the furnace was turned on (at 20 minutes) the temperatures at the hot face started to increase, consequently the thermal elongation started and the wall presented a positive strain rate. The thermal elongation surpassed the displacements caused by the mechanical load after 296 min and 214 min for specimens S05.HT.LL10.01 and S05.HT.LL10.02, respectively.

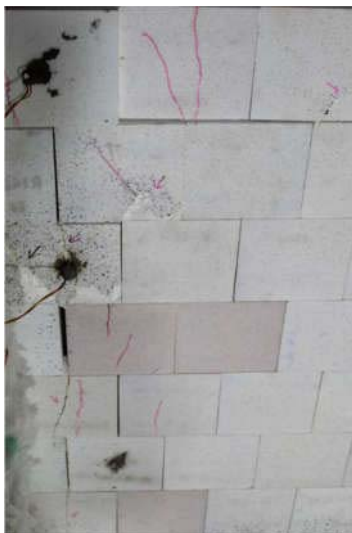
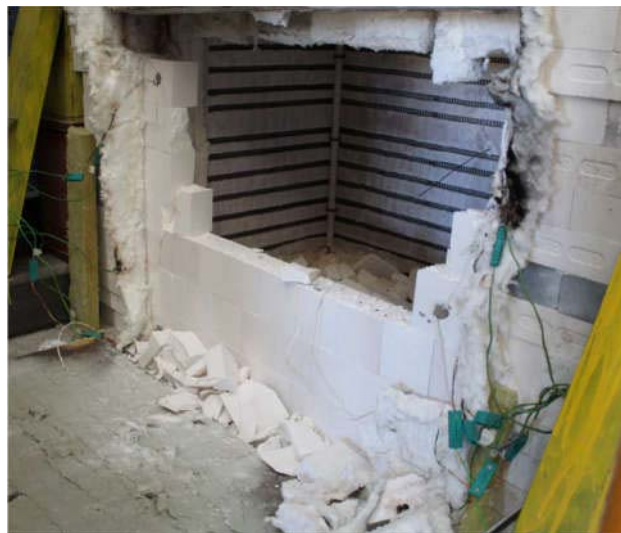
Figure 23 – Test series S05 – Damage to the wall: a) Vertical cracks in bricks and joint openings in specimen S05.HT.LL10.01;
b) Complete failure of specimen S05.HT.LL10.02

The test for specimen S05.HT.LL10.01 was stopped after 360 minutes. At this moment a positive displacement of 0.49 mm ($\epsilon = 0.0005$) was registered. The failure of this specimen was not observed in the test. Nevertheless, some cracks and crushing points were observed in the specimen, as shown in Figure 23a. The temperatures in specimen S05.HT.LL10.02 increased slightly faster in comparison with the other specimen due to the thermal insulation installed in front of the wall. As shown in Figure 22, the strain rate of S05.HT.LL10.02 was higher as the thermal elongation is more significant. The thermal gradient in the wall led to significant thermal bowing, defined as an out-of-plane displacement of the specimen. The thermal bowing caused an eccentricity in the vertical load and led to sudden failure of the wall, as seen in Figure 23b.

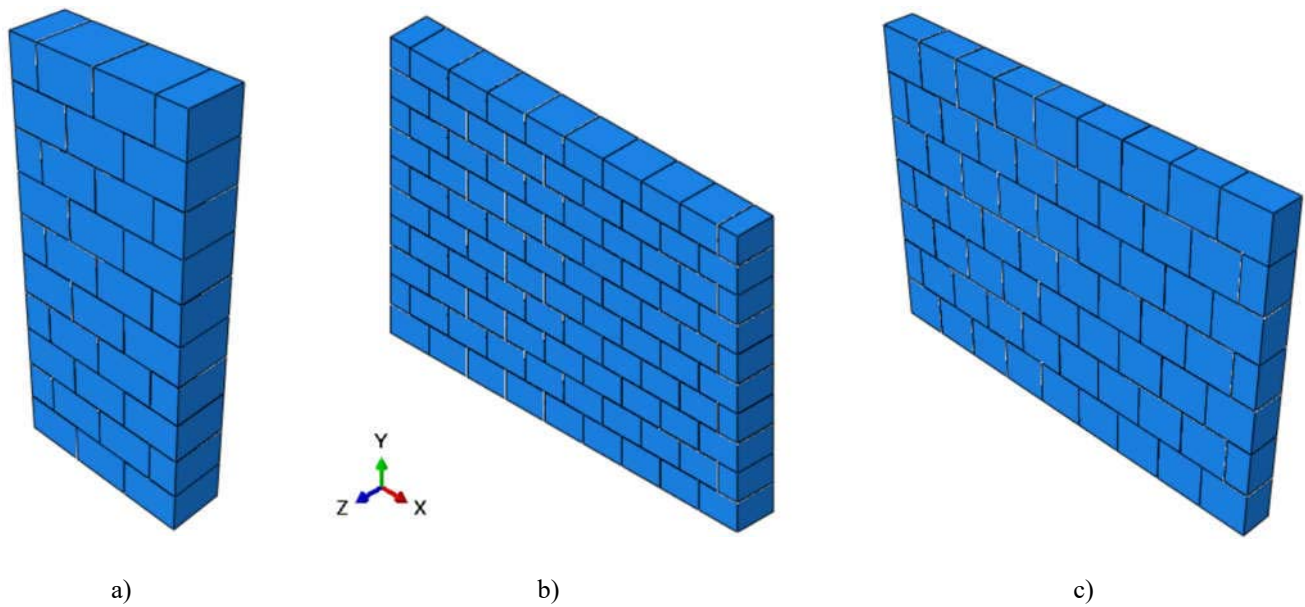
Figure 24 – Numerical models for the different specimens: a) Series S01; b) Series S02, S03 and S04; c) Series S05

The masonry walls were discretized using 8-node solid elements. The final mesh was generated automatically by Abaqus software and was rather refined (280 elements per brick and 140 elements per half brick). The influence of the finite element size on the thermomechanical behaviour of the masonry walls was evaluated, 30mm, 20 mm and 10mm elements were used in the mesh study. It was found that the 20mm x 20mm x 20mm elements led to adequate simulation results. For the heat transfer analysis, the 8-node linear heat transfer elements (DC3D8) were used. For the mechanical analysis, C3D8R elements were used, which are three-dimensional continuum hexahedral brick elements with reduced integration (R), hourglass control and linear interpolation, with the usual three degrees of freedom per node (translations in directions X, Y and Z). The use of elements with reduced integration are justified aiming to reduce the computation time, a fine mesh was used to overcome the loss of accuracy. The use of C3D8R elements have being successfully used before to simulate masonry structures in fire situations [15, 41].

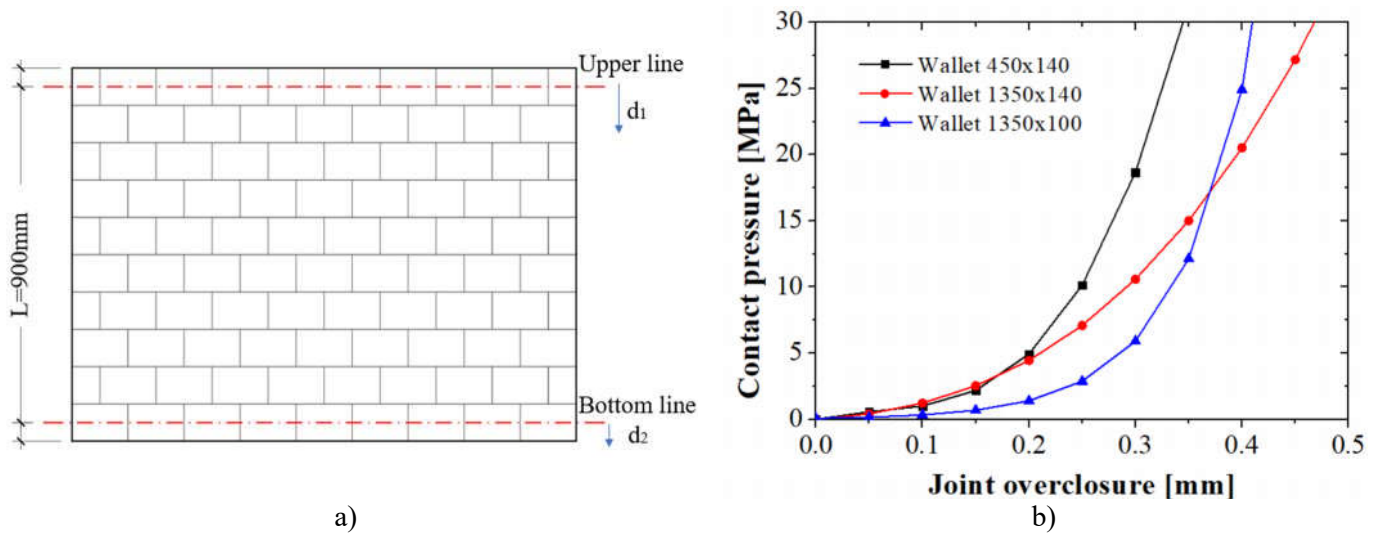
Figure 25 – a) Schematics for the calculation of average joint behaviour, b) Contact pressure-overclosure relations used for different walls dimensions.

The joints play an important role on the behaviour of dry stacked masonry and they were modelled with surface-to-surface contact properties. The joints' normal behaviour was represented by a pressure-overclosure relation. In this formulation the contact stiffness increases with the overclosure of the joint, resulting in a suitable representation of the behaviour of the dry joints. The behaviour of the dry stacked masonry depends on defects that appears during masonry building. As evidenced by Ngapeya et al [11], the increasing of the height and length of the wall statistically reduces the useful section of the wall. Therefore, different relations were used to represent masonry with different dimensions. In fact, the specimen S01 had the smaller dimension and presented the bigger useful section (a higher contact area between the bricks). The general formulation of Eq. 1, provided by Thanoon et al [13], was used to model the joint behaviour. The average joint overclosure was calculated by the difference of the average displacements measured in the upper row (d_1) and bottom row (d_2), obtained using DIC, subtracted by the displacements caused by bricks' (d_b) strains and divided by the number of joints (n) for each stress level, see Figure 25a. The displacements caused by bricks' strain in the studied area was calculated by $d_b = \sigma L / E_{brick}$.

The average curves for each geometry is being presented in Figure 25b.

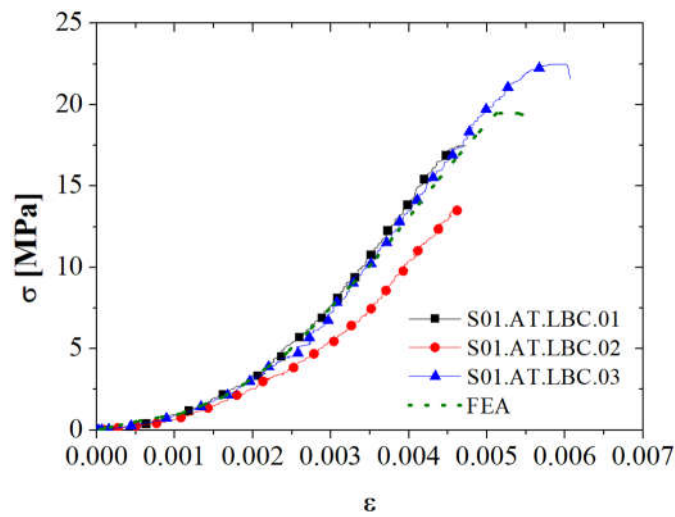
Figure 26 – Validation of numerical model – test series S01.AT.LBC: a) Stress-Strain curve; b) Comparison of failure modes

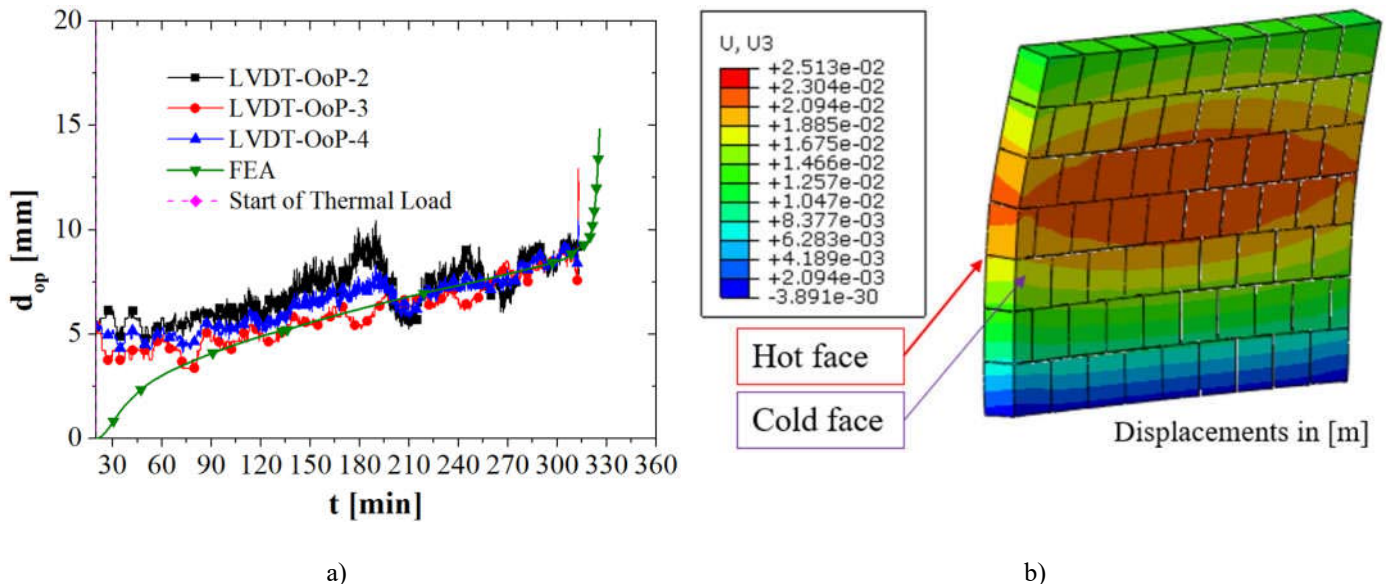
Figure 31 – Out-of-plane displacements: a) Comparison between numerical and experimental results, b) Out-of-plane displacements fields at 300 minutes

In case of specimen S05.HT.LL10.02, failure of the wall was observed. The thermal gradient through the thickness of the sample led to the thermal bowing of the wall, therefore, significant out of plane displacements were observed in the sample, with failure ultimately. Figure 31 a presents the comparison of the out-of-plane displacements (d_{op}) obtained experimentally and numerically. Figure 31 b illustrate the out-of-plane displacement fields.

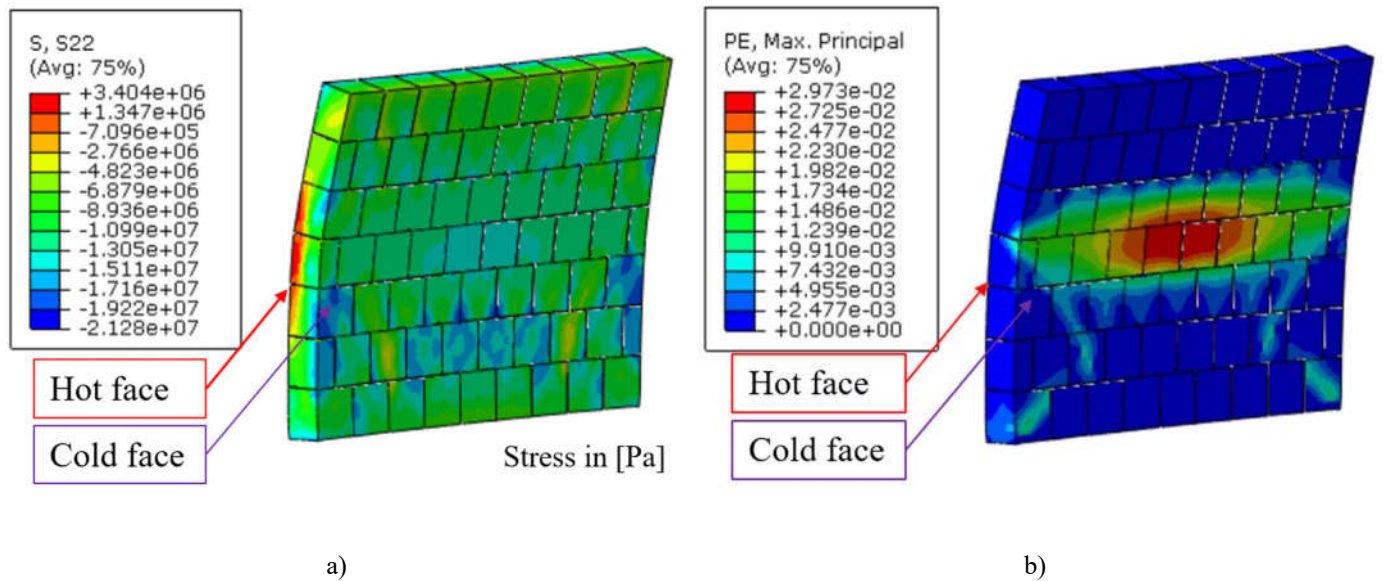
Figure 32 – Numerical predictions by the end of the tests: a) Vertical stresses; b) Plastic strains

Figure 32 shows the stresses in vertical direction and the plastic strains developed in the wall. The results clearly show that the effects of load eccentricity caused by the thermal bowing of the wall led to a significant

stress concentration in the cold face of the wall. Significant plastic strains are developed in this face, and the crushing of the bricks are observed. Thus, the developed model is able to represent all stages of the test, including the effects of thermal elongation on the masonry specimens and the failure of the wall caused by eccentricity due to thermal bowing, as shown in Figure 31 and Figure 32.
