# **Seismic assessment of metallic neo-gothic church: deterioration and safety of early structural design**

**Abstract** – The San Sebastian Basilica, located in Manila in Philippines, consists of a unique architectural monument in the area, representing the colonial neo-gothic style of the 19<sup>th</sup> century. The site where the church is constructed is characterized by high seismicity, and as an attempt to make it earthquake resistance, it was constructed by steel, after multiple collapses of previous versions of the church. The aim of this study is to assess the safety of the Basilica, by integrating an in-situ diagnostic campaign. More specifically, the investigation works performed in the last decade are enriched by experimental dynamic identification tests. After obtaining the dynamic properties of the church, a detailed numerical model is constructed and calibrated to match the experimental results. The final model is then employed and several non-linear static analyses are performed in order to assess the capacity of the church. A number of numerical and methodological issues are highlighted throughout the process, before concluding about the safety, the damage state a

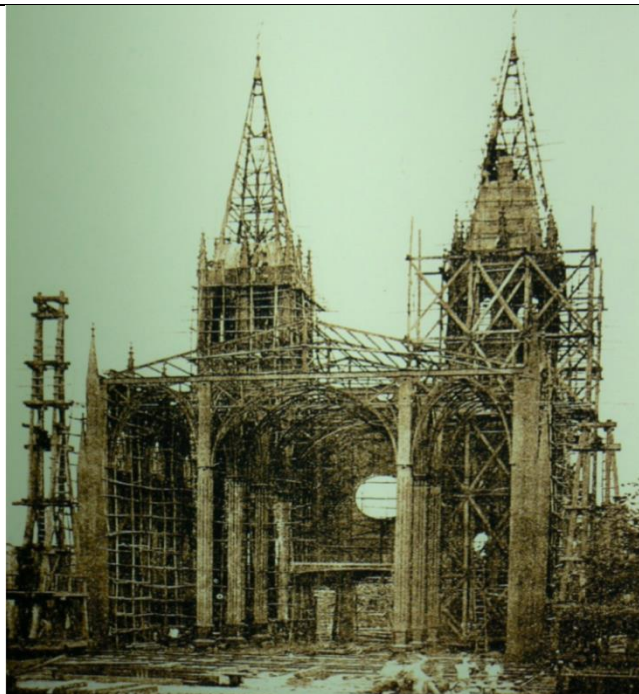
Figure 2. Construction of the Basilica on-site in Quiapo, Manila. Obtained from [10].

The construction was carried out by local workers, artisans and craftsmen, and supervised by Belgian engineers. All prefabricated elements were screwed, bolted and riveted on-site. In order to hide the industrial nature of the building, the structural elements and connections were covered by moldings, cornices, flouting and other decorative details. Similarly, the seams and joints were filled with putty so as to hide the appearance of the steel. The final surfaces were faux finished to look like stones. Due to a storm that capsized one of the ships going to Manila, the prefabricated steel reredos (a screen or decoration behind the altar) was lost. Consequently, a wooden altar was built locally as replacement. Figure 2 shows a historical photo of the construction phase.

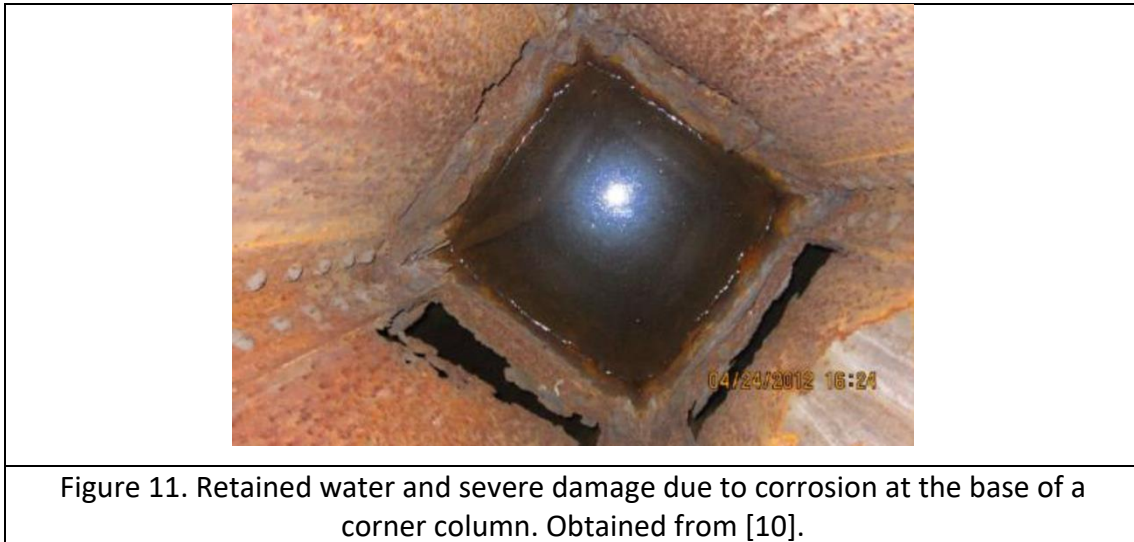
Furthermore, the cross sectional losses due to corrosion were measured using both a caliper and ultrasonic thickness gauging. The conclusion was that there is an average material loss of 10%. It should be noted that especially for the columns this percentage increases to 23% due to the leaking water mentioned before, while in five columns this percentage raises locally up to 76% (Figure 11).

Concerning the second assumption, the material loss due to corrosion was significantly higher for the columns (23% in average), when compared to the rest of the structure (10% in average), while a rather high percentage of 73% was observed in five columns. Therefore, the damage of the columns due to corrosion should be taken into account. From a phenomenological point of view, the corrosion is inducing a decrease on the effective section of the members [24], and therefore the modeling approach should reduce the sections of the finite elements. However, the model updating procedure requires several different models to be analyzed, and since all the sections of the 65 columns are defined manually as arbitrary sections, such process would be highly time consuming. As a result, the modulus of elasticity of the columns is chosen to vary, as an equivalent simplification, instead of the cross-sectional loss.

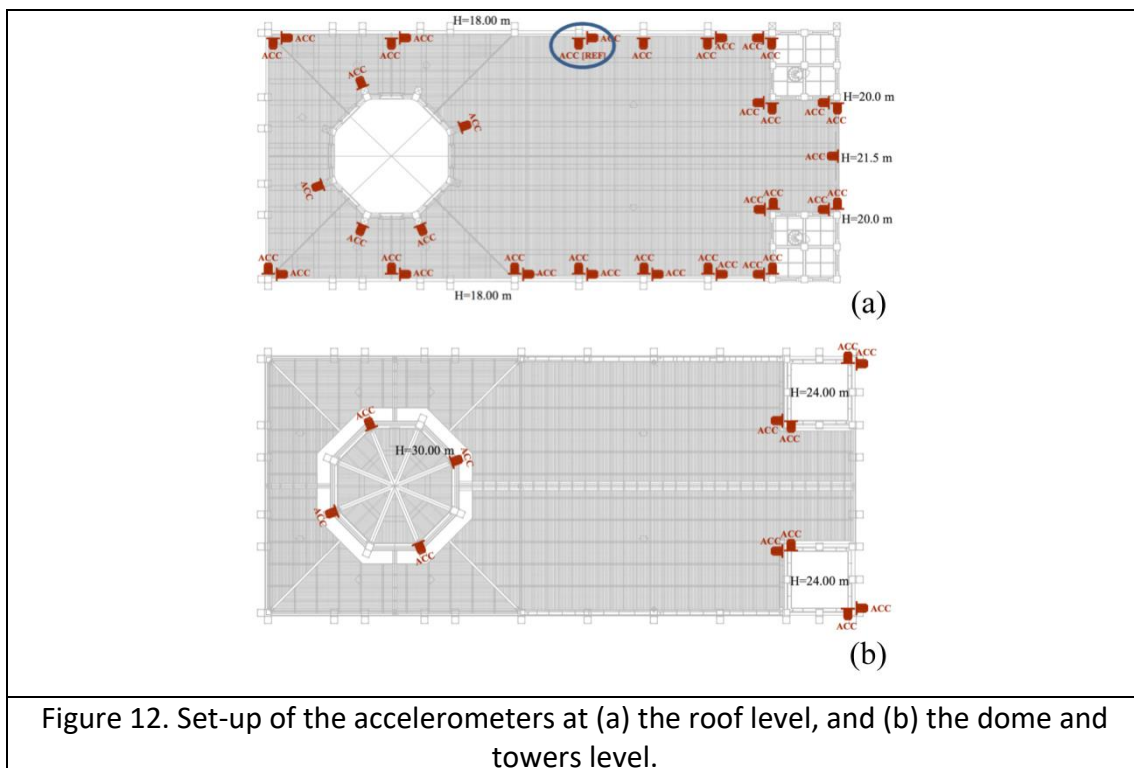
Fifty-one positions of the structure were chosen to place the accelerometers, at which the highest modal displacements were expected. Only horizontal degrees of freedom were selected and recorded, distributed at the top of the external walls, the dome and the bell towers. Figure 12 shows the exact locations of the accelerometers set-up. One degree of freedom, at the center of the nave, was kept as reference (Figure 12a), and the position of the rest of the accelerometers was changed, resulting in seventeen different setup configurations. In each configuration, 30 minutes of ambient vibration were recorded at 200 Hz sampling rate.

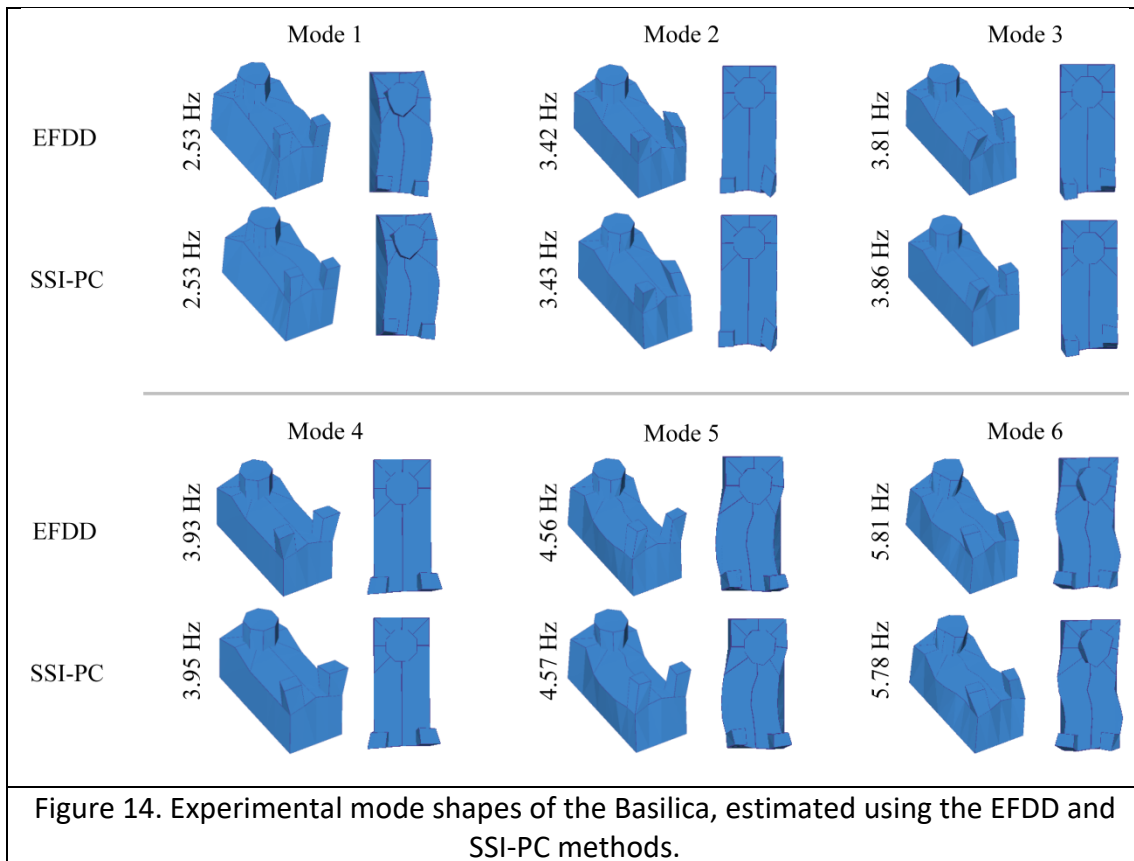
Figure 14 presents the estimated mode shapes using the EFDD and SSI-PC methods. The first mode (2.53/2.53 Hz) corresponds to the first global mode in the transversal direction of the Basilica. In this mode, the longitudinal walls present a single curvature in plan. The second mode (3.42/3.43 Hz) represents a local mode of the east bell tower, which corresponds to a torsional/wrapping mode of the tower, distorting its cross section. Such modes usually appear to be stiffer than the bending modes, while it should be noted that due to the convent building and the existence of damage, the Basilica might possess an asymmetric dynamic behavior. Mode three (3.81/3.86 Hz) indicates the bending mode of the bell towers in the longitudinal direction. In this mode, the bell towers are out-of-phase. The fourth mode (3.93/3.95 Hz) is the bending mode of the bell towers in transversal direction. Finally, the fifth (4.56/4.57 Hz) and the sixth (5.81/5.78 Hz) modes correspond to the second and third global mode of the Basilica in the transversal direction, with second and third curvature of the longitudinal walls, respectively. In both modes, the bell towers are in-phase. Using the EFDD method, the damping ratios were estimated only for the first and sixth mode with values 2.6% and 1.2%, respectively.

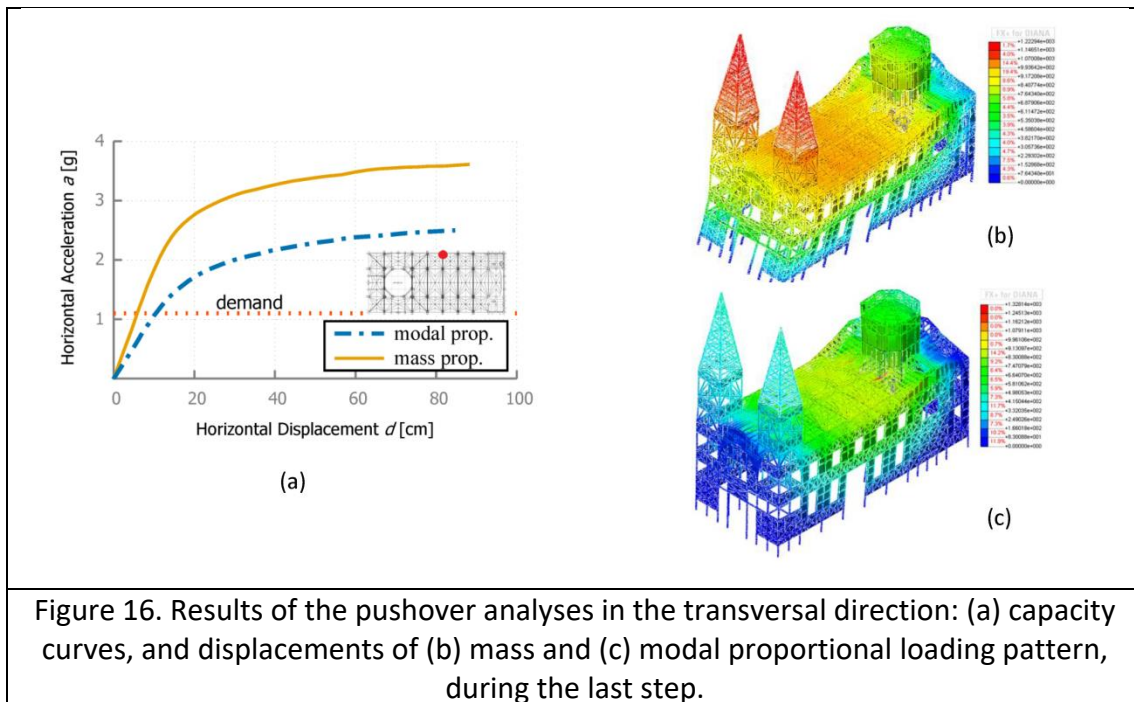
Figure 16. Results of the pushover analyses in the transversal direction: (a) capacity curves, and displacements of (b) mass and (c) modal proportional loading pattern, during the last step.

The results of the analyses performed for the transversal direction are presented in Figure 16 (a) in terms of capacity curves. The horizontal axis corresponds to the displacement of the point of the roof highlighted in the plan of the structure, while the vertical axis corresponds to the ratio of the base shear reaction to the mass of the structure. The deformed shape of the structure for both the modal and the mass proportional load patterns at the last step of the analyses are presented in Figure 16 (b) and (c). Detailed results on the distribution of stresses and strain may be found in [20].

As expected, when the load is applied according to the modal pattern, the structure is more flexible and presents a lower force capacity, compared with the mass proportional pattern. In more details, in the case of the modal loading pattern, the capacity curve is almost elastic until a horizontal acceleration of around 1.5 g and reaches a maximum acceleration of 2.5 g. In the case of mass loading pattern, the structure behaves almost elastically until around 2.4 g and shows a maximum capacity of 3.6 g. It is of interest to underline that, independently of the load pattern, the equivalent yield displacement of the structure appears at the same displacement of the roof close to 18 cm, for both cases. The same applies for the ultimate displacement at 85 cm. Such an outcome indicates that in the non-linear range, displacements are a more consistent indicator of the extent of damage rather than forces, as has been discussed extensively by [29].

By comparing the deformed shapes and damage concentration of the structure for the two load patterns, a rather different response is observed. In the case of the mass proportional loading, the structure deforms fairly linearly up to the top part of the towers, while the part of the sanctuary deforms less, when compared horizontally. This is attributed to the fact that more load is applied at the façade of the Basilica, due to the additional mass of the towers, while central nave possesses

In parallel with the capacity curves, Figure 16 (a) also displays the spectral acceleration demand according to the National Structural Code of Philippines (NSCP) [30]. The site of the Basilica is expected to be subjected to a Peak Ground Acceleration (PGA) of 0.44 g, while since the structure has frequencies higher than 2.5 Hz, it falls in the constant acceleration plateau of the spectrum at 1.1 g, after considering the SDOF to MDOF transformation factor. By comparing the acceleration demand, it is clear that the Basilica is estimated to remain elastic, despite its significant deformation capacity. This outcome points out that the Basilica is in compliance with the code seismic safety requirements. At this point, it is important to underline that the verification is performed following a force-based approach, which is justified by the following notes: a) the stiffness of the Basilica has been specified after experimental tests, and not by arbitrary a priori considerations; b) nonlinearities of the structure are included explicitly in the analysis, and not with a simplified lumped approach; and c) the structure remains in the linear range and thus an obscure reduction factor is not required to verify the structure.
