CYCLIC QUASI-STATIC TESTING OF A HALF-SCALE, TWO-STORY UNREINFORCED MASONRY BUILDING WITH STRUCTURAL IRREGULARITY

Keywords: Quasi-static test, cyclic, experimental pushover, unreinforced masonry, structural irregularities.

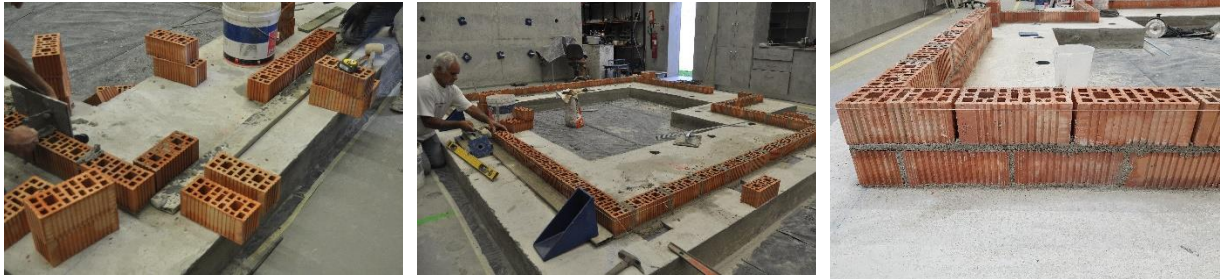
Figure 6. Construction of the URM walls

During the design and construction of the experimental building, it was observed that the dimension of the brick units was an important parameter regarding the practical application. One of the criteria during the selection process of the brick units was the representativeness of half-scale units due to scaled building. Meaning that, if the length over width ratio of the brick unit is equal to 2, then it provides easier application. In the present case, this ratio was nearly 2.3 and, therefore, during the construction of the walls, the location of each brick should be done correctly according to the design (Figure 6). Otherwise, a random distribution of such bricks may result in the length of walls that were not in the design.

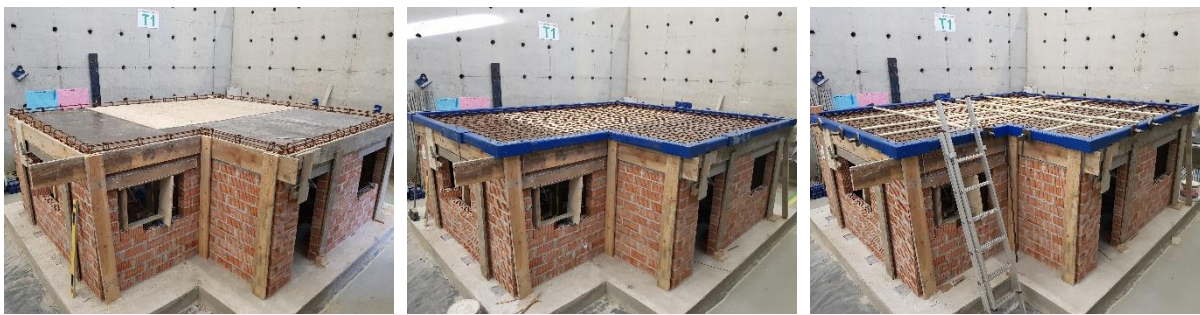
Figure 7. Construction progress of the RC slab

The design of the experimental setup is mainly controlled by the application of the loading. In other words, two hydraulic jacks with a capacity of 300 kN were installed to apply the lateral loading at each level. They were located at the centre of mass of the structure at the floor levels. To avoid point load application, steel profiles along the perimeter of the building were mounted as demonstrated in Figure 7.

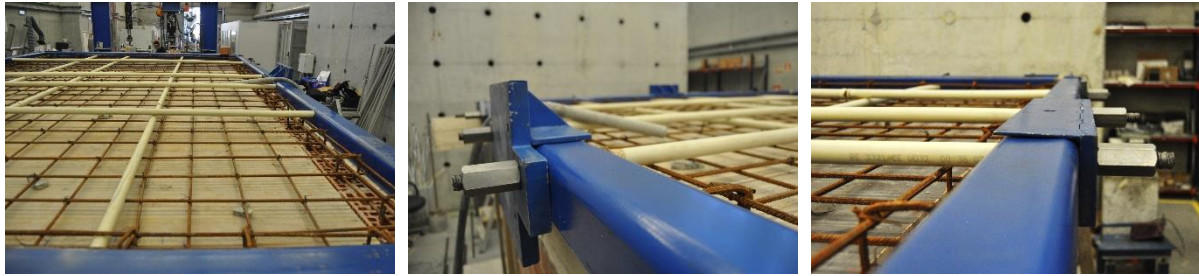
Figure 8. Details of the RC slab with post-tensioned rebar and their connection

Another important feature of this experimental campaign is the use of post-tensioned rebars with a diameter of 20 mm which were located inside the RC slab as a non-structural component. Otherwise, the post-tensioned bars should have been located below or above the slab through holes that would be made or left on the structural walls. To avoid any damage prior to the testing or concentration of any deformation, the first approach was adopted. It is highlighted that these post-tensioned rebars were placed inside PVC tubes with a diameter of 24 mm to avoid them to harden with concrete and to provide free movement before the post-stressing. The main aim of such application was to ensure the integrity of the steel profiles during the pulling and pushing of the structure and to avoid the detachment of the profiles from the slab so that they could distribute the load uniformly. Moreover, the steel profiles were used as a framework for the slab and cast with concrete to safeguard complete coverage of the interface between the RC slab and the steel profiles.

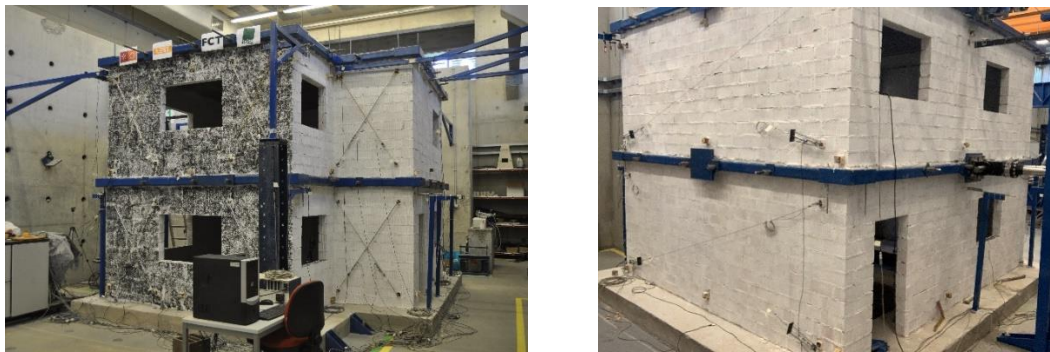
Figure 11. Views from the experimental building at the testing condition

Accordingly, the section view of the setup details is provided in Figure 9. Each hydraulic jack was installed on a reaction wall and the load application point of the jacks was connected to steel plates which were fixed to the loading beams, as shown in Figure 10(a). In this paper, these plates are called loading plates (Figure 10(b)). To apply the cyclic load, the structure was pushed and pulled through these connections. On the same alignment at the opposite wall, so-called reloading plates were mounted (Figure 10(c)). Loading and reloading plates were fixed to each other through the post-tensioned rebar. In this way, the force was transferred to the opposite wall to represent the loading in the negative direction during the reloading and pulling phase. The final configuration of the experimental setup at the time of testing is shown in Figure 11.

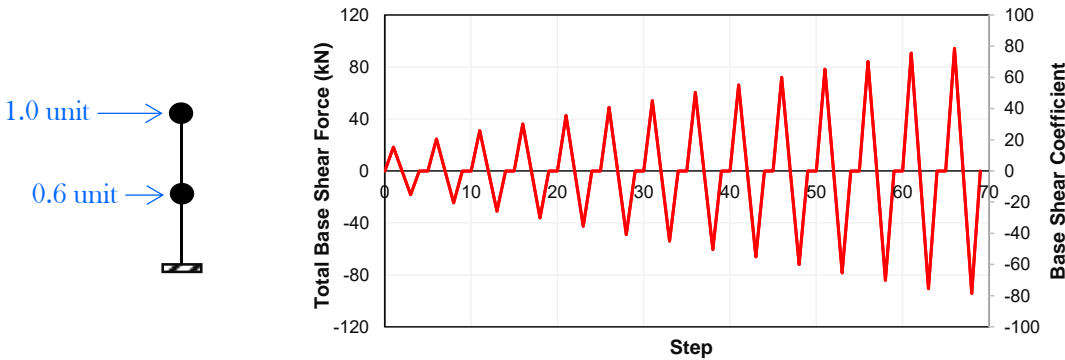
Figure 14. Applied loading protocol in force control

system is obtained. Then, the eigenvalue analysis was computed for the 2 DOF system and the eigenvectors were obtained. The normalized eigenvectors were used to define the load pattern. It was found that the structure should be subjected to 1 unit of force at the top level while in the first level 0.6 unit of force was needed. At each cycle, the same relation was used. Figure 14 presents the loading protocol that was used for the cyclic quasi-static test in terms of total base shear force and base shear coefficient (BSC, relation to the total weight of the structure). At the beginning of the test, the loading pattern was applied in displacement-control however it was not possible to ensure the relation of the forces. Thus, force-control was implemented in the testing procedure. The loading protocol is gathered in Table 1. The table starts from Cycle 3 because the first two cycles were performed in displacement-control and decided to be neglected due to the reason mentioned above. Due to limitations of the equipment, the loading at each level was applied step-wise, meaning that one level was subjected at a time.

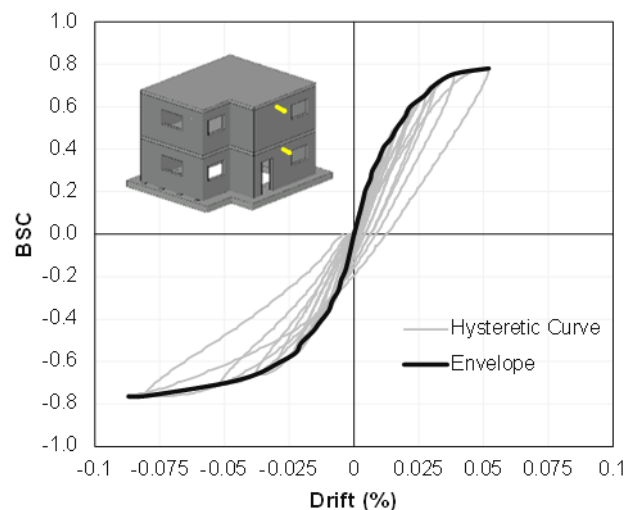
Figure 15. Capacity diagram for a given control point

The results are discussed qualitatively and quantitatively such as (i) evolution of the damage, (ii) capacity diagram, and (iii) displacement profiles along the height in the in-plane and out-of-plane walls. First of all, the lateral capacity of the building is assessed in terms of base shear and lateral displacement response. The base shear coefficient was computed as the ratio of the total base shear force and the total weight of the structure. On the other hand, the drift which is the ratio of the top displacement and the height of the building is considered. The capacity diagrams for each cycle and the backbone curve are provided in Figure 15. To plot the capacity diagrams, LVDTs right below the reloading plates were selected at each level. It is found that in terms of lateral load capacity the structure has a similar level of load in both positive and negative directions which was 75% of the total structural weight (nearly 90 kN). In addition, the displacements are significantly higher in the negative load direction which might be due to the uplifting of the structure in this direction (nearly 0.09%). On the other hand, the maximum drift was achieved at the 0.05% in the positive direction. It is noted that the test was performed up to the maximum lateral load capacity of the building, once the failure was reached since the loading was applied in force-control. Therefore, the post-peak behaviour was not achieved.

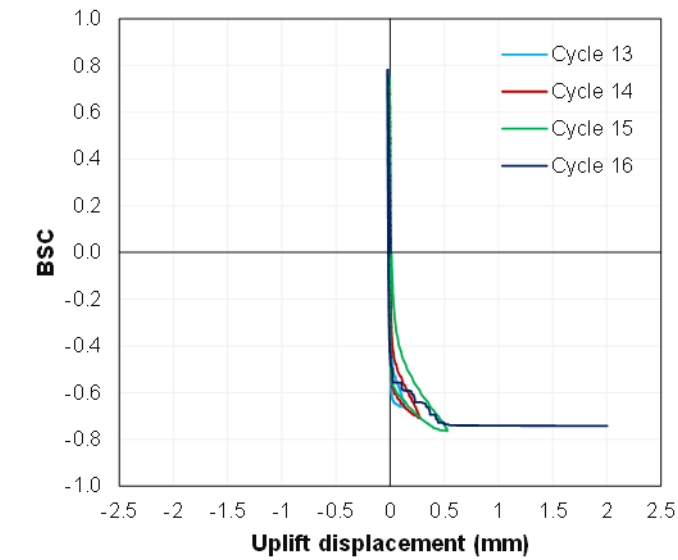
Figure 16 BSC vs displacement diagram of the uplift

In the negative phase of Cycle 13 (which is 65% of the total weight) uplifting of the walls from the foundation and slab was noticed at the first and second levels, respectively. The uplift occurred at the base of the west and south wall. As the load was increased, the level of uplift got higher and finally reached the maximum at the peak of Cycle 15 (75% of the weight). In Figure 16, the results of Cycle 16 represent the failure and, therefore, displacements after 0.5 mm are constant. In other words, Cycle 16 (78% of the weight) was ended as the repetition of Cycle 15.

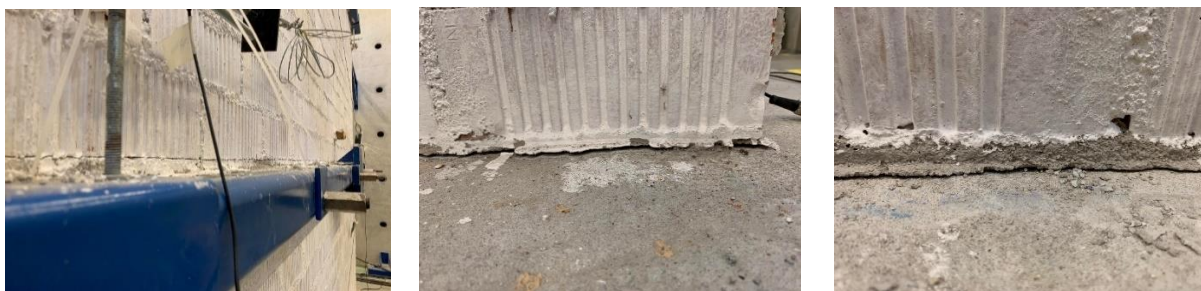
Figure 21 Uplift at the base of the URM walls at Cycle 15 (Base shear force is equal to 75% of the total weight)
