Shear testing of stacked bonded masonry

Report 02-DEC/E-10

Keywords: Shear Testing, Triplet Test, Joints Infilled with Concrete.

Universidade
do Minho

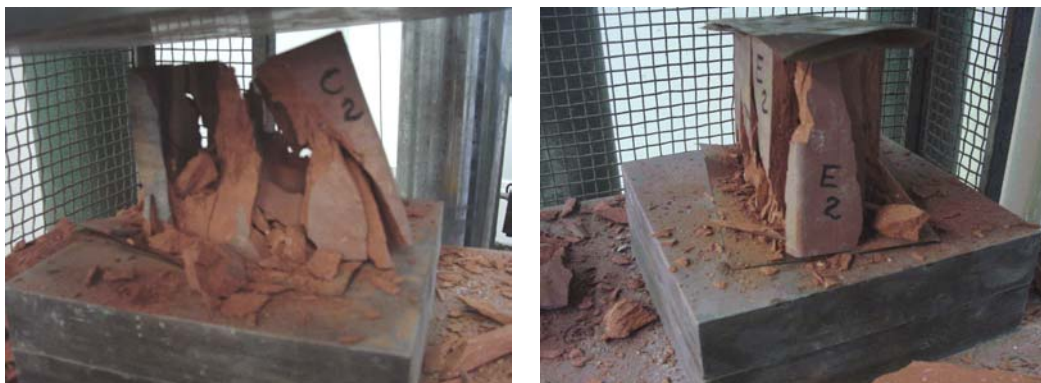
The net area of side AC, for the calculation of the net compressive strength, is obtained from $(C \times A) - 2 \times (25 \times 25)$ in mm^2 , being given in Table 2-2. Failure of the units was rather brittle and explosive, as illustrated in Figure 2-4.

Figure 2-4 – Typical failure of the specimens tested along the X direction, half unit.

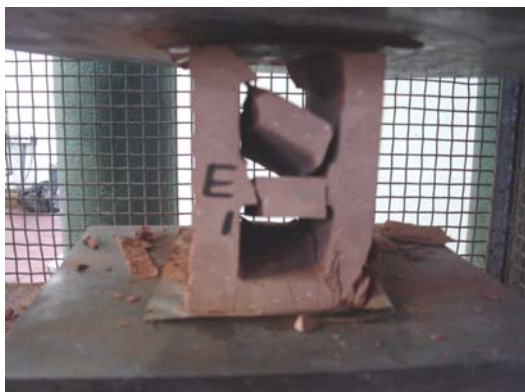
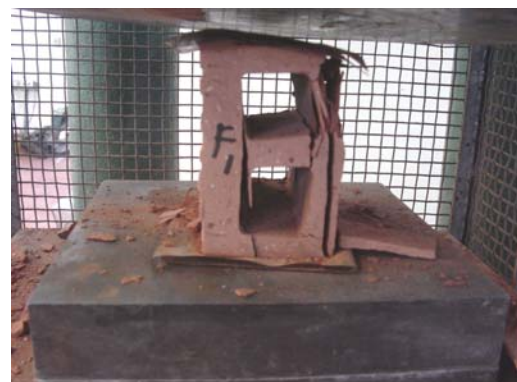
The net area considered on Y direction was calculated from $(C - 25) \times B$ in mm^2 . The net area, for the calculation of the net compressive strength, is presented in Table 2-6. Failure of the units was rather brittle and explosive, as illustrated in Figure 2-6.

Figure 2-6 – Typical failure of the specimens tested along the Y direction, half unit.

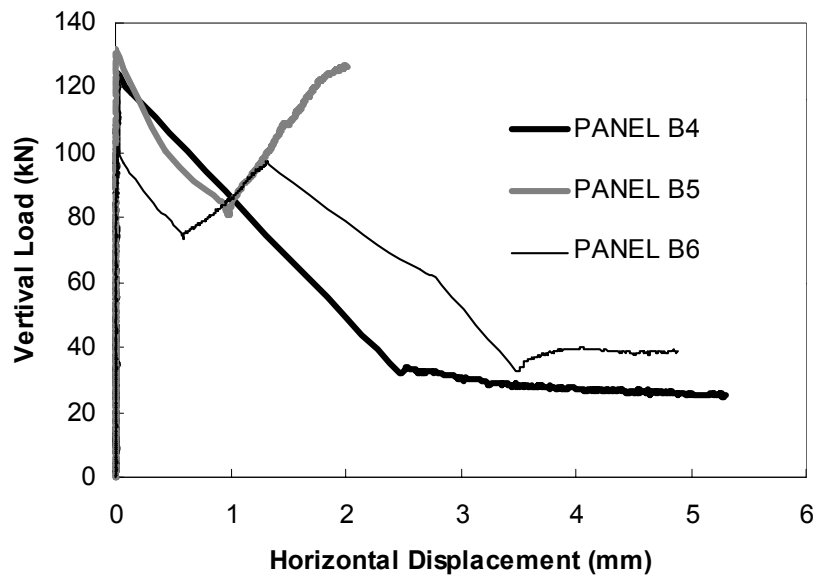
Figure 3-10 shows the relation between the shear load and the horizontal displacement at the joints for series 2. Due to the higher pre-compression level, the maximum shear load was increased. Figure 3-11 illustrates the relation between the horizontal displacements of the two horizontal joints. Finally, Figure 3-12 presents the failure mode of the panels.

Figure 3-10 – Shear load vs. horizontal displacement - series 2.

The results for Panel B4 in term of force-displacement diagram are coherent and follow the expected pattern. This panel failed simultaneously in the top and bottom joints as indicated in Figure 3-12. This can be understood from Figure 3-11, where a continuous relation between the displacements in the top and bottom joints is found.

The joints in Panels B5 and B6 have failed in a similar way. Initially, only one joint has failed but, upon reloading, a second crack developed at the non-cracked interface. This is clearly in agreement with the diagrams in Figure 3-11, where it can be seen that sliding in the bottom joint is not accompanied with sliding in the top joint, until a significant relative displacement is found. In Panel B6, it can be observed that global softening only occurs once both top and bottom cracks are formed, at an average horizontal displacement equal to circa 1.3mm (or a displacement in the bottom joint of circa 2.6mm).

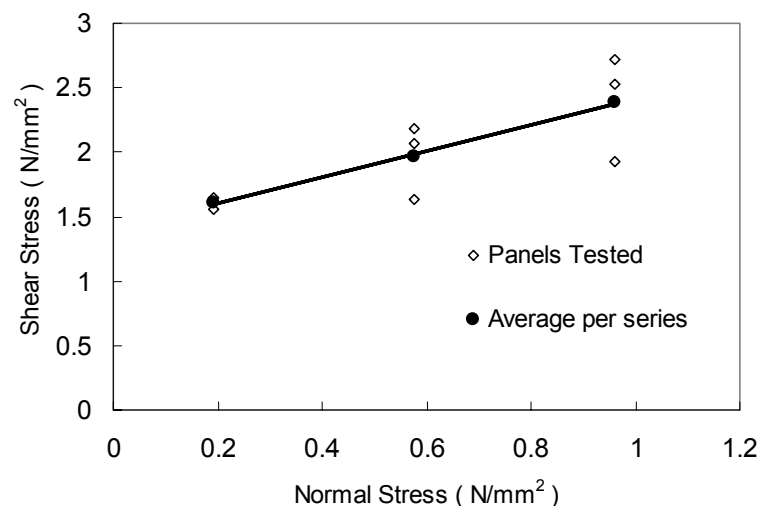
Figure 3-16 shows the relation between the normal stress and the shear strength for all tests, as well as a linear regression carried out with the shear strength average for each series of tests. The correlation coefficient r^2 of the linear regression is 0.997, which indicates an excellent correlation.

Figure 3-16 – Relation between shear strength and normal stress.

The linear regression indicates a cohesion value c equal to $1.39 N/mm^2$ and a tangent of the friction $\tan\phi$ equal to 1.03. In standard masonry, the value of the

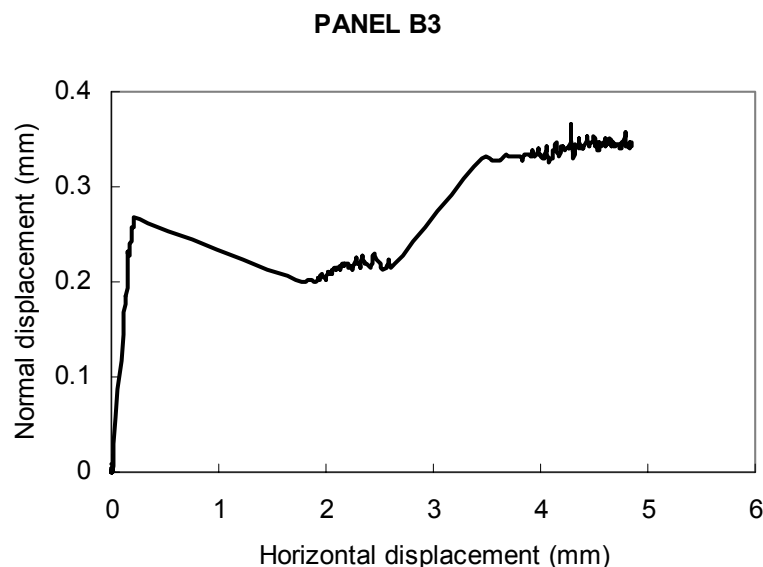
Figure 3-17 illustrates the measured dilatancy for panel B3, which is the first panel with recorded significant horizontal displacements. The figure seems to demonstrate that a zero dilatancy is also retrieved for the micro-concrete joints adopted in this case. The complete results for all tests are given in Annex A.

Figure 3-17 – Relation between horizontal and normal displacement, for panel B3.

It is further noted that the given displacements were calculated using the average of displacements recorded by LVDTs 1, 3 and 4 (horizontal displacement) and LVDTs 5, 6 and 7 (normal displacement). The selected horizontal LVDTs (1, 3 and 4) were located on the opposite side of the panel associated with vertical LVDTs (5, 6 and 7). In such a way, the horizontal and vertical displacements were measured in the same location.

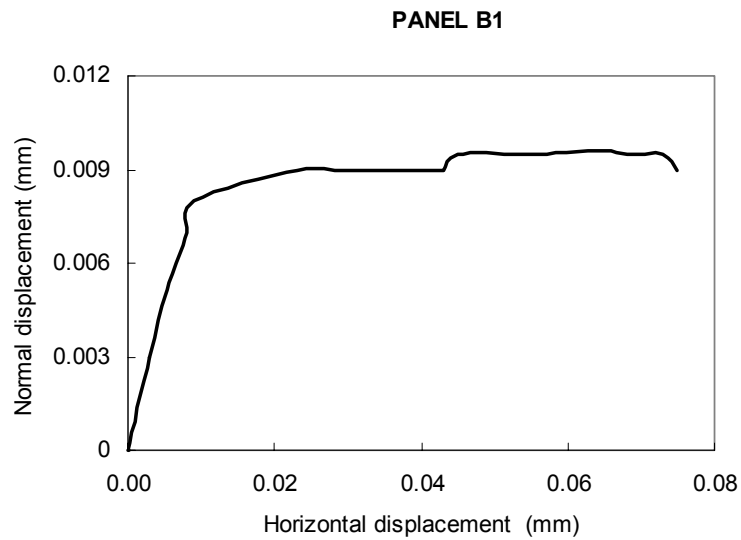
Graphic of average of displacements in shear direction \times displacements in normal direction of panel B1.

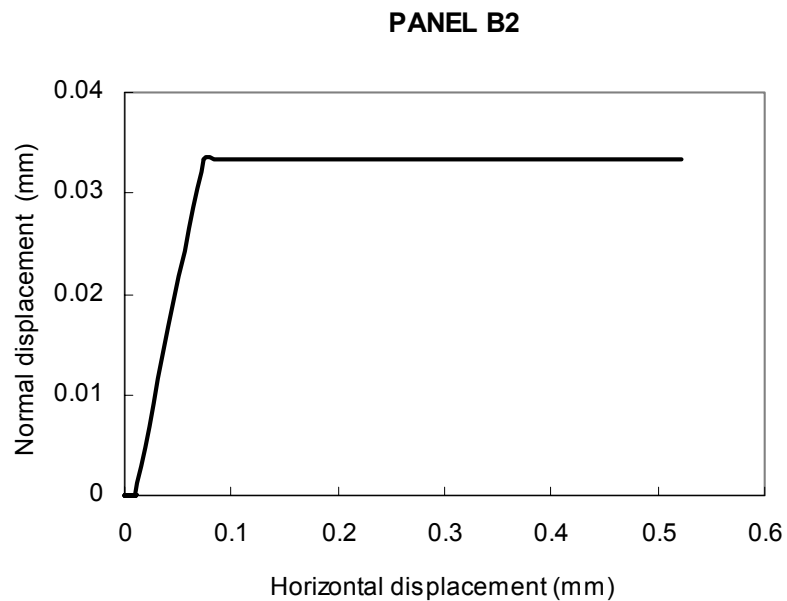
Graphic of average of displacements in shear direction \times displacements in normal direction of panel B2.

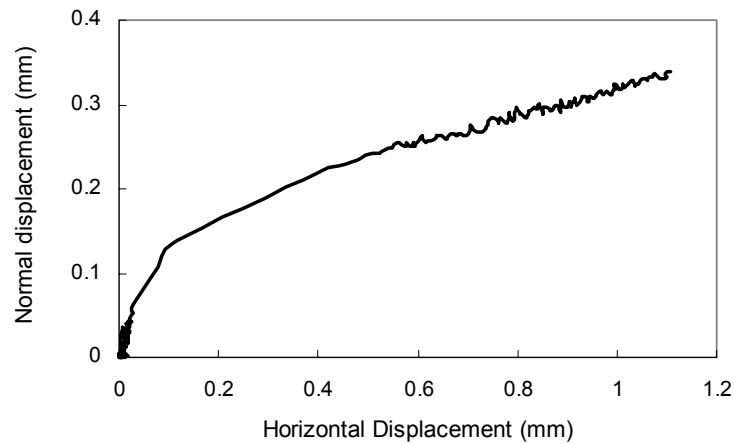
PANEL B6

Graphic of average of displacements in shear direction \times displacements in normal direction of panel B6.
