DYNAMIC IDENTIFICATION AND MONITORING OF CULTURAL HERITAGE BUILDINGS

Paulo B. Lourenço*, Luís F. Ramos**

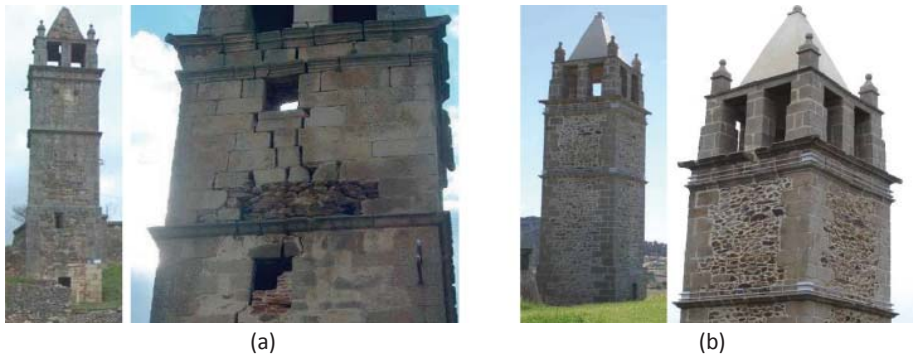
Figure 9 Mogadouro Clock Tower and conservation works: (a) before; (b) after.

The Mogadouro Clock Tower, see Figure 9, is located inside the castle perimeter of Mogadouro, a small town in the Northeast of Portugal. The tower was built after the year 1559. It has a rectangular cross section of $4.7 \times 4.5 \text{ m}^2$ and a height of 20.4 m. Large granite stones were used in the corners and rubble stone with thick lime mortar joints were used in the central part of the walls. The thickness of the walls

is about 1.0 m. In 2004, the tower was severely damaged, with by large cracks, material deterioration and loss of material in some parts. A geometrical survey of the structure was performed and the existing damage was mapped. Conservation works carried out in 2005 reinstated the tower safety, including lime grout injection for the consolidation of the walls, replacement of material with high level of degradation, filling of voids and losses, and installation of ties (or a steel belt) at two levels.

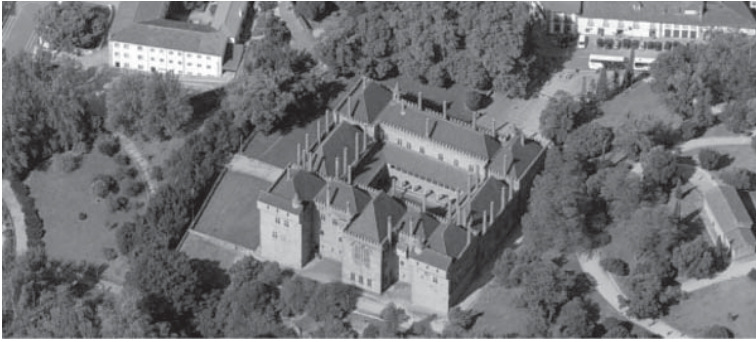
Figure 20 Palace of the Dukes of Bragança (“Paço dos Duques”), in Guimarães.

The Paço dos Duques (Palace of the Dukes of Bragança) was built between 1422 and 1433 by D. Afonso in Guimarães, north of Portugal, see Figure 20. One of the most important changes in the structure of the building was the addition of chimneys in the roof. The original building had only four chimneys and, in the intervention started in 1937, 34 more chimneys were added. Since 2002, the building suffered some conservation works, mostly related to the roofs and chimneys. The chimneys exhibited considerable damage, with one chimney requiring strengthening.

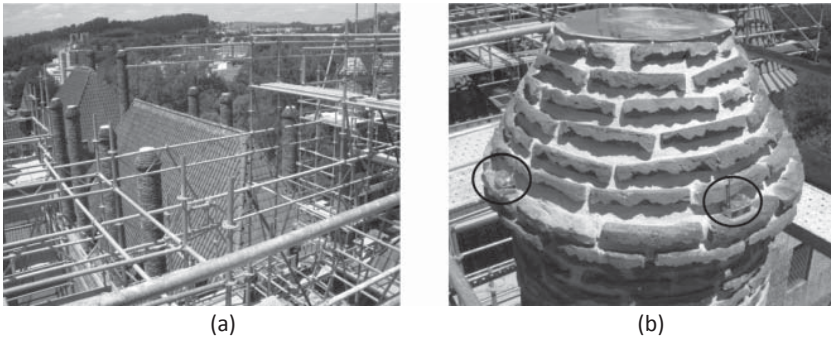
Figure 21 Chimneys at Paço dos Duques: (a) recent conservation works; (b) sensors location.

Based on the previous results of the experimental tests, the use of commercial wireless platforms for structural dynamic monitoring was again explored. The dynamic response of one of the four original chimneys was studied using conventional and wireless platforms. Figure 21a shows a general view of the conservation works that were carried out and Figure 21b shows the location of the wireless platforms in the experimental tests.
