Portuguese traditional timber structures: Survey, analysis and strengthening

J.M. Branco

ISISE, University of Minho, Portugal

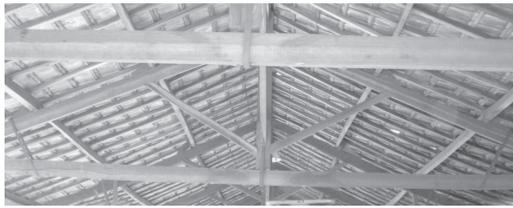
Figure 1. Incorrect truss configuration for the roof span.

Improper maintenance of the structure and faulty design or construction are the main causes of safety reduction of Portuguese timber trusses. Problems associated with moisture contents, especially near the supports, are usually present. The faulty design is frequently consequence of a wrong selection of the truss configuration for the roof span (Fig. 1) and due to eccentricities in the purlins.

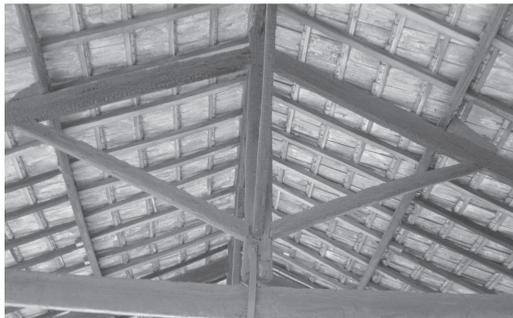
Figure 2. Wrong positioning of the purlins with eccentricity relatively to the truss joint.

In fact, although, a strong emphasis is traditionally placed on the need to limit bending moments in the truss elements, eccentricities in the purlins are common (Fig. 2).

1. The application of concentrated loads out of the joints, for example originated by a wrong positioning of the purlins, can compromise the structural global safety;

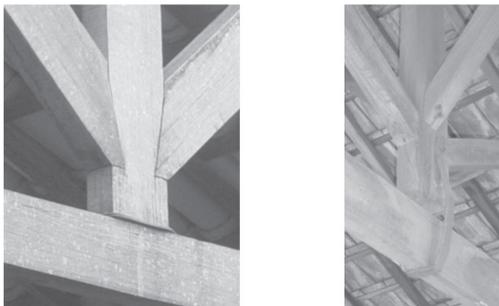
Figure 3. Examples of misconceived connections between the king post: and the tie beam.

Despite being less significant, eccentricities of the supports to the tie beam-rafter connection are common. When important eccentricity exists it is normal to introduce braces. A major source of uncertainty in the global structural behavior of traditional trusses, in particular in the case of the king post configuration, is related to the connection between the king post and the tie beam. Although traditional construction manuals suggest the disconnection between the post and the tie beam, in practice, examples of misconceived connections are not uncommon (Fig. 3).

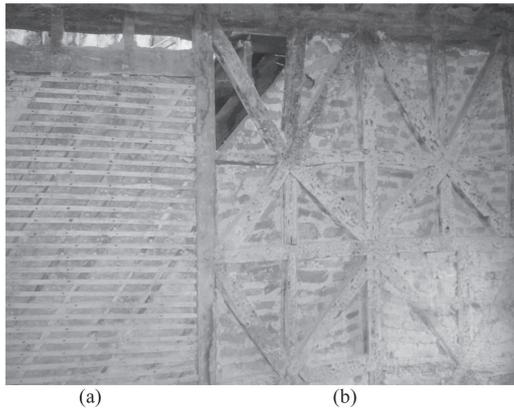
Figure 8. Examples of Portuguese traditional timber walls. (a) Tabique walls and (b) Frontal walls.

Two types of timber walls can be found in Portuguese buildings: light-framed timber partition walls (tabique walls) and timber reinforced masonry walls (frontal walls) (Fig. 8).

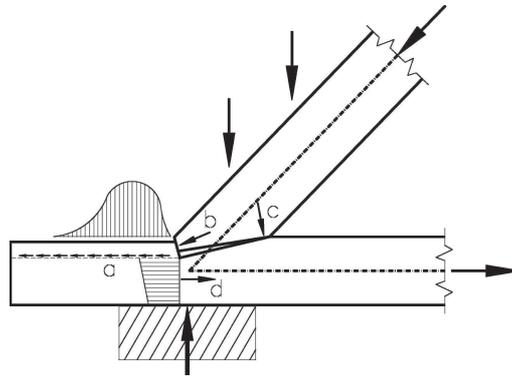
Figure 9. Main resistant mechanism in a traditional timber connection (Piazza et al., 2005).

Behind this simple definition, it is important to point out that the contact surface, through which the forces are transmitted, is normally smaller than the cross-section of the element and is not orthogonal to the grain direction of any connected element. In the schematic drawing of Figure 9, reporting a connection between the tie beam and the rafter, which can be assumed as the general example, the main resistant mechanism are presented.

In the design of traditional timber connections, it is essential to understand the force equilibrium in the joint and, therefore, to identify all critical zones verifying for each one its resistance capacity. Analyzing the forces mechanism that occurs inside the joint it is important to draw attention to:

- Existence of not negligible tension perpendicular to the grain often followed by significant shear stresses;
- Concentration of stresses caused by the particular shape of the notches of each connected element;
- Possibility that cracks begin in the step edges;
- Eccentricity in force transmission.
