In situ investigation and stability analysis of Famagusta Churches

Keywords: Gothic churches, in situ evaluation, stability, seismic analysis

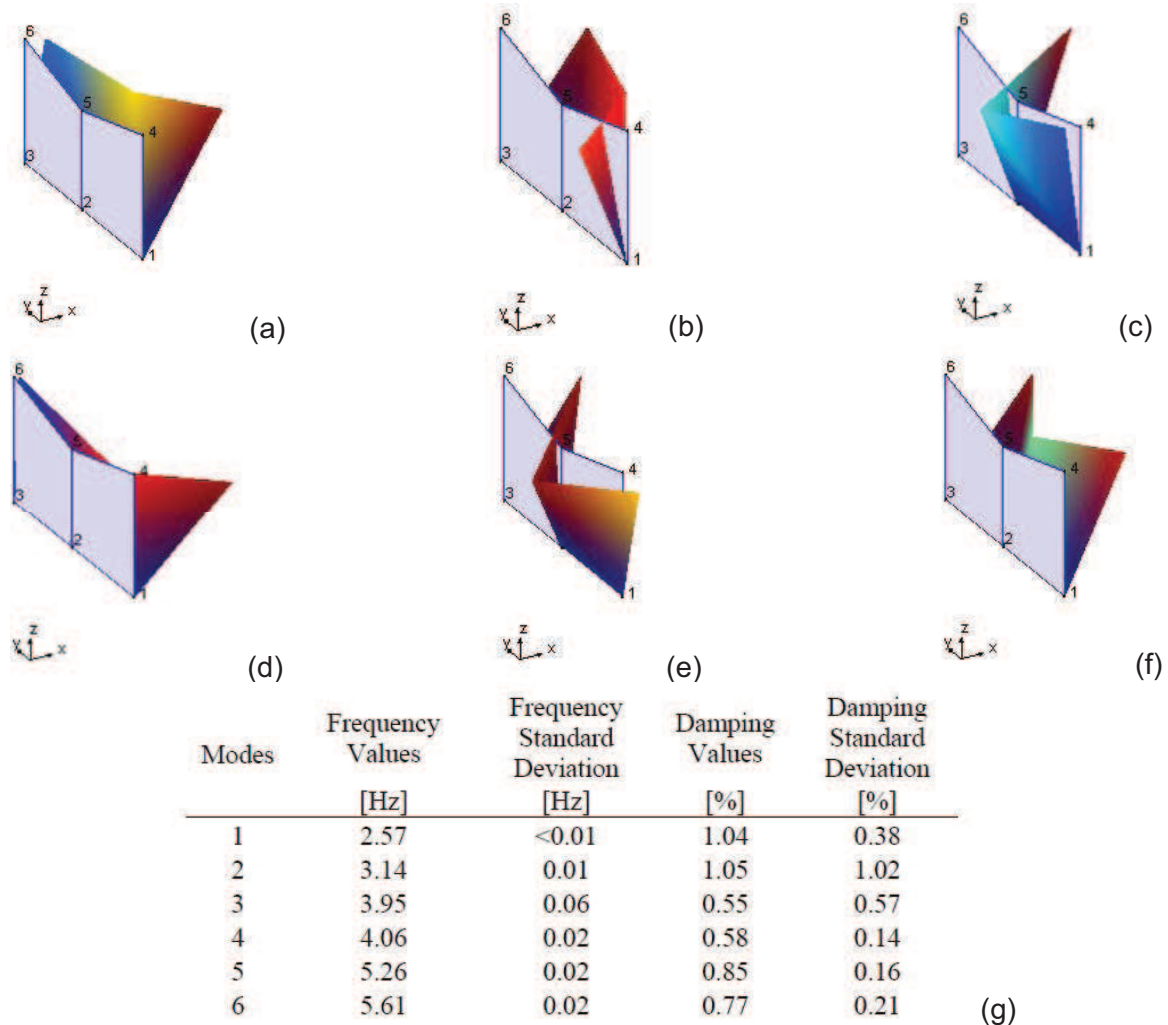
The measurements were carried out mainly at three points in the North façade, close to the top of three buttresses [1]. The natural frequencies of the structures which were found are well spaced and their values range between 2.6 to 18.0 Hz. The standard deviation is low, indicating that they were well estimated. The configurations of the mode shapes are mainly out-of-plane modes, as expected, due to the unconstrained walls of the church ruins. The first six modes, and their measured frequencies and damping coefficients are presented in Figure 6.

Figure 6. Modal identification: (a) 1st mode; (b) 2nd mode; (c) 3rd mode; (d) 4th mode; (e) 5th mode; (f) 6th mode; (g) frequencies and damping coefficients

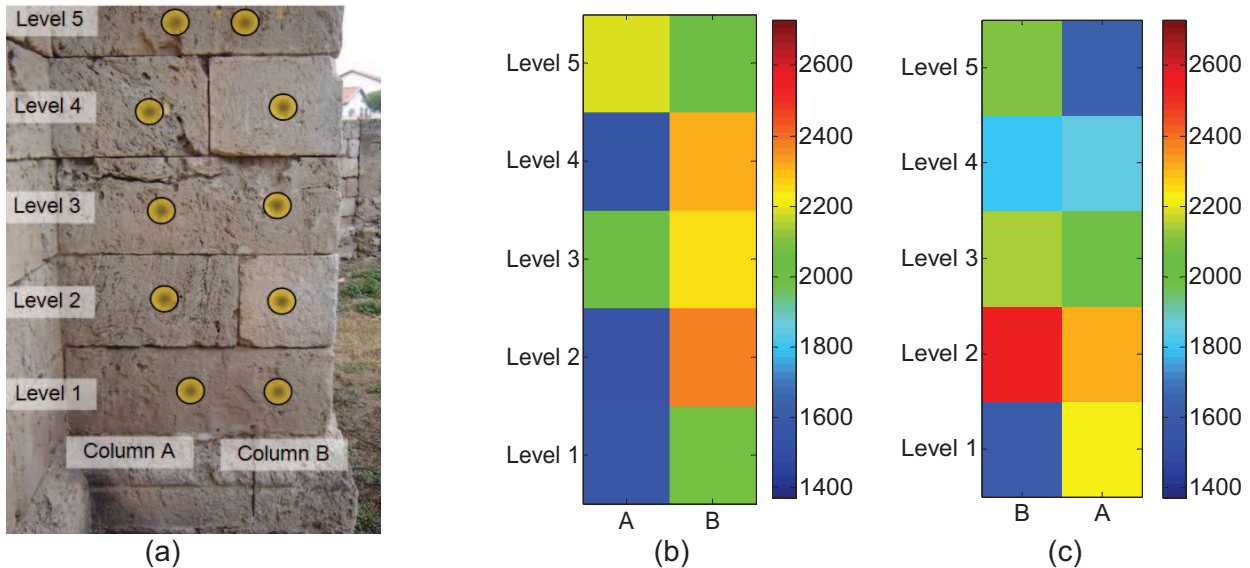
One calibration stone block and two buttresses thickness were tested [1]. The buttresses, one in the north façade and one in the south façade, were chosen to evaluate their internal condition, to determine if there are internal voids, different density materials or if repair works occurred in the recent past. The average value for the sonic velocity of the stone block was 3033 m/s, with a Coefficient of Variation (CV) equal to 5%. On each of the buttresses two vertical columns (denoted as A and B) and five horizontal levels were tested (10 points per column), see Figure 7a. The velocity results are illustrated in Figure 7b for the north buttress, where the sonic velocity ranges from 1400 to 2400 m/s and the average value for column A and B are 1597 and 2249 m/s, respectively. The outer points of the buttress (column B) have higher velocity than the inner points (column A), indicating that the stones in the outer column were probably replaced by new ones in the recent past, while the internal part of the buttresses are in worse condition. Concerning the south buttress, small differences

were found between the velocity values. Ranging from 1400 to 2600 m/s, the average values for A and B were 1923 and 1996 m/s, respectively, see Figure 7c. The values indicate that the internal condition of the buttress in the two columns (internal and external) is similar.

Figure 7. Sonic test results: (a) location of measured points; (b) North buttress; (c) South buttress

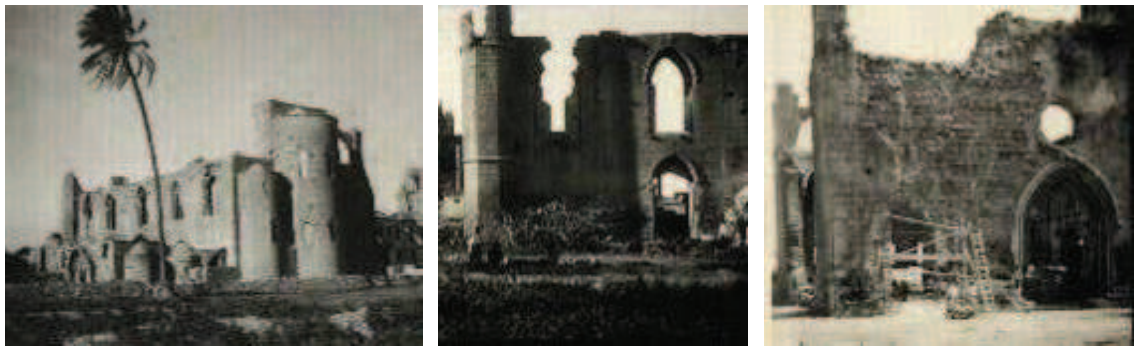
Figure 8 again indicates that the present condition of the church seems not to differ significantly from the condition around 1940. Some aspects to be considered in a conservation project are given in Figure 9.

Figure 8. St. George of the Greeks: Historical photographs (1939)

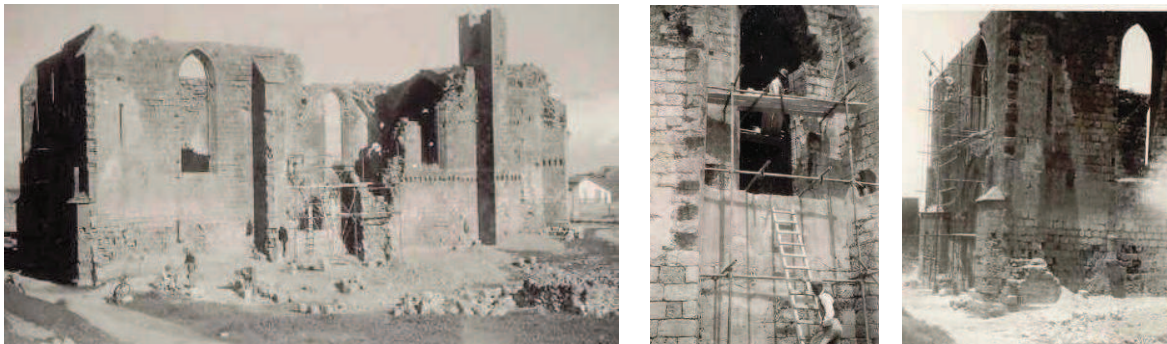
quarter of the city. The church was built in the 14th century as the church of a monastery. It has a single nave of four bays and a three-sided apse. In the second bay, two small chapels were added. The roof had ribbed vaults, and the exterior walls were supported by buttresses. The tomb of Peter Thomas, who was the Pope's representative and the Patriarch of Constantinople, who died in 1366 was in this church. The walls of the church were covered in frescoes, and some of those are still (just) visible. Outside the west door, one can also see the remains of sculptures above the entrance. Recently, the tracery added by the British above the main door around 1940 collapsed, see Figure 10. Figure 11 again indicates that the present condition of the church seems not to differ significantly from the condition around 1940. Some aspects to be considered in a conservation project are provided in Figure 12.

Figure 11. Historical photographs (1940, 1941), showing conservation works and the deficient condition of the church
