## FAILURE MODE, DEFORMABILITY AND STRENGTH OF MASONRY WALLS

*Keywords: Masonry, Deformability, Walls, Failure Mode*

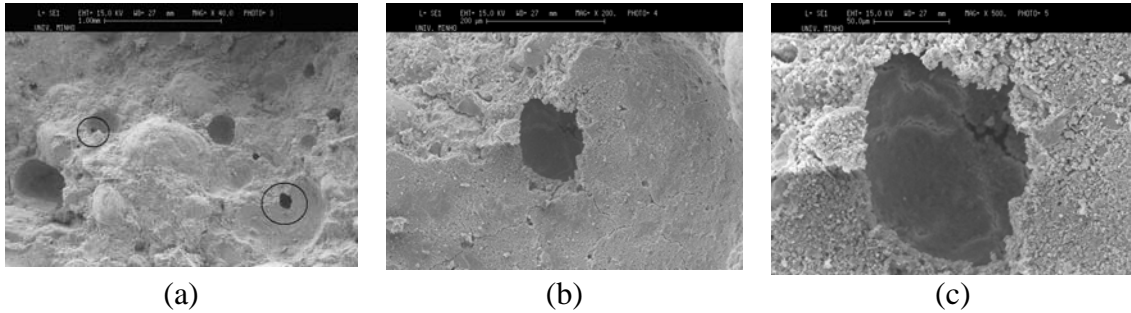
**Figure 1: Images obtained from bedding mortar.**

The structural masonry is an anisotropic composed resulting from the interaction between block and mortar. This material under loads could be subjected to a complex stress state that produce failure by reaching the tensile strength of the block or, even, mortar crushing. The failure mechanism of masonry is caused by the initiation and propagation of cracks, which starts often induced by the mortar that exhibits high porosity and different sizes of voids, with a possible initial decrease in volume caused by closing of flaw and voids. An example can be seen using visual analysis on scanning electron microscopy of mortar samples presented on Figure 01 that shows images obtained from bedding mortar. The image (a) of Figure 01 presented the highest magnification of mortar, where is possible to see the macro and micro porous, the contours of the sand and paste. From the magnification of the first image it is possible to observe the interface between paste and grain of sand with macro and micro porous linked by shrinkage cracks (image (b)). The image depicted on Figure 01 (c) shows the pore produced from the capillarities from water exudation.

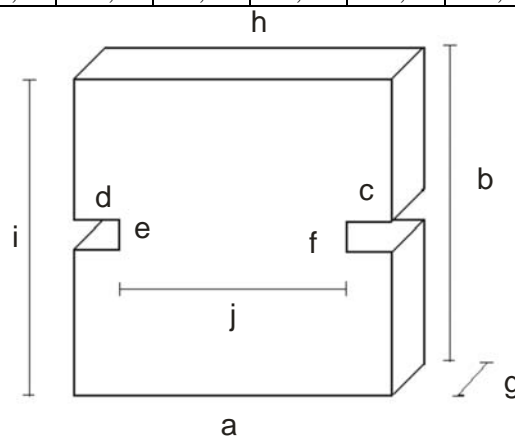
**Table 1: Dimension of concrete samples cutted from block.**

In this work, tensile tests on concrete had been done to determine the stress-strain relationship before and after reach the ultimate load. Samples were cutted from the block and used in experimental tests. To induce cracks in a fracture plane under tensile, notches were done on concrete samples. The table 01 presents the dimensions of the samples tests. The tests were done with displacement control mode with a constant velocity of load. The loading rates used for testing were 0,0001 mm/s. Two LVDTs with maximum displacement field of  $\pm 0,5$  mm were used.

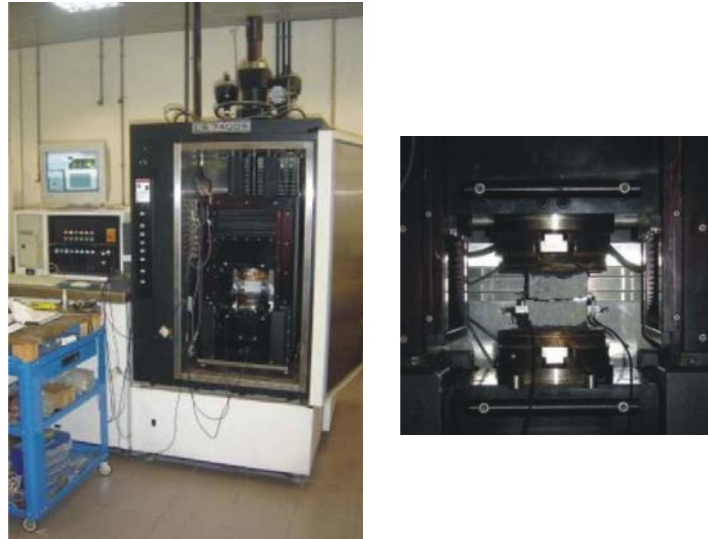
**Figure 2: Tensile test machine and the concrete sample.**

Previously, the concrete samples were bonded under a steel mould guide to ensure the parallelism between the sample and the plate of the servo-hidraulic testing machine. After this, the sample was positioned in the testing machine and the grips were closing. The Figure 2 shows the sample and test machine.

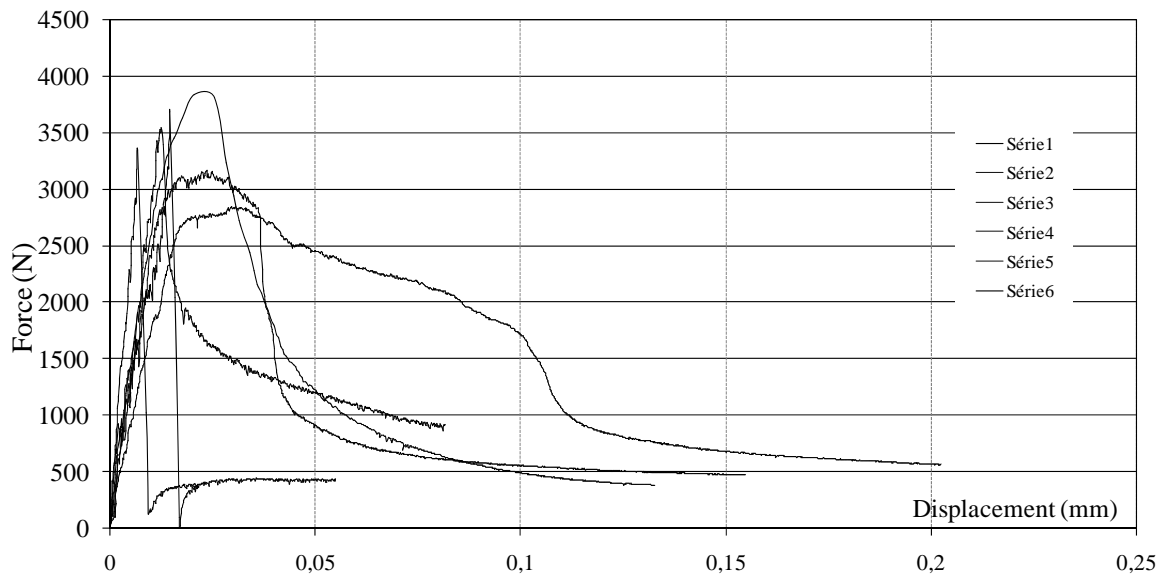
**Figure 3: Experimental results of force (N) and displacement (mm) of concrete sample.**

Experimental results of force (N) and displacement (mm) of concrete samples is depicted in Figure 3, where it is possible to show the behaviour of the concrete samples under tensile. It can be observed, from experimental tests, that the post peak behaviour of concrete is a hard task due to the fragile nature of the material and the sudden crack growth. Because of this, the coefficient of variation of axial strain obtained in middle of the samples was considered high (47%). The results of tensile strength obtained in experimental tests indicate that the relation between tensile strength was approximately 10% of the compressive strength.

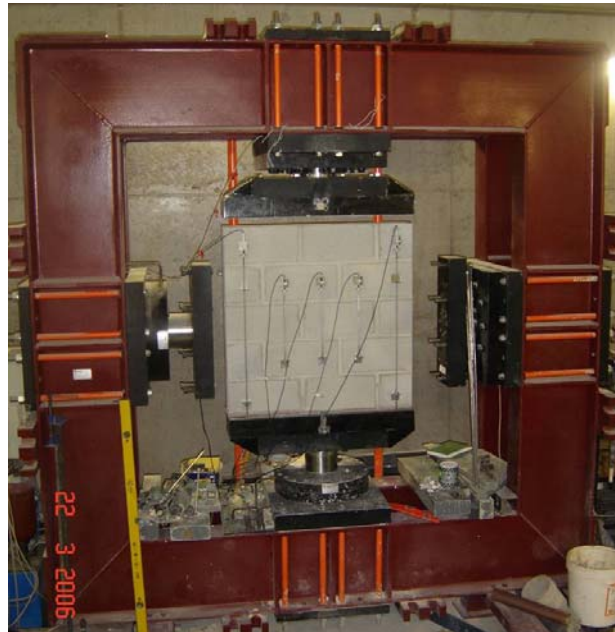
**Figure 4: Overall view of hydraulic servo-controlled machine test.**

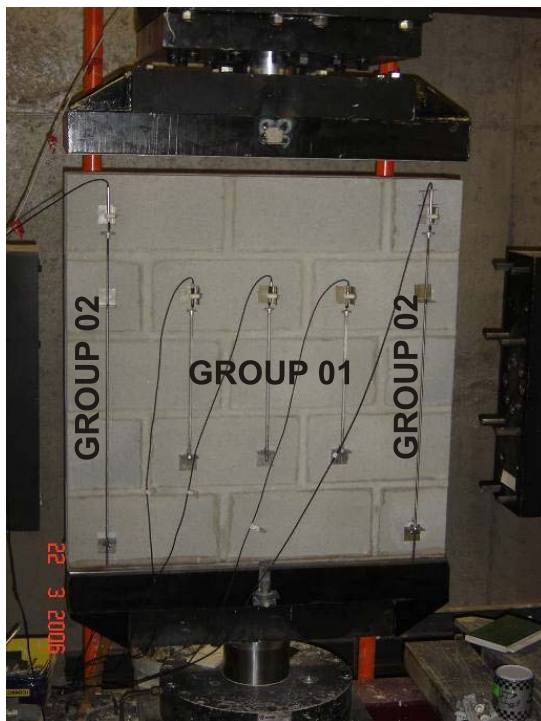
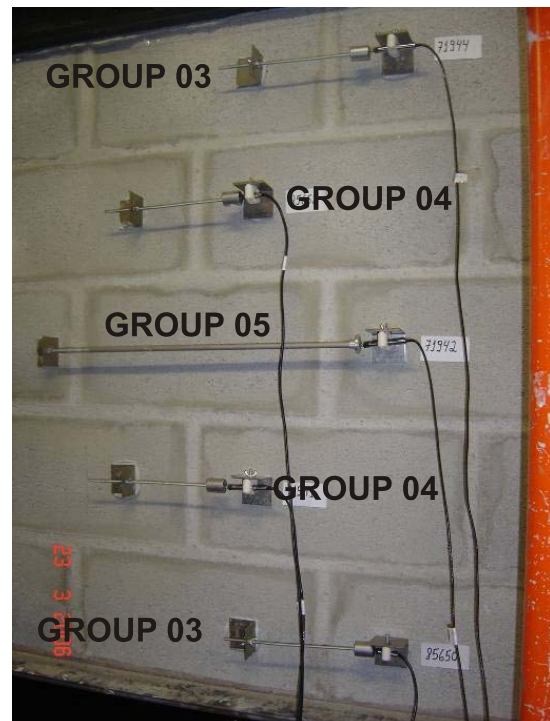
**Figure 5: Positioning of LVDTs groups for compression tests of masonry.**

The walls were built under rigid steel beam, which was previously levelled surface and could be carried to the machine test without flexural. The first course of masonry walls was levelled using a cement paste. The mortar used for experimental tests was the medium strength, as indicated in the standards ASTM C-270 and BS-5628, which de cement:lime:sand proportioned in volume was 1:0,5:4,5 and the water/cement ratio was 1,07. It was used in experimental program only one mortar, because the main purpose of this work is determine the deformability and failure mode of structural masonry walls. So, this work isn't intended to evaluate the influence of the mortar in the masonry strength results. The tests of compressive strength of masonry walls were carried out using a hydraulic servo-controlled machine test with displacement control and the apparatus is presented in Figure 4. To increasing the stiffness of the apparatus for testing the masonry walls, two vertical rods were fixed at both sides of the equipment. A total of ten (10) LVDTs with different displacement fields were used to obtain the vertical and horizontal displacement and were divided by groups. The LVDTs of group 01 were for measuring the axial strain of two bedding joint; two LVDTs were used for measuring axial strain of four bedding mortar (group 02). Two LVDTs were positioned at the first and fifth layer of the wall for measuring horizontal displacement (group 03). Two LVDTs were positioned at the second and fourth layer (group 04). One LVDT was

positioned for measuring horizontal strain of two vertical joint (group 05). The instrumentation layout of the compression test is shown in Figure 5.

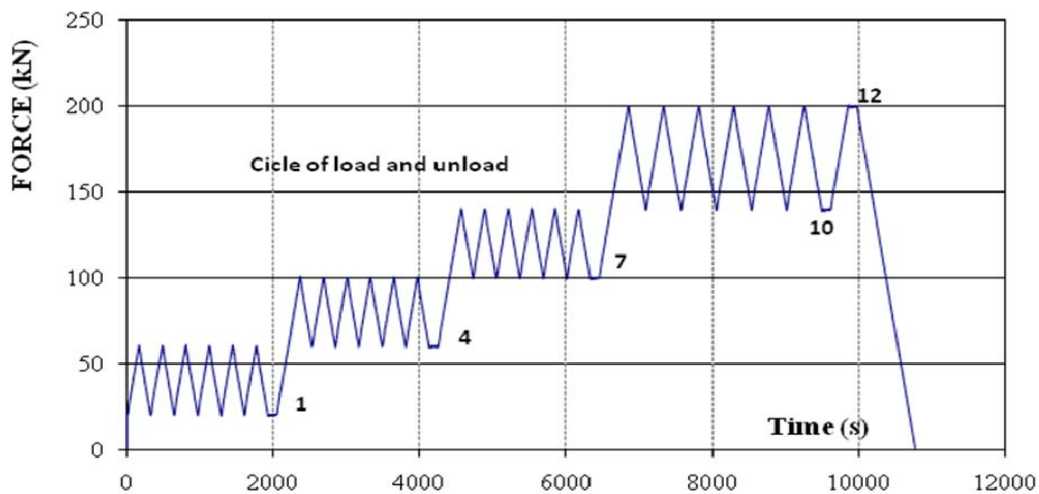
Figure 6: Cicle of load and unload on masonry.

The masonry walls specimens were tested in a load controlled testing machine with a loading rate of 0,1 KN/s, 0,2 KN/s, 0,5 KN/s, 1,0 KN/s and 1,5 KN/s. The displacement on step 12 were checked, as depicted on Figure 6. The Figure 7 presents the results of the displacement for different velocity of load. From the experimental results, it was possible to conclude that the displacement of the wall was influenced by the velocity of load. Thus, with increasing of load it was observed a decrease on the displacement of masonry and, by low velocity of load, the time of the test was increasing so much, which turns the tests impractical. So, for compression test of masonry wall it was used a velocity of load of 0,5 kN/s.

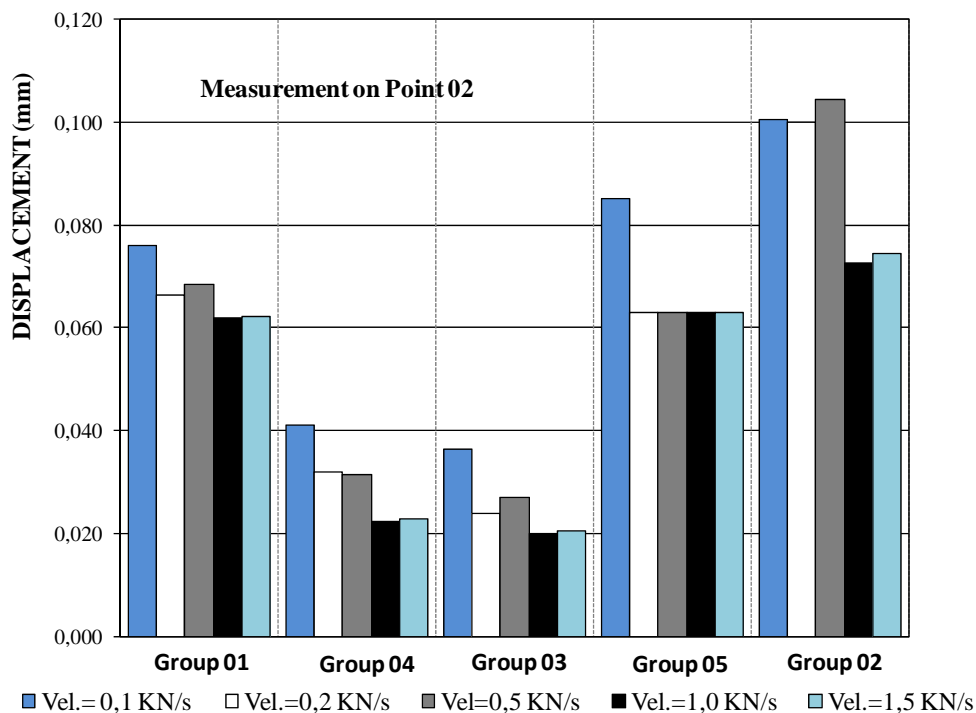
Figure 7: Measurement of displacement for different velocity of load.

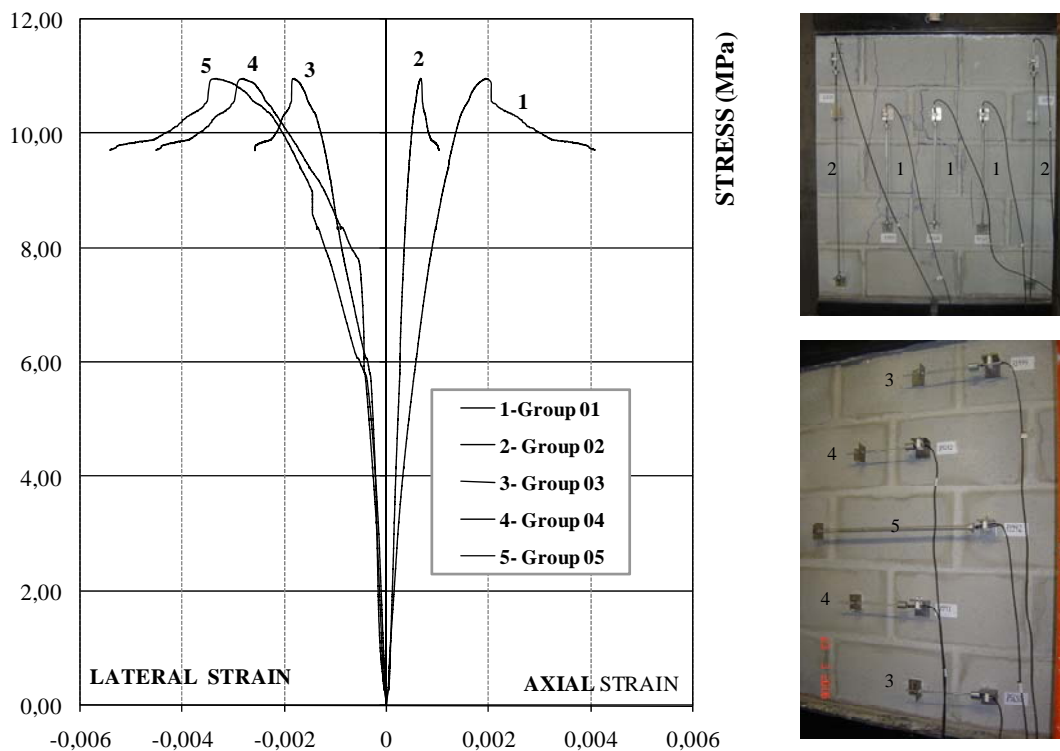
**Figure 8: Stress and strain diagram of masonry wall.**

The concrete masonry walls were tested until reach the failure. The compressive strength of the bedding mortar was 8,3 MPa and the block was 23,1 MPa. The Figure 8 shows the stress and axial and lateral strain diagram of masonry walls for different groups of LVDTs.

The LVDTs groups 3, 4 and 5 had the same strain until reach 55% of the ultimate stress, after these occurred an increasing on the strain provoked by the confinement of the steel plate. When the proportion of the stress and strength level reached 60%, starts to appear cracks on the middle of the walls between block and mortar. It is possible to observe on Figure 8 a change on the inclination of stress and lateral strain up to 60% of the compressive strength of the masonry wall for LVDTs groups 3, 4 and 5. From these results, it is possible to conclude

that the interface between block and mortar was the weakness point of the set. It is possible to observe that when the stress of the wall reached 8 MPa the cracks prolonging and cutting the block and bedding joint. The failure modes of the walls were crushing of the bedding mortar and tensile stress, which cut the block and the vertical mortar joint. The Table 3 presents the mechanical results of compressive strength of block, mortar and wall and tensile strength of block and the relation between them.
