## Experimental investigation on the repair of rammed earth by means of injection of mud grouts

R.A. Silva, D.V. Oliveira & P.B. Lourenço  
*ISISE, University of Minho, Guimarães, Portugal*

**ABSTRACT:** This paper assesses the adhesion capacity of unmodified mud grouts used to repair structural cracks on medium and large scale rammed earth specimens. Beam and wallet-specimens were manufactured using a soil from Alentejo (Portugal), whose particle size distribution had to be first corrected due to its high clay content. An “artificial” (composed by kaolin and limestone powder) and a “natural” (composed by sieved soil and limestone powder) mud grout were used to repair the specimens, which were previously tested under three-point bending and diagonal-compression and then retested. The grout injection shown to provide satisfactory results regarding the adhesion capacity, but only if it is performed with the “natural” mud grout.

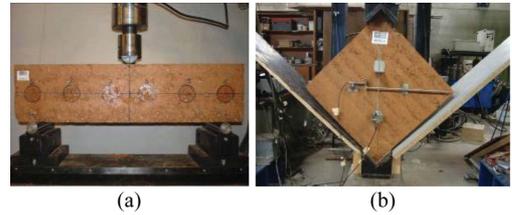
Figure 5. Tests carried out on the rammed earth specimens: (a) three-point bending and (b) diagonal-compression. (Credits: Authors).

The beam-specimens were first tested under three-point bending after drying for 6 weeks under a room temperature of about  $22 \pm 2^\circ\text{C}$ . The load was applied at middle span and the distance between supports was of about 500 mm (Fig. 5a). The application of the load was carried out under monotonic displacement control at a rate of  $1 \mu\text{m/s}$ . The testing procedure of the specimens after injection was similar, but the tests were carried out 3 weeks after the repair. The drying was processed under a room

The wallet-specimens were first tested under diagonal-compression after drying for about 12 weeks under a room temperature of about  $22 \pm 2^\circ\text{C}$ . The test was carried out according to ASTM E519 (ASTM 2002). The supports were 100 mm width and the load was applied under monotonic displacement control at a rate of  $2 \mu\text{m/s}$ . The vertical and horizontal displacements were measured in both faces of the wallet, resorting to LVDTs attached to the middle third of each diagonal (Fig. 5b). The same testing procedure was followed after repairing the wallets, which were tested 5 weeks later.

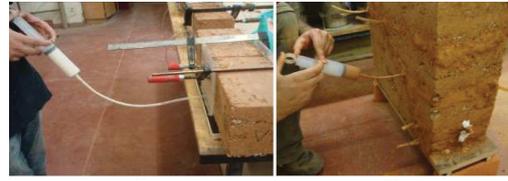
Figure 7. Injection of the (a) beam-specimens and (b) wallet-specimens. (Credits: Authors).

to mitigate the water sorption during the injection (Figure 7a). The base of the specimens was sealed using a plywood board and silicone sealant, while the sides were sealed with silicone and Plexiglas plates pressed against the specimen by means of two screw clamps. This apparatus allowed visualising the rising of the mud grout within the crack during the injection. The specimens' parts were positioned on the board such that the gap width ( $d_{cr}$ ) would be of about 2 mm or 8 mm, totaling 6 specimens for each case. The injection was performed using a 100 ml syringe coupled to a 4 mm diameter tube installed at the bottom of one of the Plexiglas plates. For each set of six specimens with the same  $d_{cr}$ , three specimens were injected with grout A and other three with grout B.

mortar prepared with soil sieved through ASTM sieve #4. Plastic tubes with 6 mm diameter were installed in one of the sides of the specimens such that they penetrated about 4 cm in the wallets and that their spacing was inferior to 10 cm. A 100 ml syringe with water was injected in all tubes 1 hour before injecting the grouts in order to mitigate the water sorption by the wallets. Only the grout B was used to inject the five specimens, and their injection started from the bottom tubes up to the top ones, using the same 100 ml syringe (Fig. 7b).
